**LABORATORY ANALYSIS
OF HANGAR 1 SIDING**

Analysis of Laminate

Project: Hangar 1 / Sub-Contract # 056016

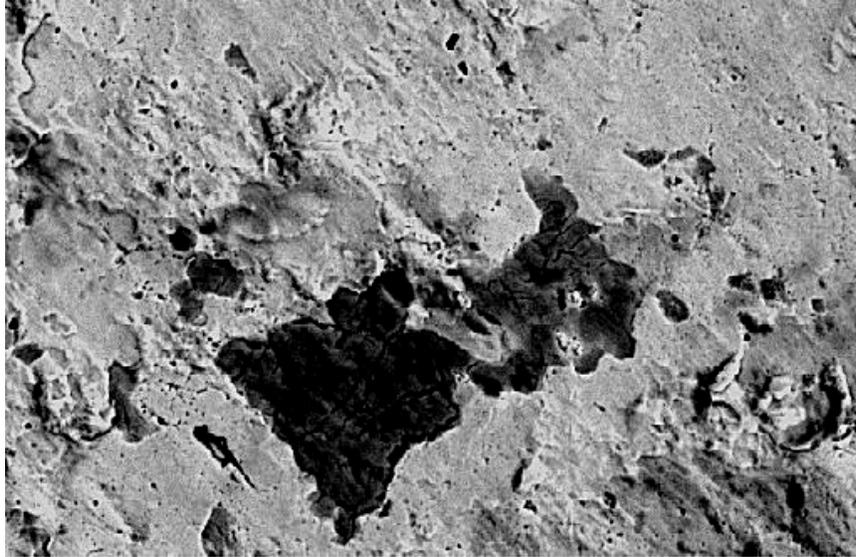
Figure 1: SEM back-scatter electron image (BEI) showing the surface of the metal. The dark area is remaining tar and the light is the iron. No evidence of galvanization is present.

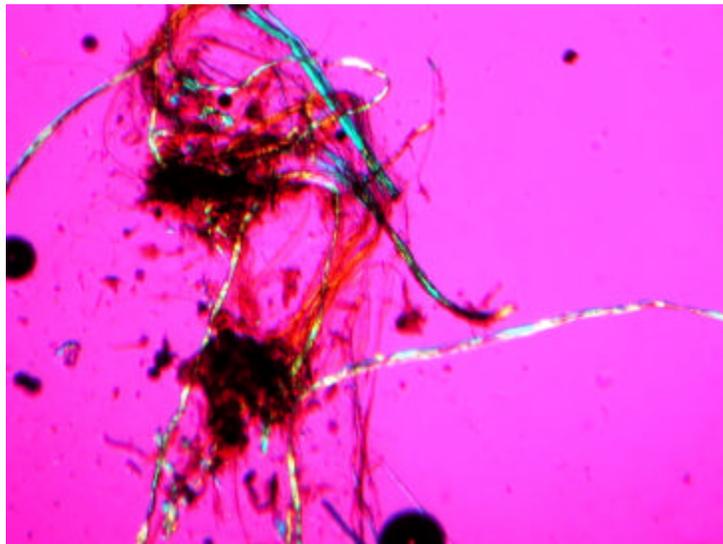
Figure 2: PLM 400X image of the fibrous mat showing the chrysotile asbestos and cellulose components.

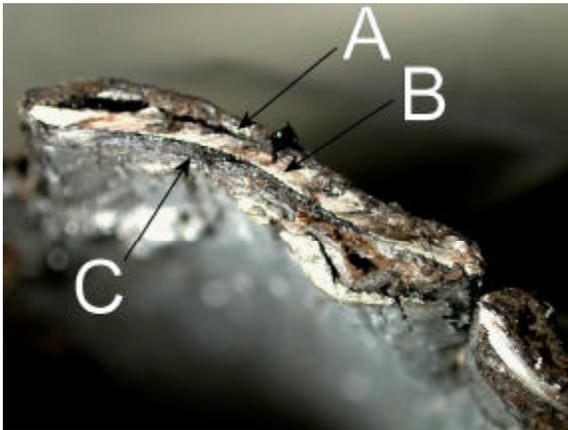
Figure 3: Cut section of the metal sample showing the tar/fibrous mat/paint layers (A&C) and the metal (B)

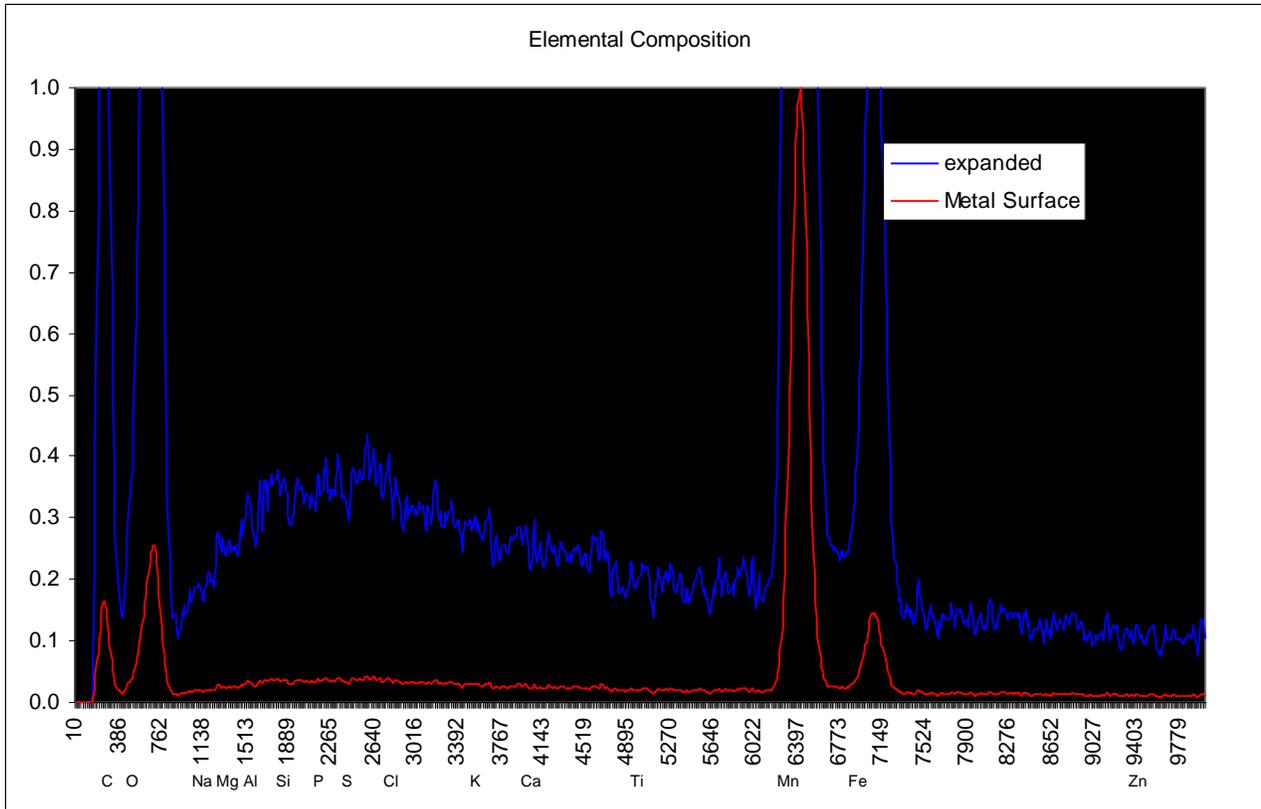
Figure 7: EDX spectra of the surface of the metal showing no evidence of a galvanized coating.

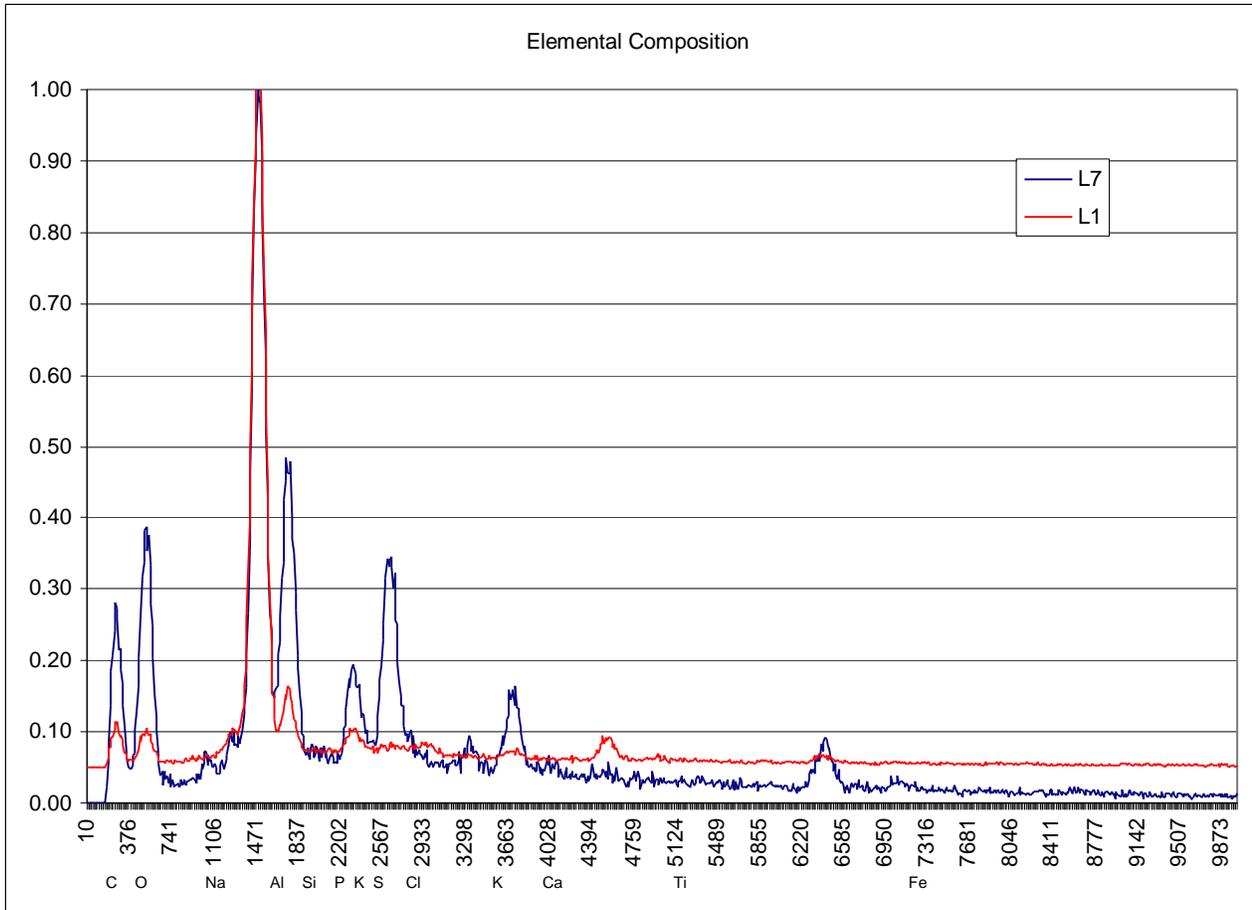
Figure 8: EDX spectra showing the elemental composition of the paint layers. L1 is nearly all paint. L7 is a mixture of aluminum-based paint with the fibrous mat particles.
