2013 Institutional Controls Site Inspection Report

Operable Units A and B-1

Former Naval Complex

Adak, Alaska

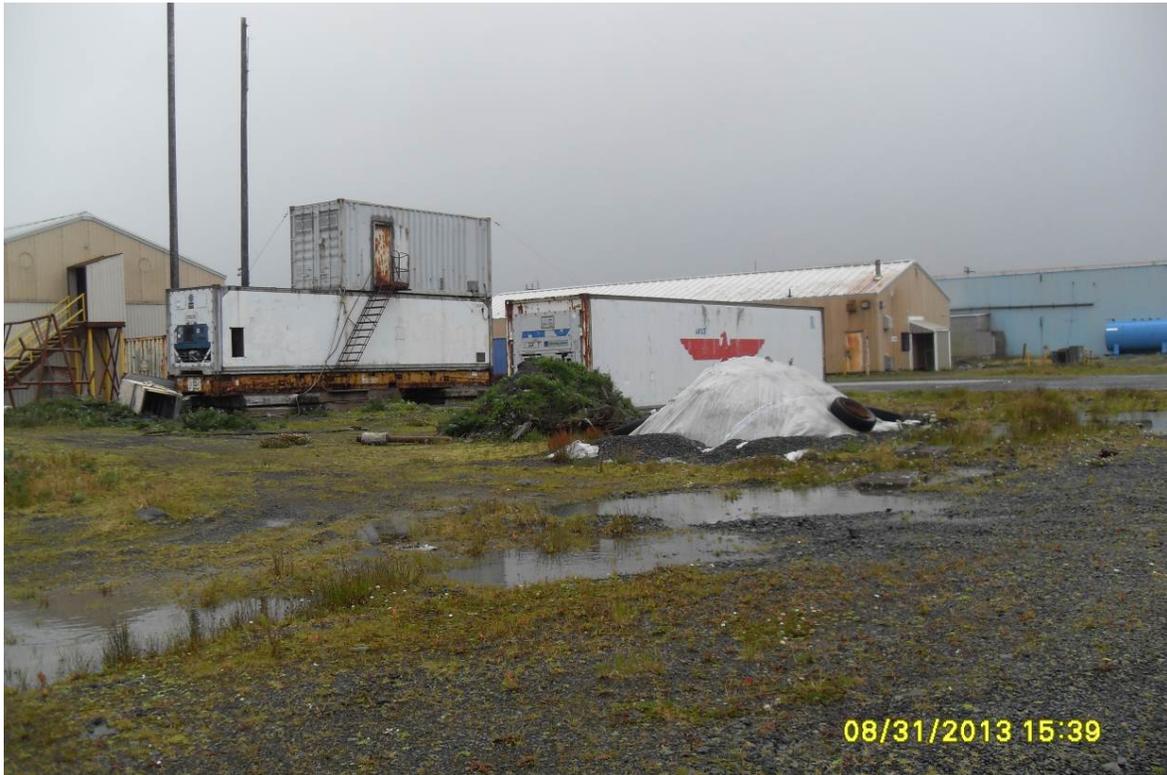
As observed in 2012, the aboveground storage tank (AST), and 55-gallon drums of fuel (not associated with Navy activities) located south of the site and near well MW15-424 is offsite. The pile of gravel fill covered by poly-sheeting observed last year remains onsite (Figure 2-1). The oily stained soil observed at this location during the 2011 inspections was not observed during the 2013 inspection (Photograph 2-4).

Photograph 2-4. SWMU 15, Future Jobs/Defense Reutilization Marketing Office - looking southwest where the AST, drums and stained soil was located south of site during the 2011 inspection.

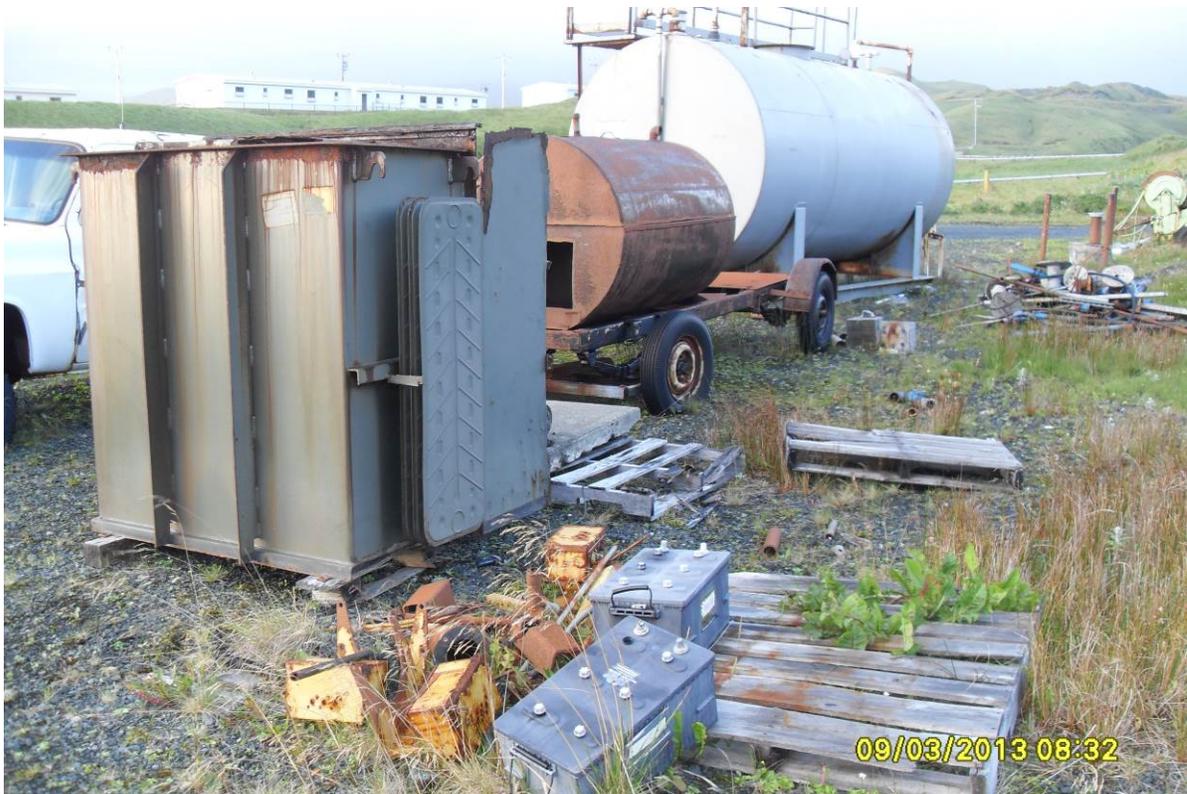
Photograph 2-6. SWMU 17, Power Plant No. 3 Area – looking south at the transformer stored east side of Building 10203. Monitoring well 05-735 in background.

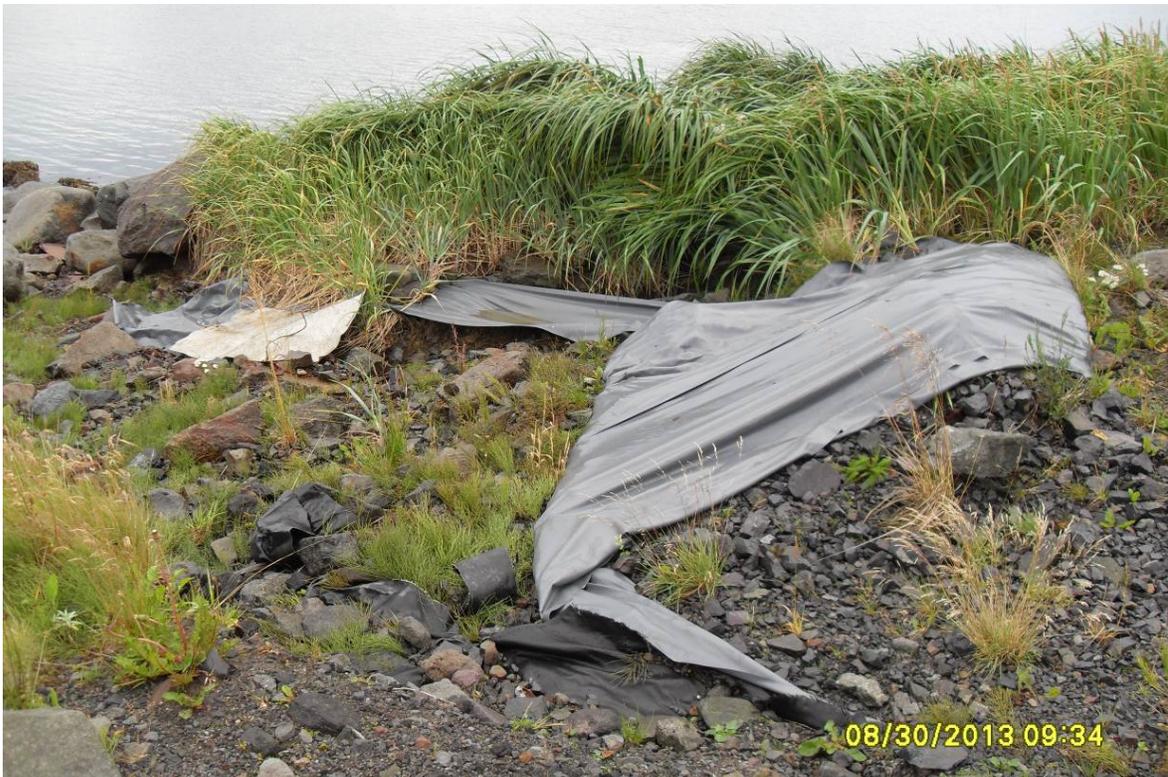
Photograph 2-13. SWMU 13, Metals Landfill – looking east at erosion and damaged Swale 6

ICs appear to be functioning as intended to protect human receptors from exposure to contaminated soil or groundwater. The four eroded areas along the armor wall are recommended for repair.

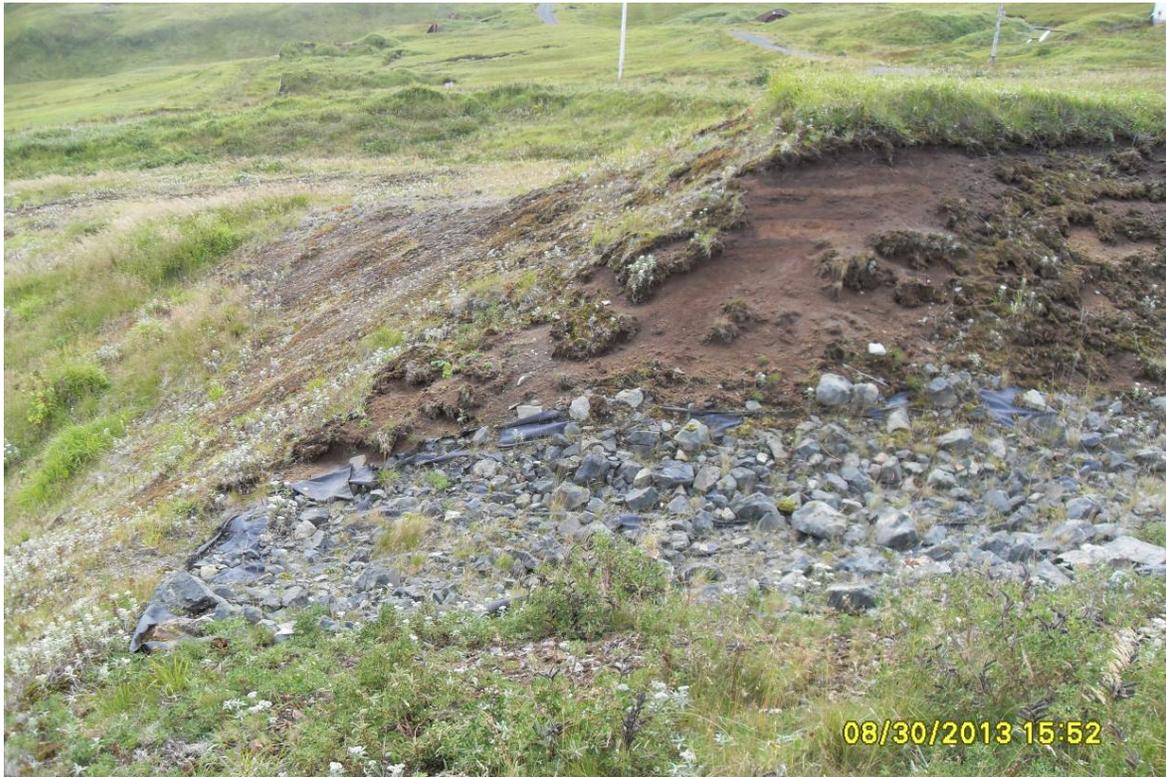
During the 2009 through 2011 inspections, a large, sparsely vegetated area was noted in the central portion of the landfill. Vegetation in this area shows improvement in that the vegetation was generally thicker and taller than in previous inspections (Photograph 2-14). The two sparsely vegetated areas in the southern portion of the landfill were not observed during the August 30, 2013 inspection. In general, the remainder of the vegetative cap appears adequate.

Photograph 2-15. SWMU 25, Roberts Landfill – looking southwest at sparsely vegetated and eroded area near swales

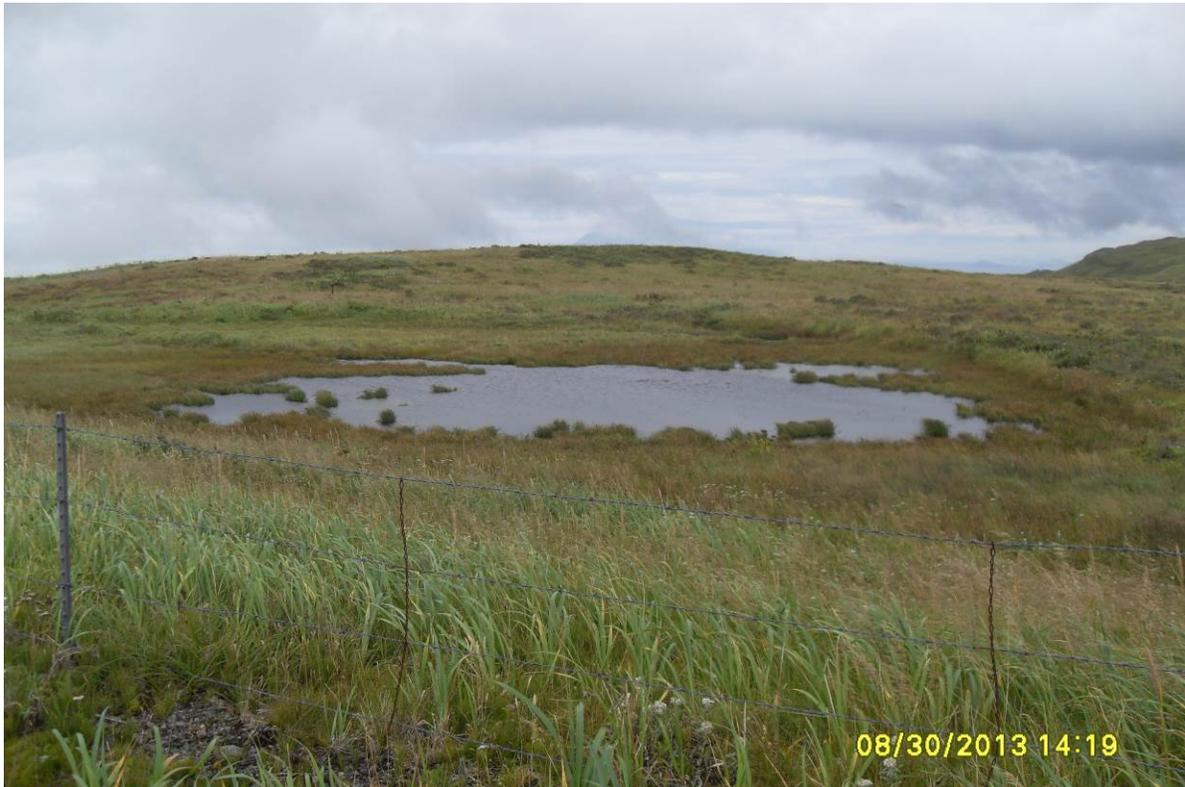
the landfill cap or impacting its integrity. A small ponded hole was observed at the southeast end of the site near monitoring well B-1. The hole is about 5 feet by 5 feet and is not located on the landfill cap and not impacting the integrity of the cap. A ponded area was observed at the south end of the site at the end of a swale along Happy Valley Road (Figure 2-5) and may be caused by a blocked culvert. An area of ponded water was observed south of the pond located on the southern portion of the landfill near the gates approximately 5 feet wide and 15 feet long.

Photograph 2-17. SWMU 25, Roberts Landfill – looking northeast at the pond

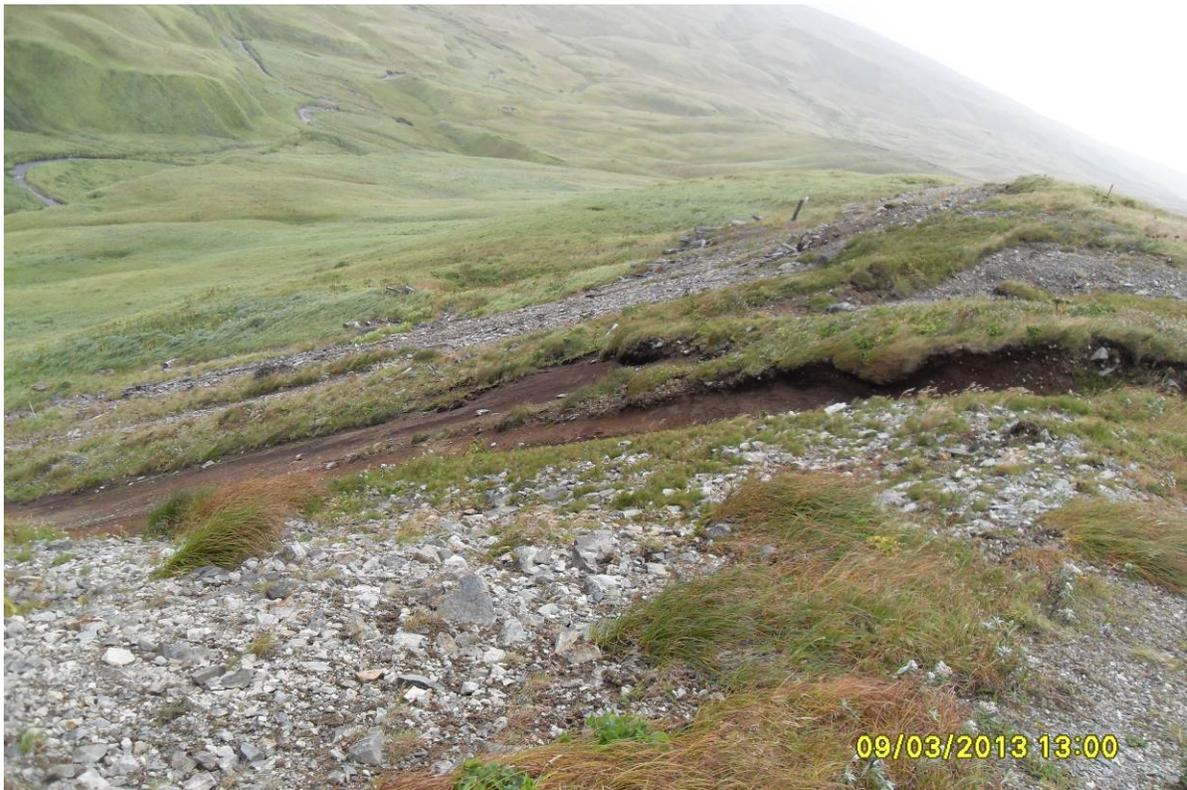
Photograph 3-1. SWMU 20, White Alice/Trout Creek Disposal Area – looking east towards site and eroded area

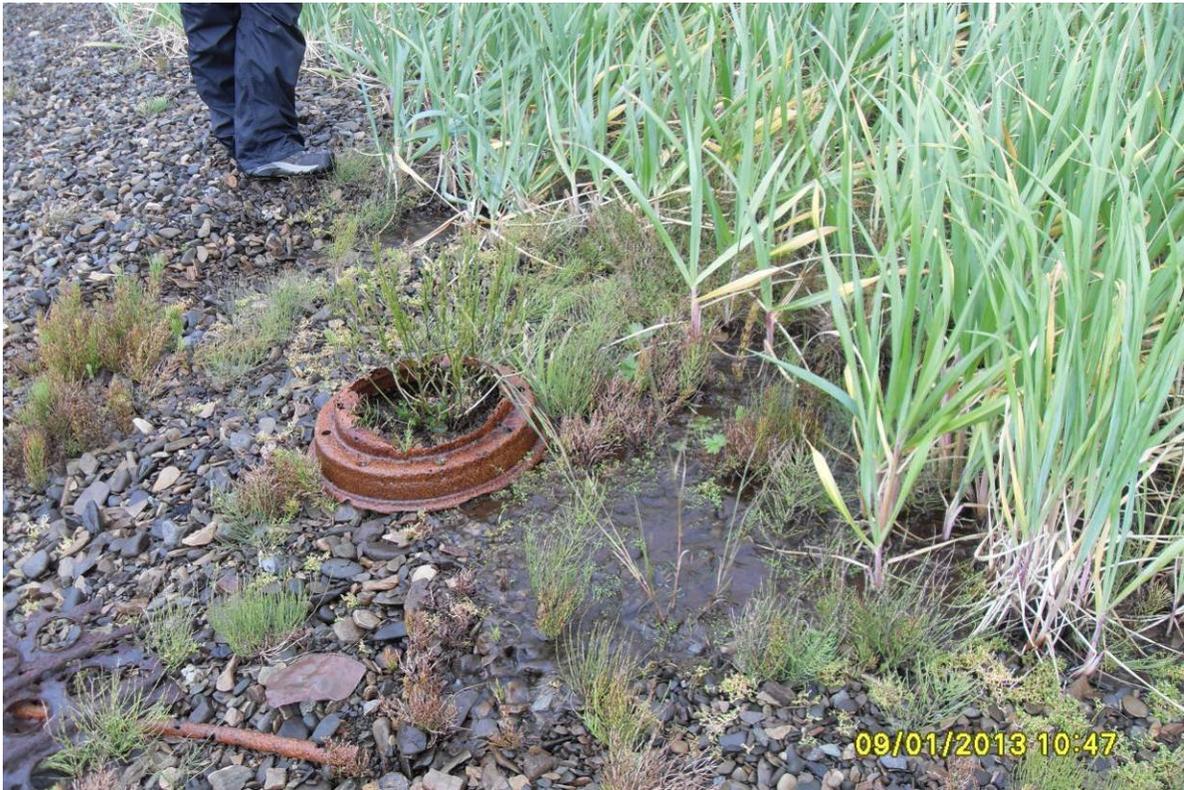
Photograph 3-7. SWMU 4, South Davis Road Landfill - looking east at seep on the south end of landfill with some metal debris.

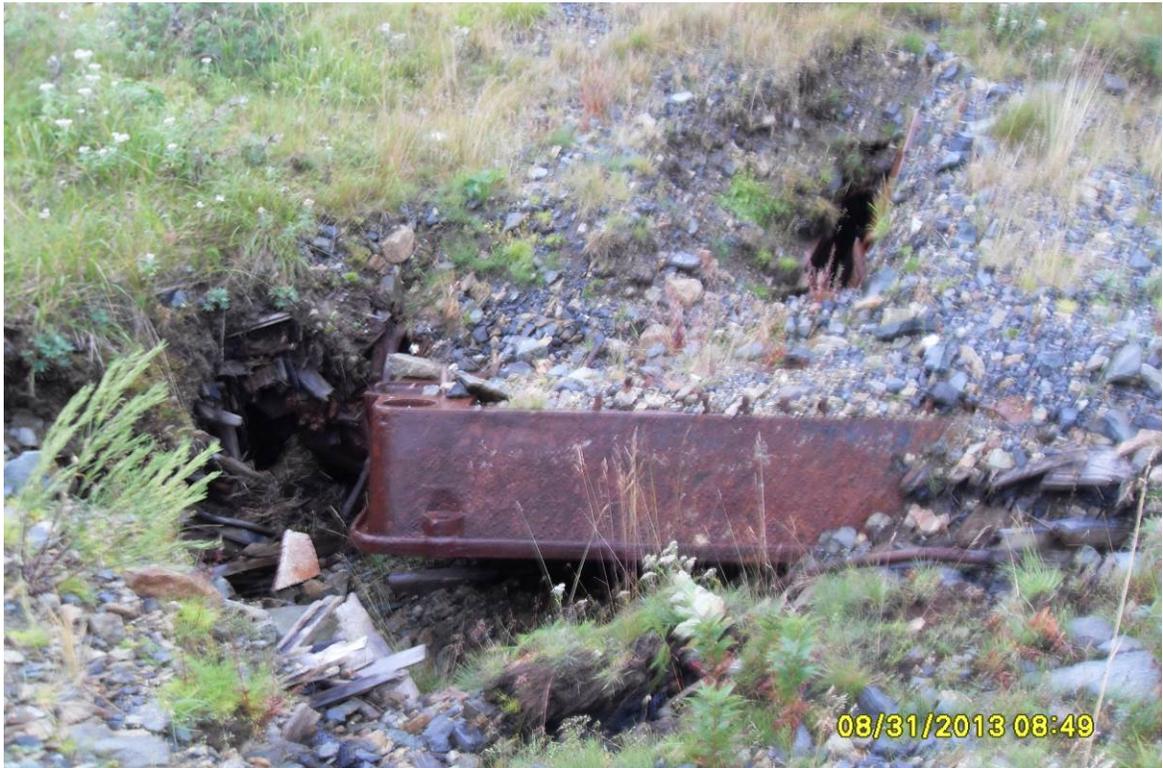
Photograph 3-8. SWMU 11, Palisades Landfill – looking south sinkhole with debris

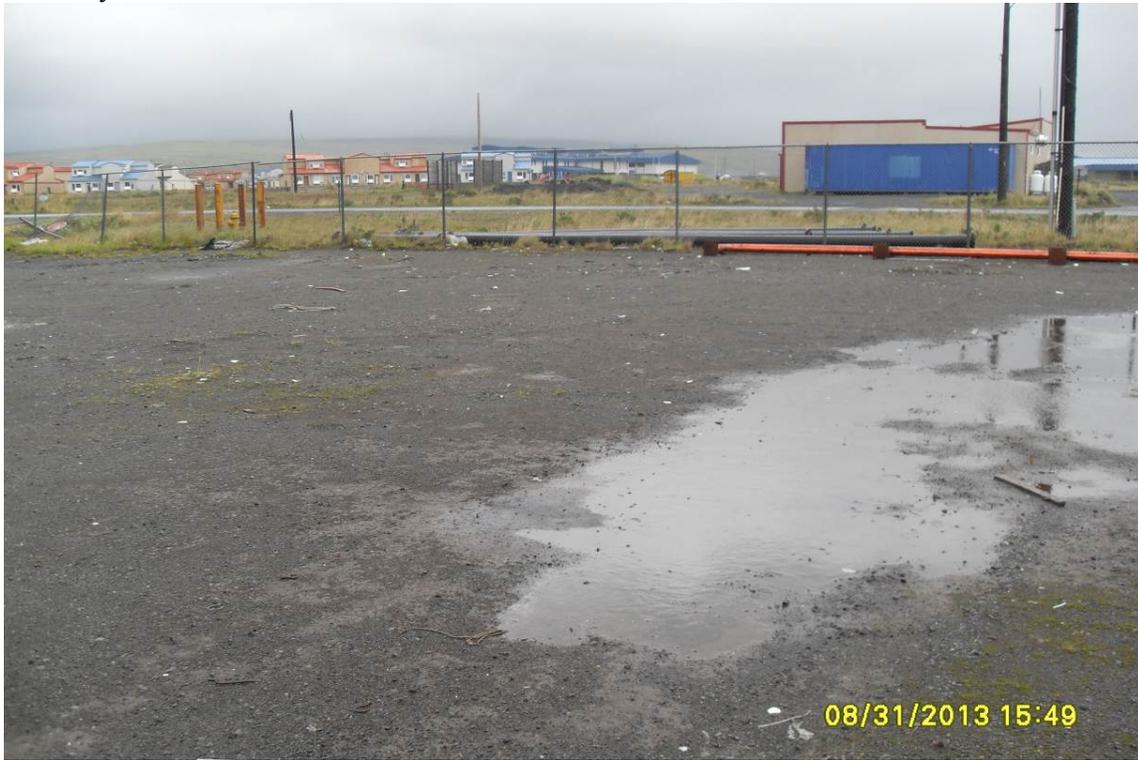
Photograph 1549- Stained soil where drums used to be stored

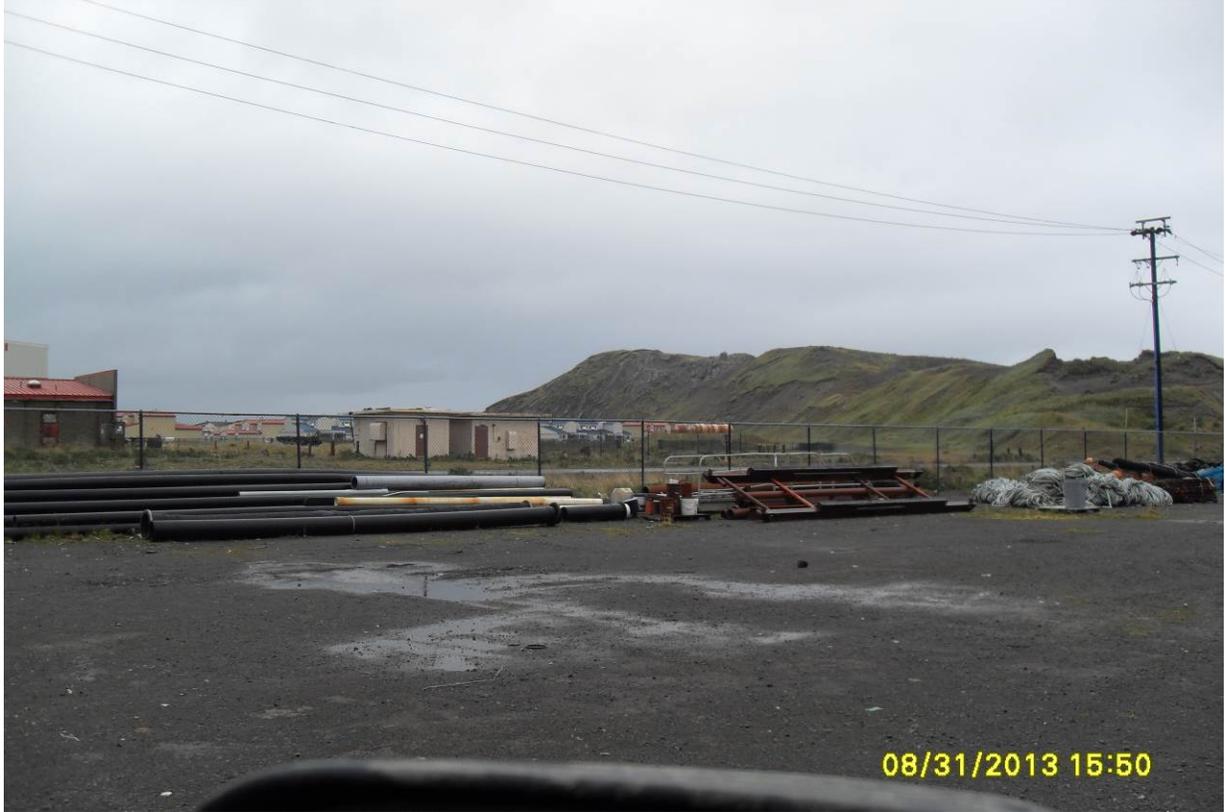
Photograph 1550 – Five-gallon containers (middle of photograph) stored onsite previously identified as oil and paint cans.

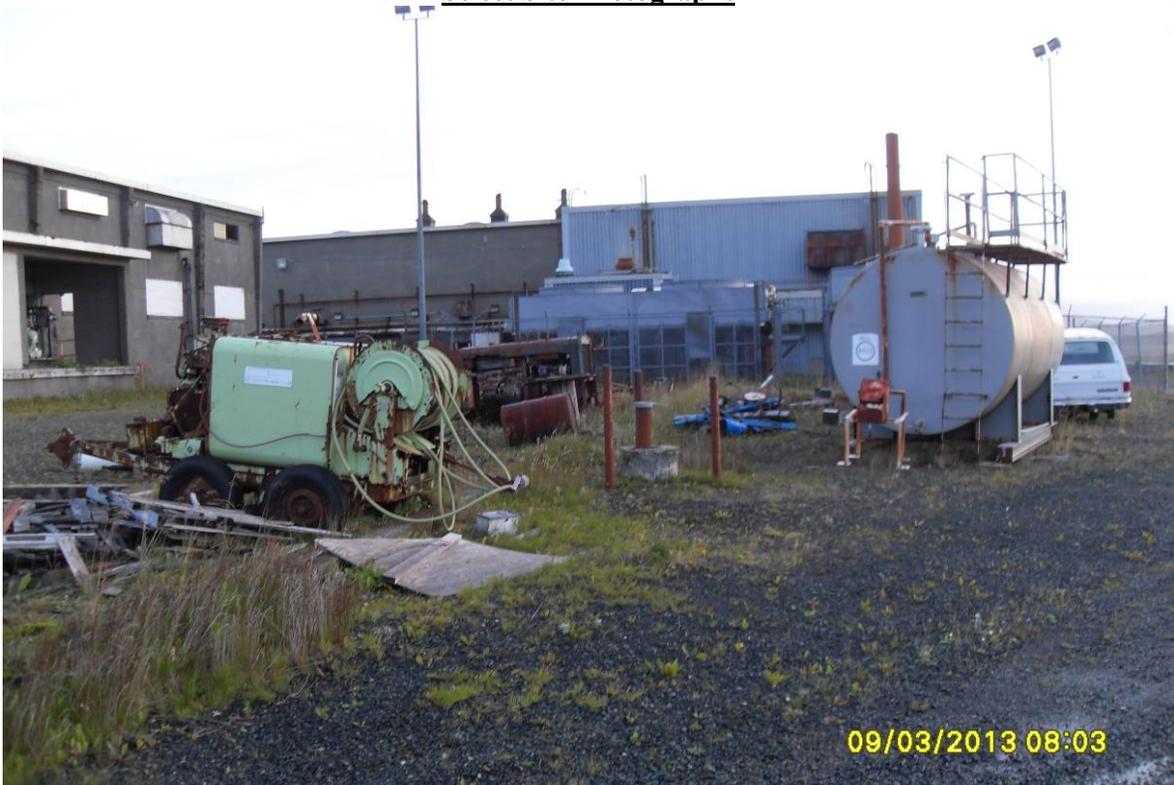
Photograph 0803 – AST, batteries, transformer, leaking drum, and equipment stored on site along the access road on the southeast side of the power plant looking north. Well 05-735 in middle of photo.

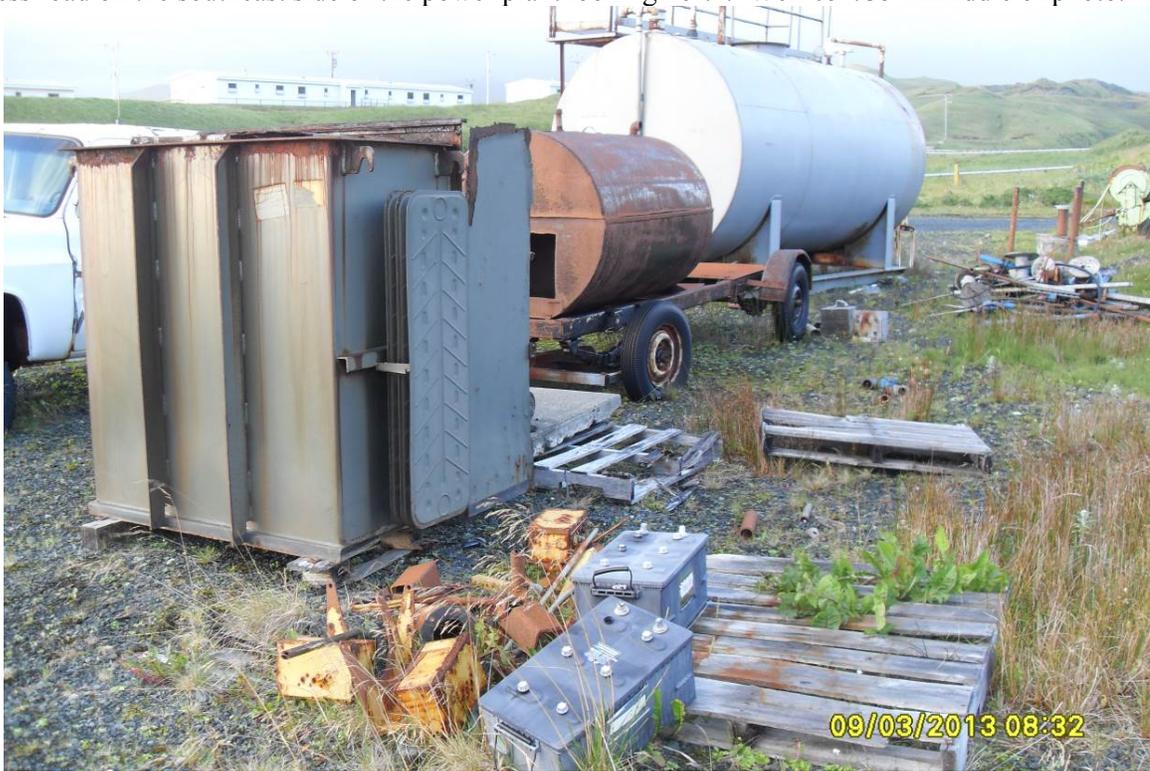
Photograph 0832 – Transformer stored on southwest side of site along access road on the east side of the power plant looking south

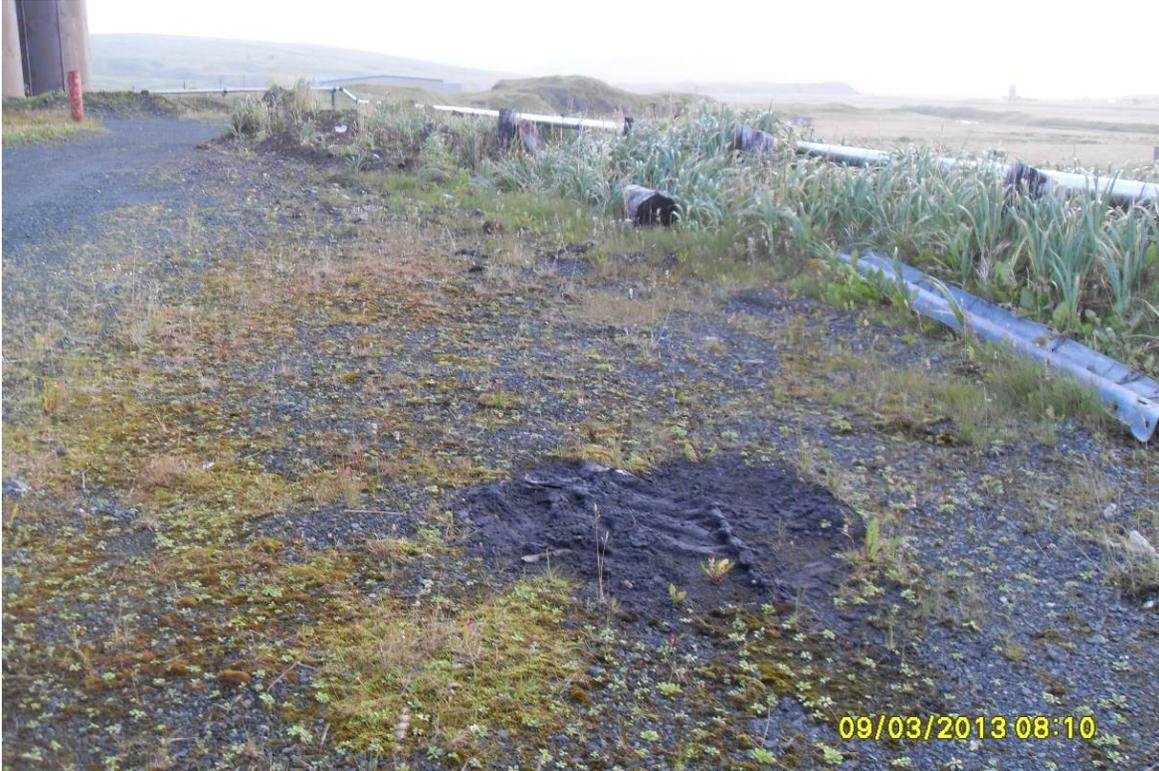
Photograph 0810 – Stained area on the east access road south of excavated area looking north

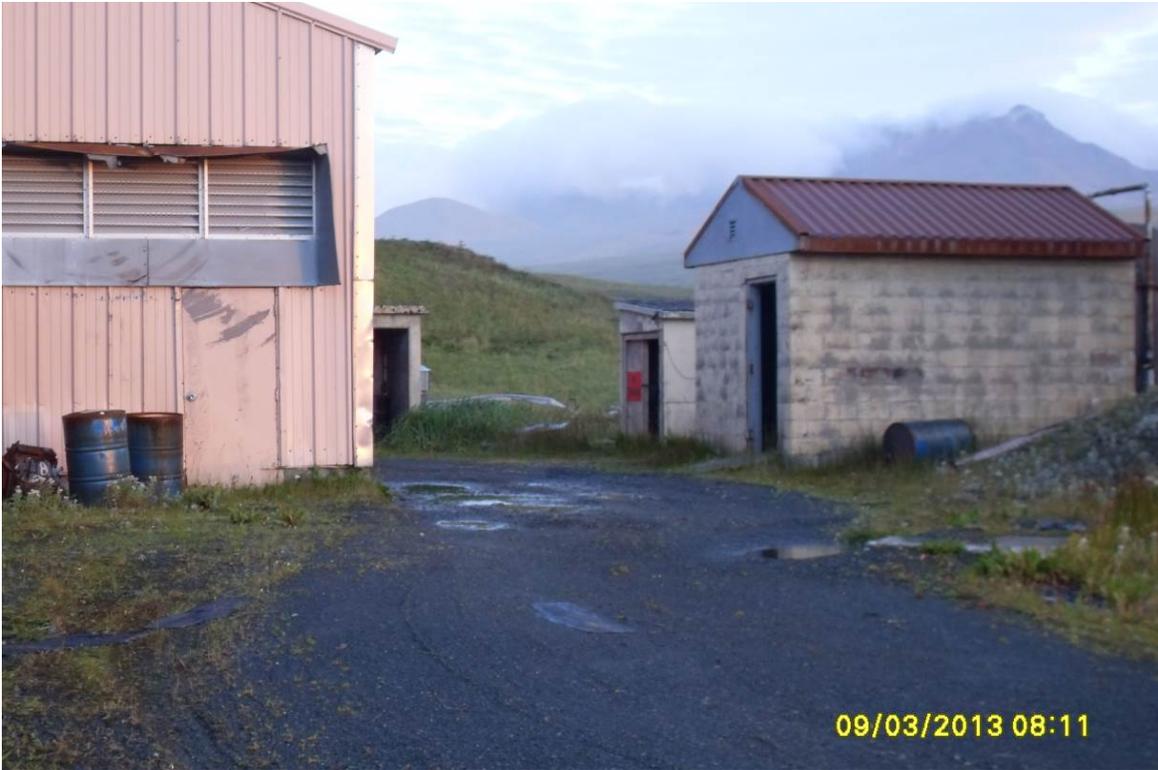
Photograph 0811 – Three drums observed onsite along the access road on the north side of the power plant looking west

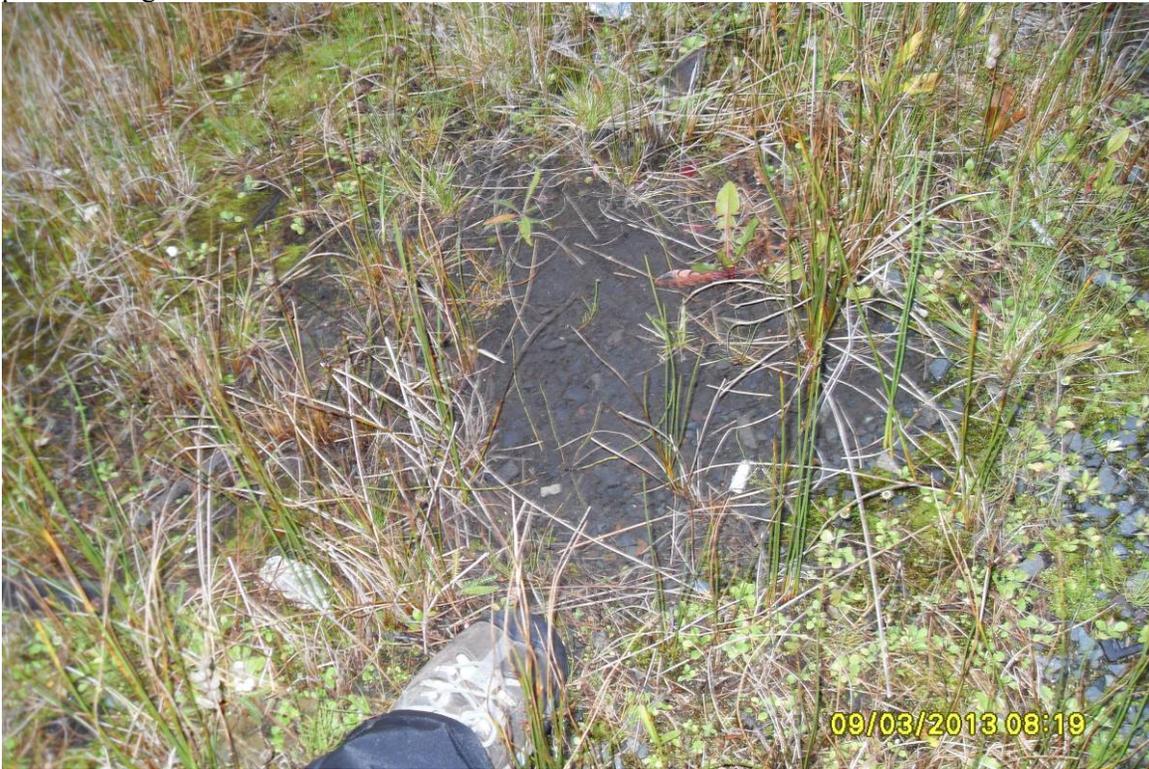
Photograph 0819 – Small stained area in front of the AST secondary containment area along the access road on the north side of the power plant

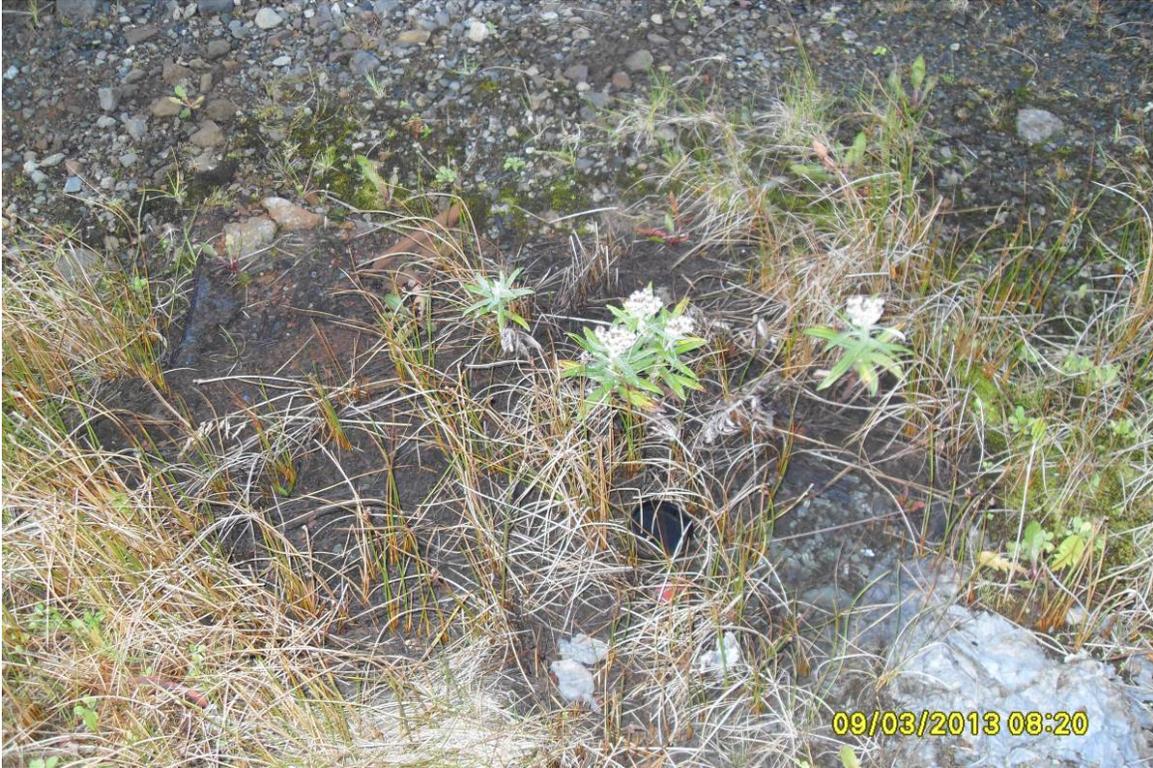
Photograph 0820 – Second small stained area in front of the AST secondary containment area along the access road on the north side of the power plant looking east

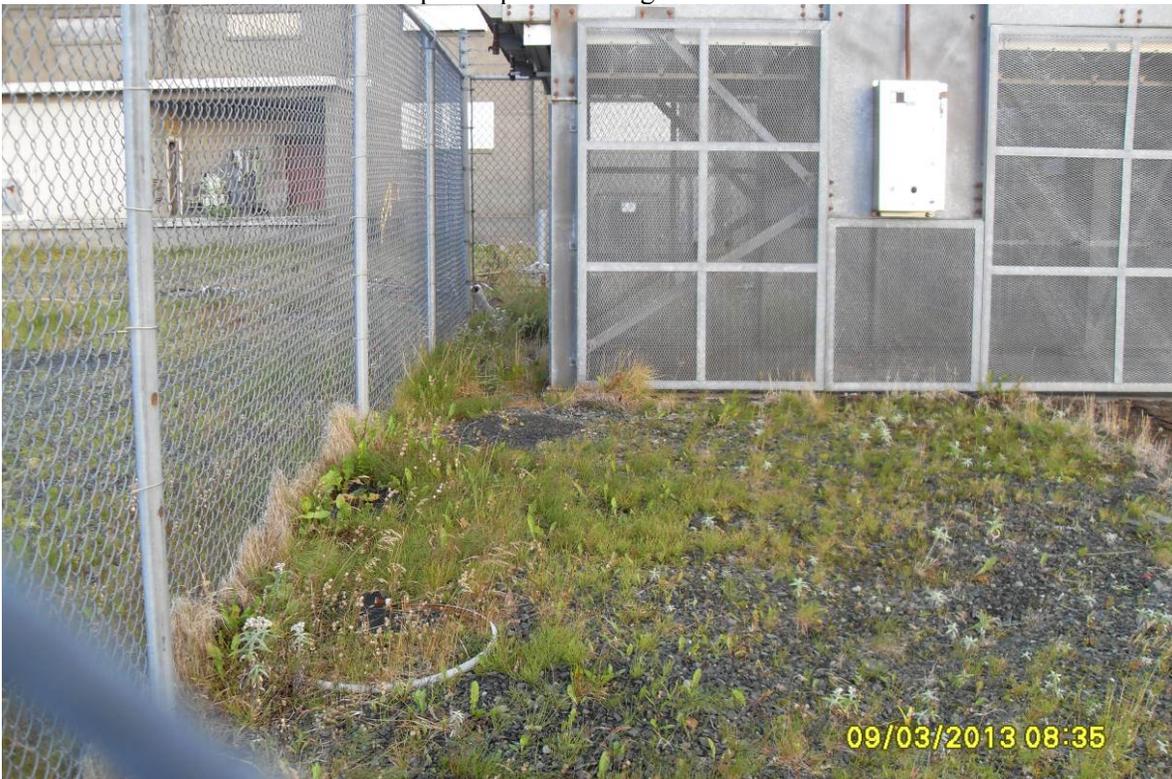
Photograph 0835 – Two of the stained areas within the fenced area on the east side of the site looking northwest

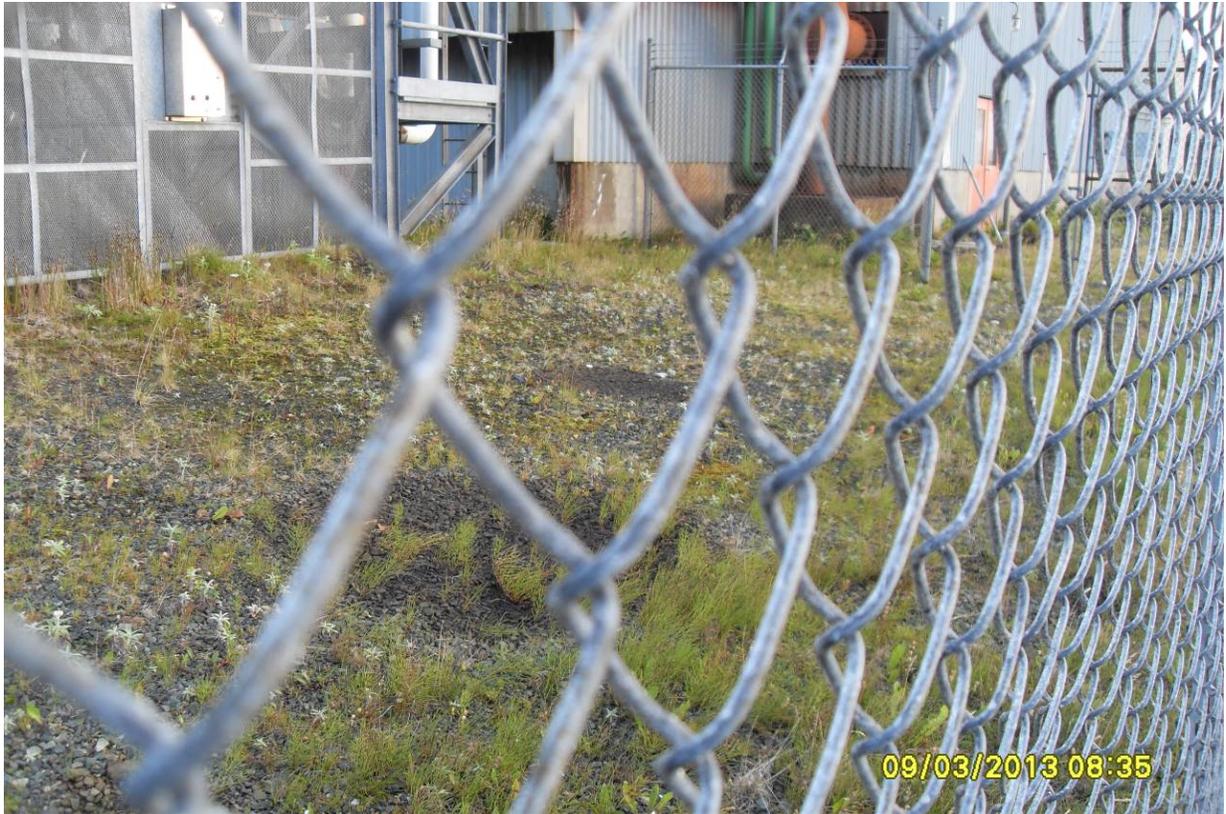
Photograph 0835 – Stained area with in the fenced area on the east side of the site looking west

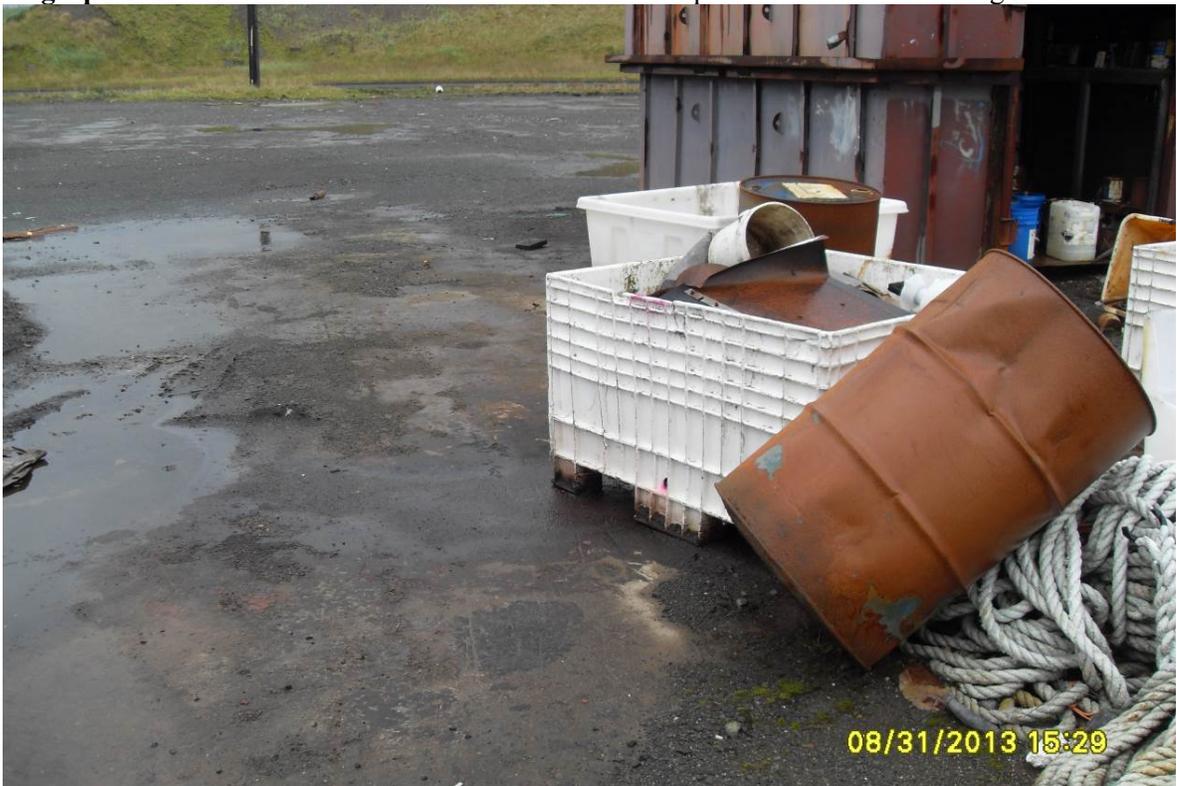
Photograph 1529 – Drum and paint containers with staining and sheen on the ground looking north

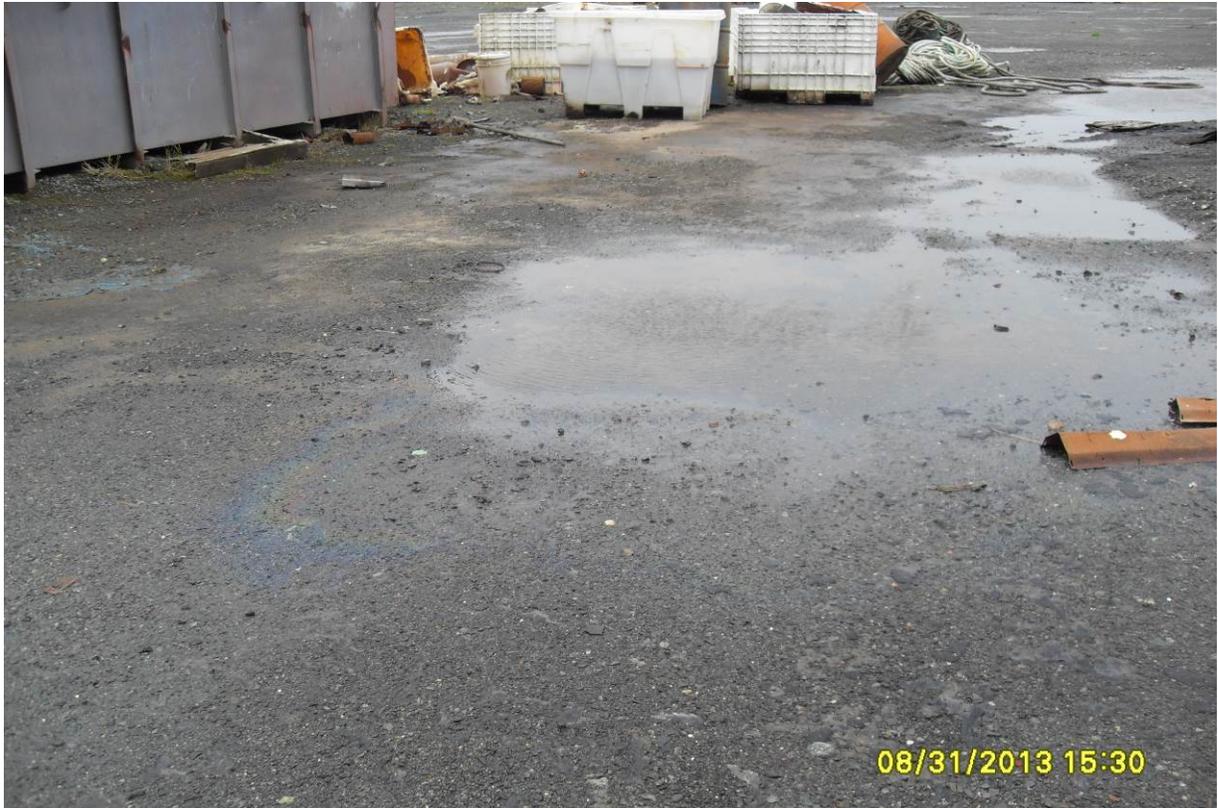
Photograph 1530 – Sheen on ponded water looking south

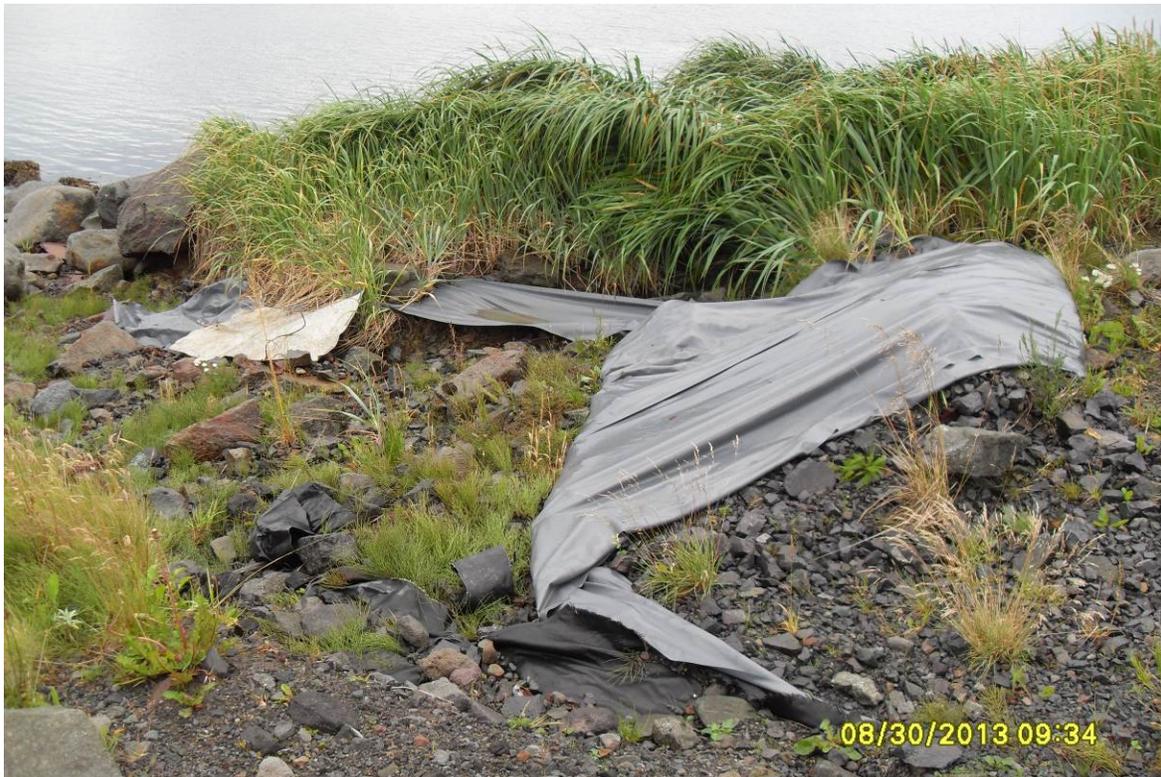
Photograph 0934 – Swale 6 erosion and liner damage on the east side of the site looking southeast

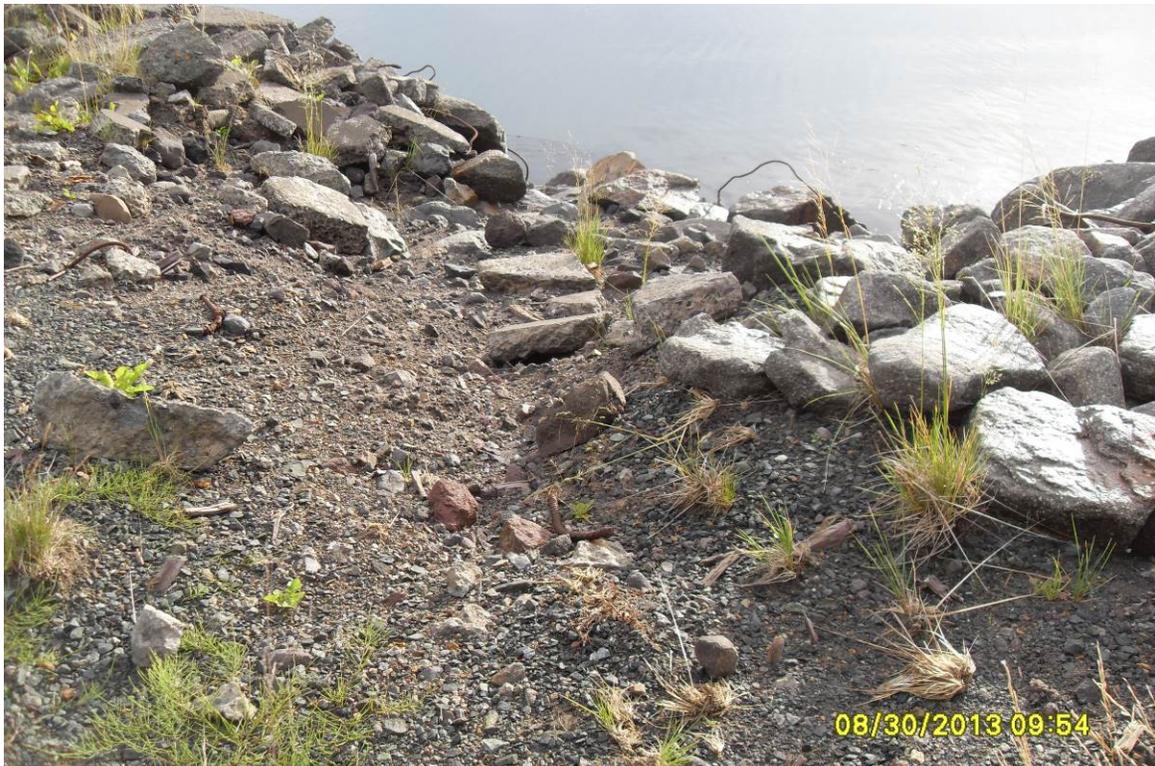
Photograph 0954 – Eroded area at the top of the armor rock slope north of well MW-603.

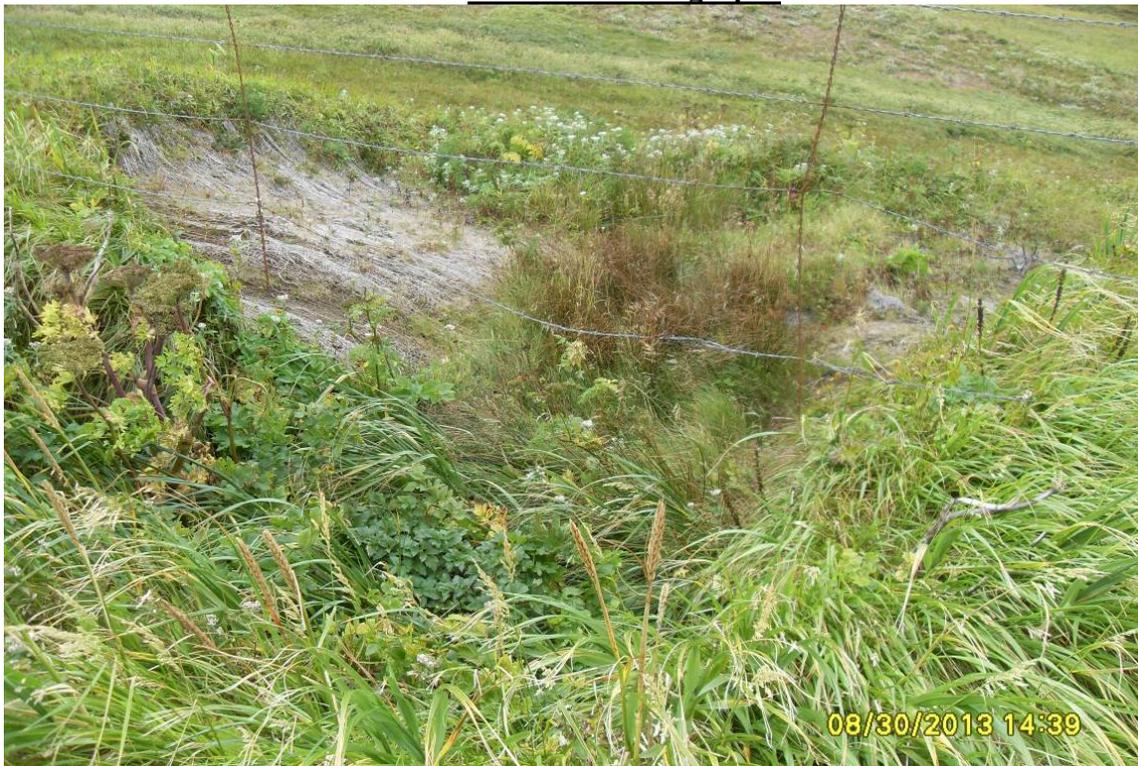
Photograph 1439 – Repaired eroded area with vegetation growing on the western fence line looking east; continue to monitor.

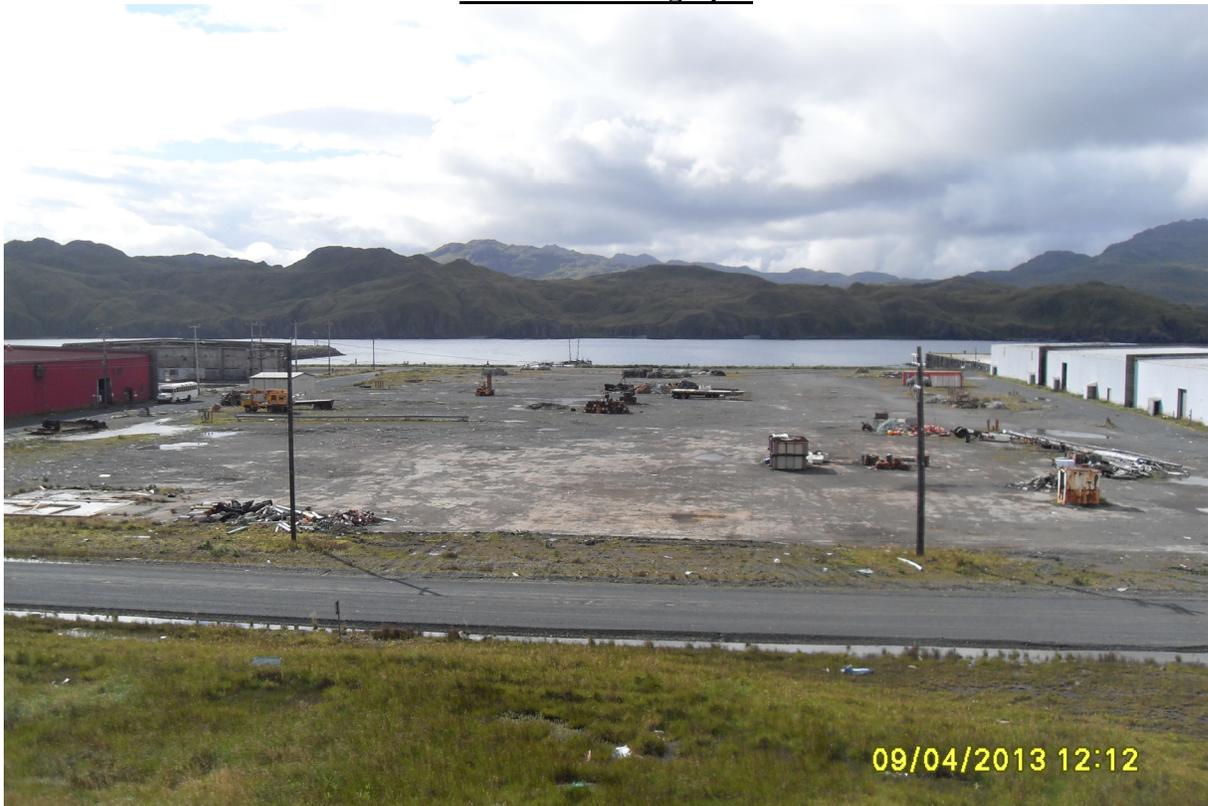
Photograph 1212 – Site overview looking south; creosote log pile on northwest site corner, pink conex with drums, paint cans and stained soil near middle of photo, cylinders at northeast site corner.
