2013 Institutional Controls Site Inspection Report

Operable Units A and B-1

Former Naval Complex

Adak, Alaska

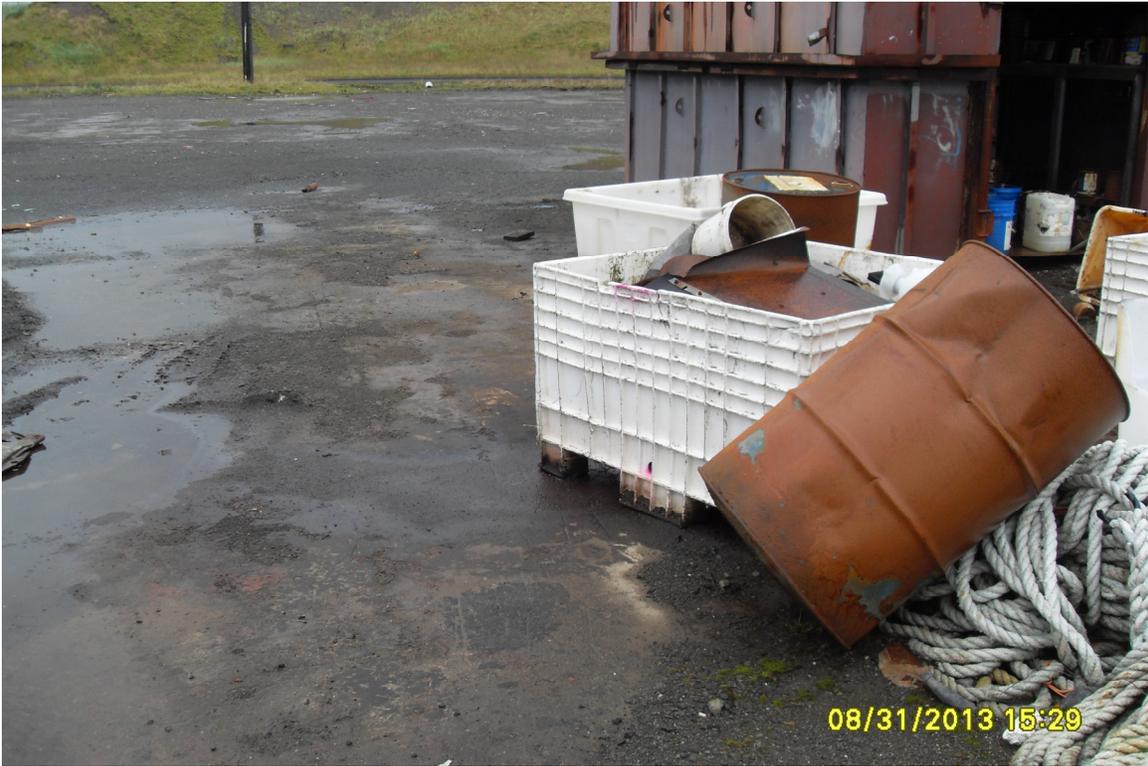
Photograph 1529 – Drum and paint containers with staining and sheen on the ground looking north

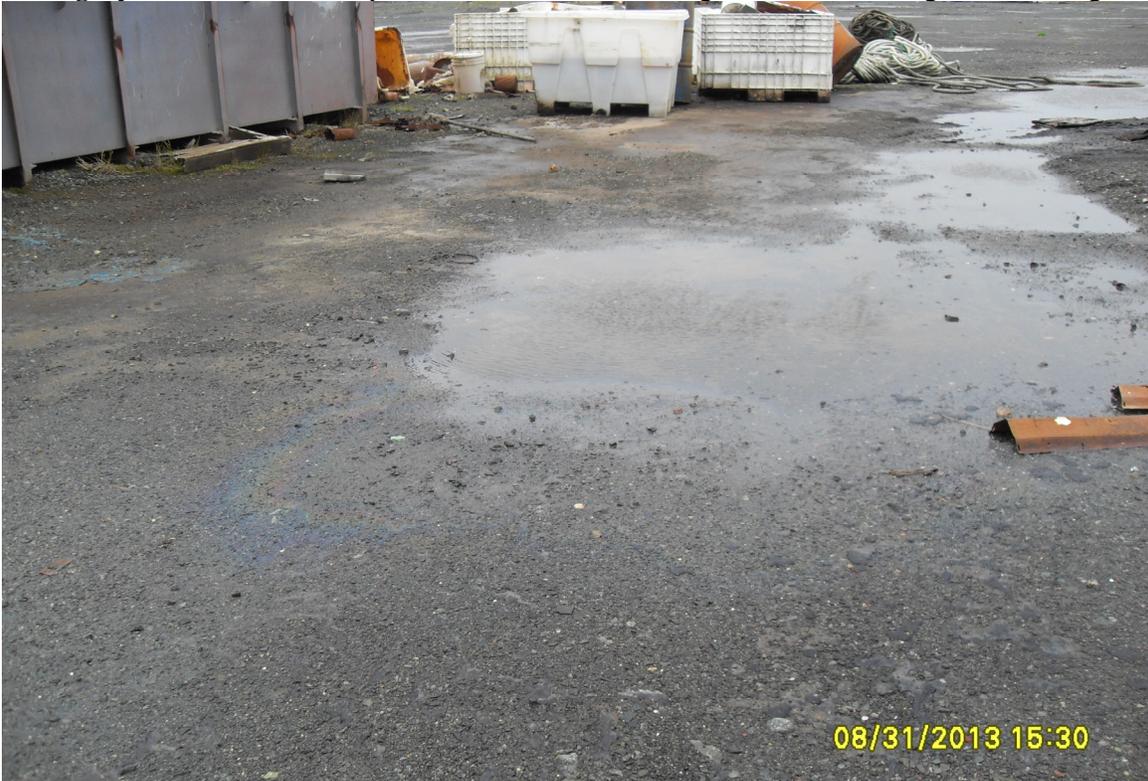
Photograph 1530 – Sheen on ponded water looking south

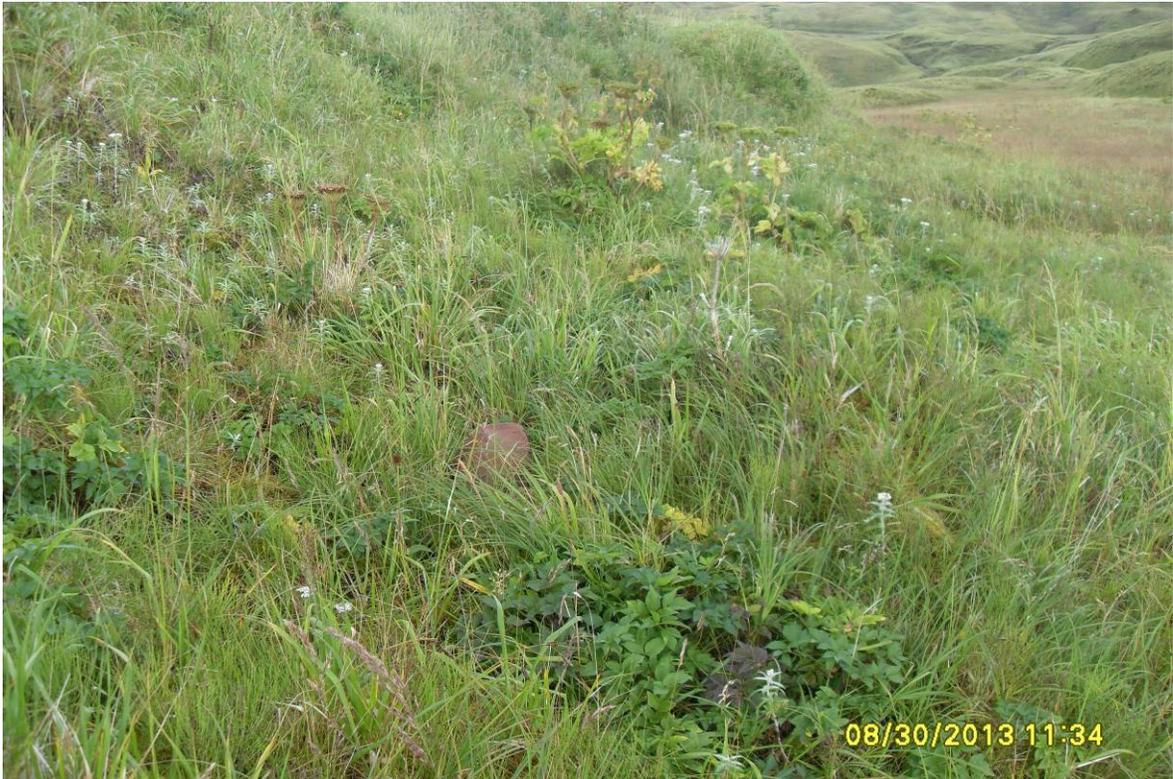
Photograph 1134 – Debris on the east side of mound looking north
