Asbestos-Containing Material and Lead Based Paint Pre-Renovation Survey for Building 1 Naval Reserve Center Duluth, Minnesota

Contract No. N62467-96-D-0998
Delivery Order No. 0021

July 9, 2001

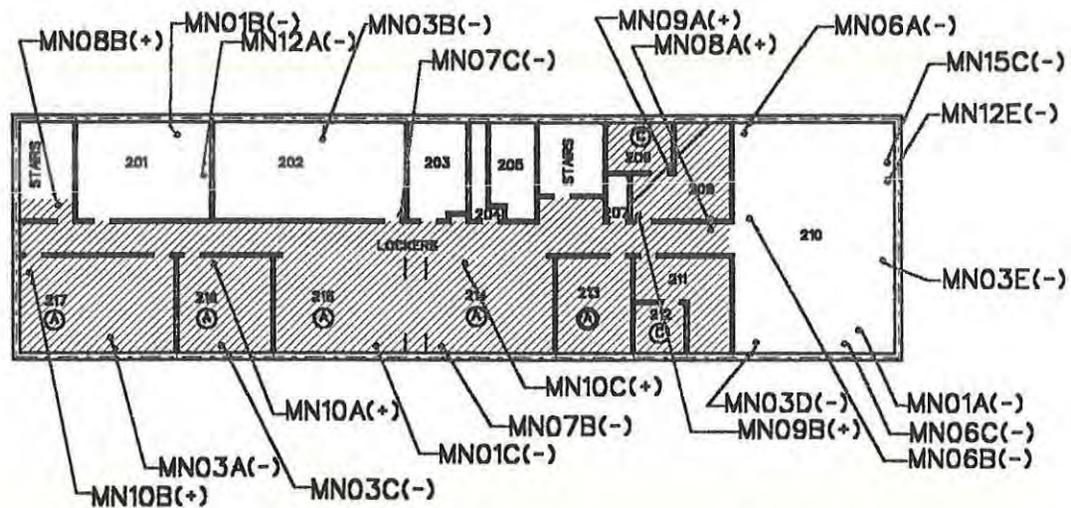
**NAVAL RESERVE CENTER, DULUTH, MN
BUILDING 1, SECOND FLOOR
Asbestos-Containing Material And
Sample Locations**

NOTE A:
No Asbestos-Containing Floor Tile Is Under Non-Asbestos-Containing Flooring.

NOTE B:
Roofing Materials Were Assumed To Contain Asbestos Due To Inaccessibility.

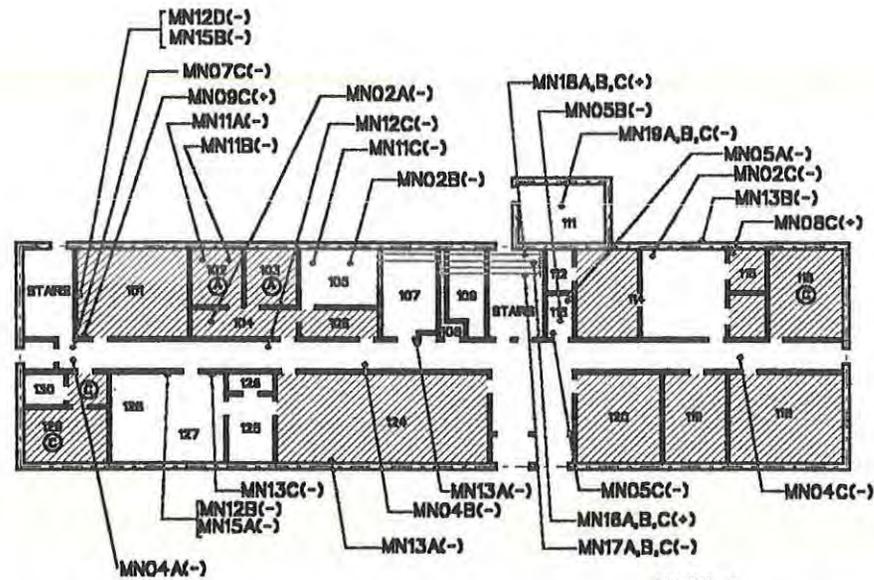
NAVAL RESERVE CENTER DULUTH, MN
BUILDING 1, FIRST FLOOR

NOTE A:
Asbestos-Containing Floor Tile is Under
Non-Asbestos-Containing Flooring.

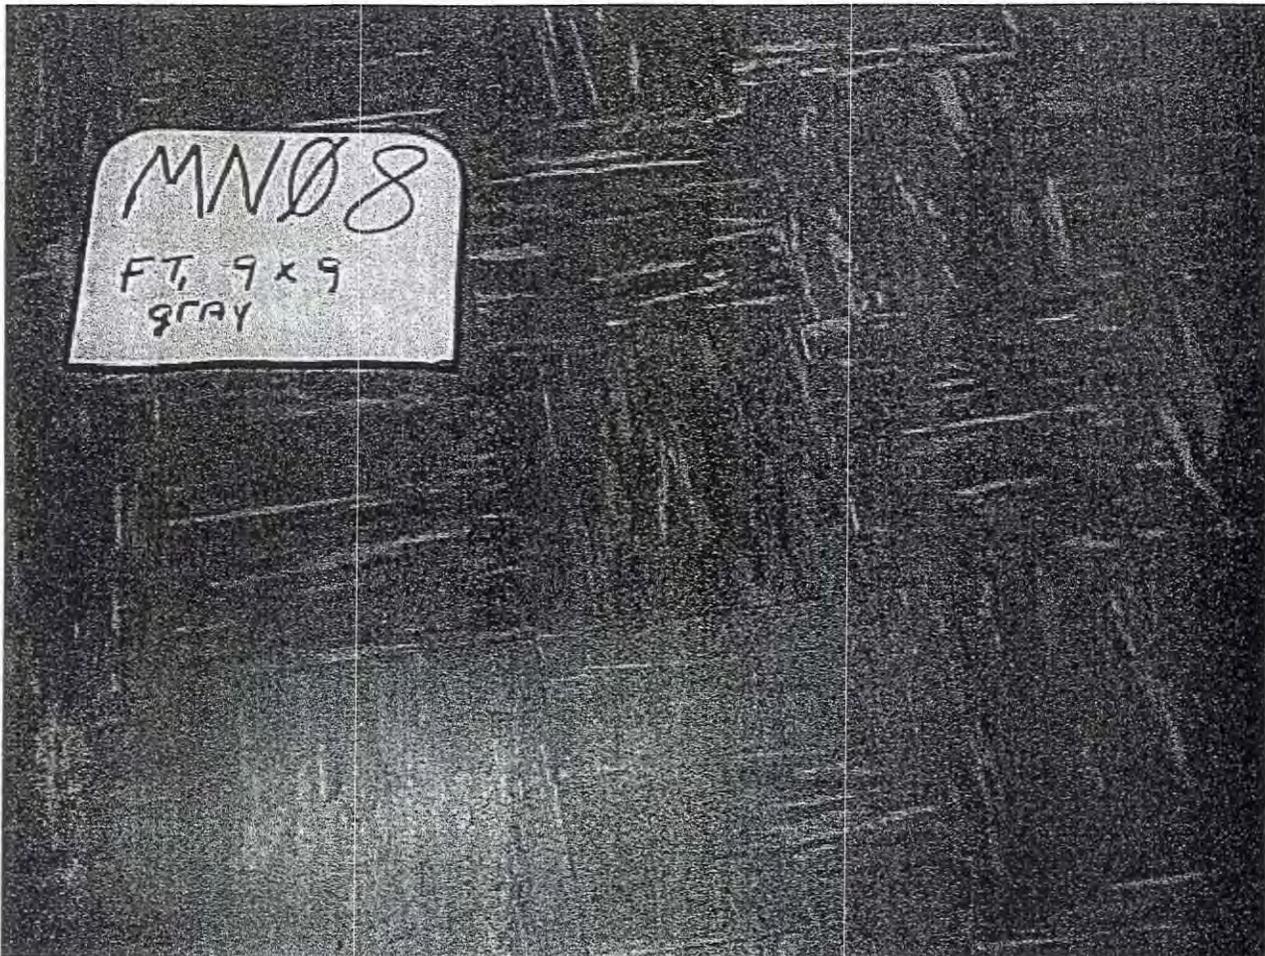
Floor Tile, 9" x 9" gray, HA # 08

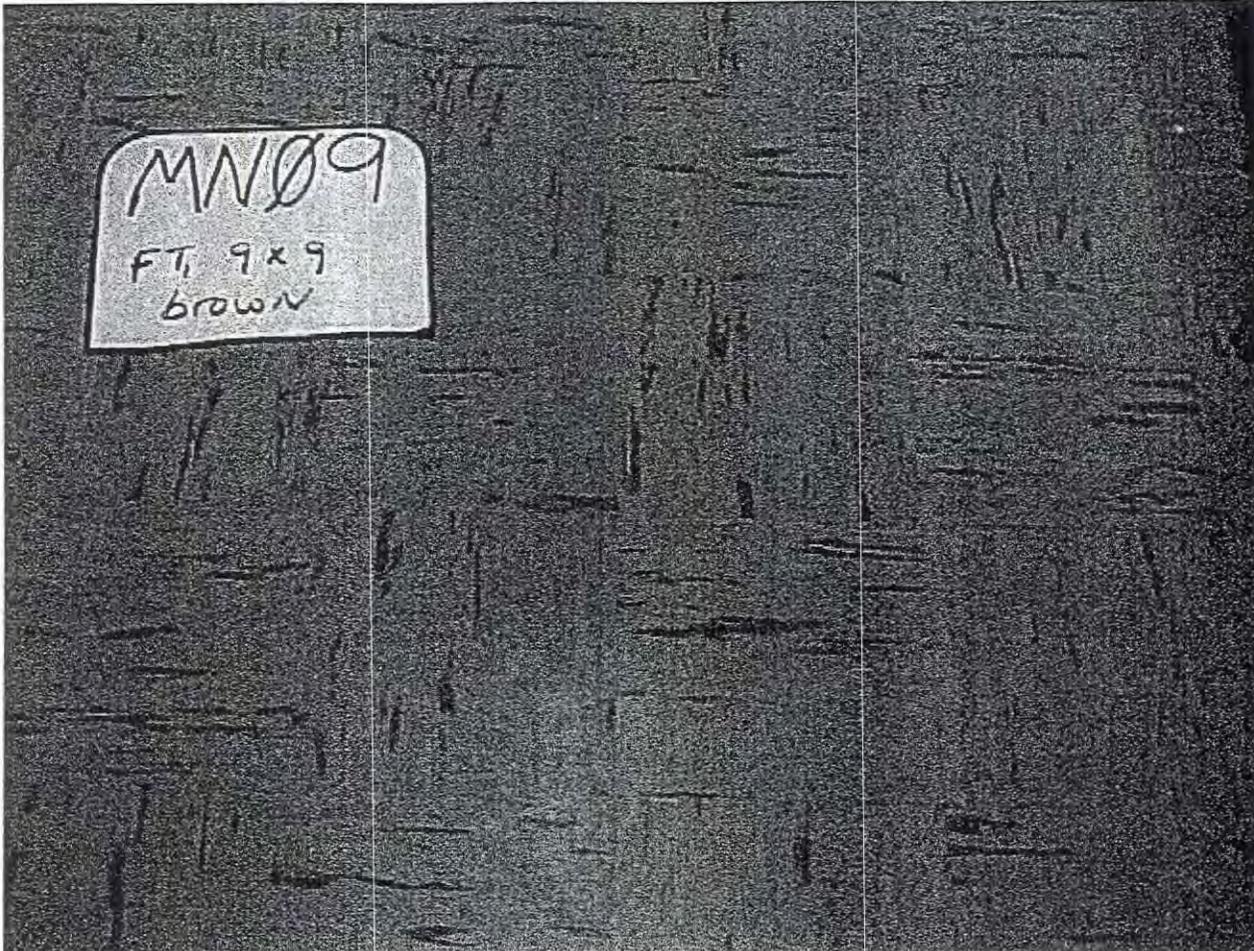
Floor Tile, 9" x 9" light brown, HA# 09

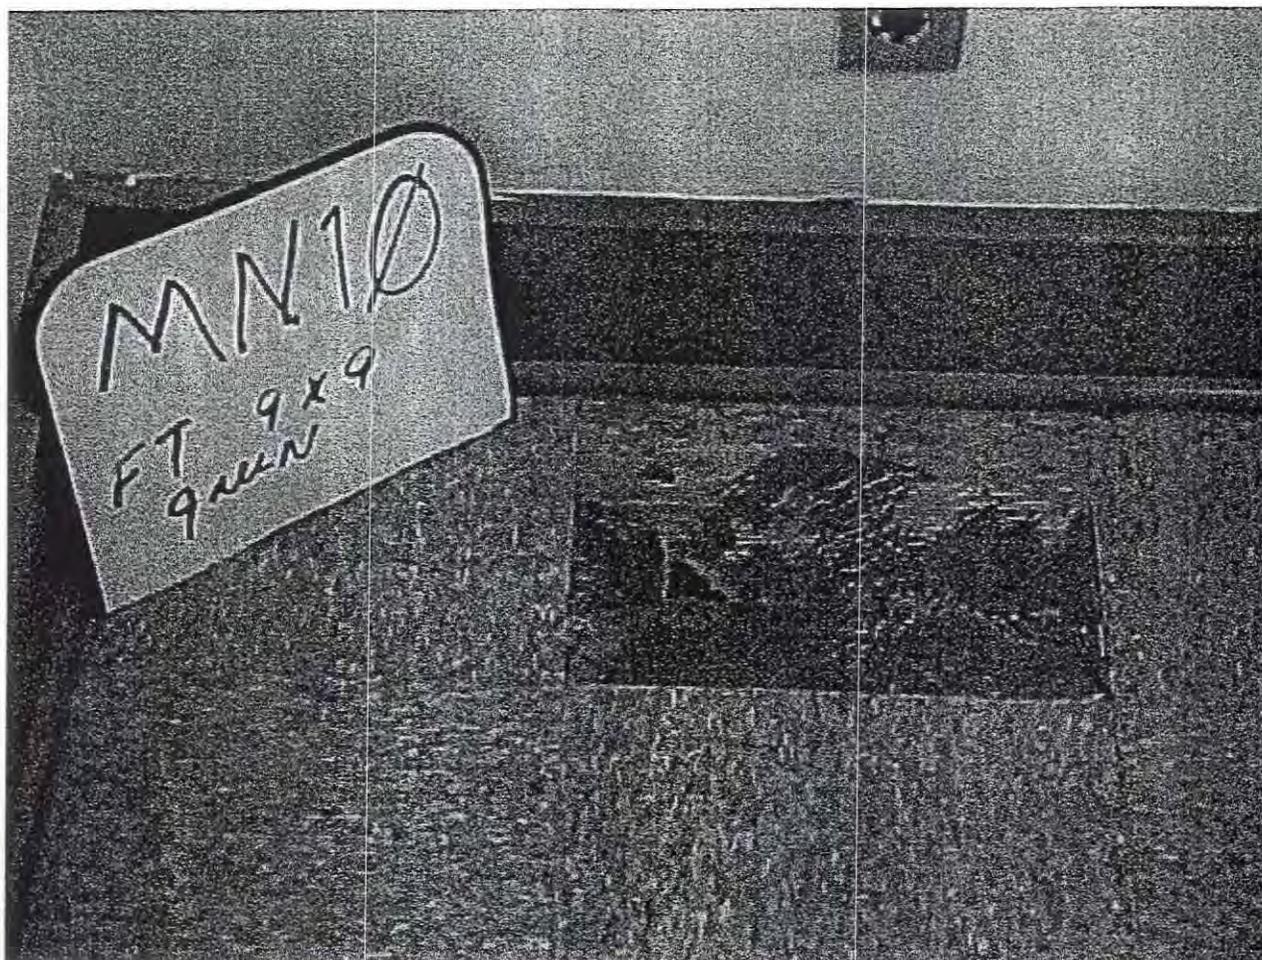
Floor Tile, 9" x 9" green, HA# 10

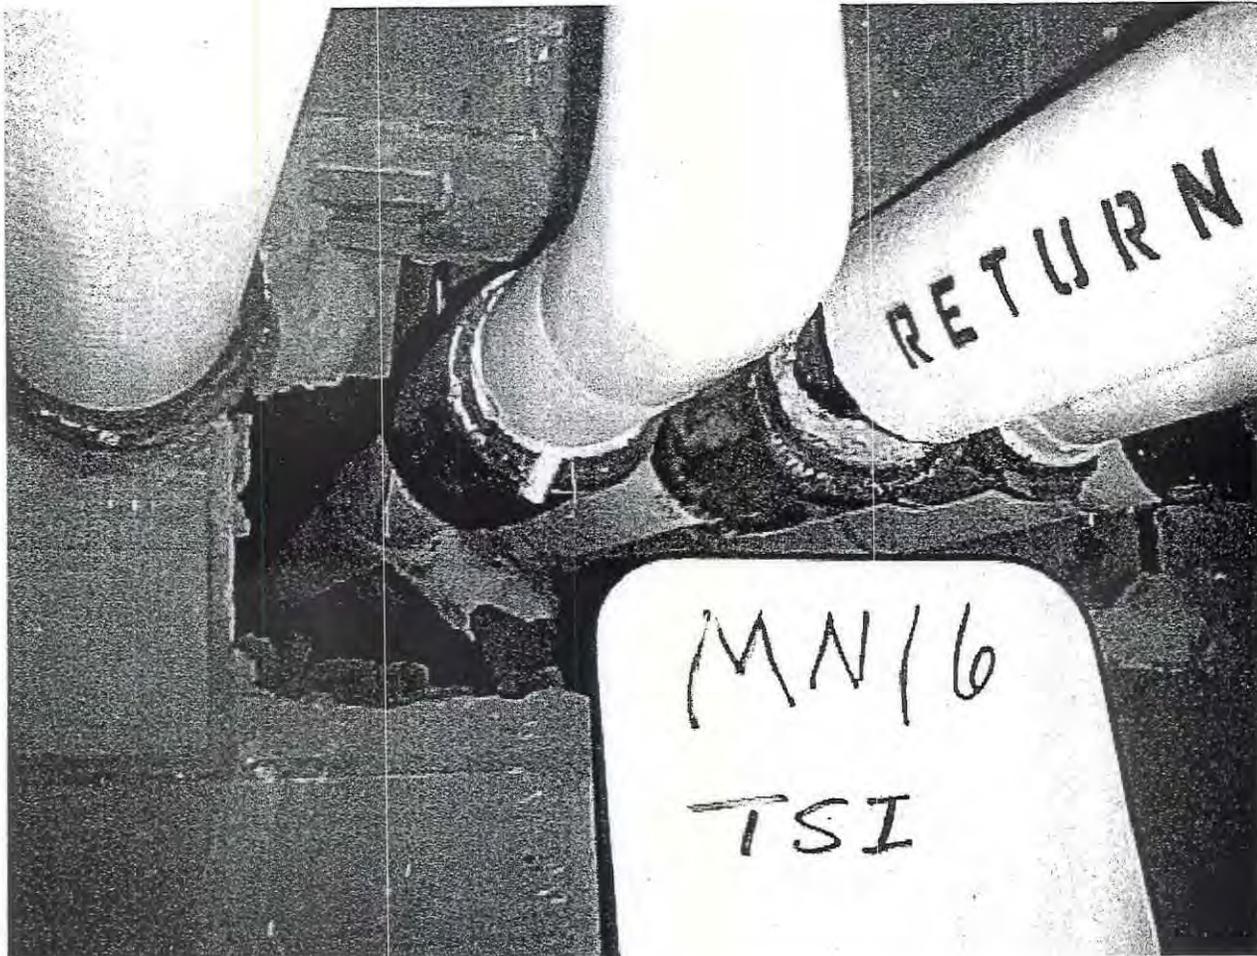
Pipe Insulation, steam, HA #16

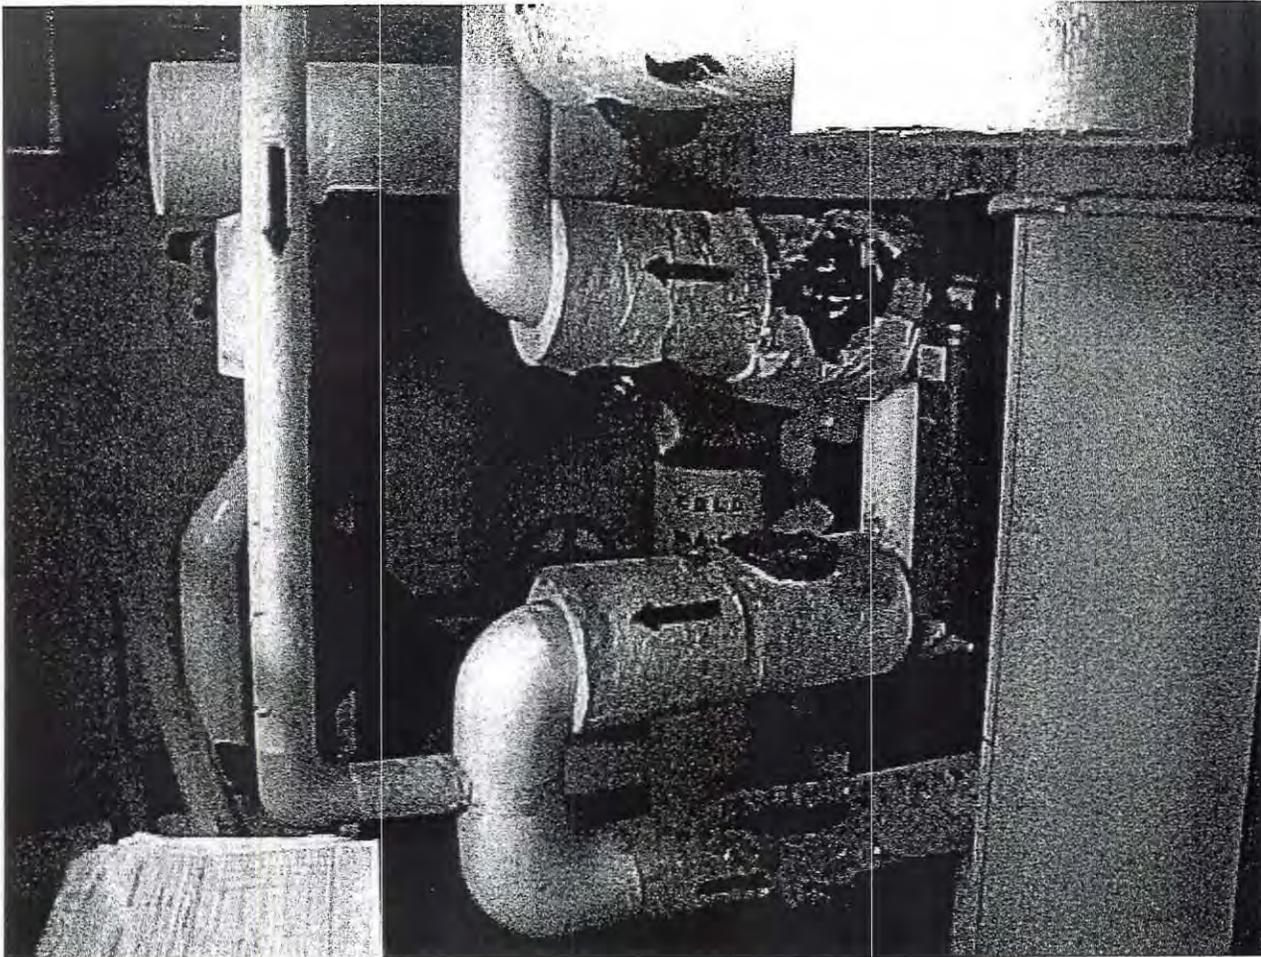
Pipe Fitting Insulation, on domestic hot and cold water, HA# 18
