FORMER MARINE CORPS AIR STATION (MCAS) El Toro

98th Restoration Advisory Board (RAB) Meeting Minutes

**INSTALLATION RESTORATION PROGRAM (IRP)
OPERABLE UNIT 2C
SITE 3 – ORIGINAL LANDFILL
SITE 5 – PERIMETER ROAD LANDFILL**

REMEDIAL ACTION UPDATE

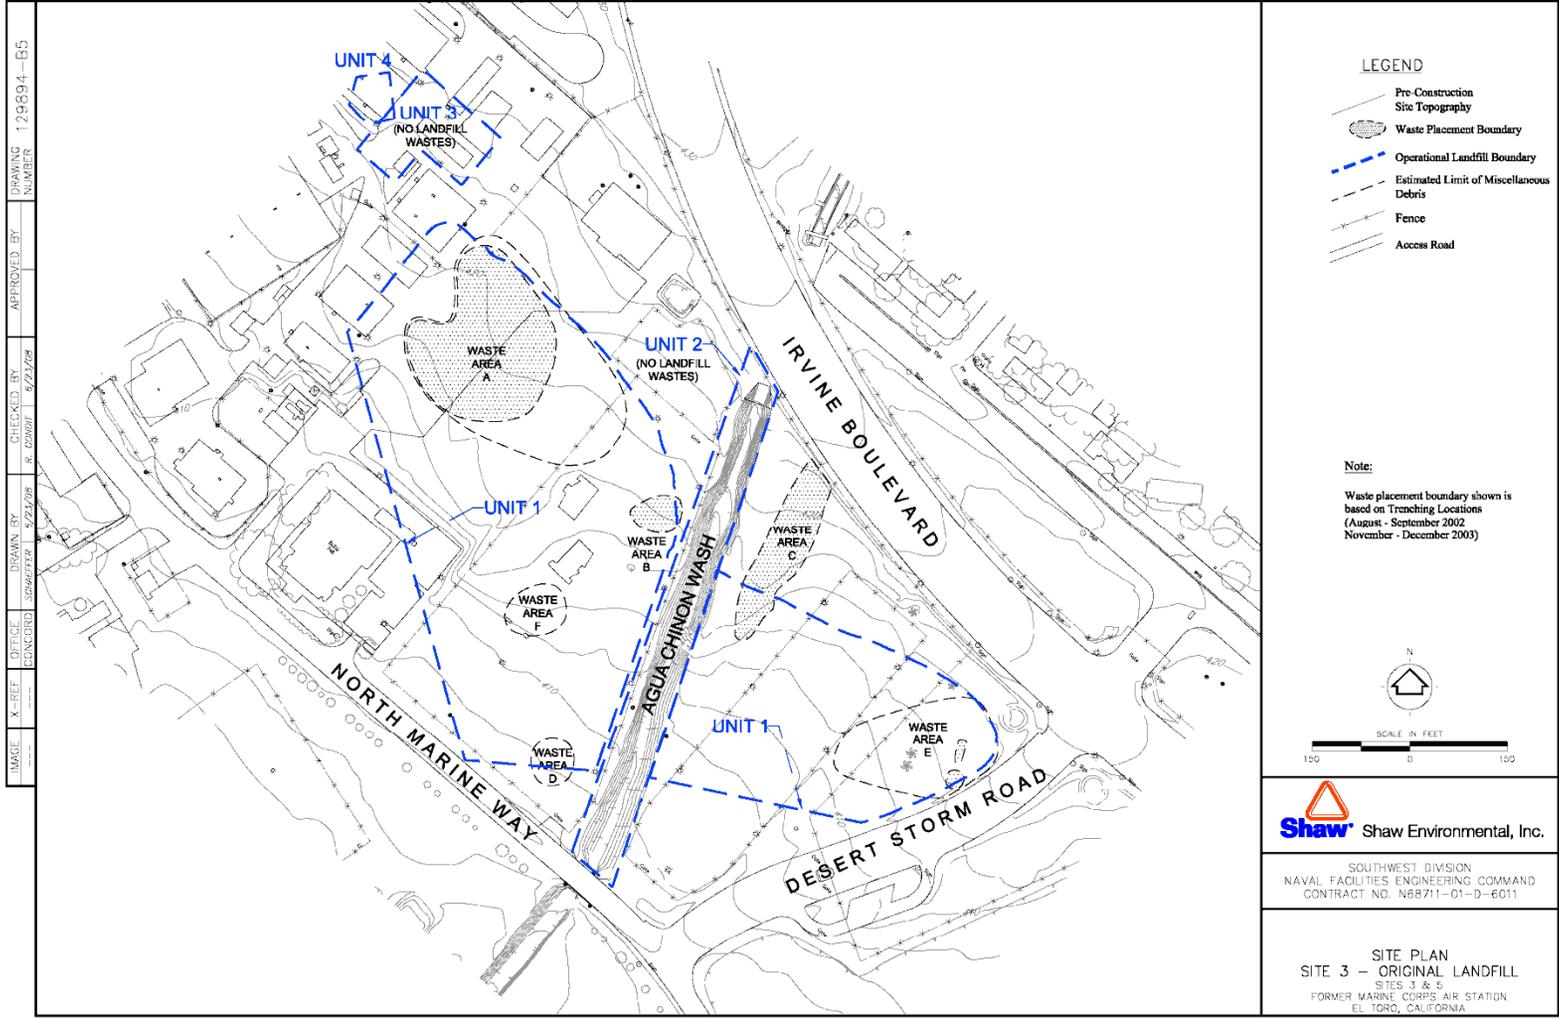
SITE 3 SITE PLAN

- Active from 1943 to 1955
- Encompasses Approximately 11 acres
- Unlined Channel (Agua Chinon Wash) bisects the Site
- Original landfill at Base - Operated as a Cut-and-Fill Disposal Facility
- Types of Waste Included Metals, Incinerator Ash, Solvents, Paint, Residues, Hydraulic Fluids, Engine Coolants, Oily Wastes, Municipal Solid Waste, and Inert Solid Wastes
- Several Small, Waste and Debris Areas (Areas B – F) Exist Outside of Main Landfill Area (Area A)

- Site Plan maps of IRP Sites 3 and 5 showing the extent of waste placement (Slide 7) and a summary of the components of the remedy (Slide 8), which include installation of a synthetic flexible membrane liner, construction of a landfill gas (LFG) collection system, installation of passive soil gas control trenches, groundwater and LFG monitoring, operations and maintenance of drainage features and monuments, and implementation of institutional controls (ICs).

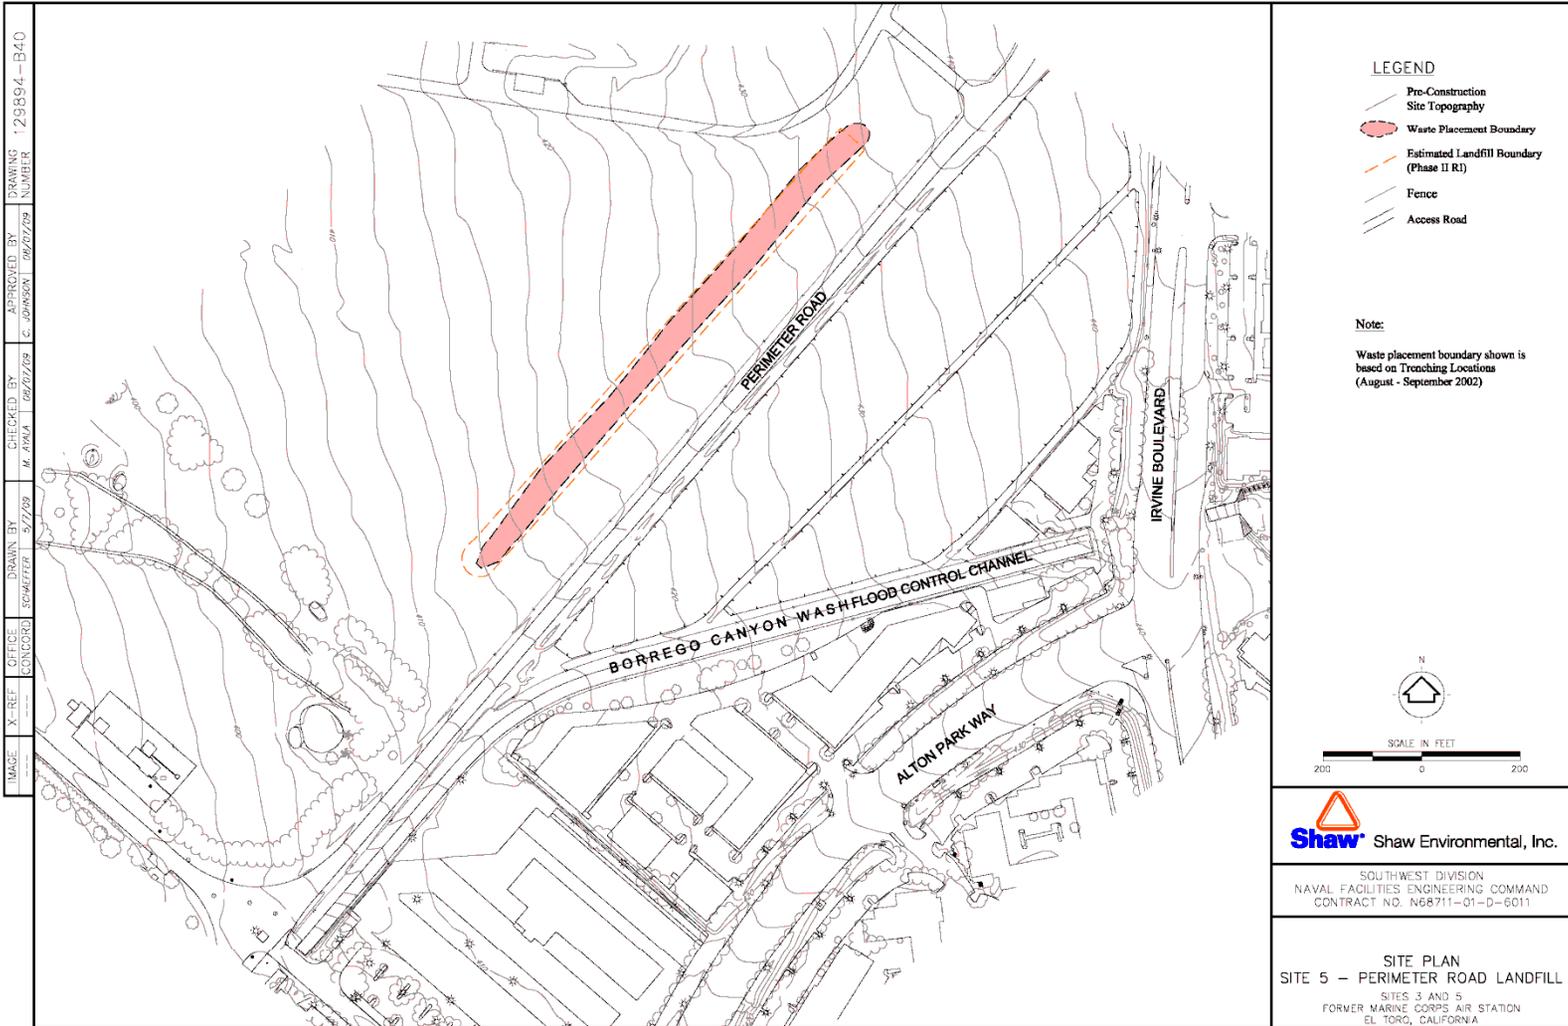
SITE 5 SITE PLAN

- Active from 1955 to the late 1960s
- Encompasses Approximately 1.8 acres
- 300 feet Northwest of Borrego Canyon Wash
- Operated as a Cut-and-Fill Disposal Facility
- Types of Waste Included Burnable Trash, Municipal Solid Waste, Cleaning Fluids, Scrap Metals, Paint Residues, and Unspecified Fuels, Oils, and Solvents

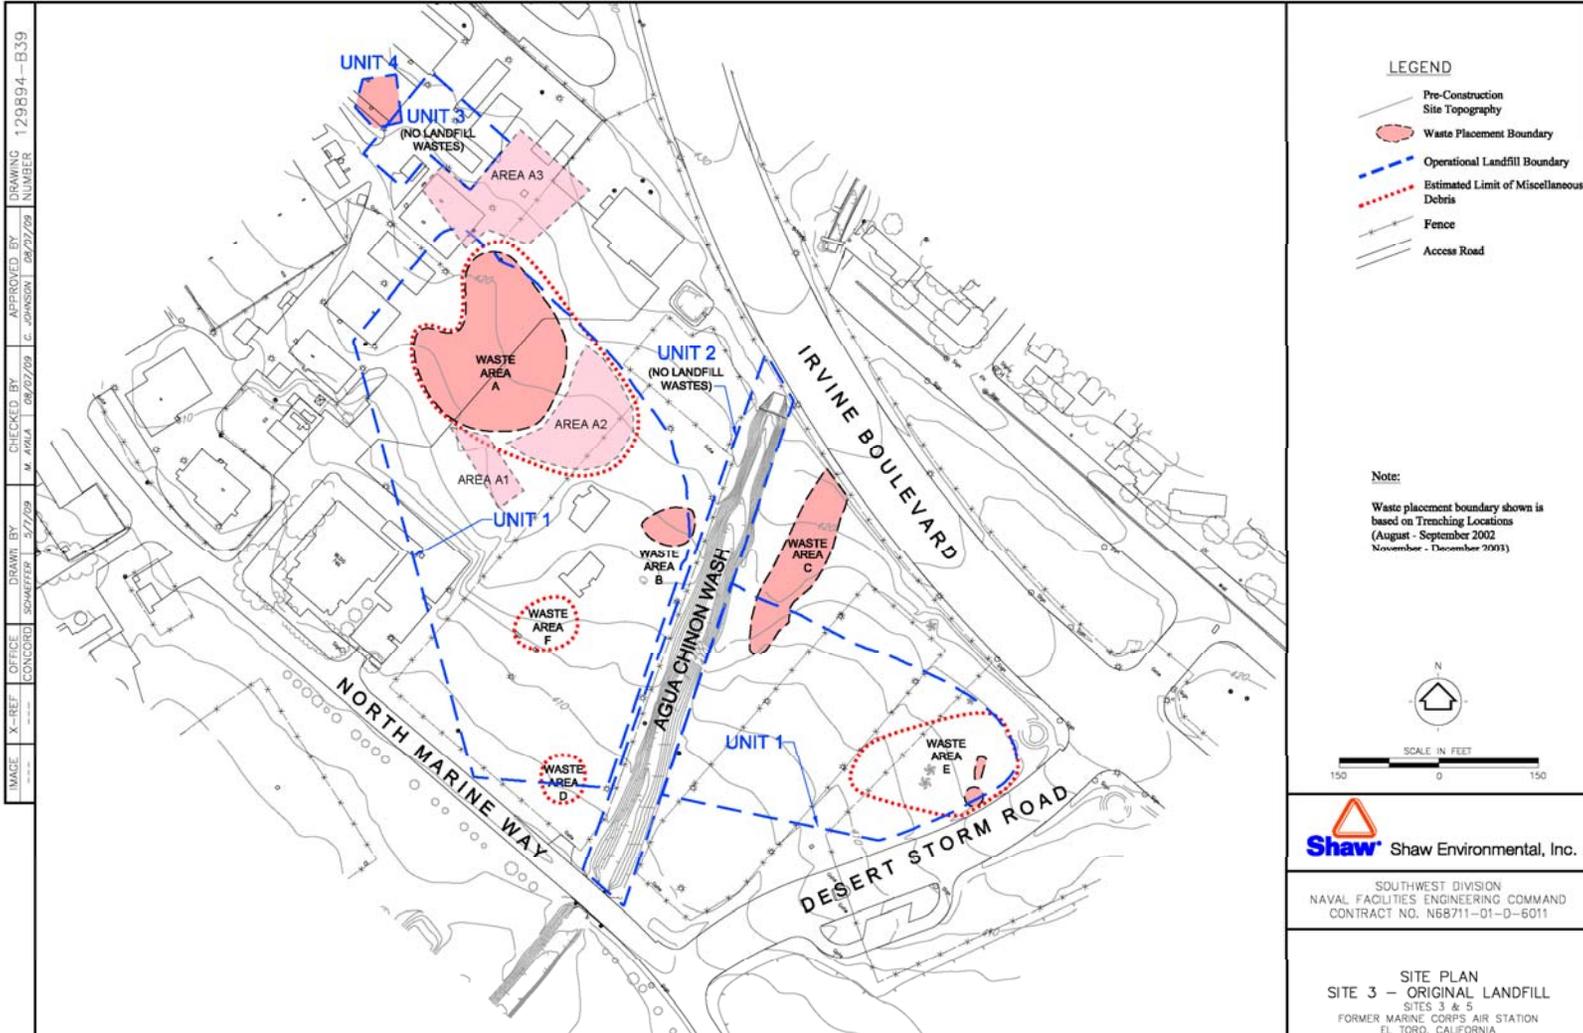
- A total of nine areas have been identified for consolidation of waste into the main landfill
- Six areas were initially identified for consolidation into the main landfill (Waste Area A) at IRP Site 3
- Three additional areas were subsequently identified adjacent to Waste Area A for consolidation (Areas A1, A2 and A3)
- Overall landfill footprint will be decreased by approximately 1/3 and less soil will be required for the landfill cap

- A summary of on-going construction activities (Slide 11) including radiological screening, soil consolidation, and confirmation sampling. Mr. Smits noted that by consolidating the areas as shown on the plan map, the overall landfill footprint was reduced by 1/3 and less soil would be required for the landfill cap.

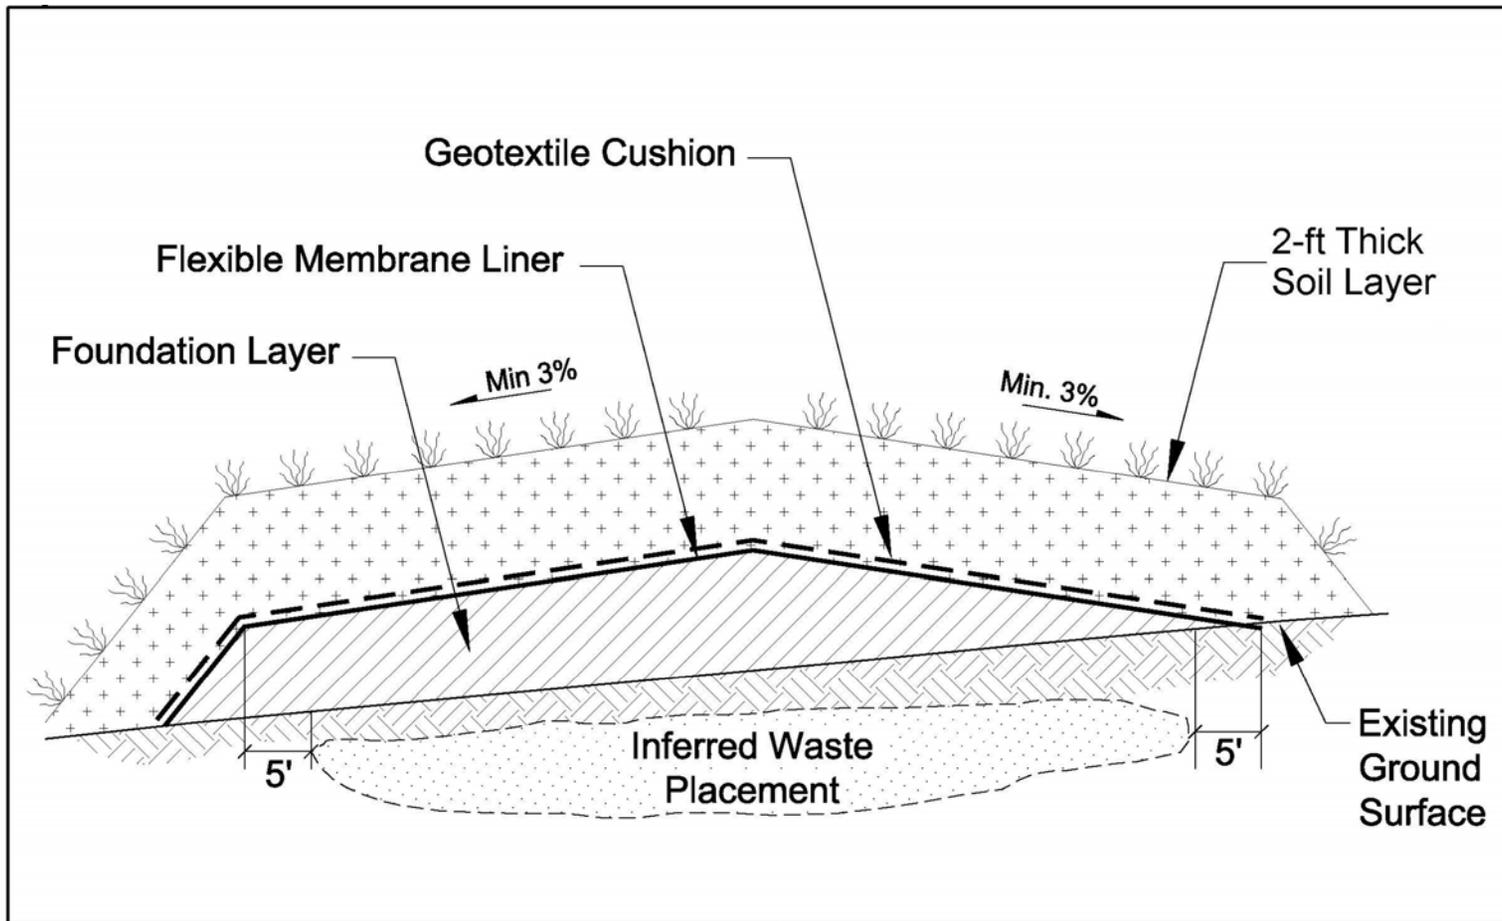
TYPICAL COVER CROSS-SECTION

- An explanation and figure showing a cross section of a typical landfill cover (Slide 12).
- Photographs of on-going construction activities at IRP Sites 3 and 5 including scraping of the soil cover (Slide 13), exploratory trenching to re-verify limits of waste (Slide 14), excavation and scraping (Slides 15, 16, 17, and 18), and compacting the foundation layer to 90% compaction (Slide 20), which will result in a minimum of two feet of soil covering the waste.

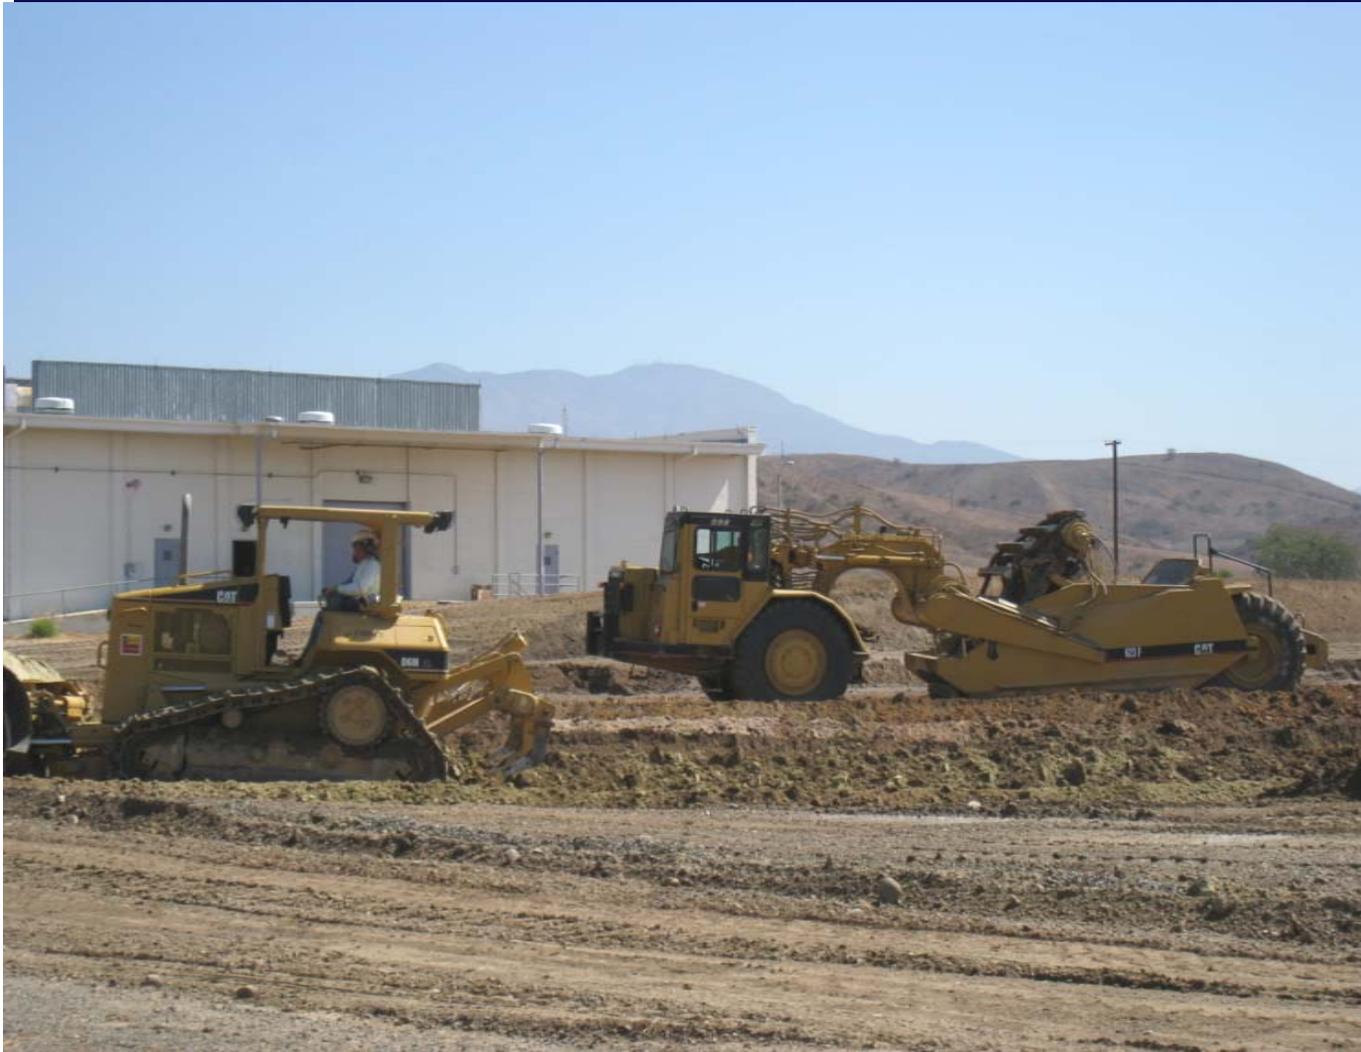
Bulldozer/scrapper removing 6-inches of cover soil at IRP Site 3, Waste Area A.

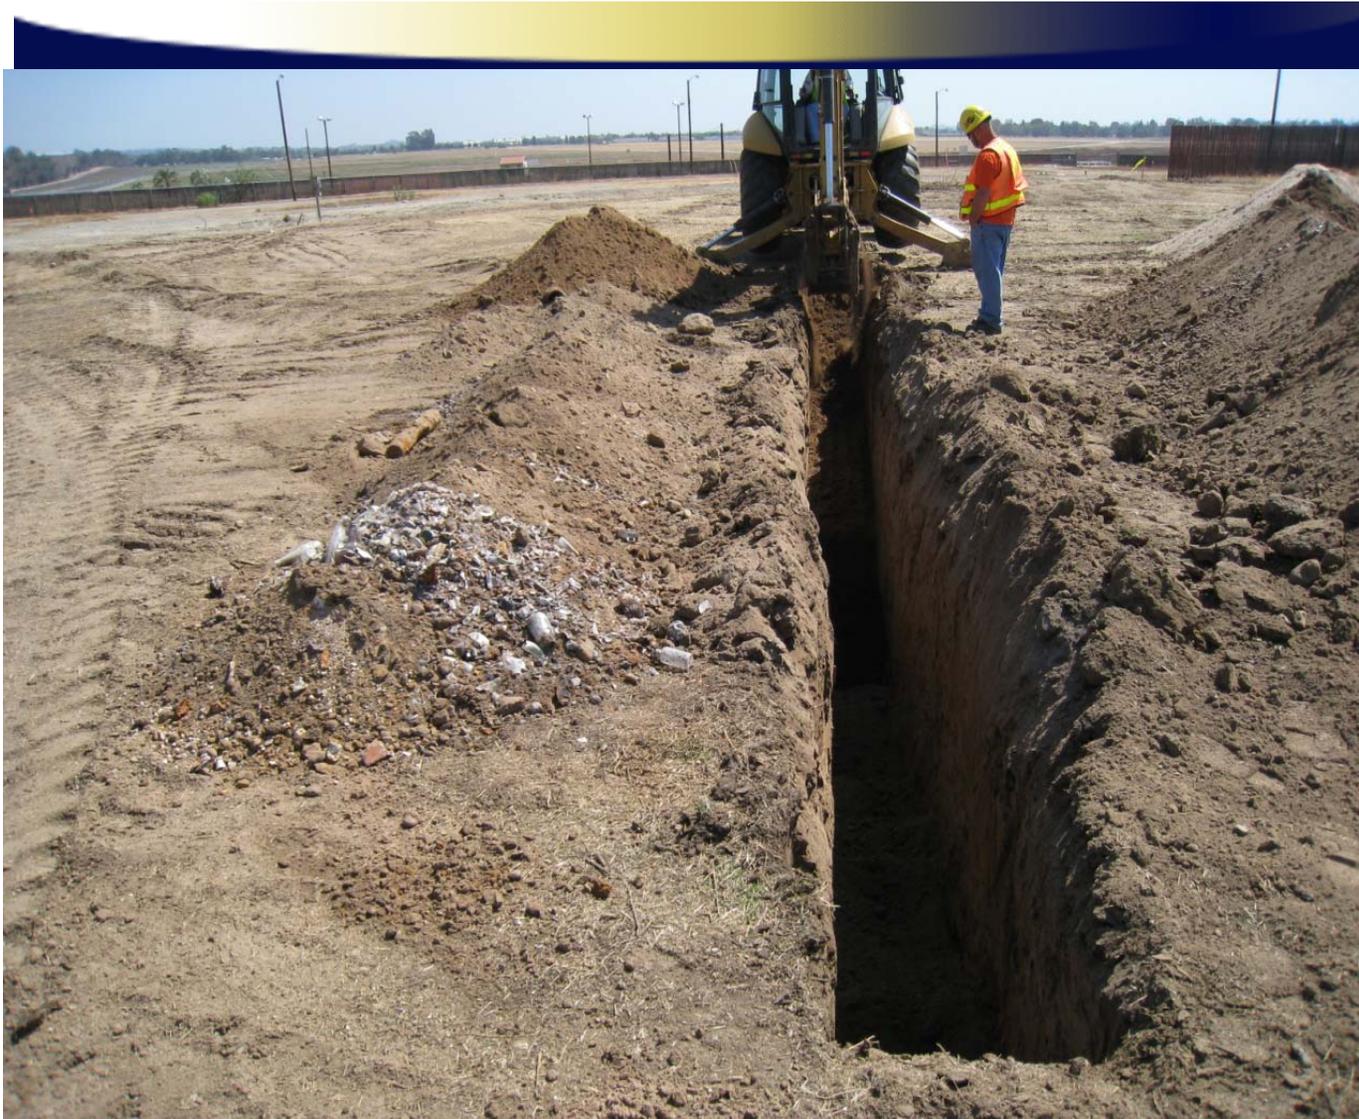
Exploratory trenching to re-verify limits of waste at IRP Site 3, Waste Area A.

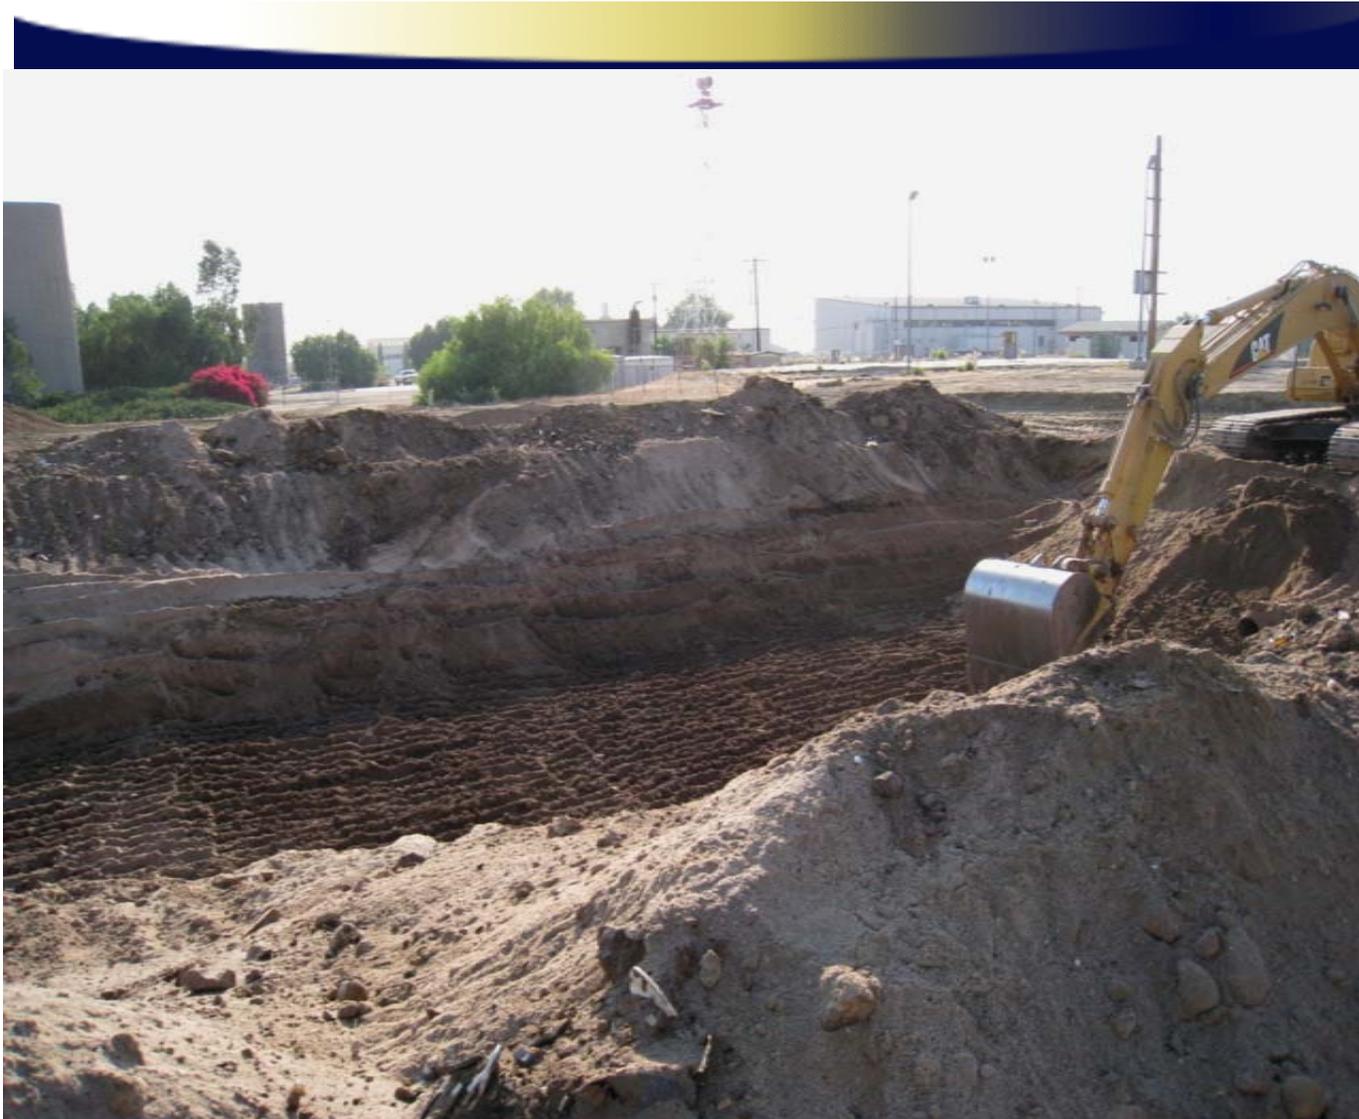
Excavation of native soil between waste cells at IRP Site 3, Waste Area A.

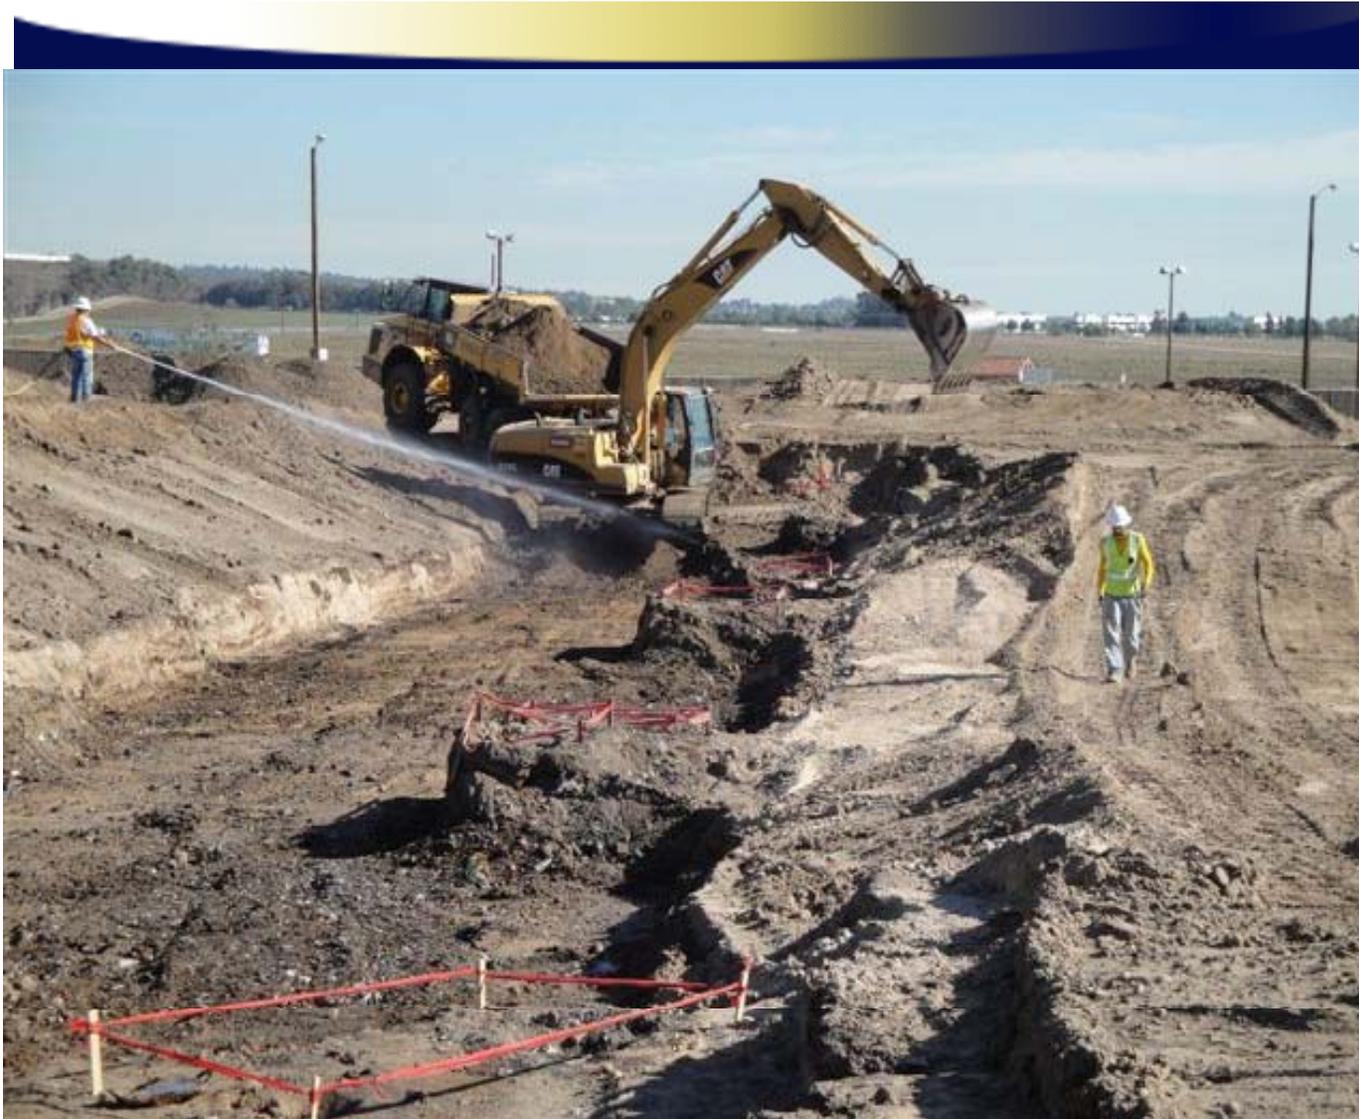
Excavation of incinerator waste/debris at IRP Site 3, Area A1.

Waste was transported to and consolidated within waste cells in Waste Area A.

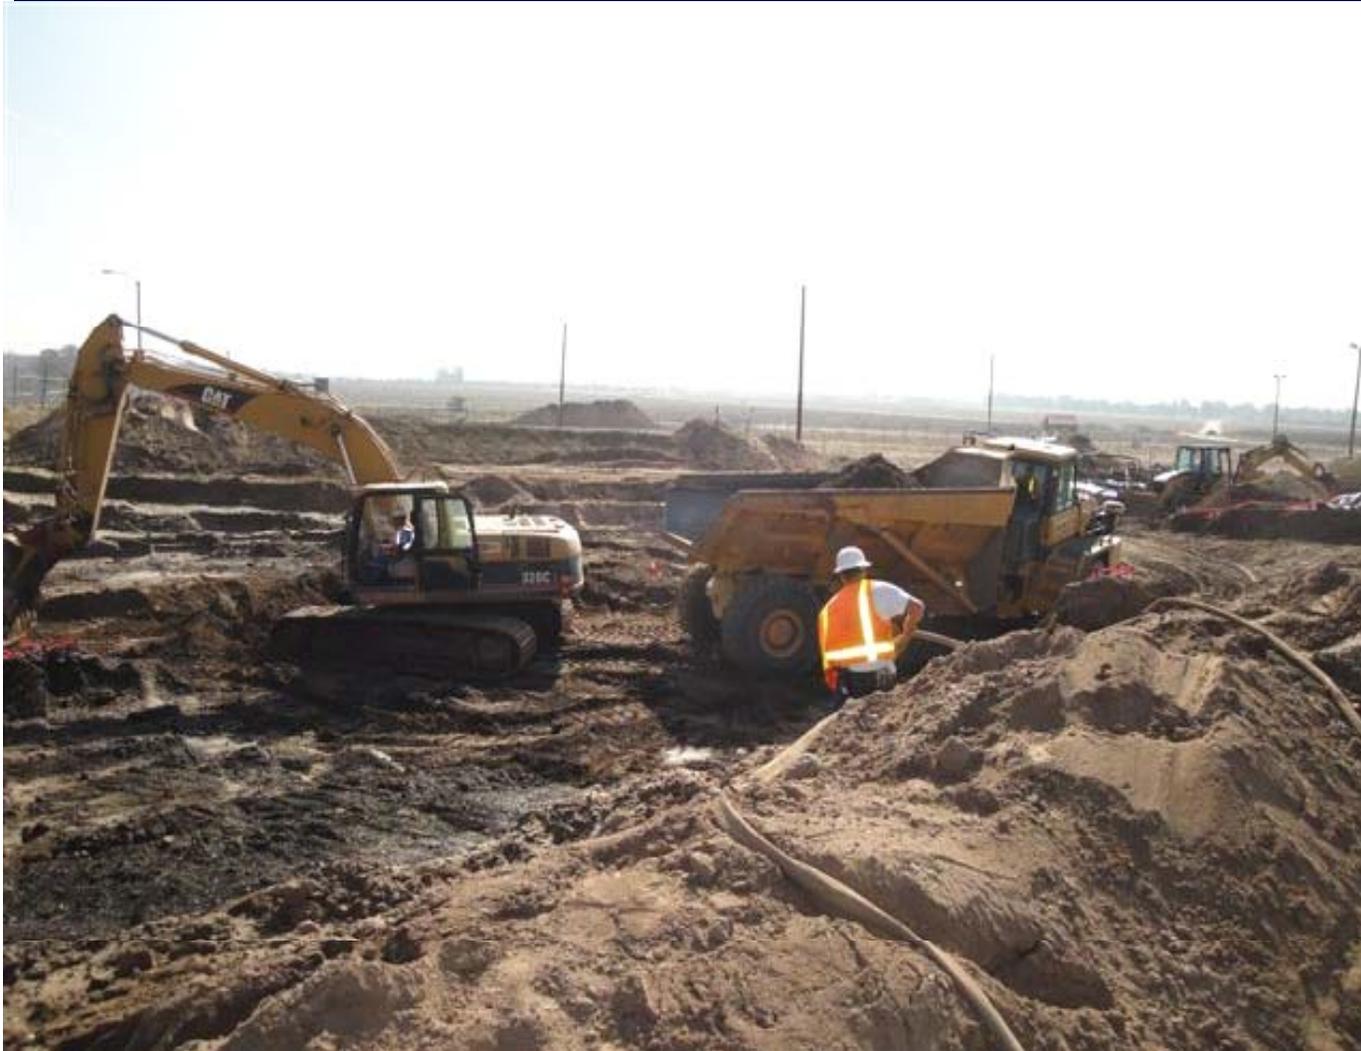
Excavation of incinerator waste/debris at IRP Site 3, Waste Area C.
Waste was transported and consolidated within waste cells in Waste Area A.

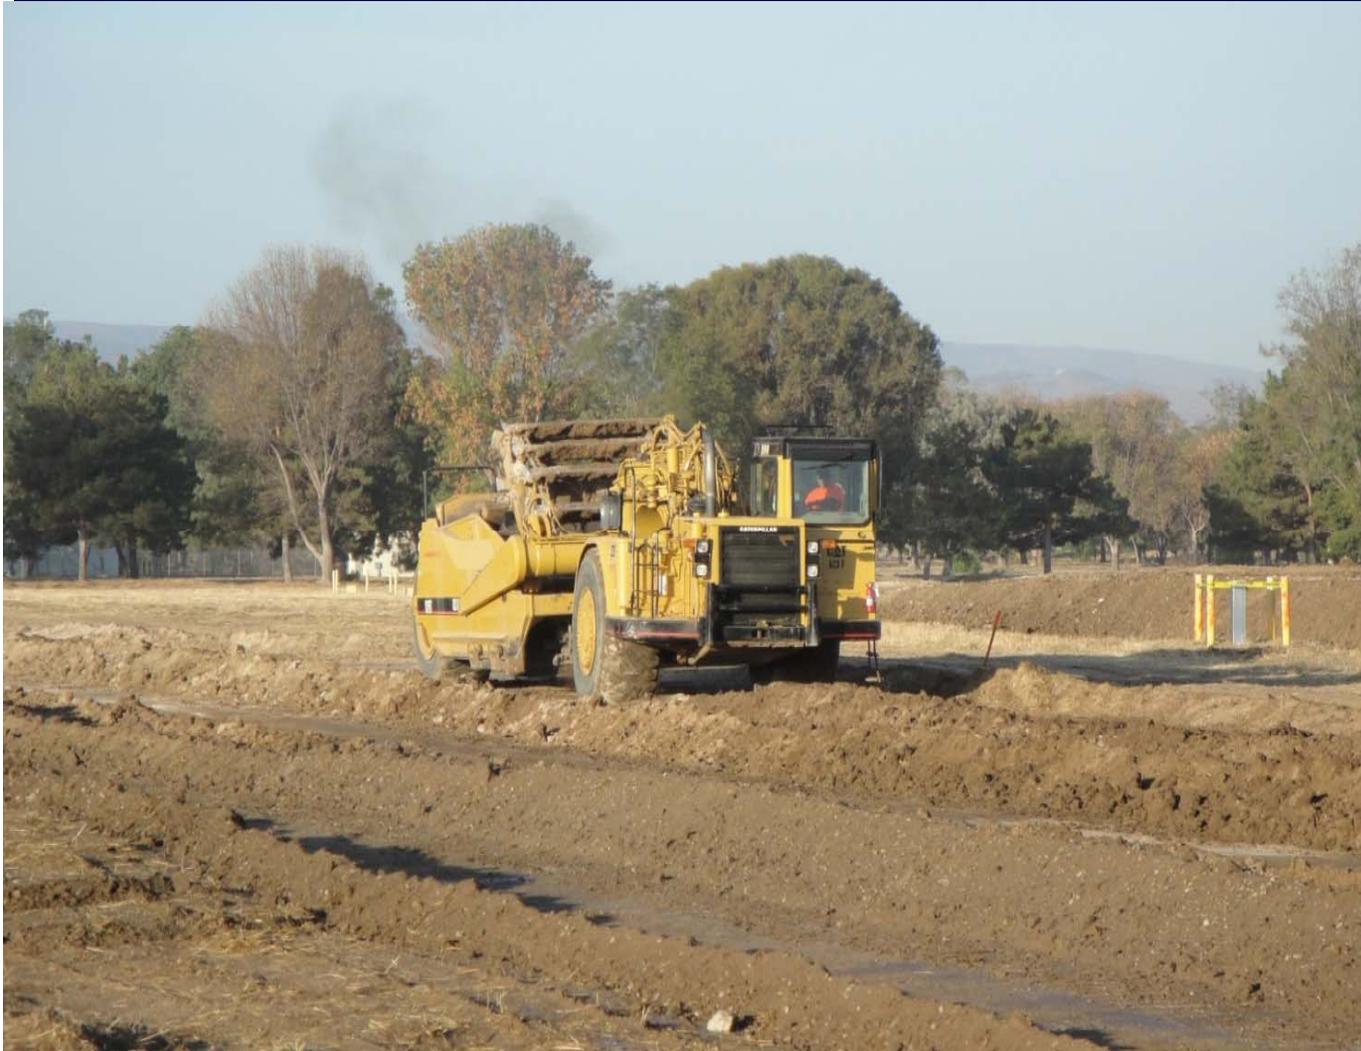
Scraper removing a windrow of cover soil at IRP Site 5.

The stockpile of removed cover soil is in the background on the right behind the well monument.

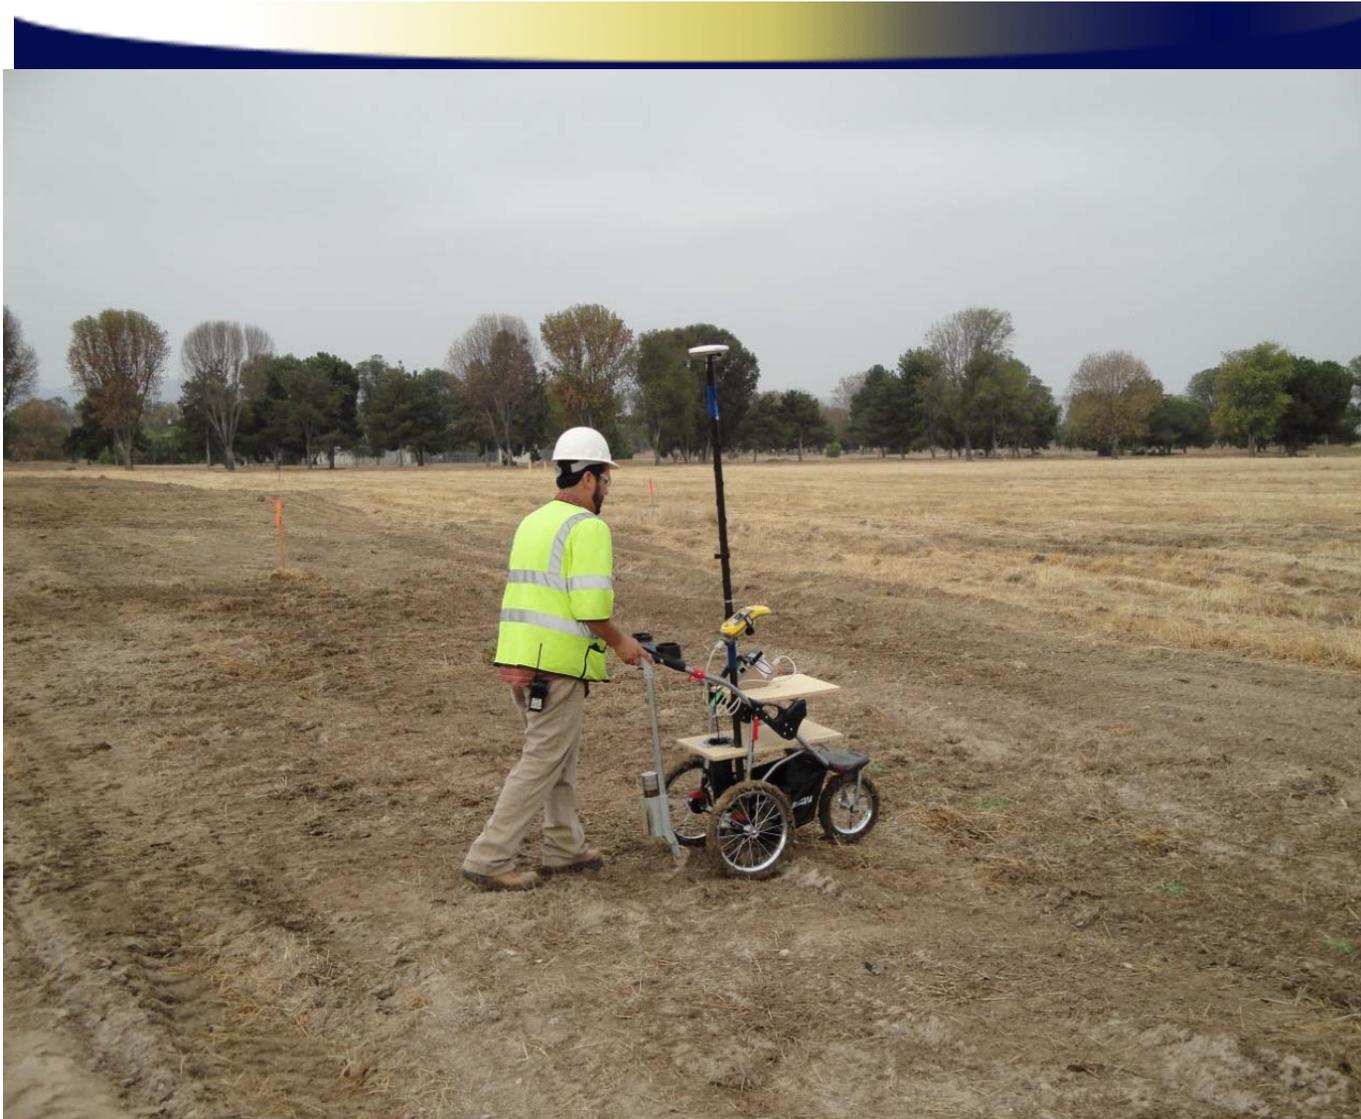
Radiation survey following removal of initial 6-inch lift of cover soil at IRP Site 5.

- Summary and photographs of the radiological survey conducted at IRP Site 5 (Slide 19), which involves maneuvering a device with a sodium iodide detector and a global positioning system (GPS) six inches off the ground over the surface of the area being investigated. The detector is capable of identifying subsurface radiological anomalies. Mr. Johnson explained that the operator would traverse the site in a serpentine pattern recording readings to identify anomalies in the subsurface which potentially contain radiological materials. To date, he noted, the operator has surveyed an equivalent of about 40 miles and has downloaded about 350,000 survey points.

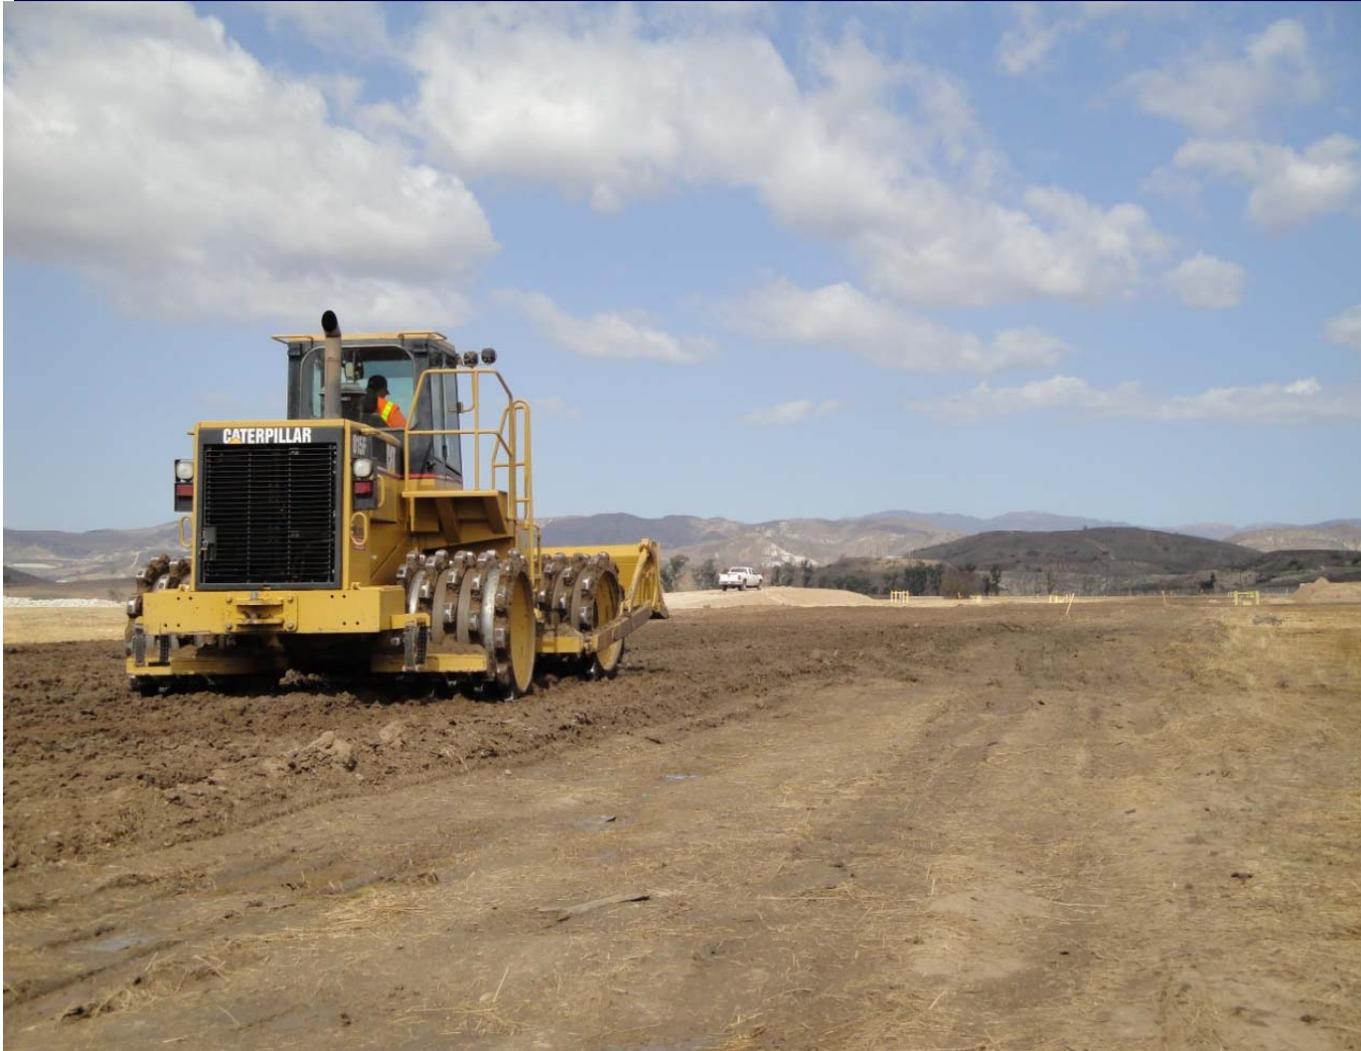
Compacting foundation layer soil at IRP Site 5.

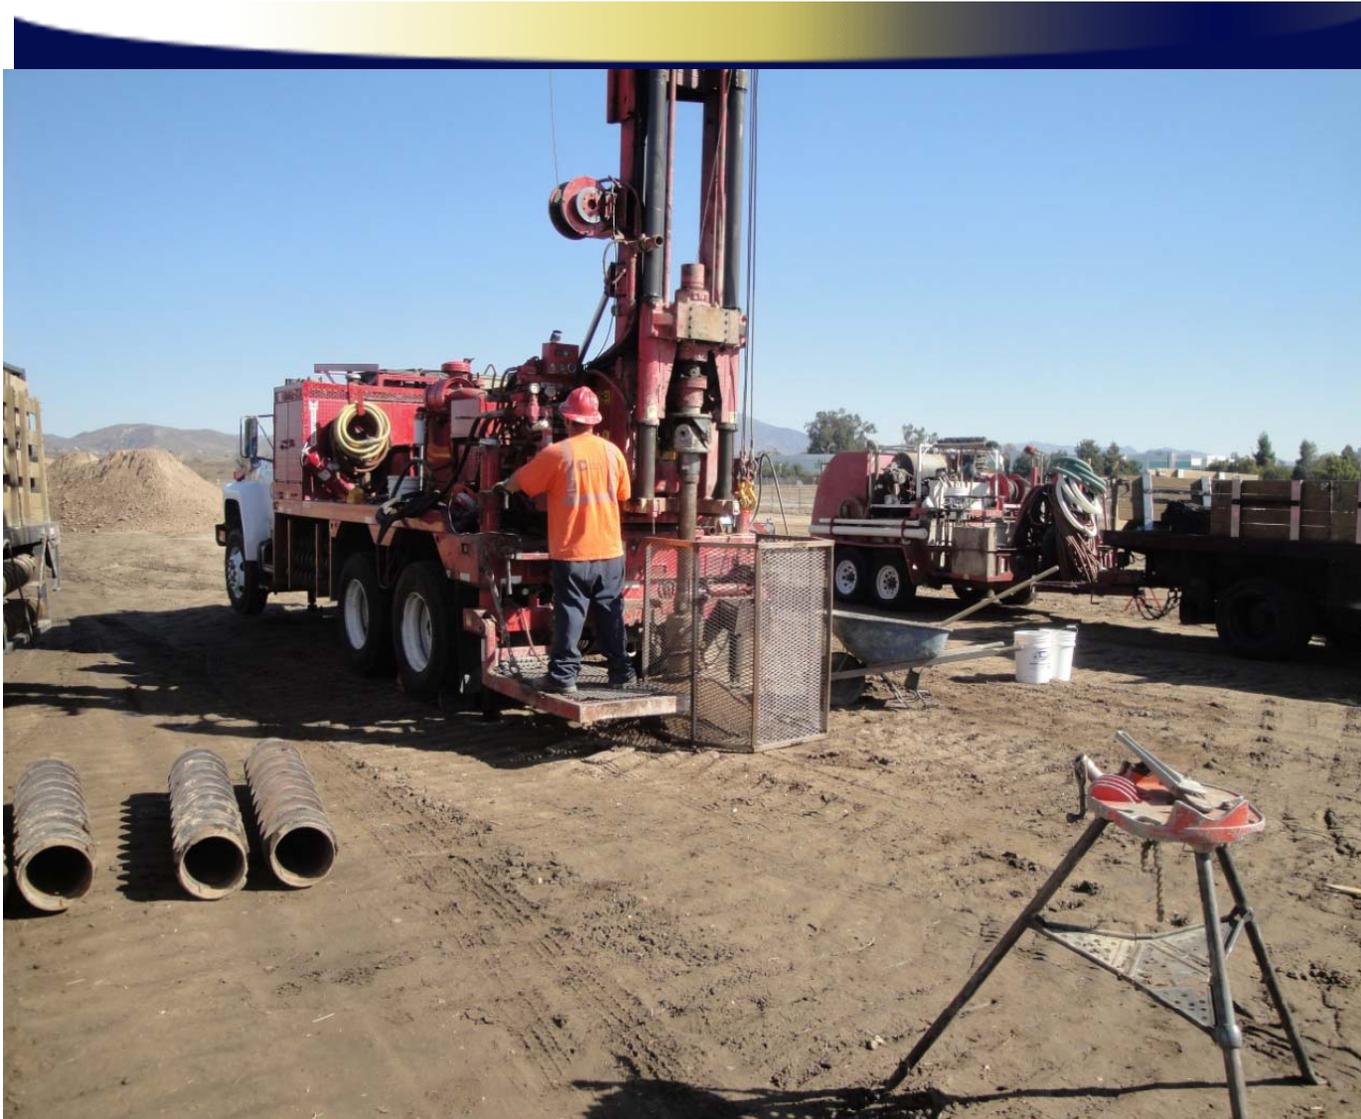
Installing a landfill gas well at IRP Site 5 with 12-inch outside diameter hollow stem auger.

- Photograph of LFG well installation (Slide 21) for both passive and active LFG monitoring, venting, and mitigation, if necessary. Mr. Johnson noted the LFG wells were screened from approximately 11 feet below ground surface (bgs) to 20 feet bgs.

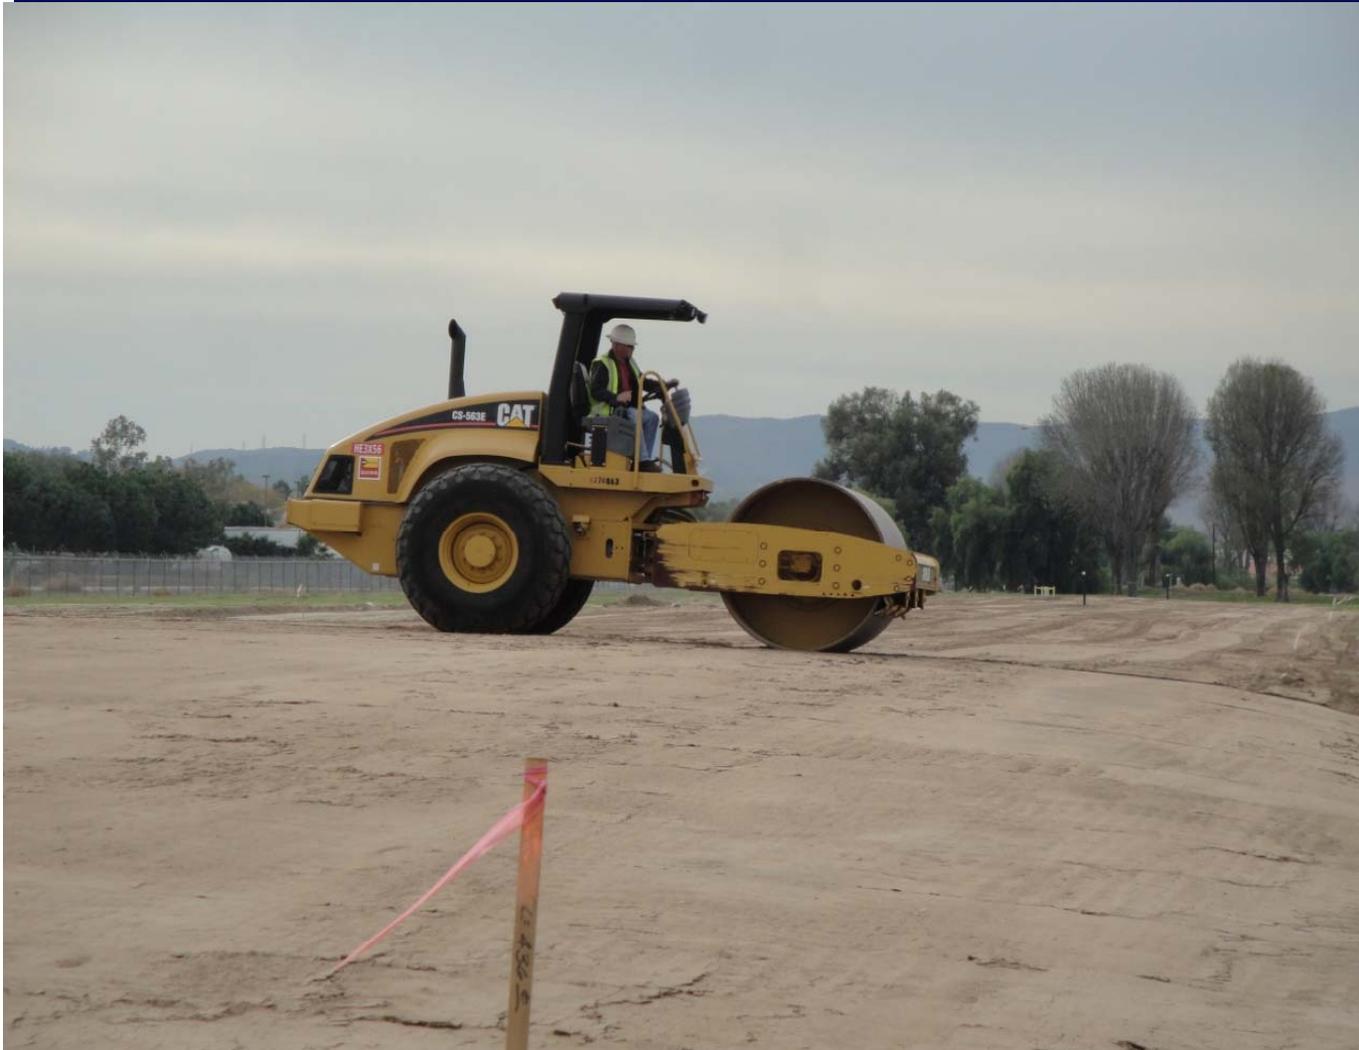
A smooth drum compactor was used to roll a finished surface on the foundation layer at IRP Site 5 prior to the installation of the geomembrane.
