FORMER MARINE CORPS AIR STATION (MCAS) El Toro

98th Restoration Advisory Board (RAB) Meeting Minutes

**INSTALLATION RESTORATION PROGRAM (IRP)
OPERABLE UNIT 2C
SITE 3 – ORIGINAL LANDFILL
SITE 5 – PERIMETER ROAD LANDFILL**

REMEDIAL ACTION UPDATE

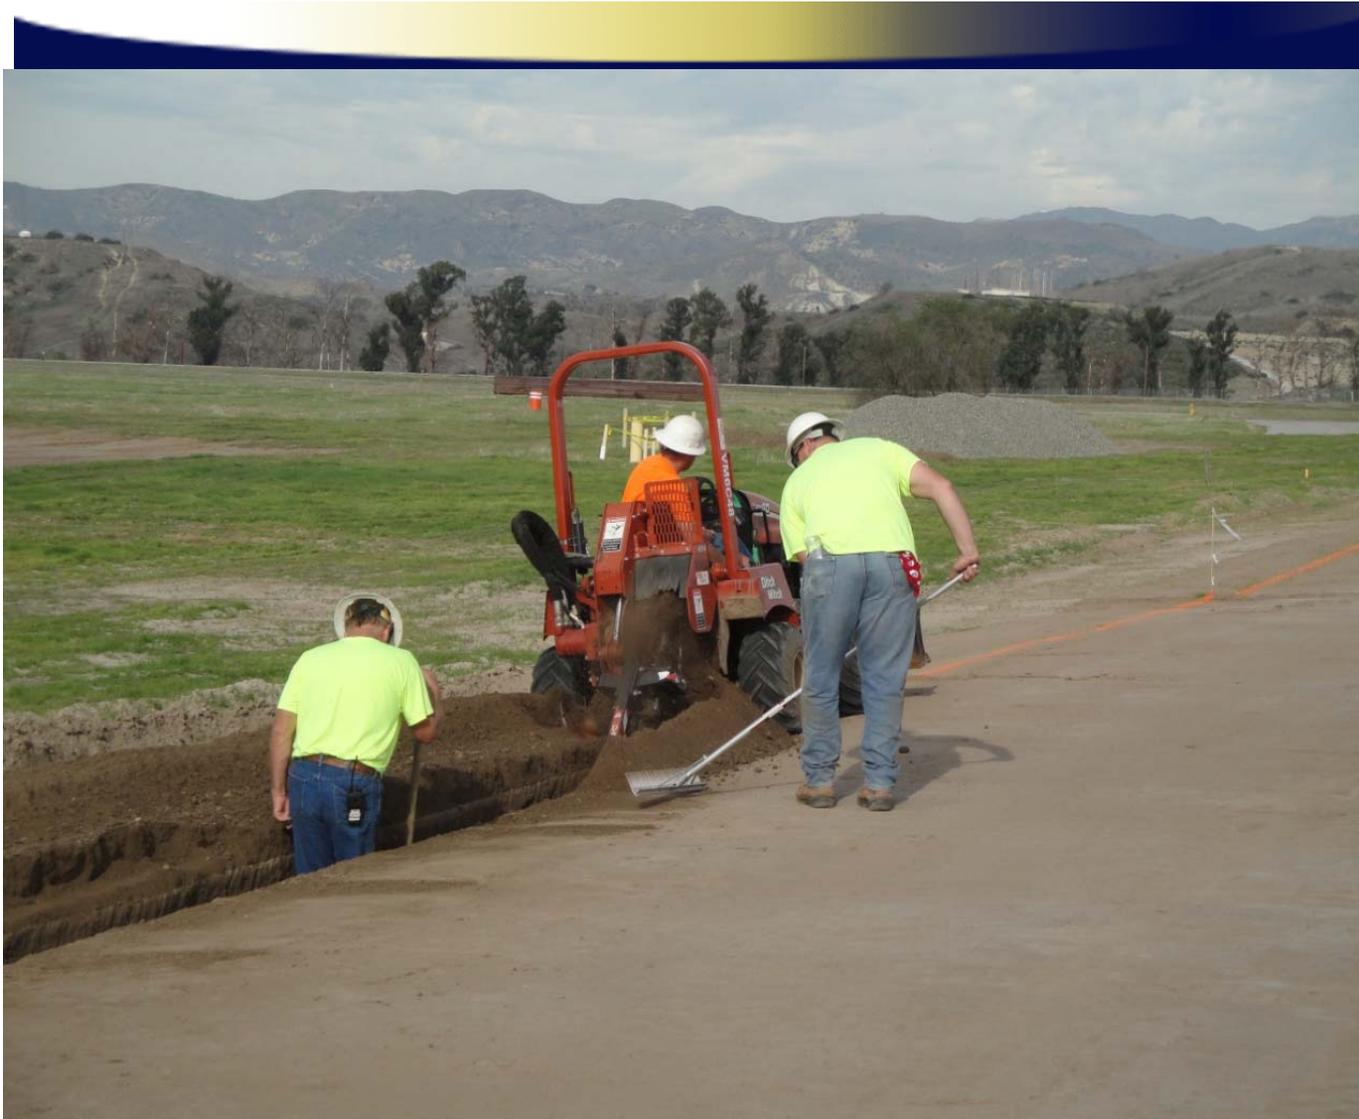
Excavating the geomembrane anchor trench at IRP Site 5.

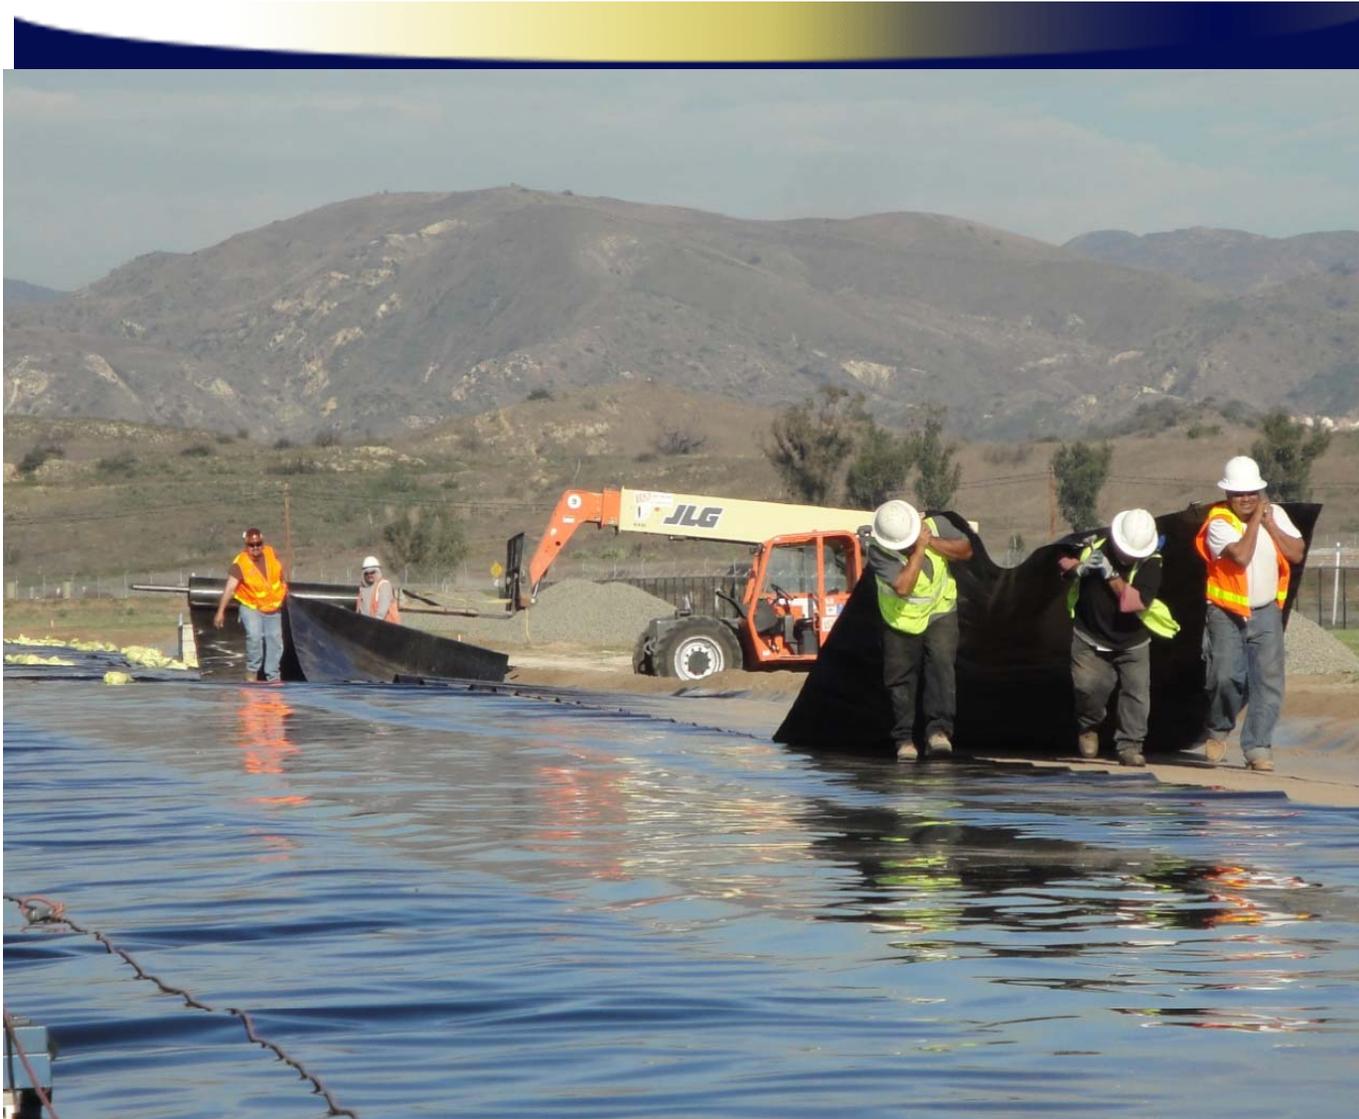
Crew deploying a roll of 60-mil linear low-density polyethylene (LLDPE) geomembrane at IRP Site 5.

Rolls were deployed as a single panel.

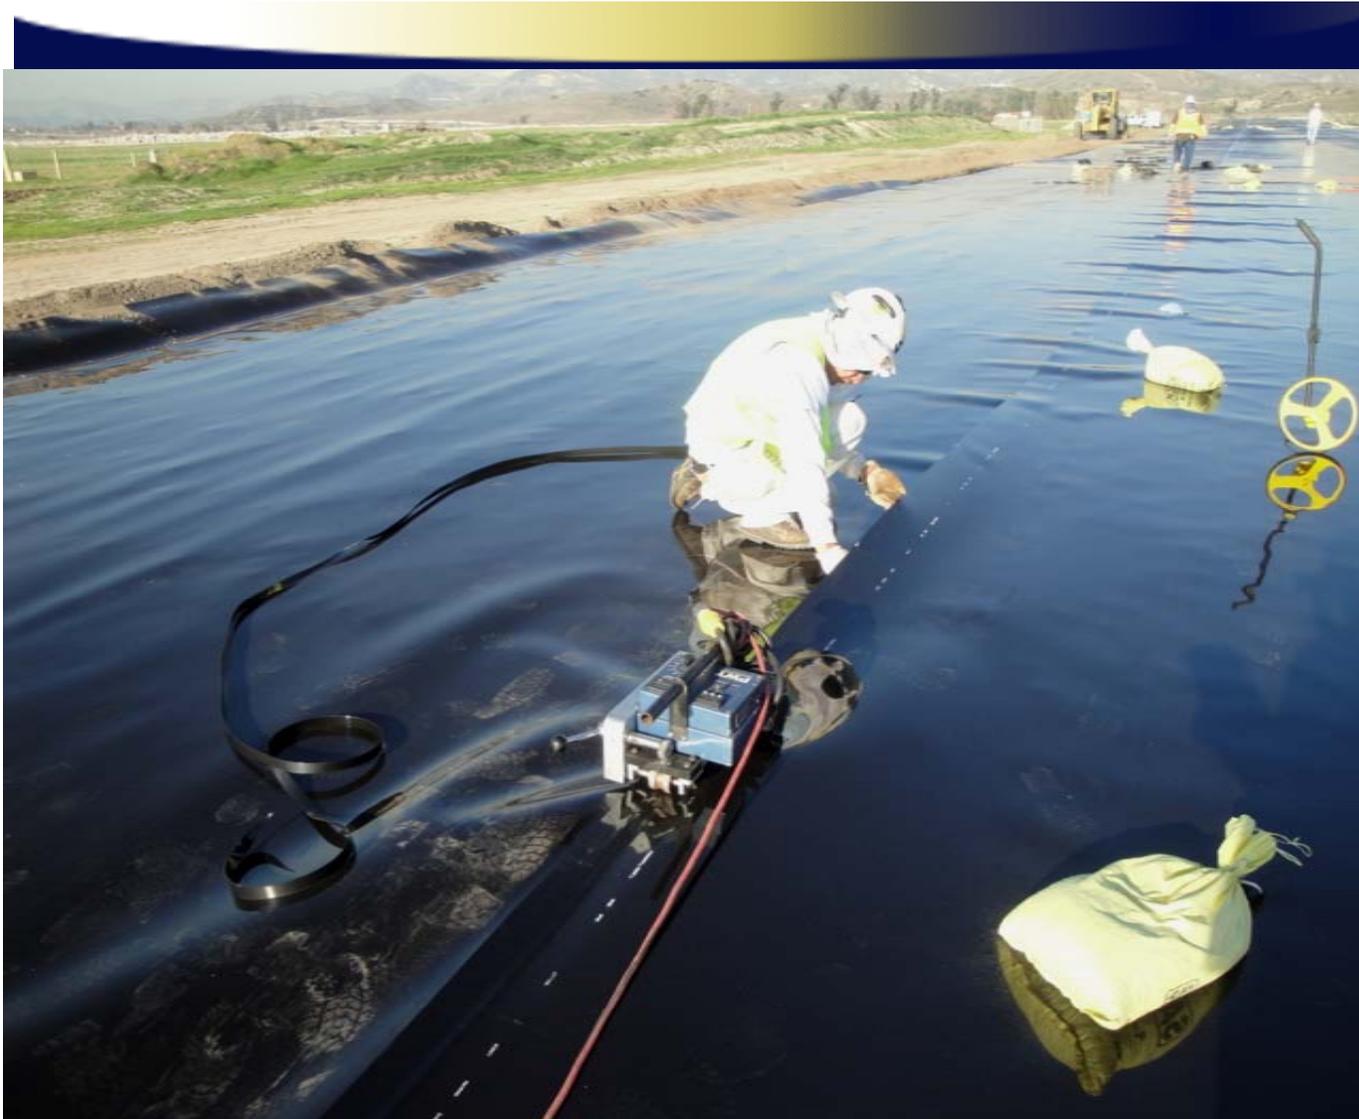
A welder operating a dual-track fusion welder at the seam between two LLDPE panels at IRP Site 5.

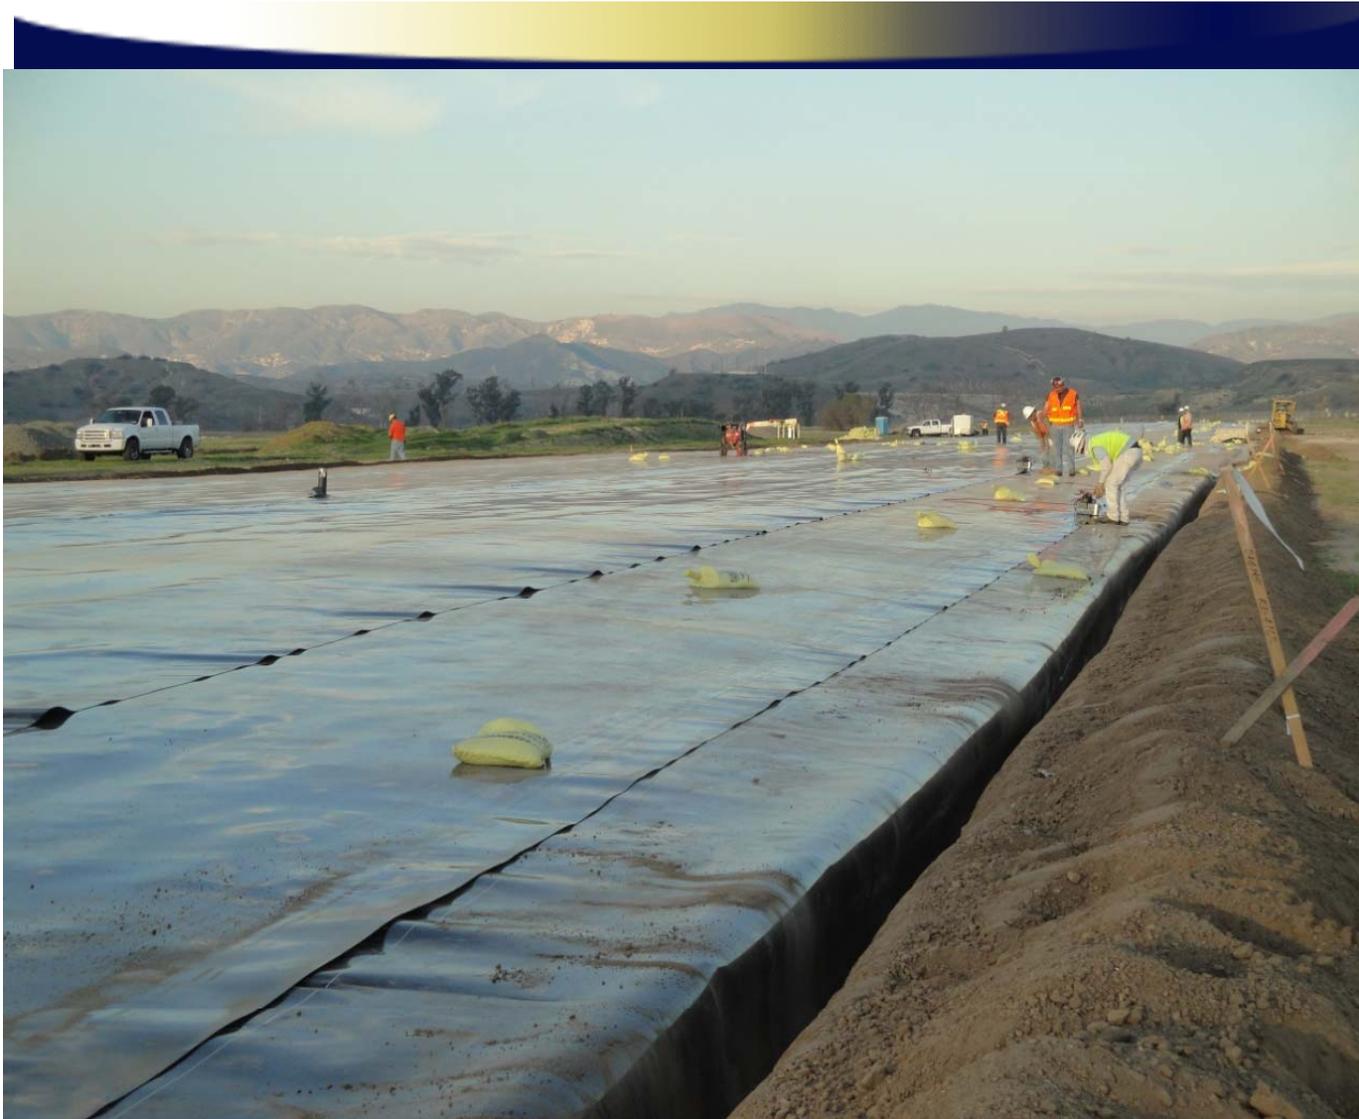
The geomembrane fully deployed at IRP Site 5.

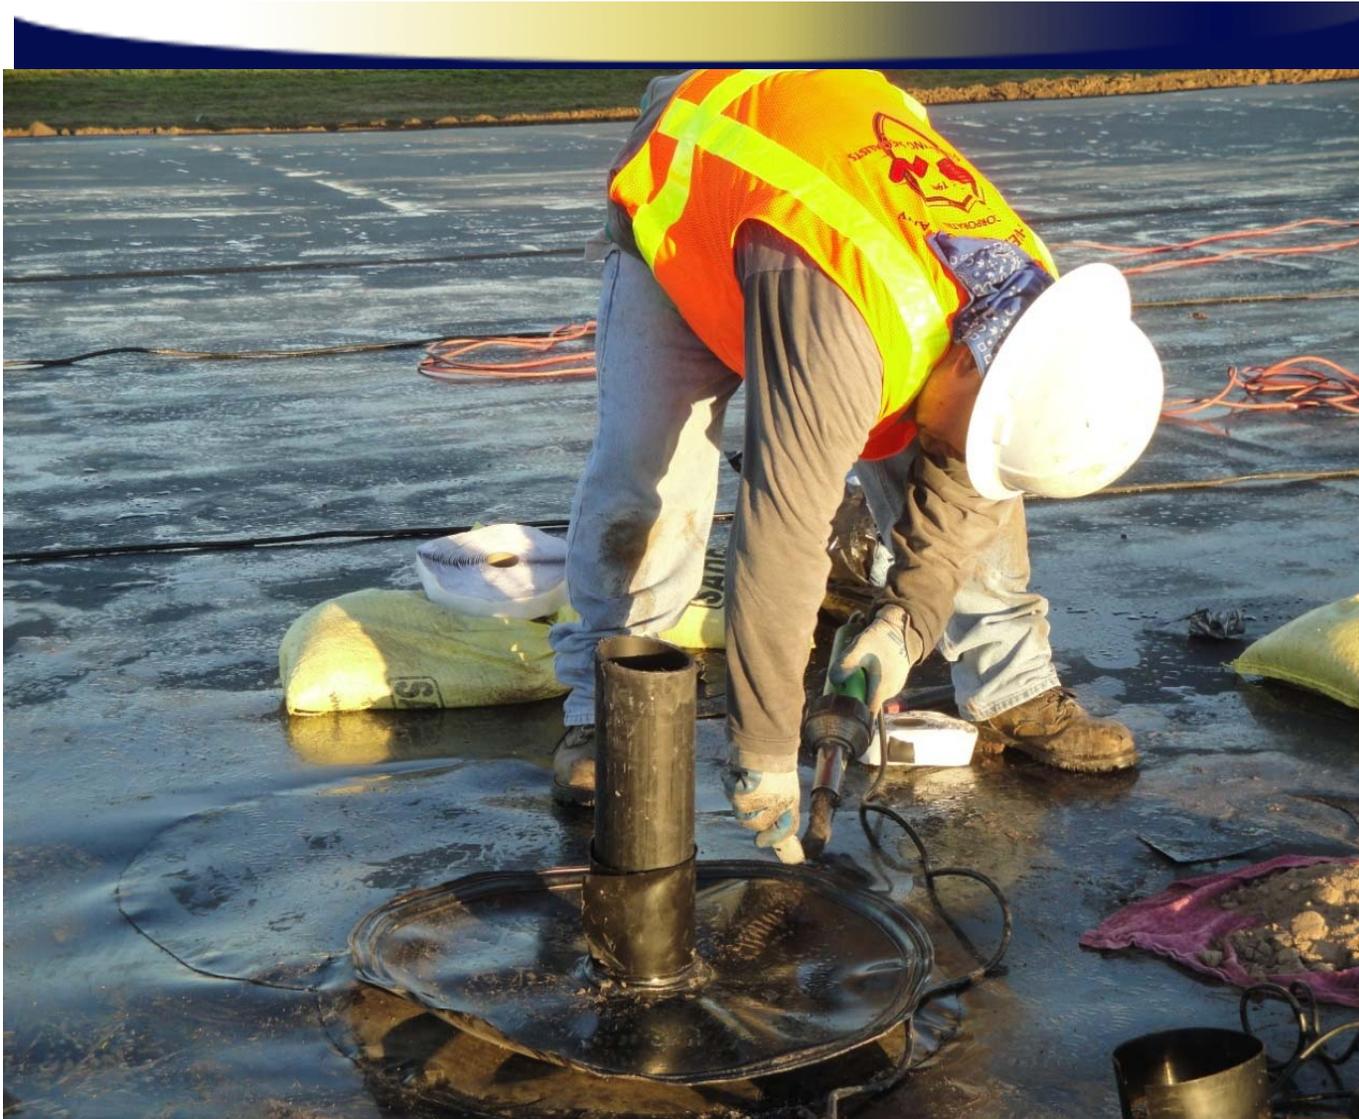
Extrusion welding a protective boot around a landfill gas well at IRP Site 5.

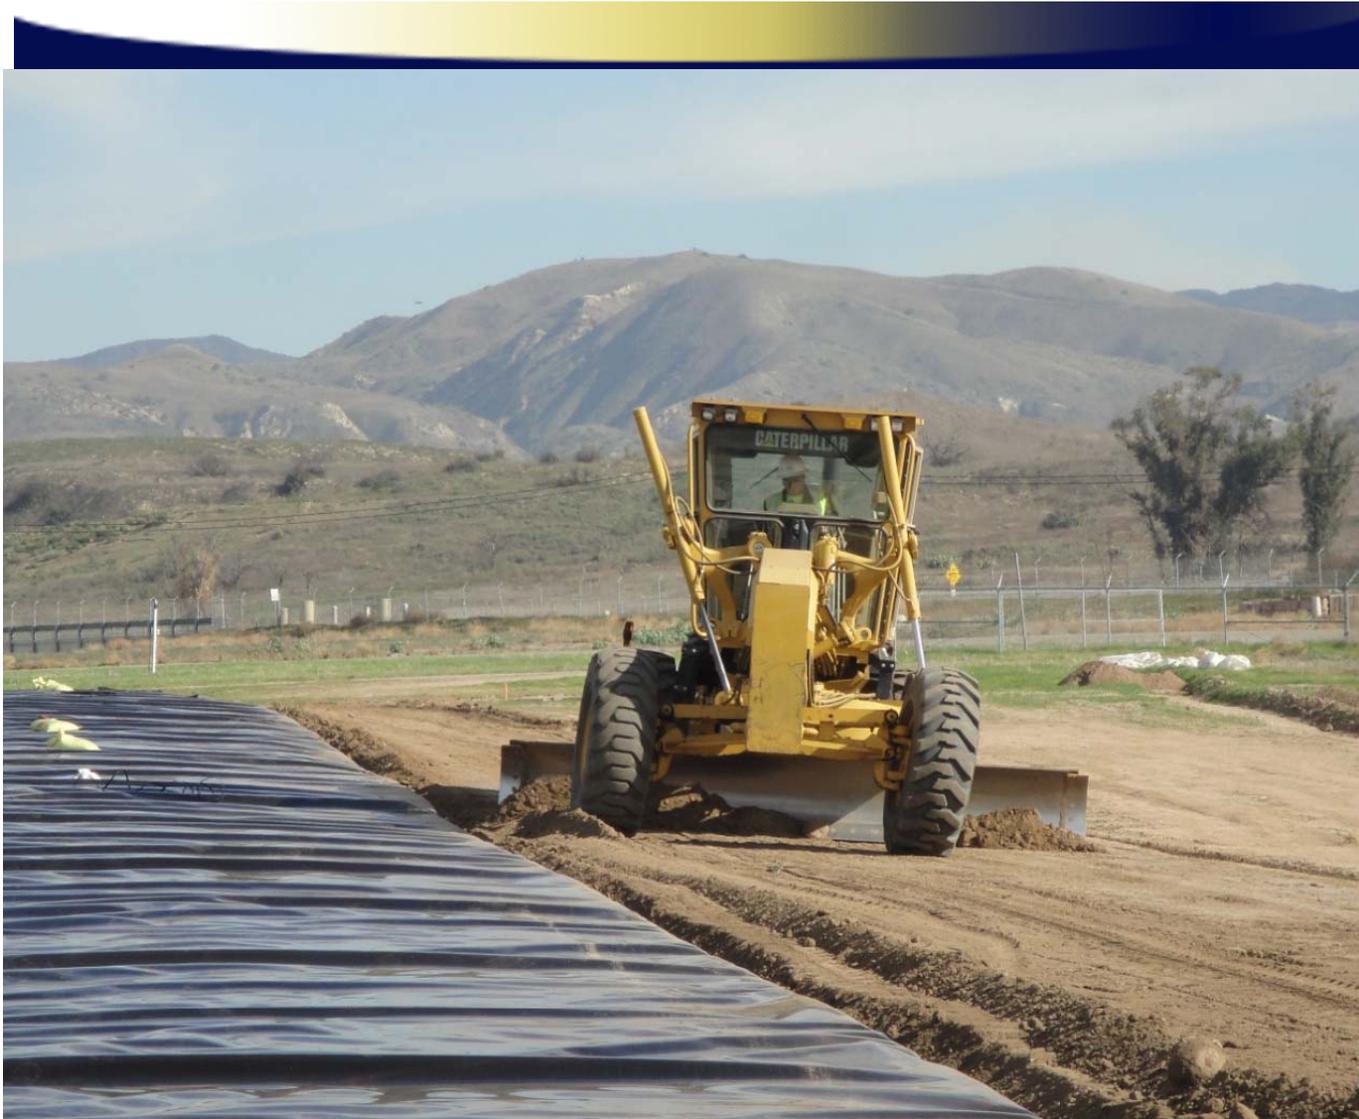
Operator backfilling the geomembrane anchor trench at IRP Site 5.
