NAS Alameda Environmental Fieldwork Update

Alameda RAB Meeting Alameda Point

Mr. William McGinnis, PE
Navy BRAC PMO West
September 11, 2013

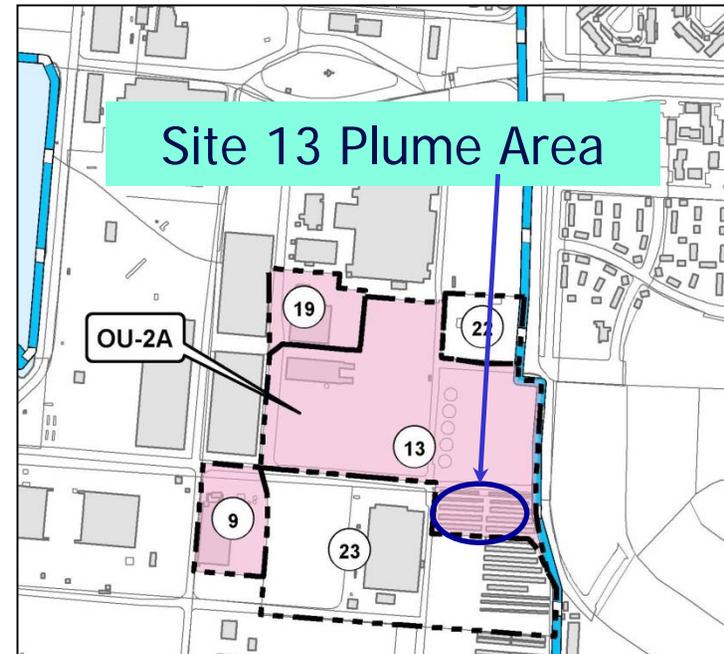
- Monitoring well (4) installation
- Biovent well (54) installation
- Auger boring (23) emplacement
- Direct push injections
- Phase 1: March (calcium peroxide)
- Phase 2: July (Klozur CR)
- Phase 3: December (calcium peroxide)

Monthly bio-vent operations and maintenance began in August 2014. Groundwater performance monitoring is being conducted quarterly to evaluate effectiveness.

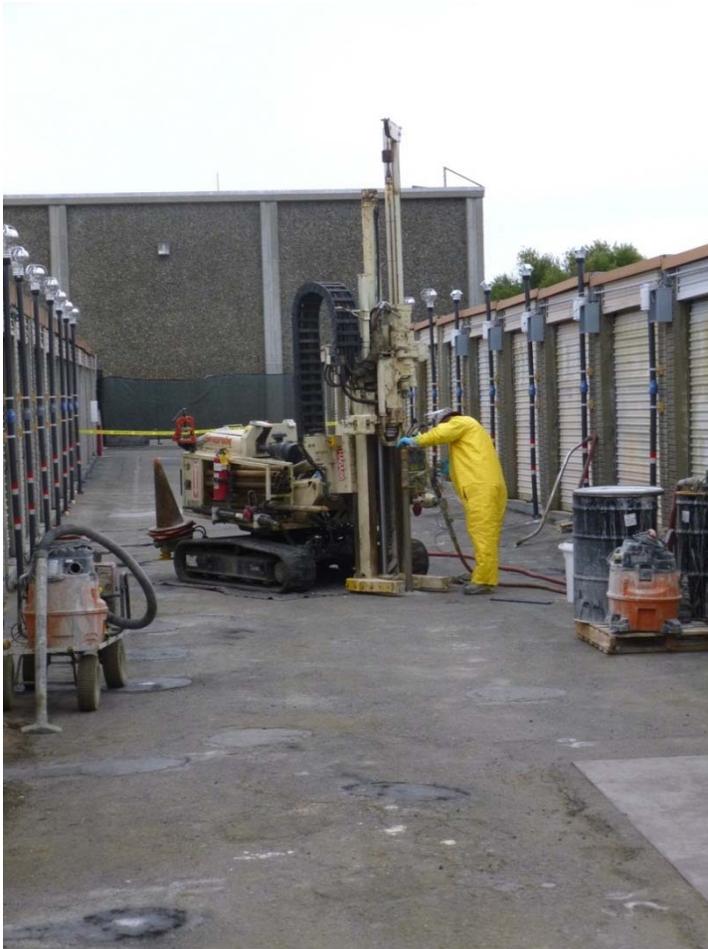
Site 13 In-situ Bio Remedial Action

Mobilization to Site: March 17

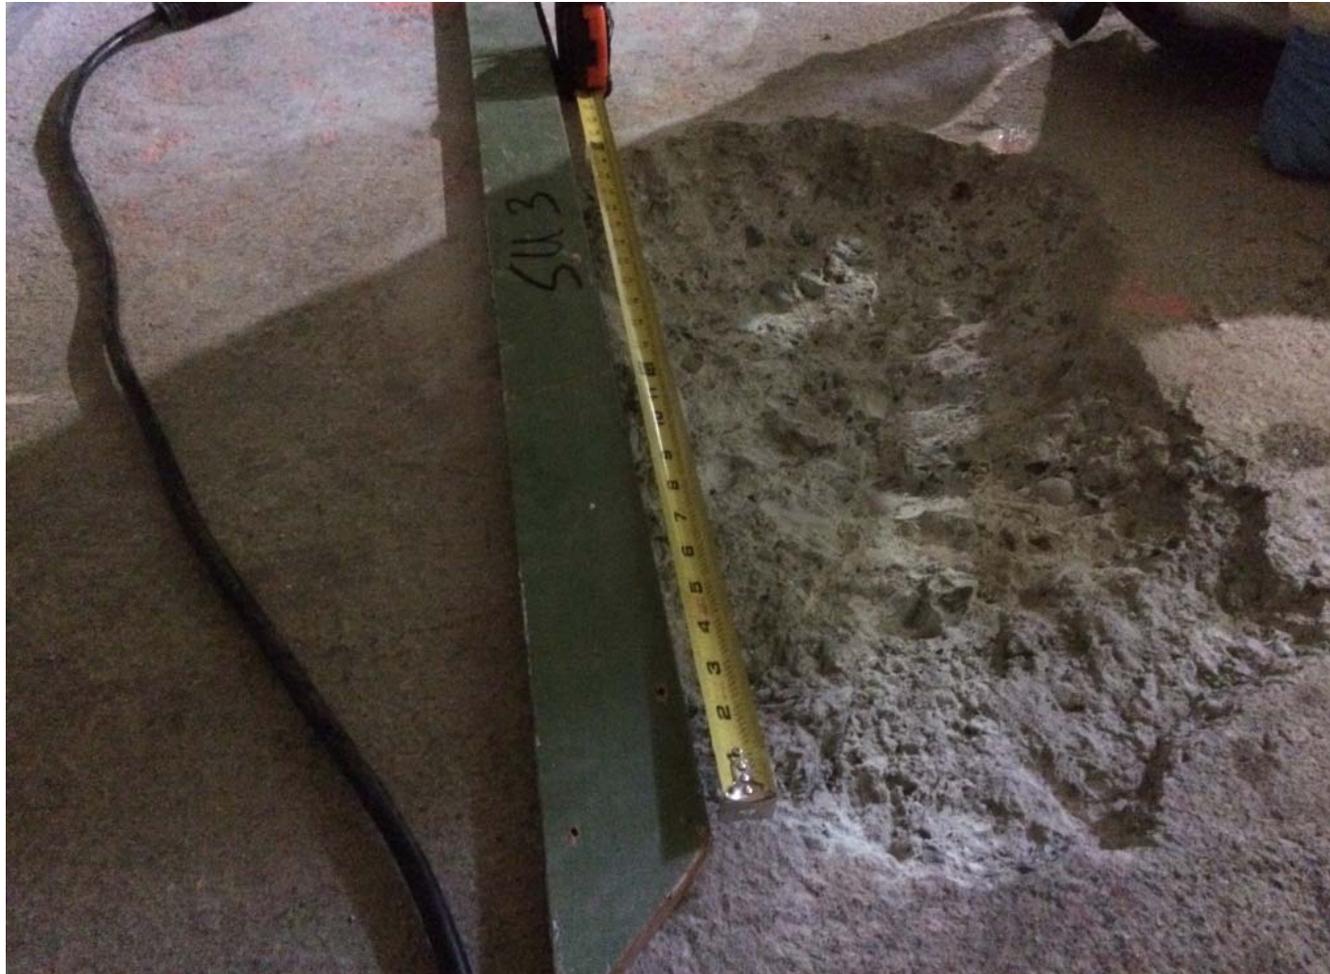
OU2C -Building 400 Clean Up

- Radiological clean-up on the 2nd floor of Building 400 (Site 10)
- Further investigation of the drain lines (storm water and former industrial waste lines) associated with Sites 5 and 10

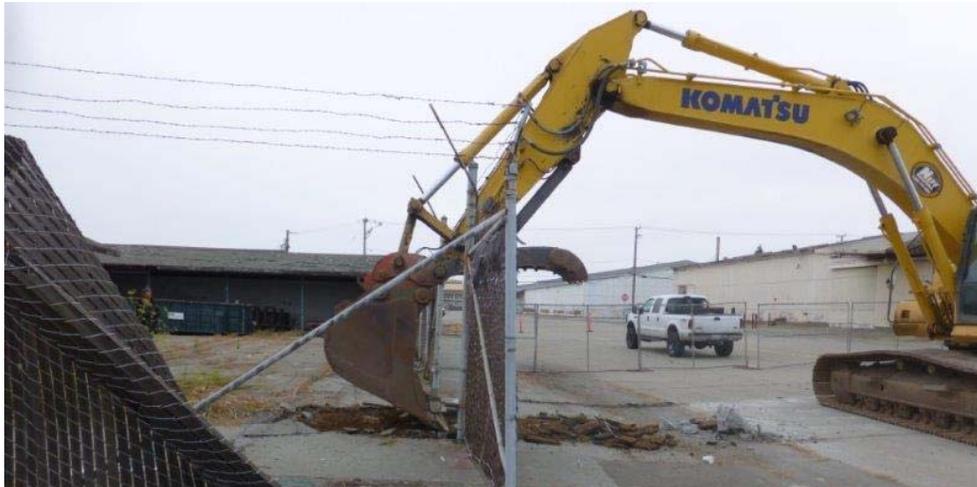
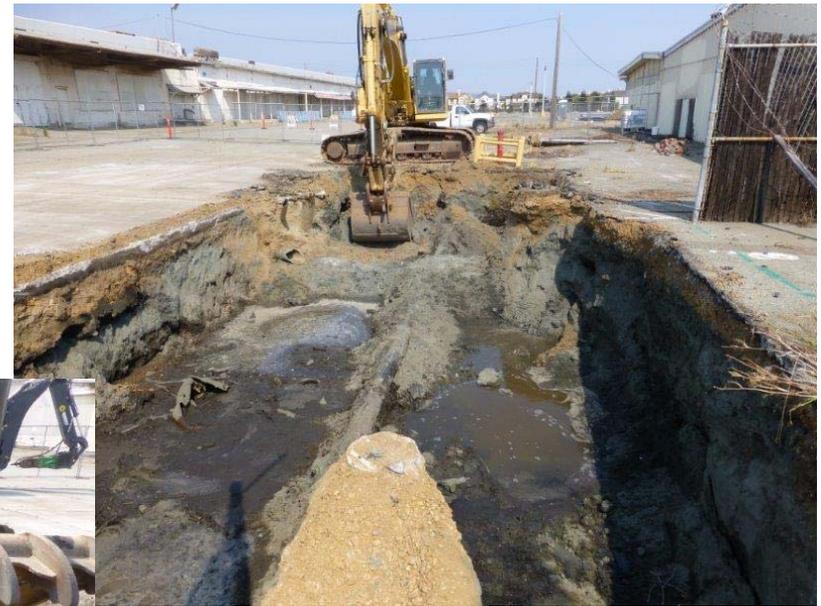
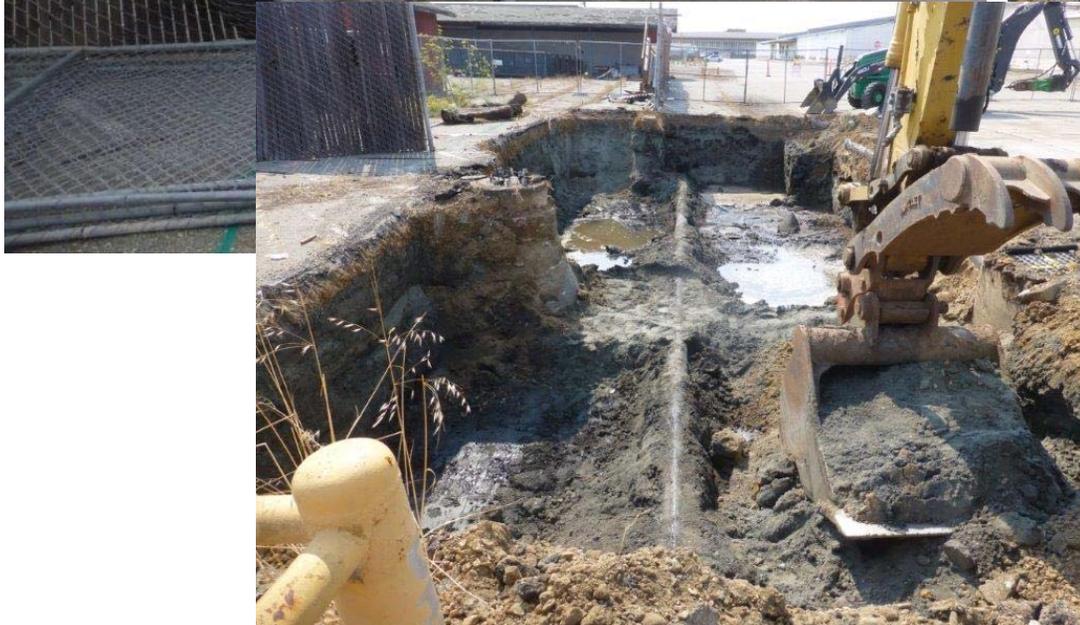
Site 3

- Excavations for lead contaminated soil began in early-August 2014
- Excavation completed in mid-August and confirmation samples collected
- Confirmation results meet criteria

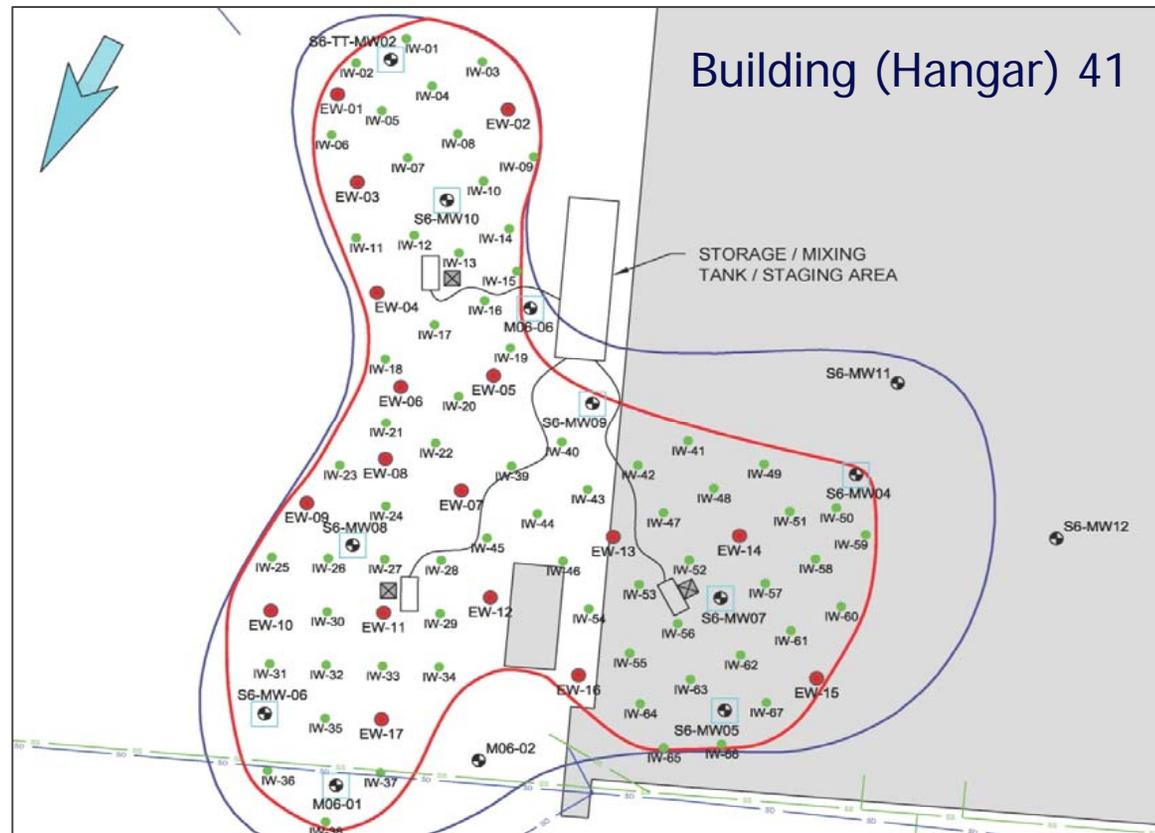
ENHANCED ISB TREATMENT LAYOUT

66 Injection Wells and 27 Extraction Wells
Treatment area is 42,000 sq ft., depth - 11 feet bgs

- Injection Well
- Extraction Well

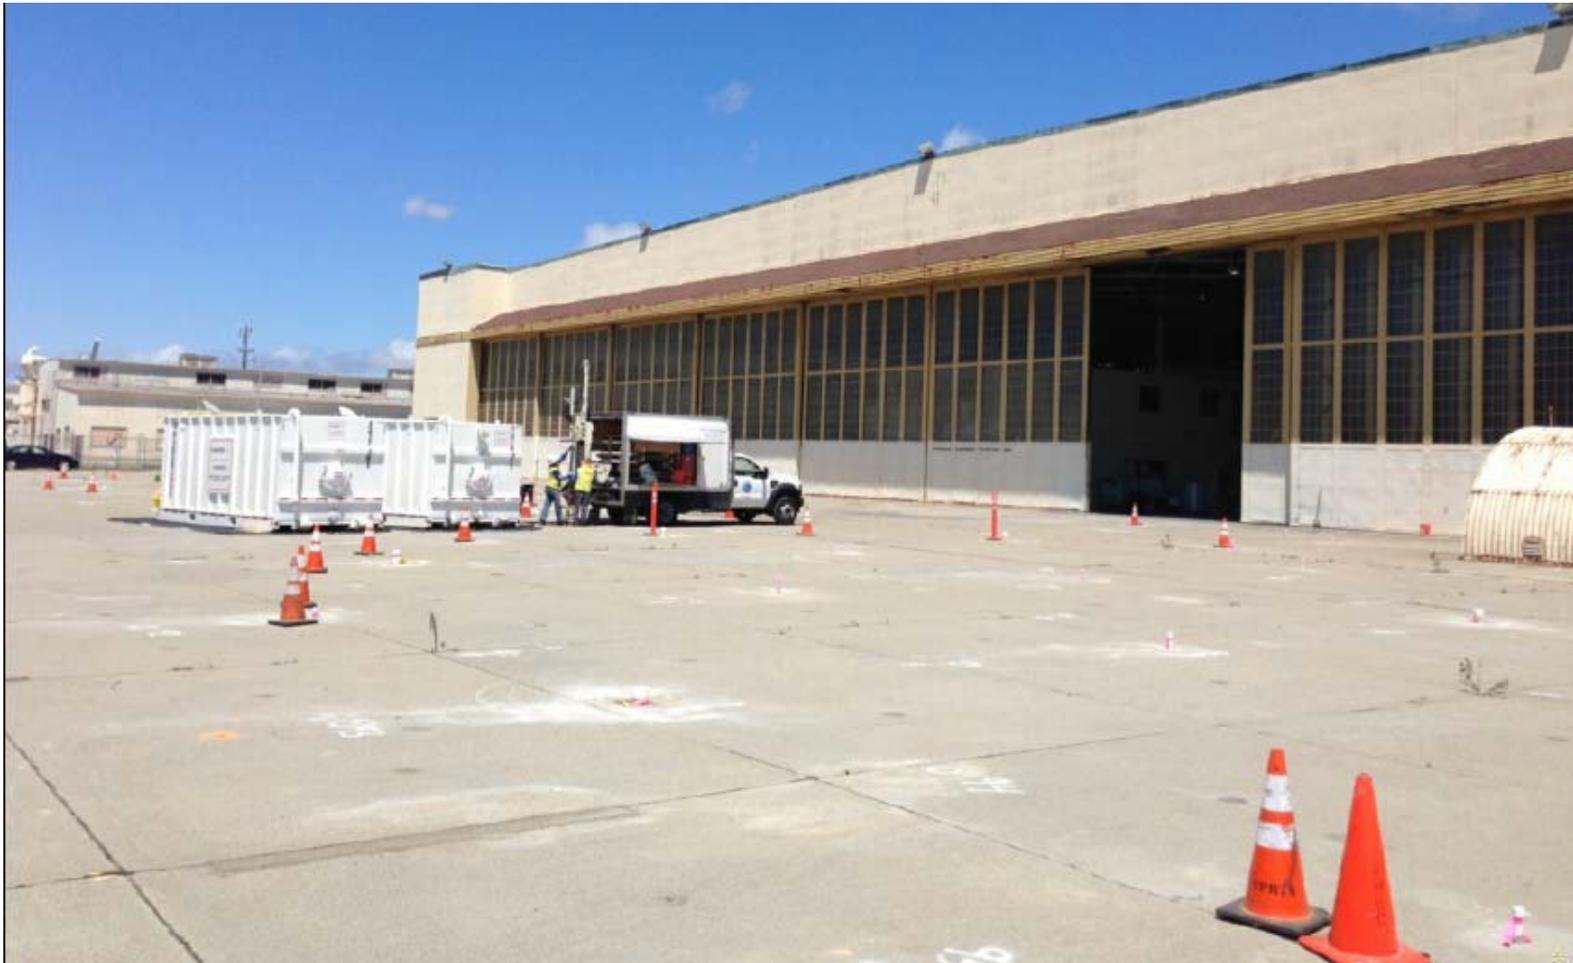
ISB Treatment area looking northeast towards

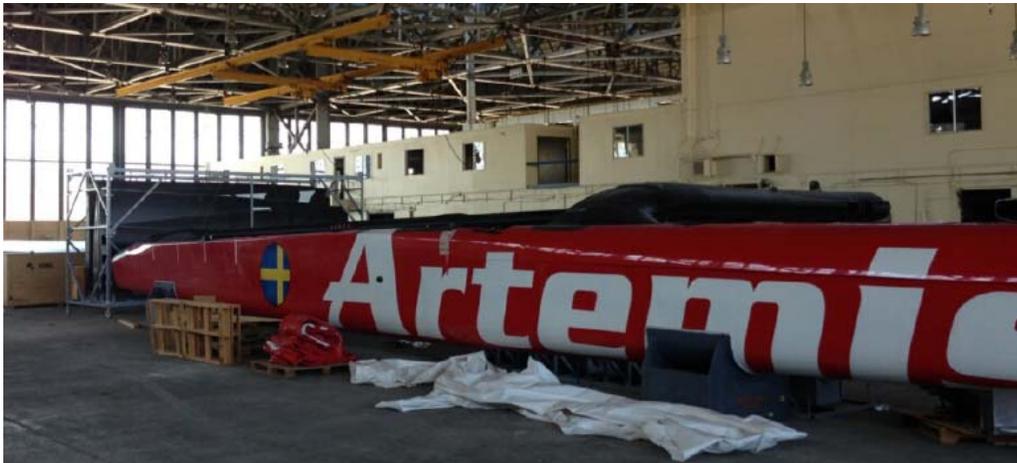
Artemis racing sailboat (above)
inside Bldg. 41 needed to be
removed before system (right)
was installed.

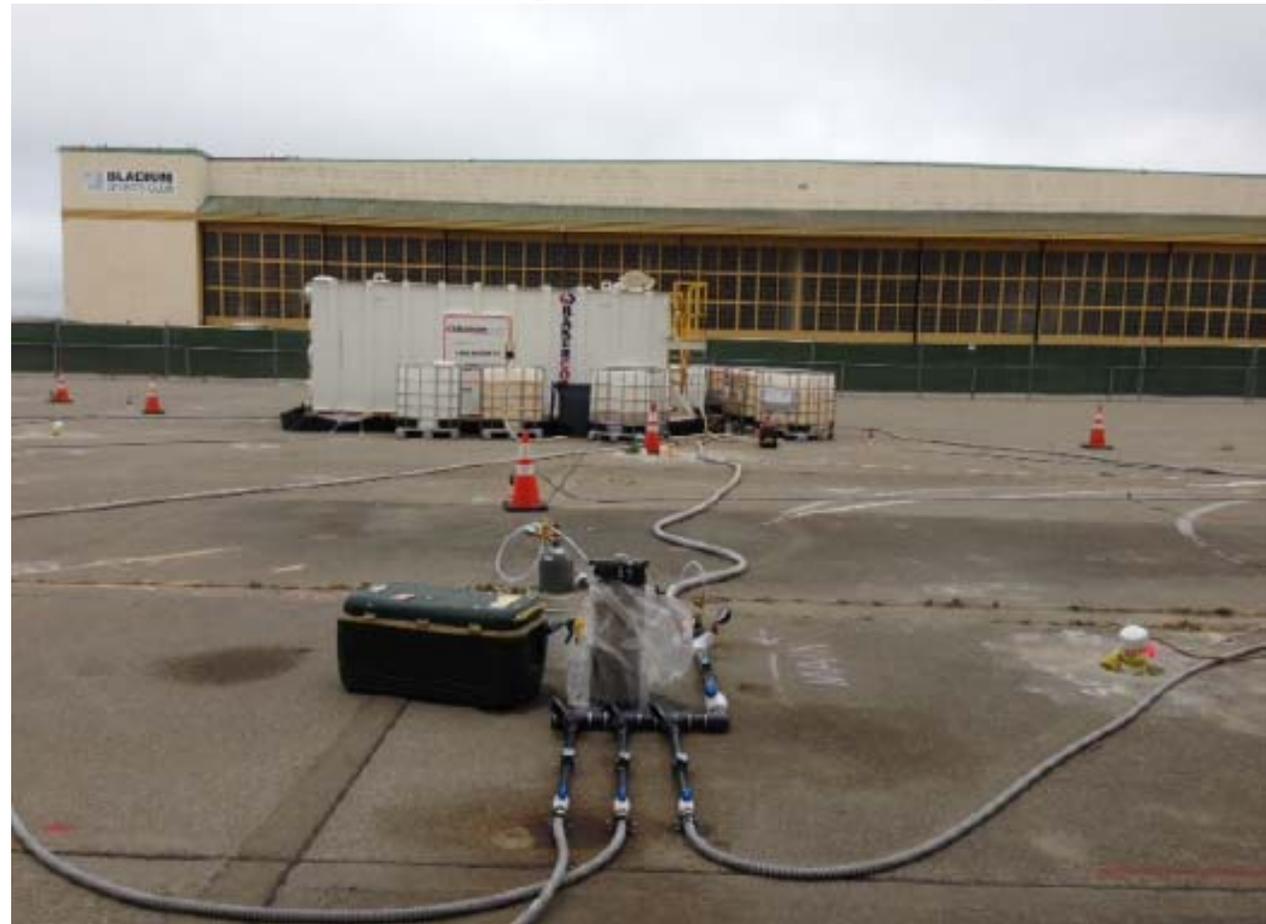
View Looking West from Bldg. 41

- Background shows two 10,000 gallon mixing tanks surrounded by totes of lecithin.

- Foreground shows valve assembly and 5-gallon tank holding *dehalocoides* (bacteria that degrade chlorinated solvents)

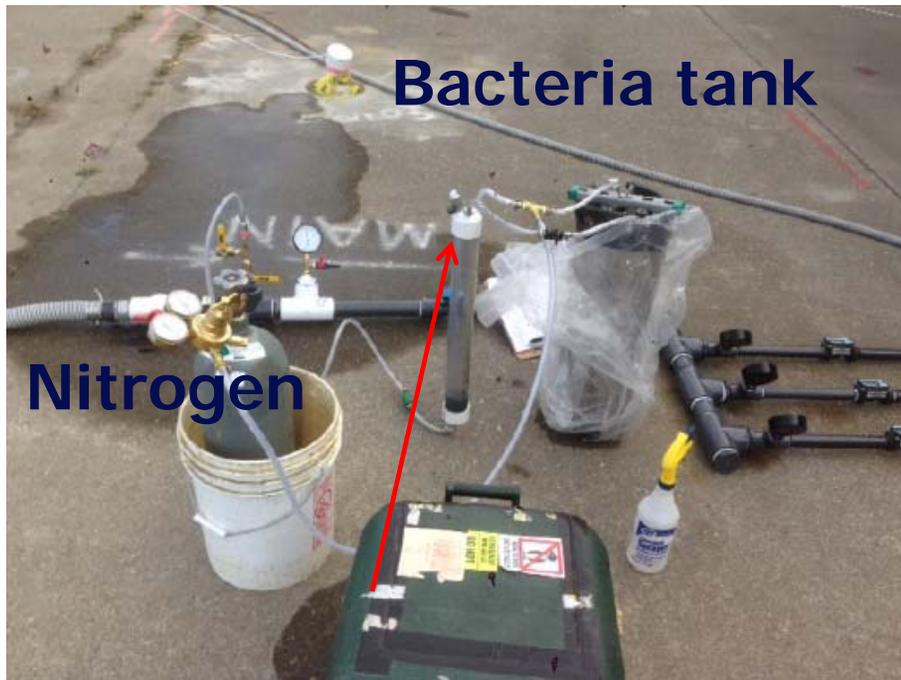
Graduated cylinder with 5-gallon tank of *dehalocoides* to measure dechlorinating bacteria "innoculation". Tank on the left is nitrogen to push the bacteria into the manifold.

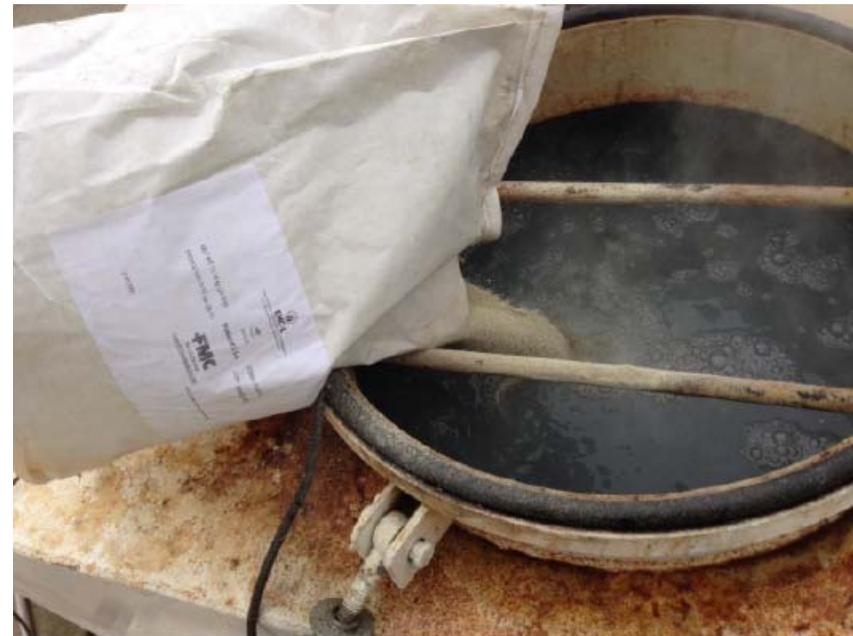
Powdered iron mixing into extracted groundwater in top of 10,000 gallon tank

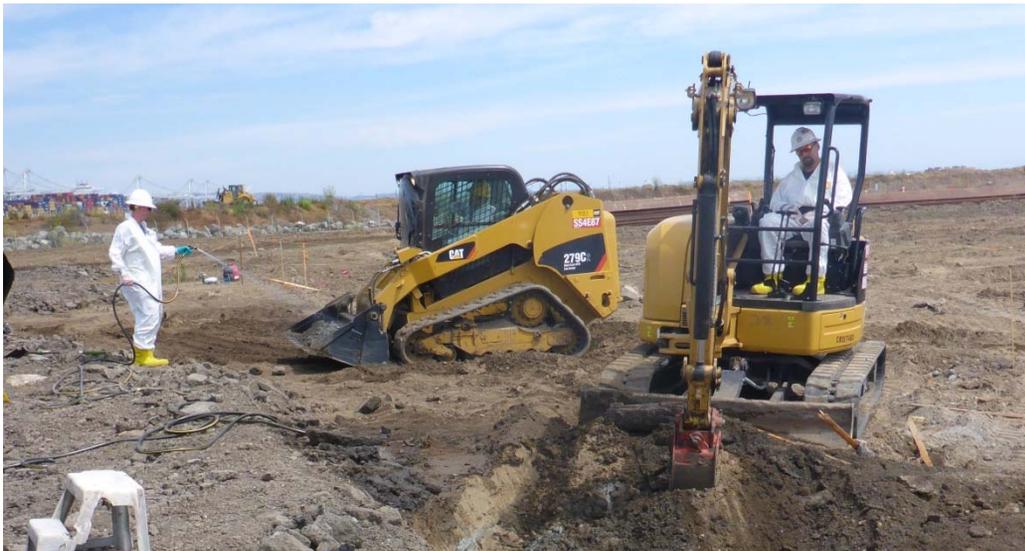
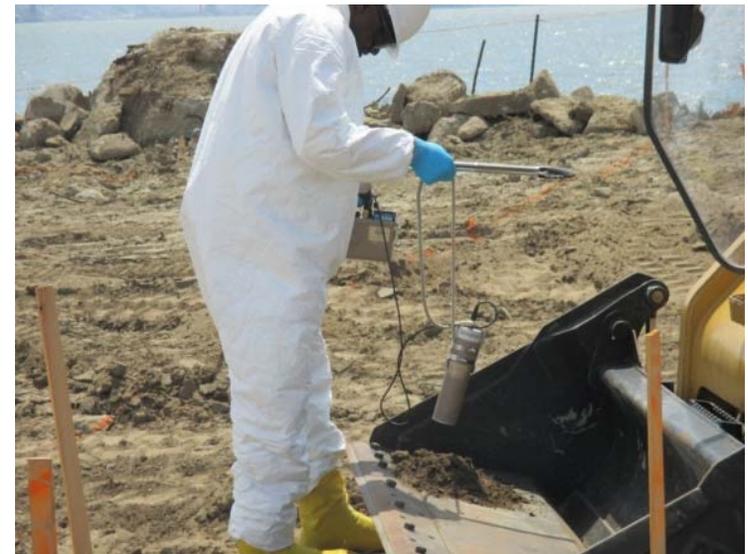
Site 1 – Summary

- Stormwater BMPs installed and deployment of silt curtain (continue throughout the project)
- Clearing of vegetation and tree chipping
- Placement of crushed asphalt road along the northwest shoreline for the installation of the WIB
- Demolition of above ground structures
- Revetment placement on beach of Area 5a

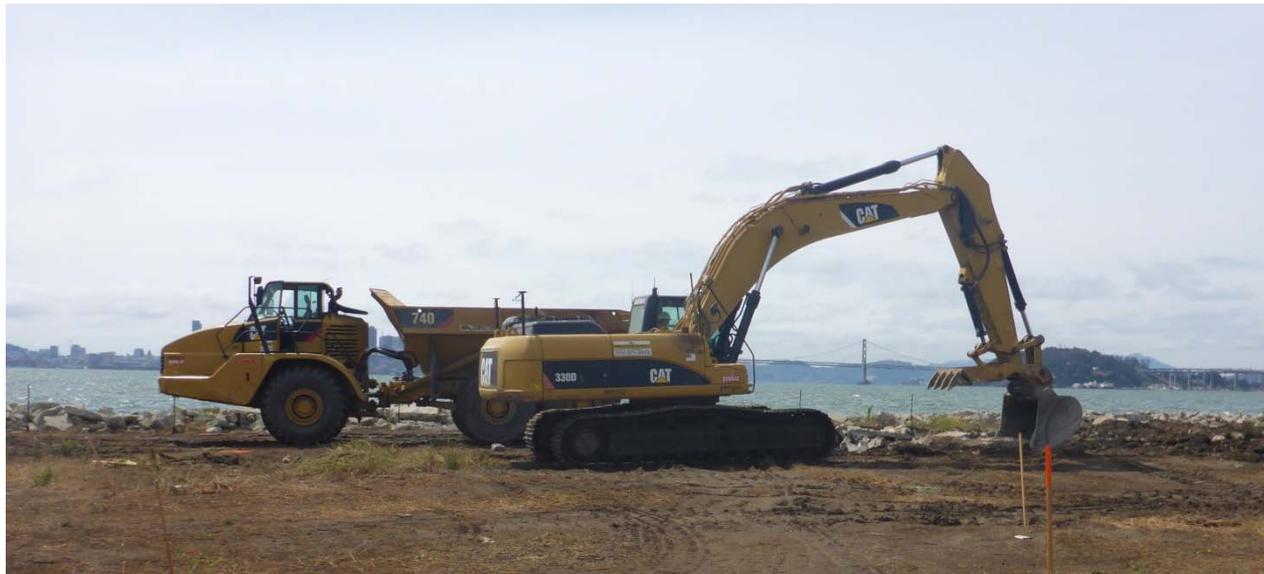
Site 1 – Current Activities

- Surface gamma scans to identify and remove radiological hot spots
- Excavation of bayside and harbor side setback areas and the burn area select excavation
- Segregate radiologically impacted material for offside disposal
- Placement of the WIB templates and sheet pile driving of the WIB steel sheets
- Pulverizing and removing the harbor side taxiway
