ENVIRONMENTAL CONDITION OF PROPERTY REPORT

**INSPECTOR-INSTRUCTOR STAFF
(MARINE CORPS RESERVE CENTER)
WEST TRENTON, NEW JERSEY**

12 April 2006

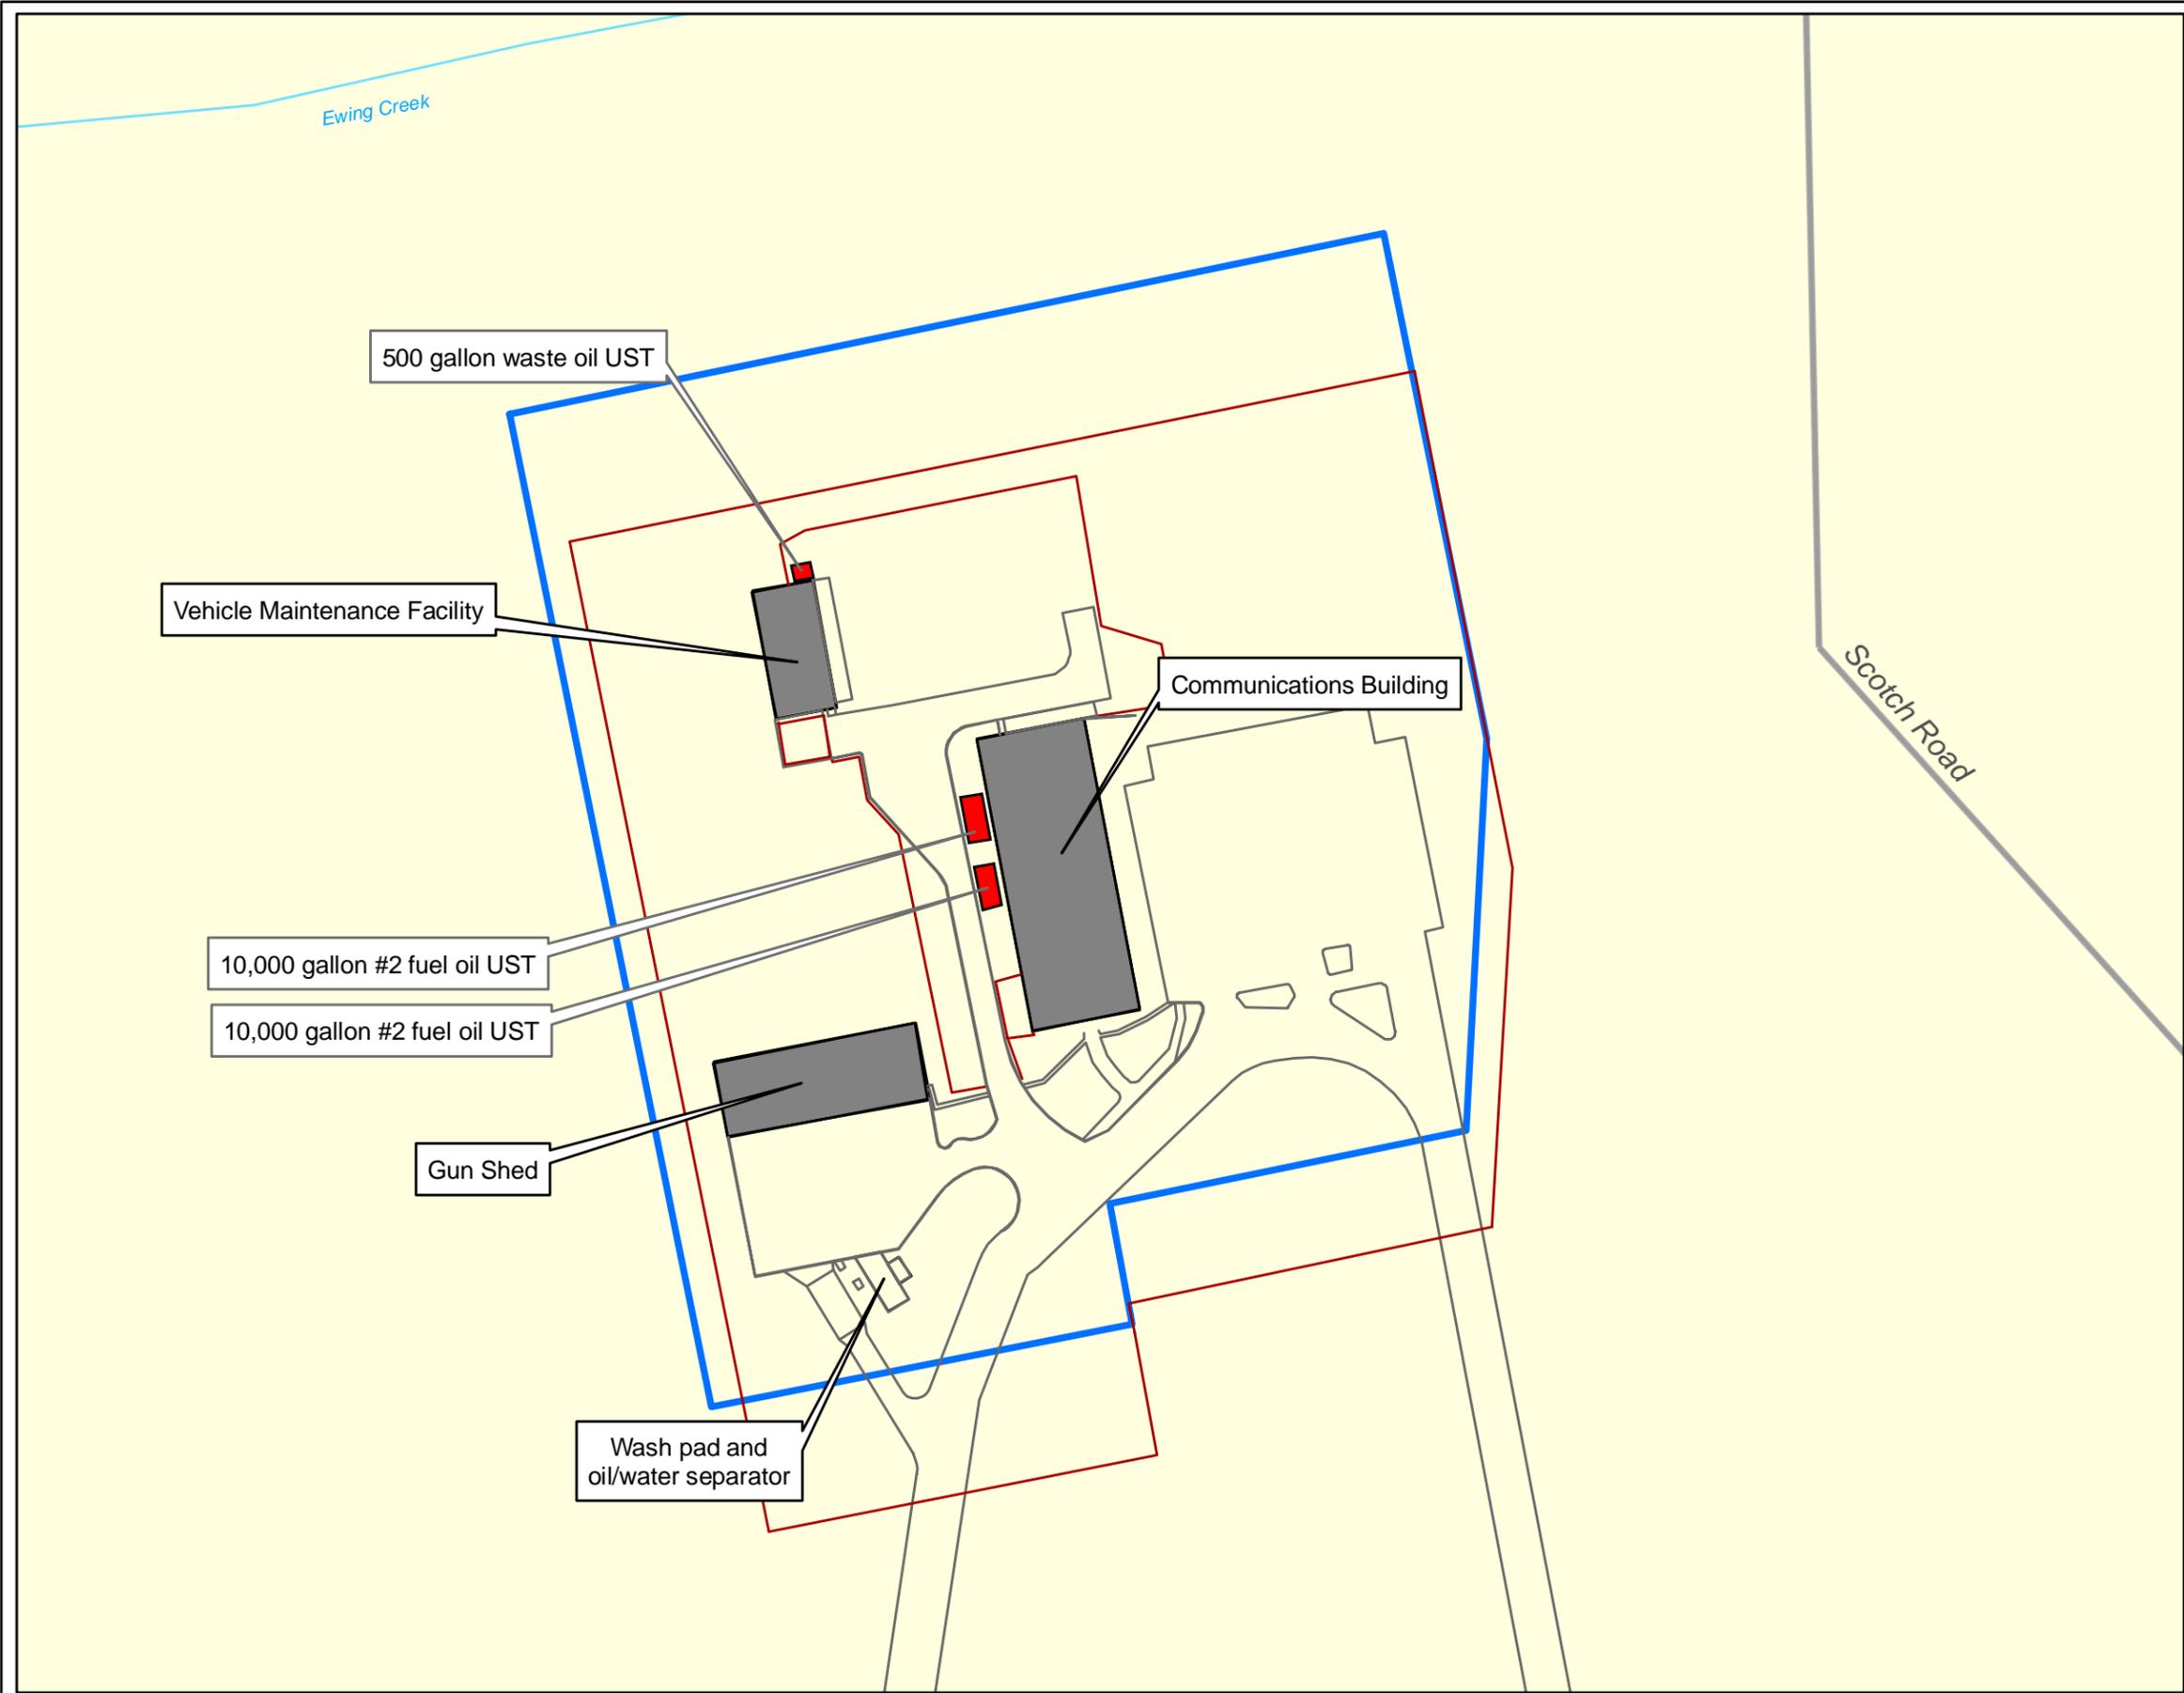
FIGURE
4-1

There were formerly three underground storage tanks (UST) located at MCRC West Trenton (**Figure 4-1**). The tanks consisted of two 10,000-gallon #2 fuel oil USTs, and one 500-gallon waste oil UST. According to the *Underground Storage Tank Site Assessment Summary Report Revision* (JMT 1997), the tanks were excavated and removed in April of 1994. During tank removal operations, visual observation revealed small holes and minor soil staining in the vicinity of the two 10,000-gallon USTs. There was no visual evidence of holes or stained soil near the 500 gallon waste oil UST. Soil under the two 10,000-gallon tanks was excavated until field screening of soil vapors from soil grab samples indicated nominal organic vapors were present in soil from the bases of the excavation and sidewalls. Following tank removal, five confirmatory soil samples were collected from each of the three excavations for laboratory chemical analysis. The laboratory data indicated that petroleum hydrocarbon concentrations were below applicable New Jersey Department of Environmental Protection (NJDEP) standards in all samples. Based on these results, all three excavations were backfilled with clean fill. In January 1998, the Navy received formal approval from the NJDEP for No Further Action (NFA) at the former UST sites (NJDEP 1998).

FORMER UST LOCATIONS

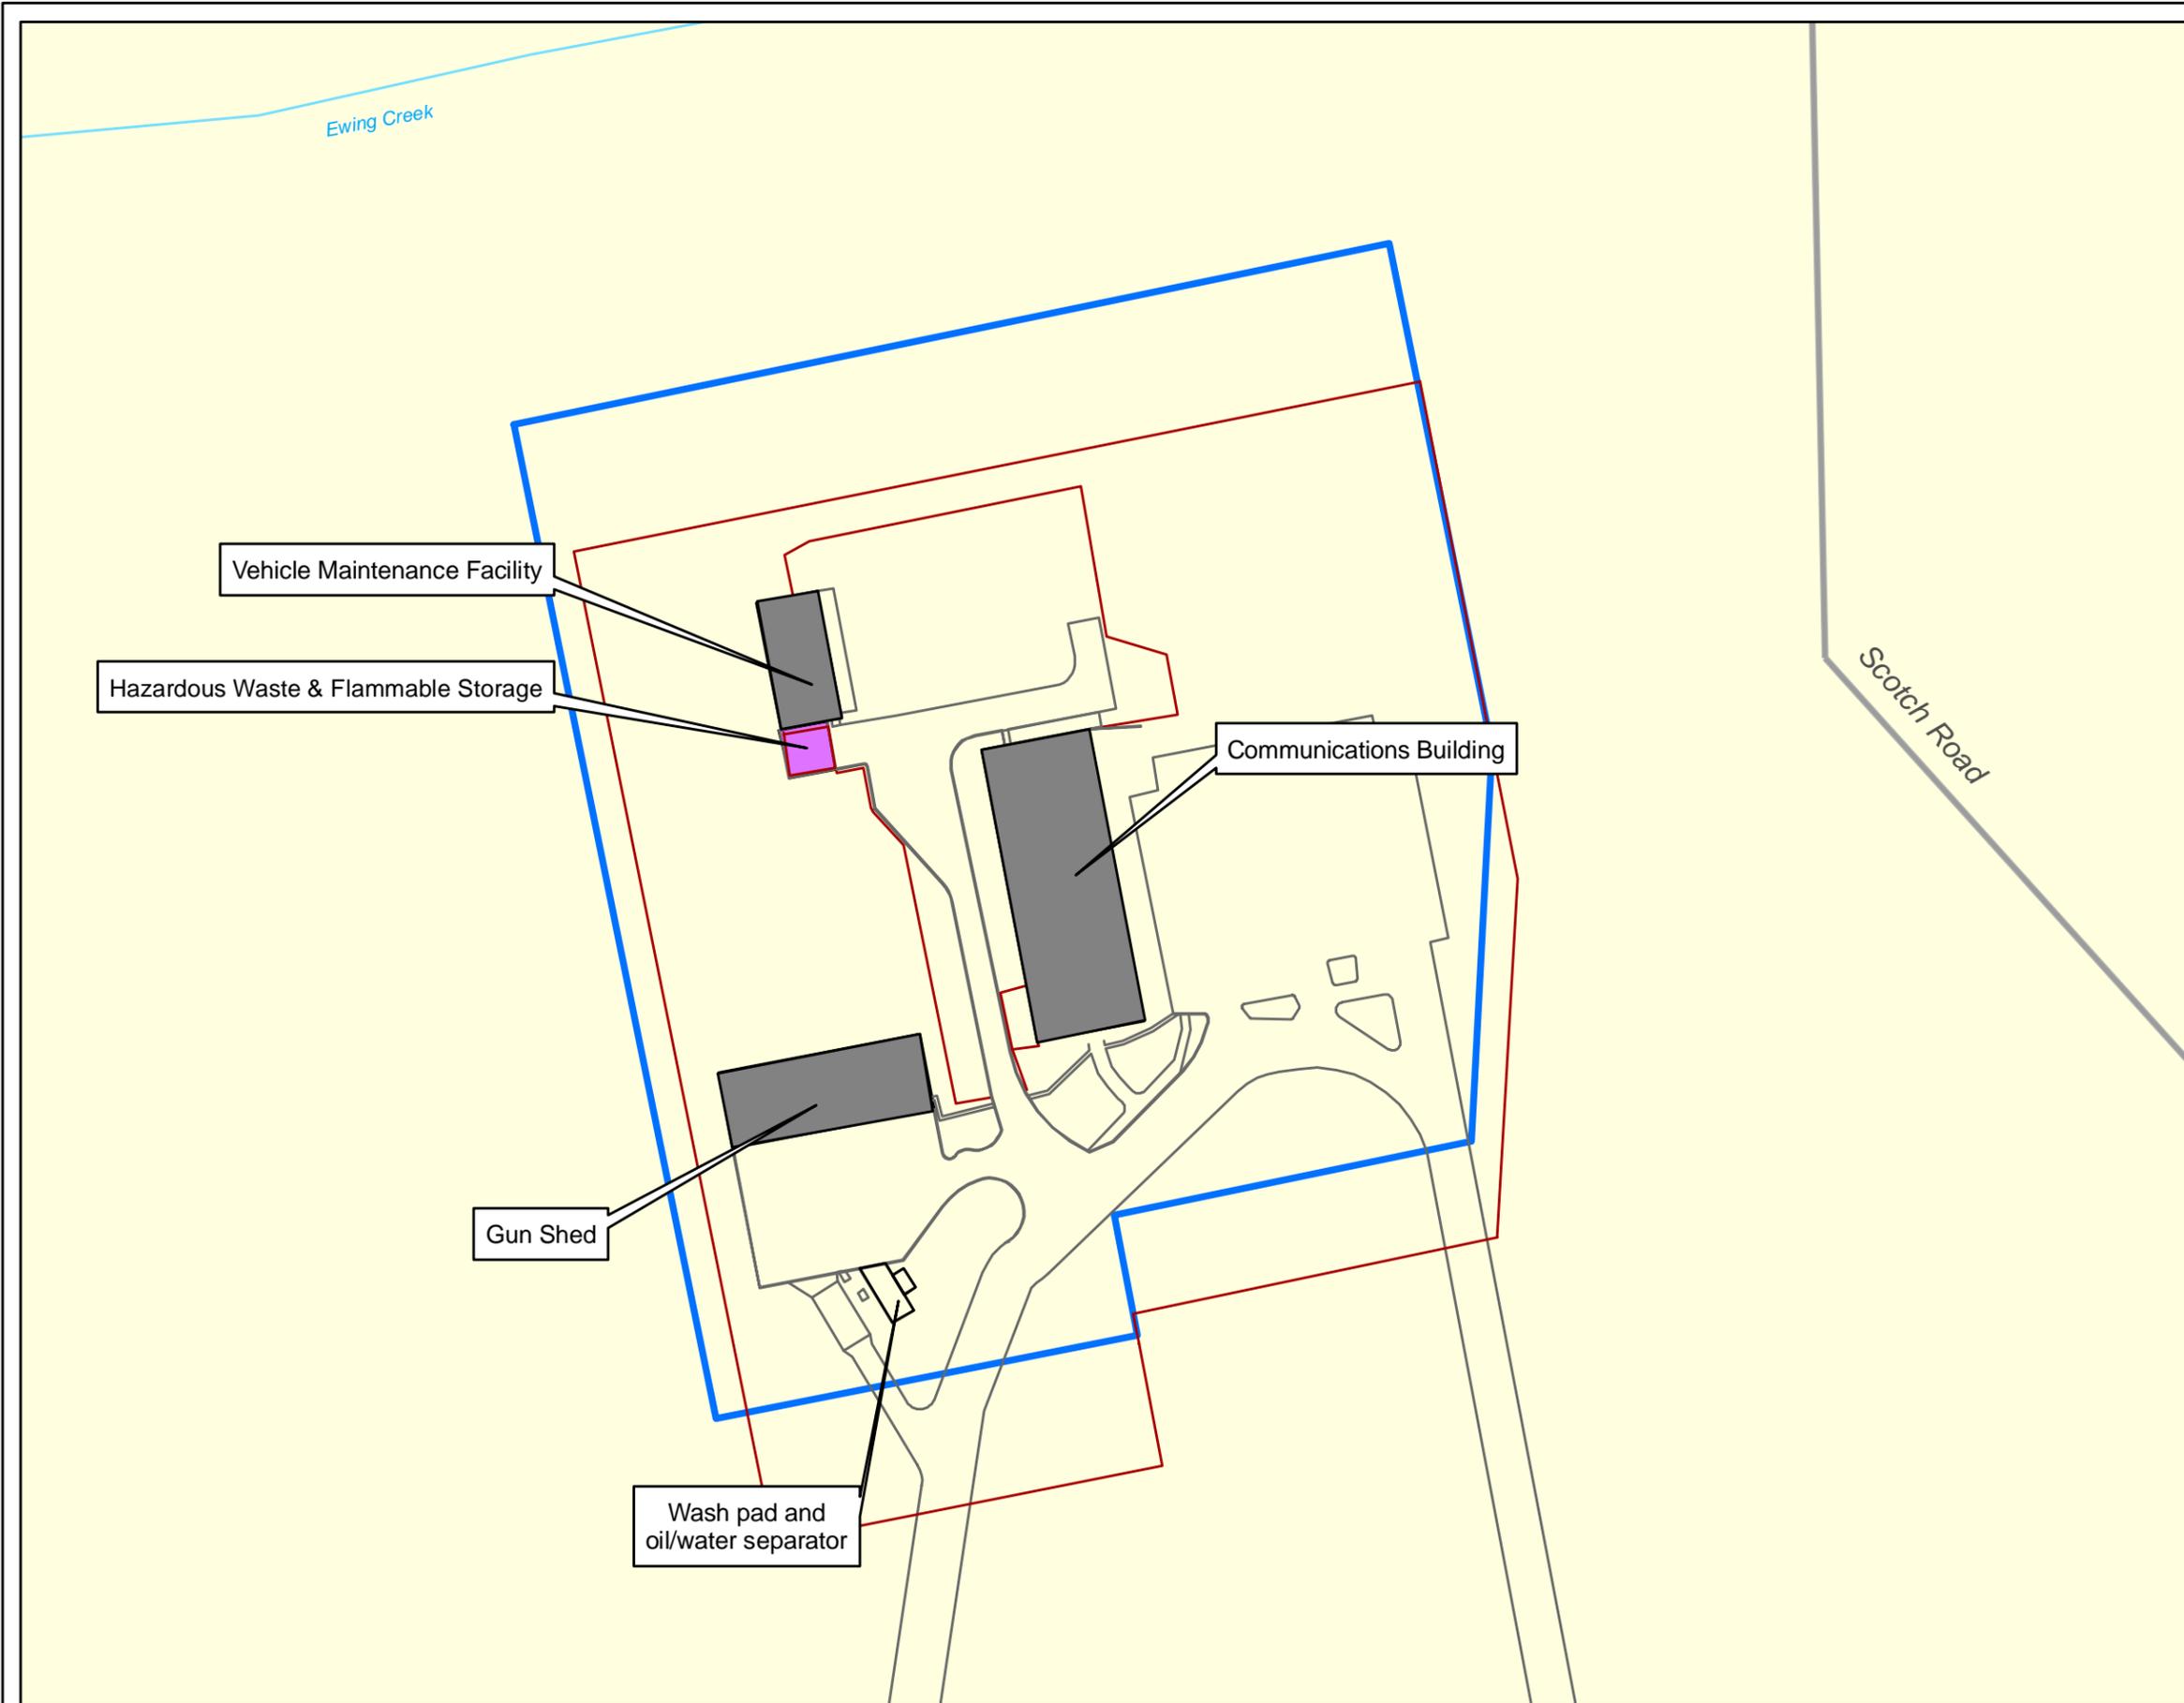
4-2

MCRC West Trenton is classified as a small quantity hazardous waste generator (generator identification code NJ4170022400) and handles waste on a less than 90-day basis. The waste generated at the facility is the result of vehicle maintenance and consists of used oil, used antifreeze, oily rags, spent absorbent material, and parts cleaning solvents. No vehicle painting occurs at the site (Woodhead 2005). All waste is accumulated in the hazardous waste and

flammable storage building (**Figure 4-2**) and is managed by a contractor (Safety Kleen) (Navy 1997).

Hazardous materials stored at MCRC West Trenton include the vehicle maintenance materials such as: oils, gasoline, antifreeze, lubricants, and solvents. The hazardous materials are stored in the flammable storage locker or in the vehicle maintenance facility (**Figure 4-2**).

HAZARDOUS WASTE & FLAMMABLE STORAGE

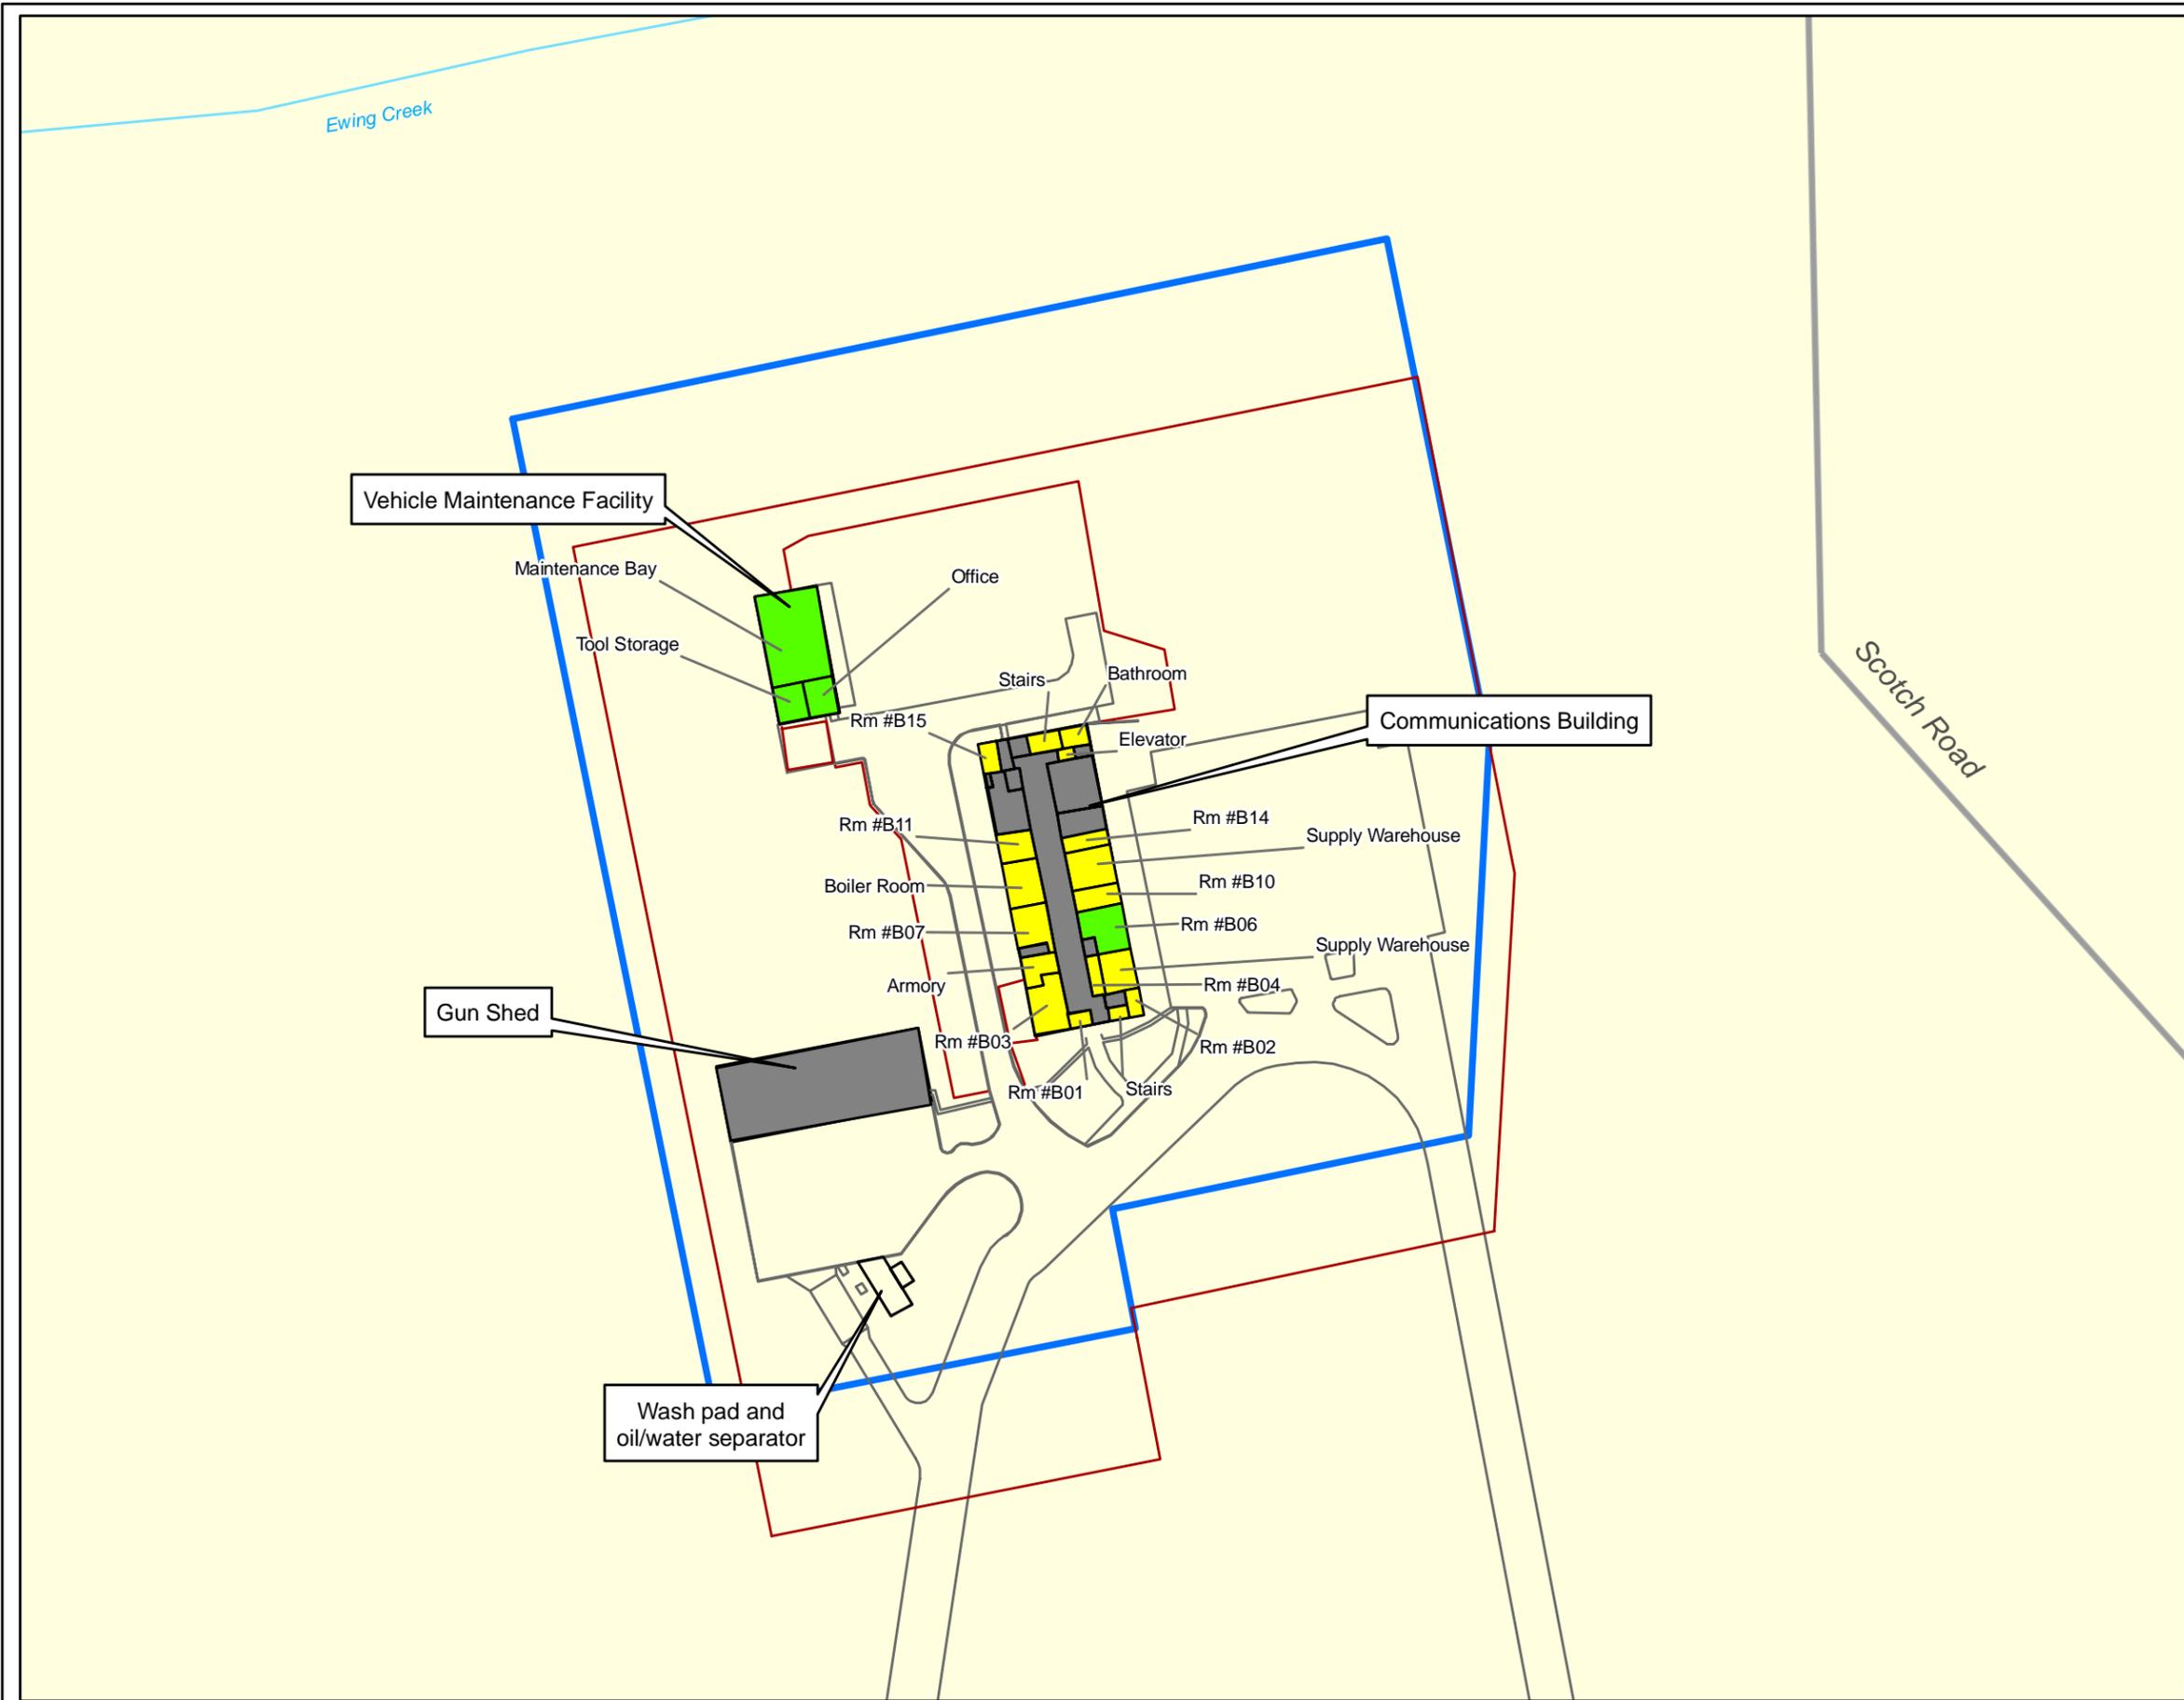
4-3

- **Radon.** A February 1999 radon survey consisted of the placement of radon detectors in 22 rooms within two buildings (Communications Building and Vehicle Maintenance Building). In February 2000, a total of 18 radon detectors were retrieved (four were lost) and sent for laboratory analysis. None of the detectors contained radon gas concentrations in excess of the United States (U.S.) Environmental Protection Agency (USEPA) maximum contaminant level of 4 picoCuries per Liter (pCi/L) (DOE 2001).

RADON SAMPLE LOCATIONS

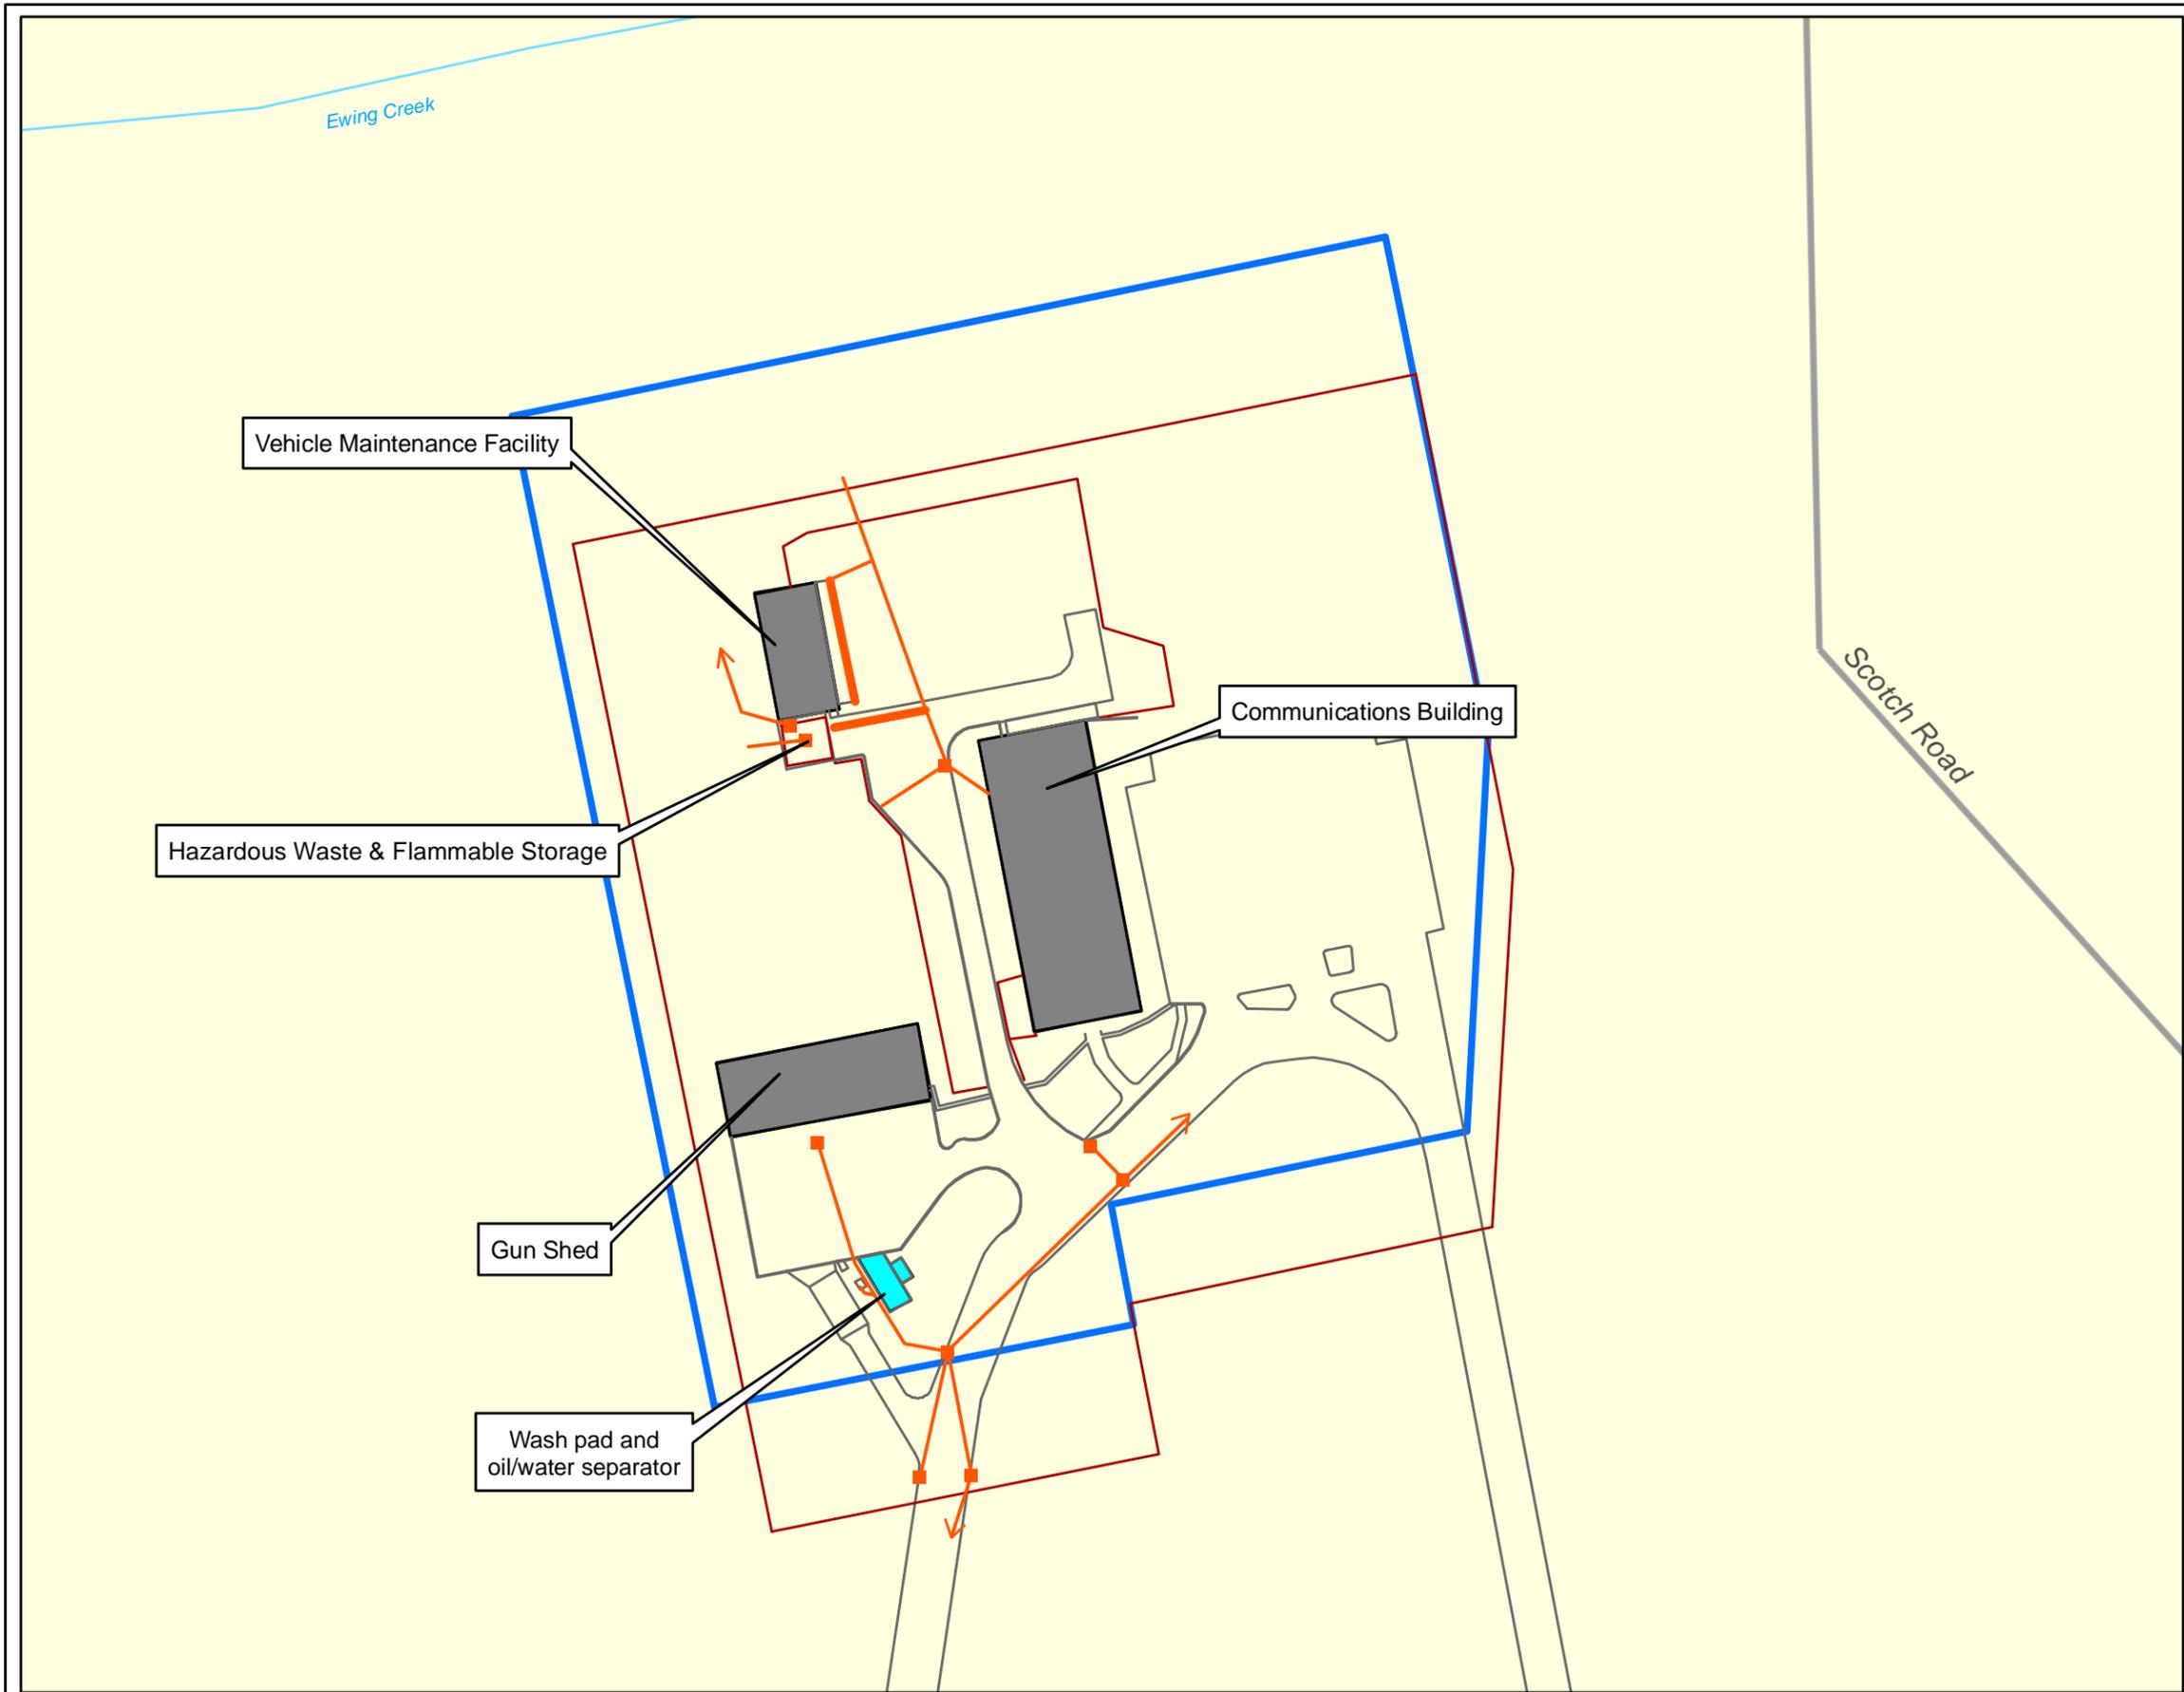
FIGURE
4-4

- **Stormwater.** Stormwater runoff from the northern end of MCRC West Trenton property flows through a combination of storm drains and trench drains along culverts discharging to a drainage swale and eventually to the wetland located north of the site. The stormwater collected on the hazardous waste/flammable material storage area and the stairwell vault of the maintenance garage flow through storm drains along culverts discharging to the drainage swale behind the garage and eventually into the wetland located north of the site. A National Pollutant Discharge Elimination System (NPDES) permit is required for facilities discharging stormwater associated with industrial activities. There were no known NPDES permits for the reserve center and no on-site industrial activities; therefore, an NPDES permit is not required for MCRC West Trenton.

stormwater from the northern half of the MCRC West Trenton discharges through catch basins and trench drains to a drainage swale on the north end of the site (**Figure 4-4**) and eventually to the wetland located north of the site. In addition, the plans indicate that stormwater from the hazardous waste/flammable storage pad along with the vehicle maintenance garage stairway vault are collected in drains and discharge to the drainage swale on the west side of the property and eventually to the wetland located north of the site. However, there is no record of a NPDES permit associated with the MCRC West Trenton (Woodhead 2005).

STORMWATER SYSTEM

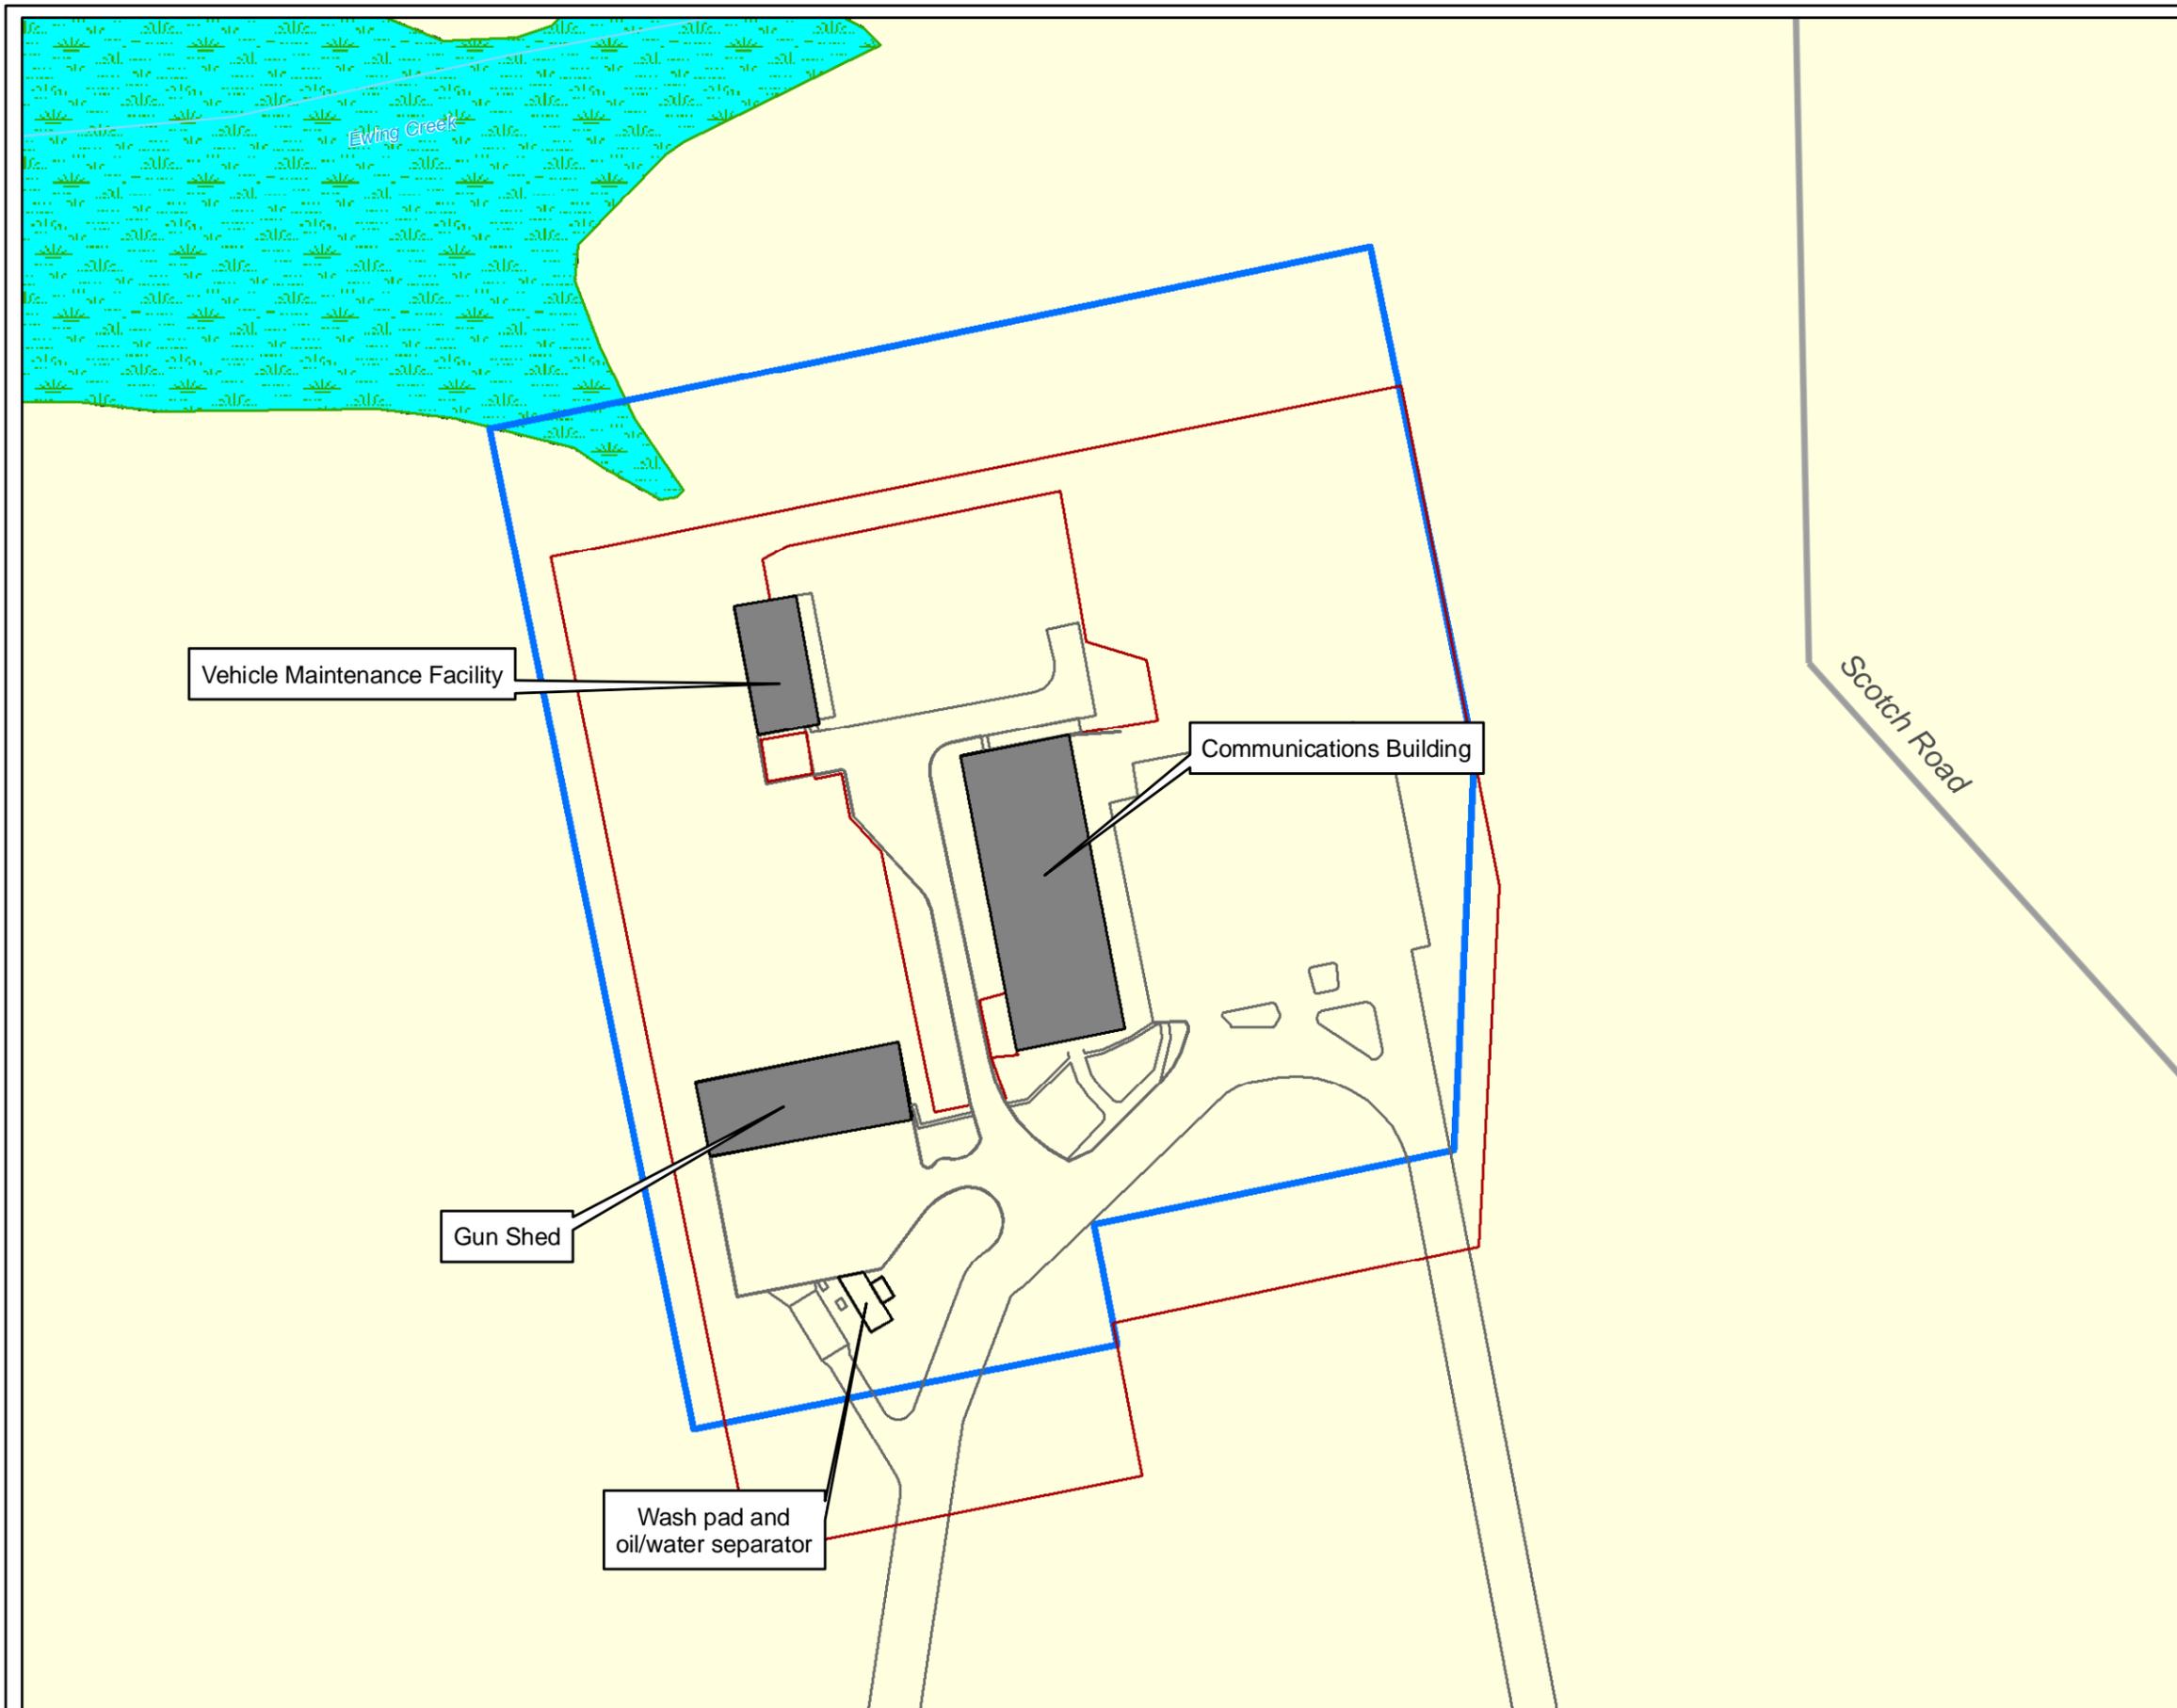
FIGURE
4-5

- **Wetlands and Aquatic Habitats (Special Aquatic Sites).** According to facility personnel, there are no known wetlands on the MCRC West Trenton property (Woodhead 2005), although according to the New Jersey Department of Environmental Protection GIS, a finger of deciduous wooded wetlands is mapped in the northwest corner of the property (NJDEP GIS 2006).

**WETLANDS
(PLANNING LEVEL ONLY)**
