ENVIRONMENTAL CONDITION OF PROPERTY REPORT

**INSPECTOR-INSTRUCTOR STAFF
(MARINE CORPS RESERVE CENTER)
WEST TRENTON, NEW JERSEY**

12 April 2006

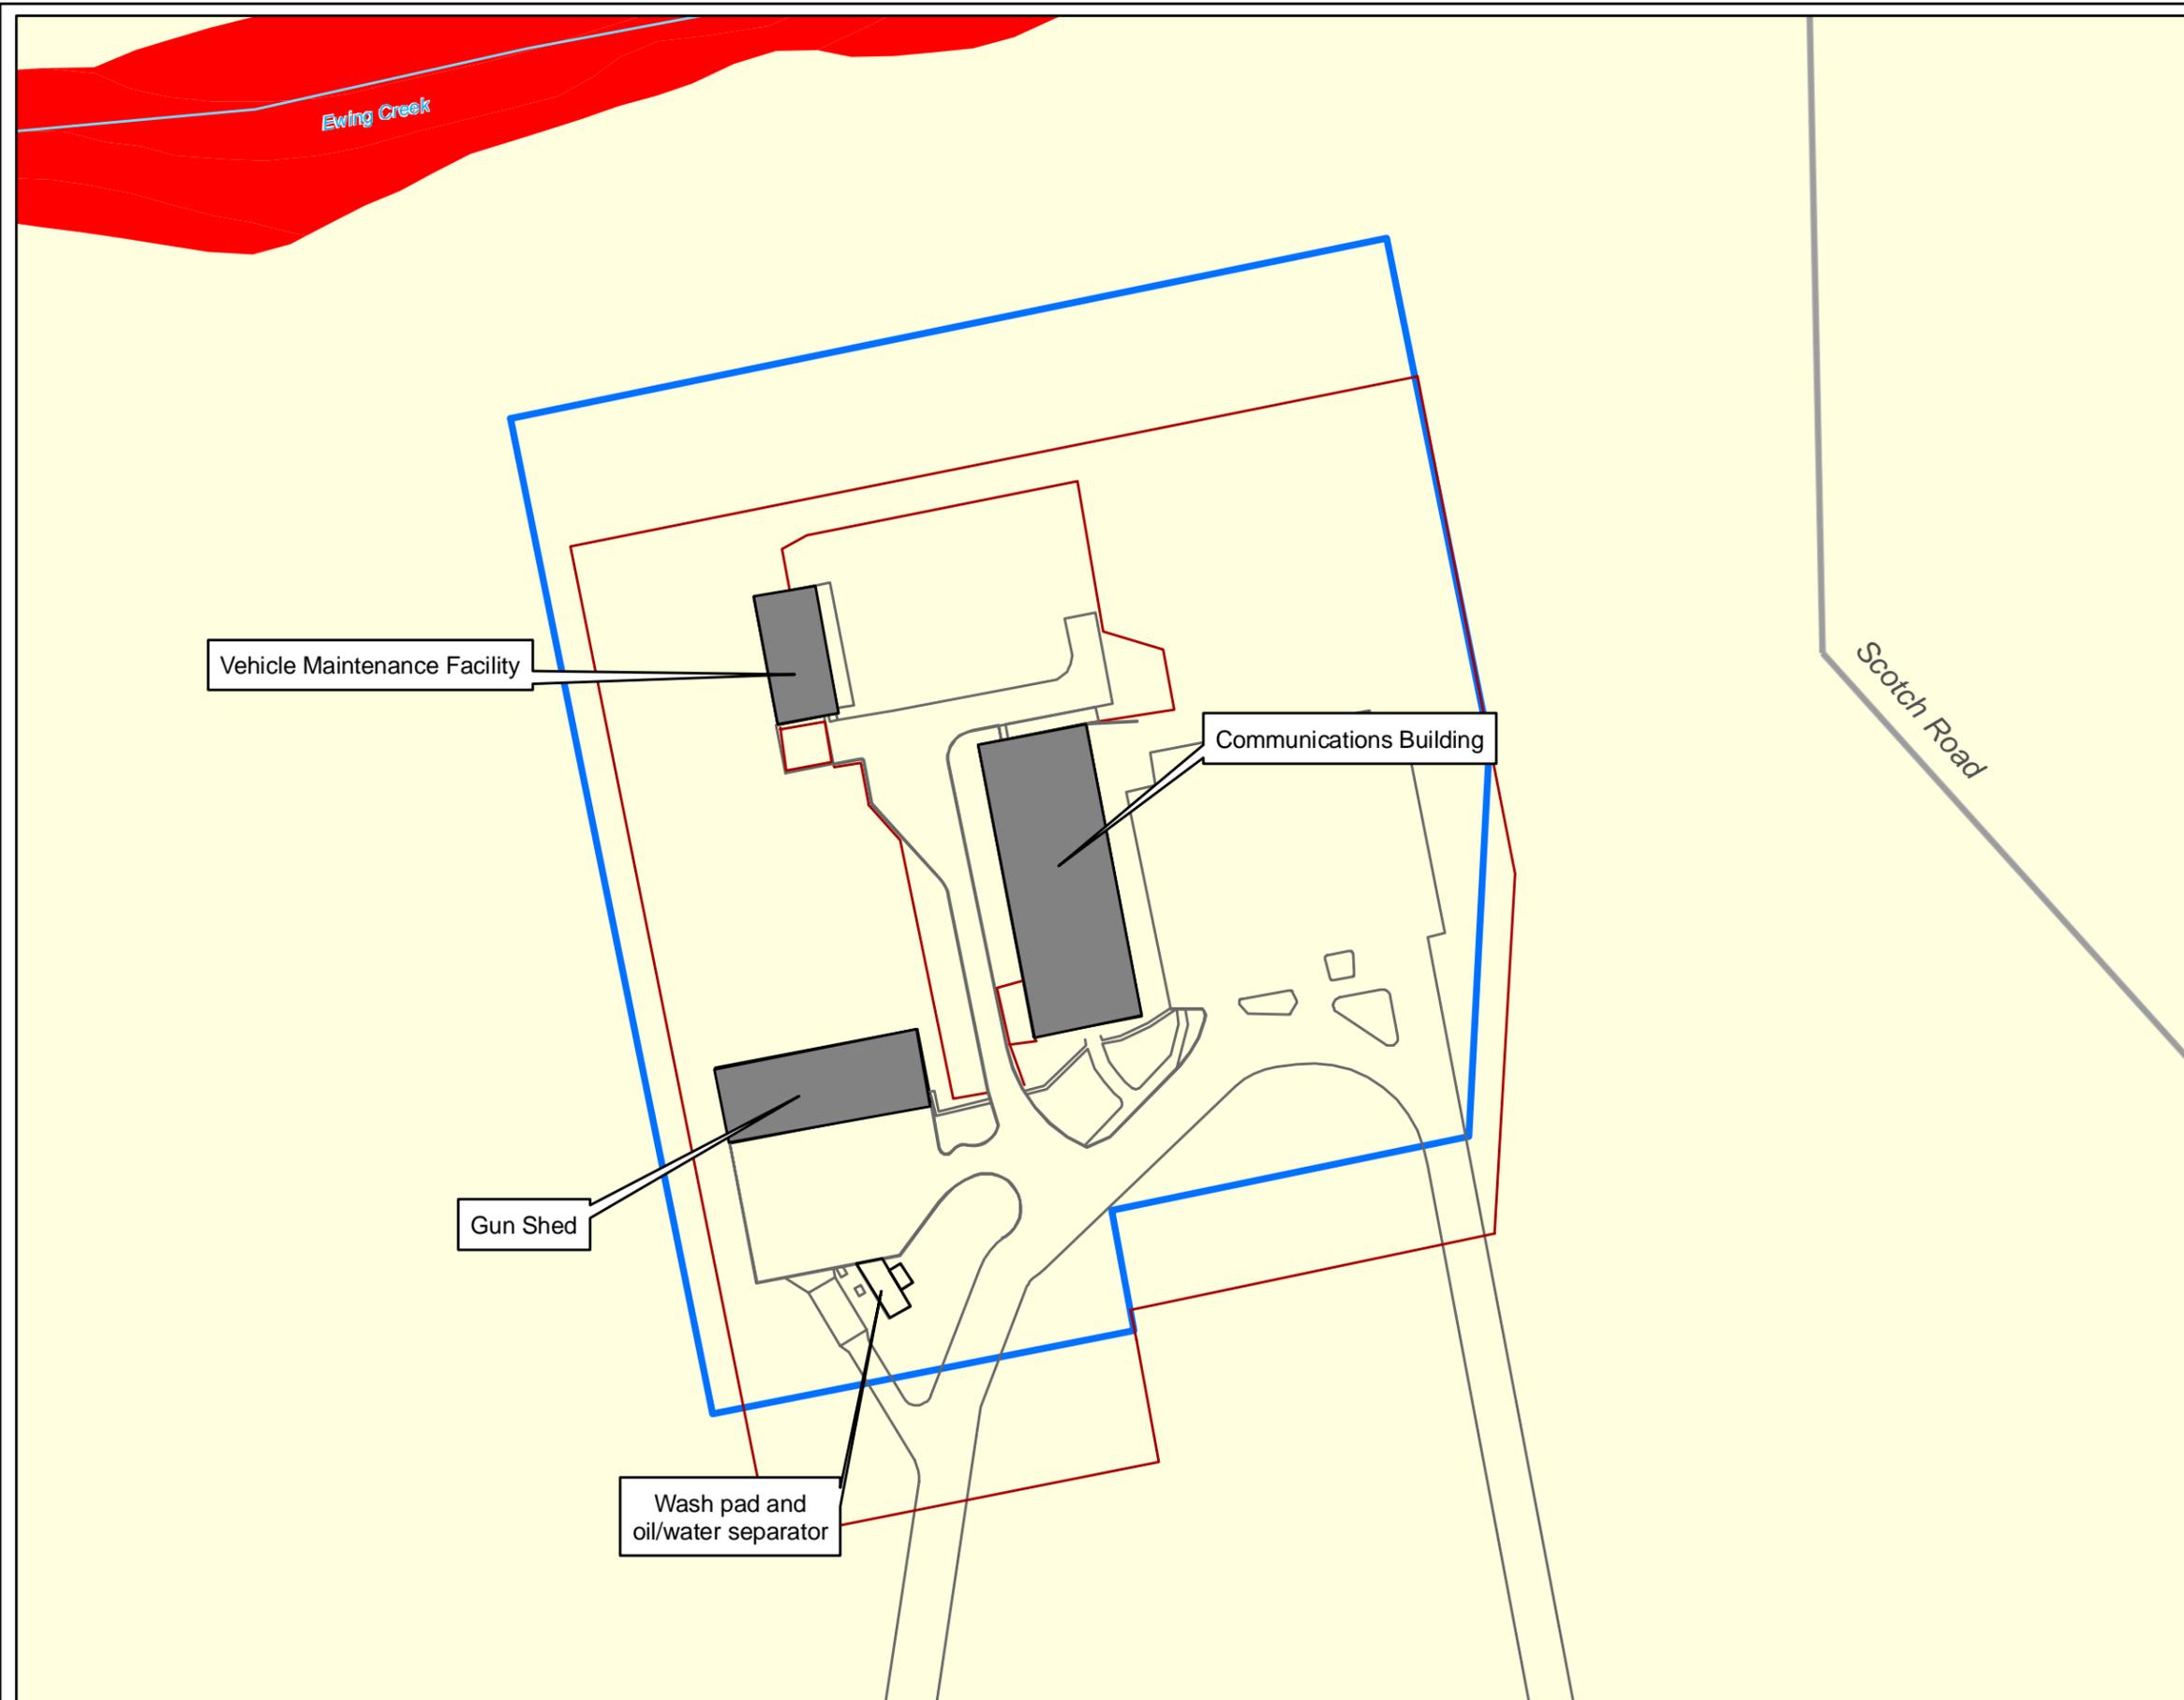
- **Floodplains.** No portion of the MCRC West Trenton lies within a designated 100-year flood zone (FEMA 2006). The nearest 100-year flood boundary is approximately 300 ft. north of the site, in the floodplain of Ewing Creek.

FEMA FLOOD MAP
