NORTHERN ADAK ISLAND – ALASKA AREA 1, OPERABLE UNIT B-2 HISTORICAL PHOTOGRAPHIC ANALYSIS

FINAL REPORT
DECEMBER 2011

Prepared for the U.S. Navy, Naval Facilities Engineering Command

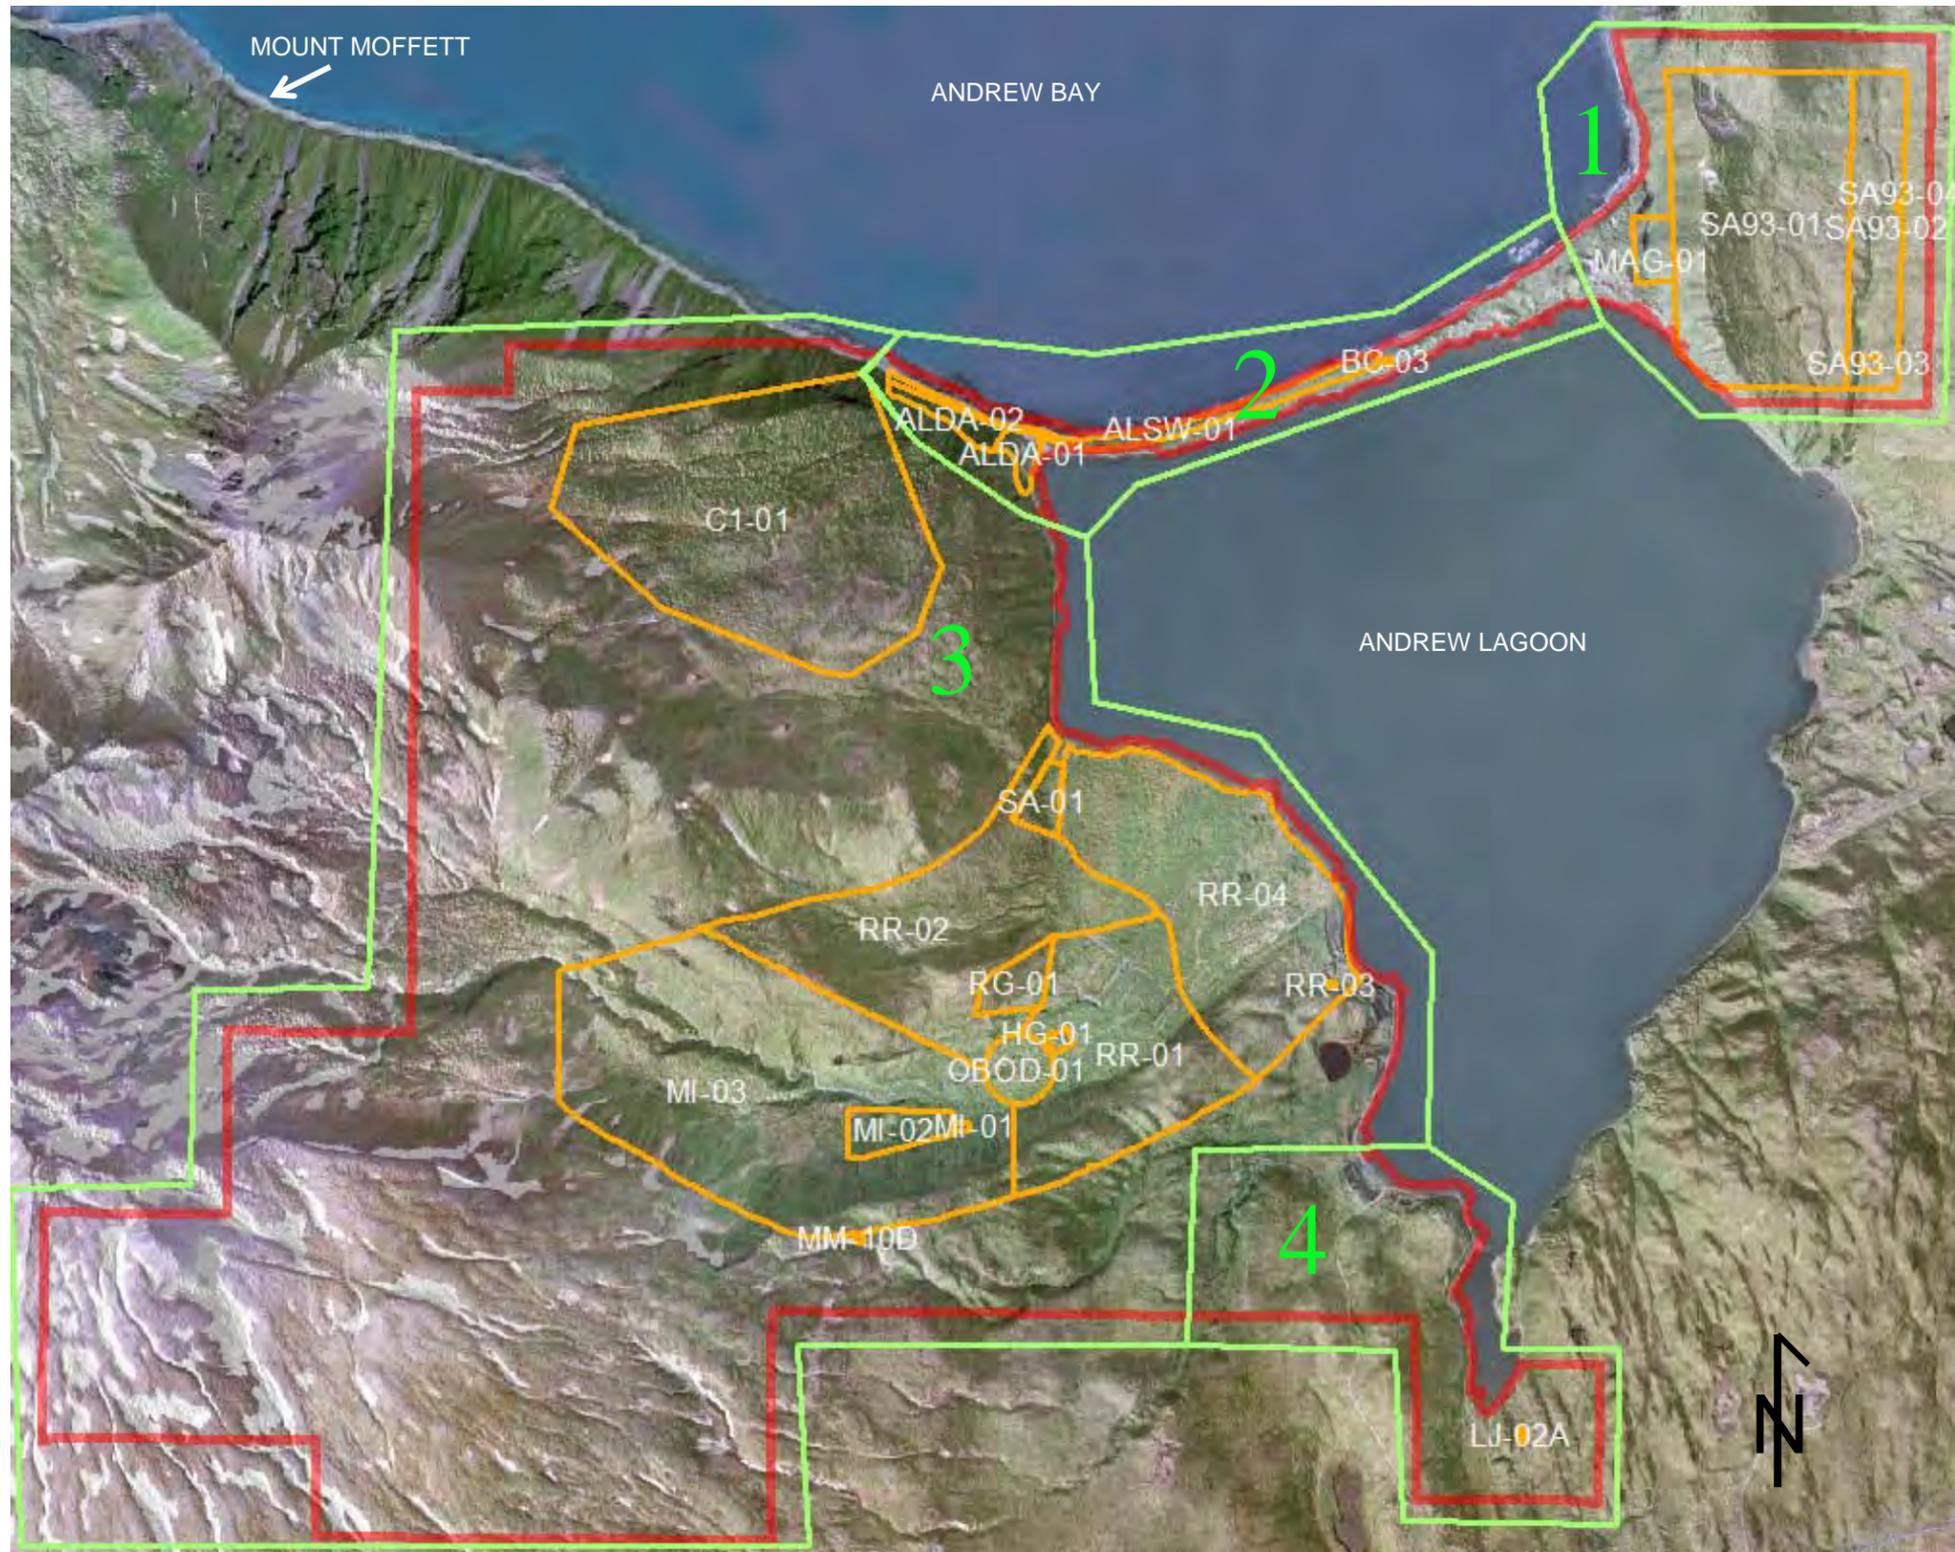
PROJECT AREA ANALYSIS

For ease of use and continuity of this presentation, the Northern Adak, Area 1 (OU B-2) is divided into four sections, as denoted on this page.

Four sections (Northeast Lagoon - 1, Seawall - 2, West Lagoon - 3, and Lake Jean - 4) were created for use in this report only and have no relevance outside of this report.

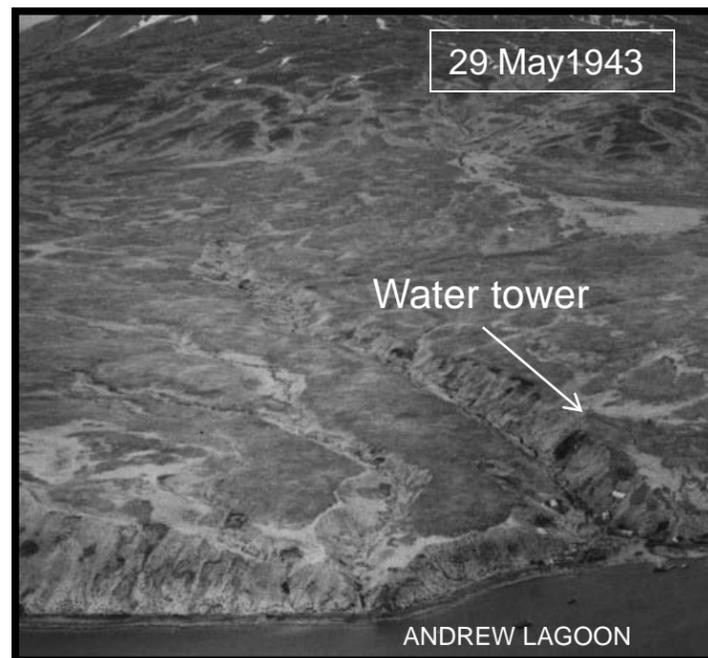
NORTHEAST LAGOON – POTENTIAL IMPACT AREA INVESTIGATION 1943 OBLIQUE, VERTICAL AERIAL AND STILL PHOTOGRAPHS

Potential impact areas are not clearly observed on these May and June 1943 photos. Factors which limit the identification and capture of impact areas include:

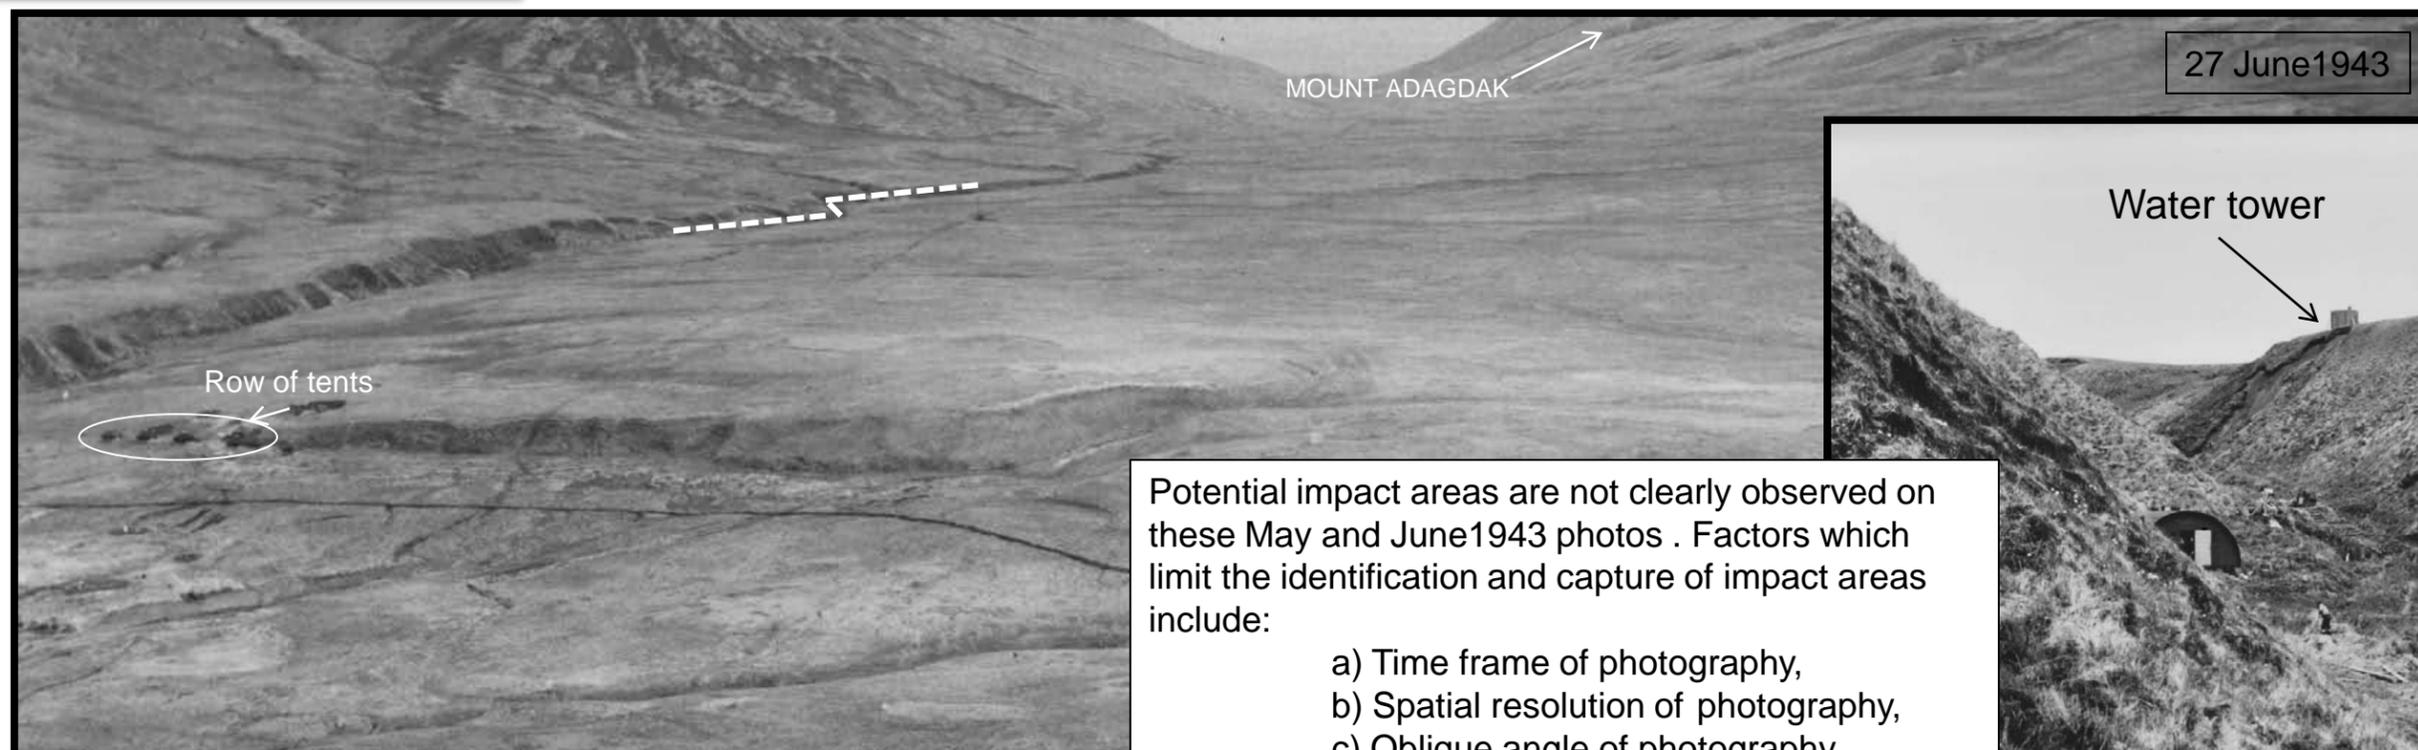
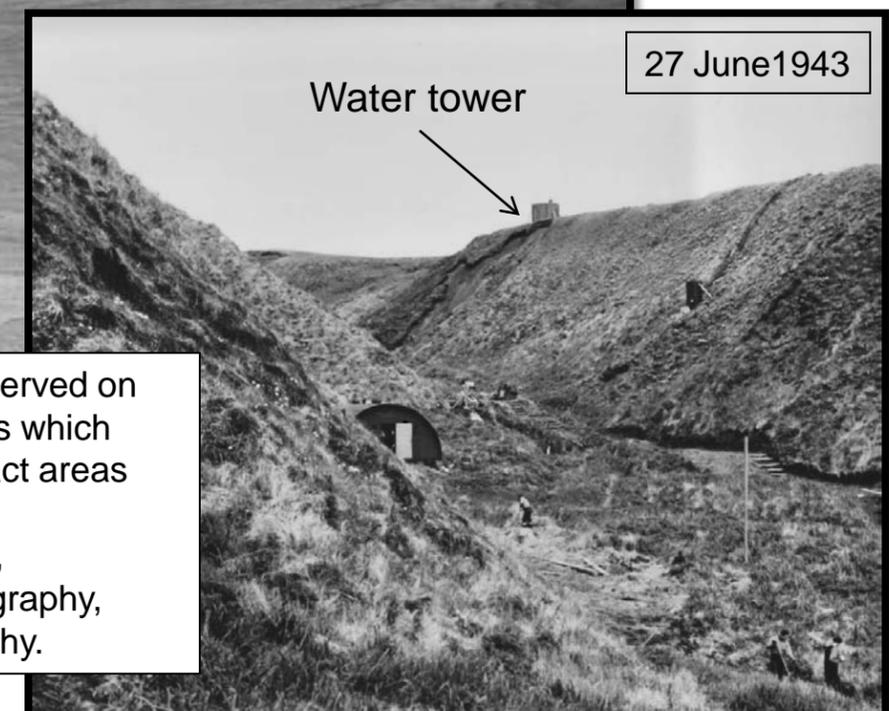
- a) Time frame of photography,
- b) Spatial resolution of photography,
- c) Oblique angle of photography.

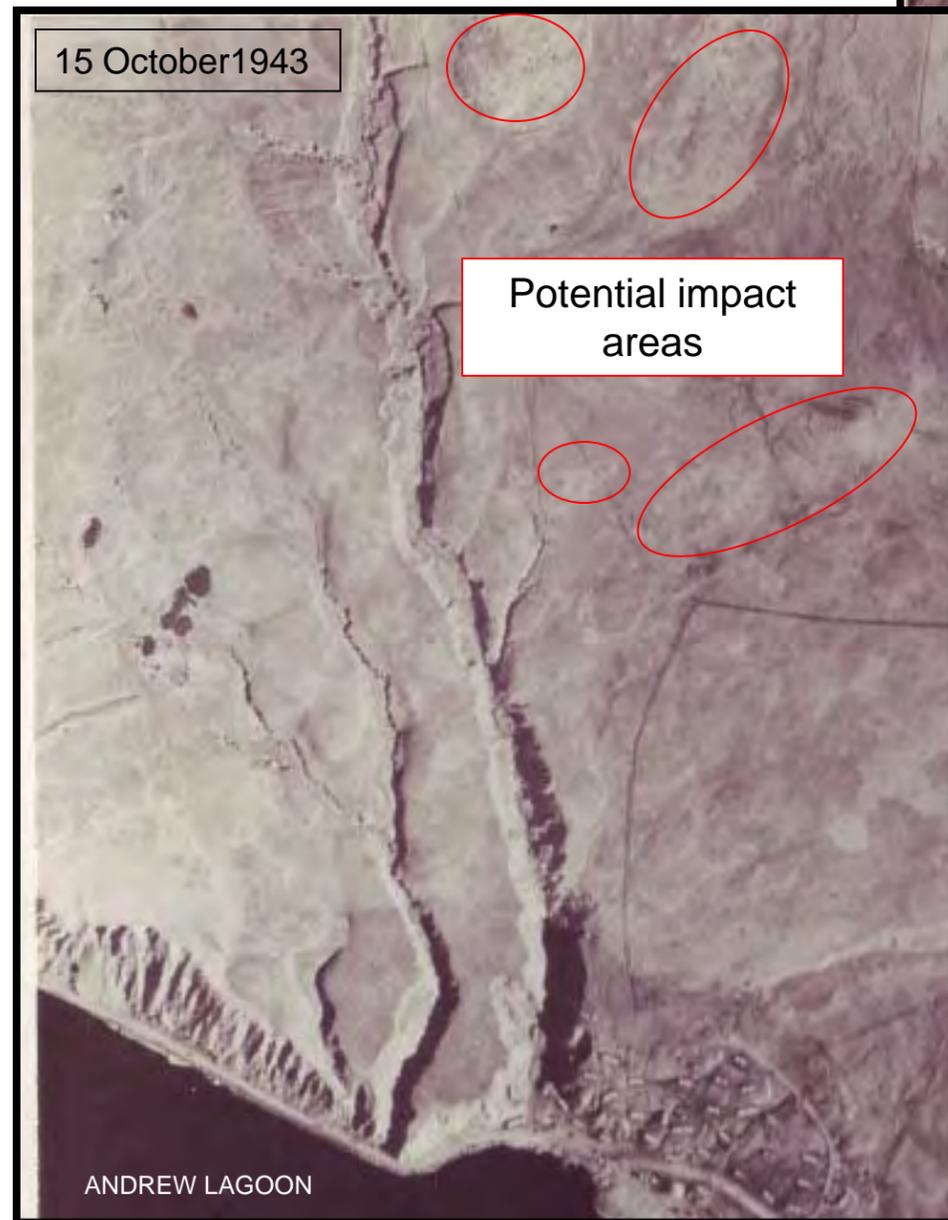
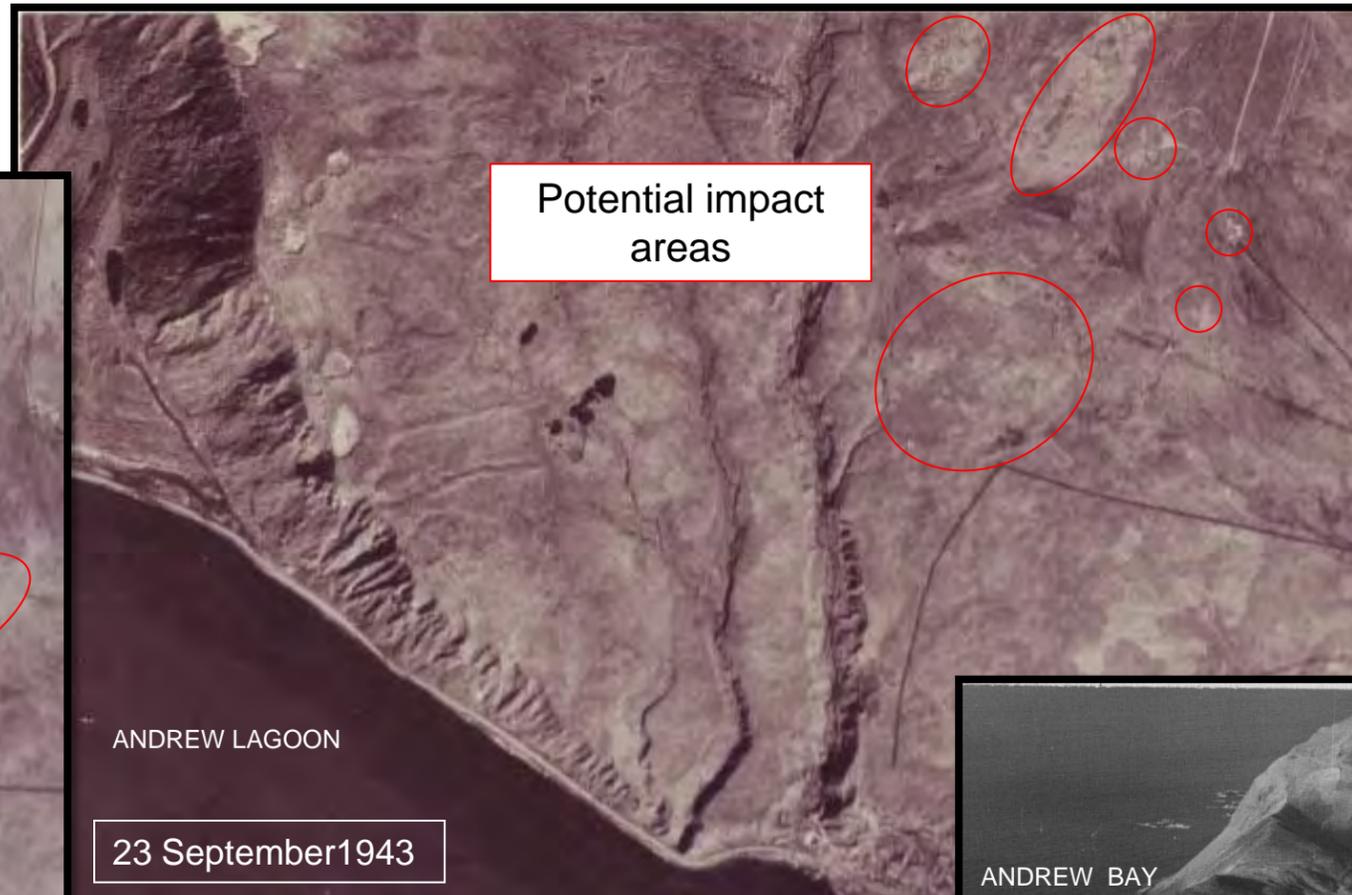
EAST OF SA-93 – POTENTIAL IMPACT AREA INVESTIGATION 1943 OBLIQUE, VERTICAL AERIAL AND STILL PHOTOGRAPHS

Potential impact areas are observed on the September and October 1943 photos . Factors which limit the identification and capture of impact areas include:

- a) Spatial resolution of photography,
- b) Oblique angle of photography.

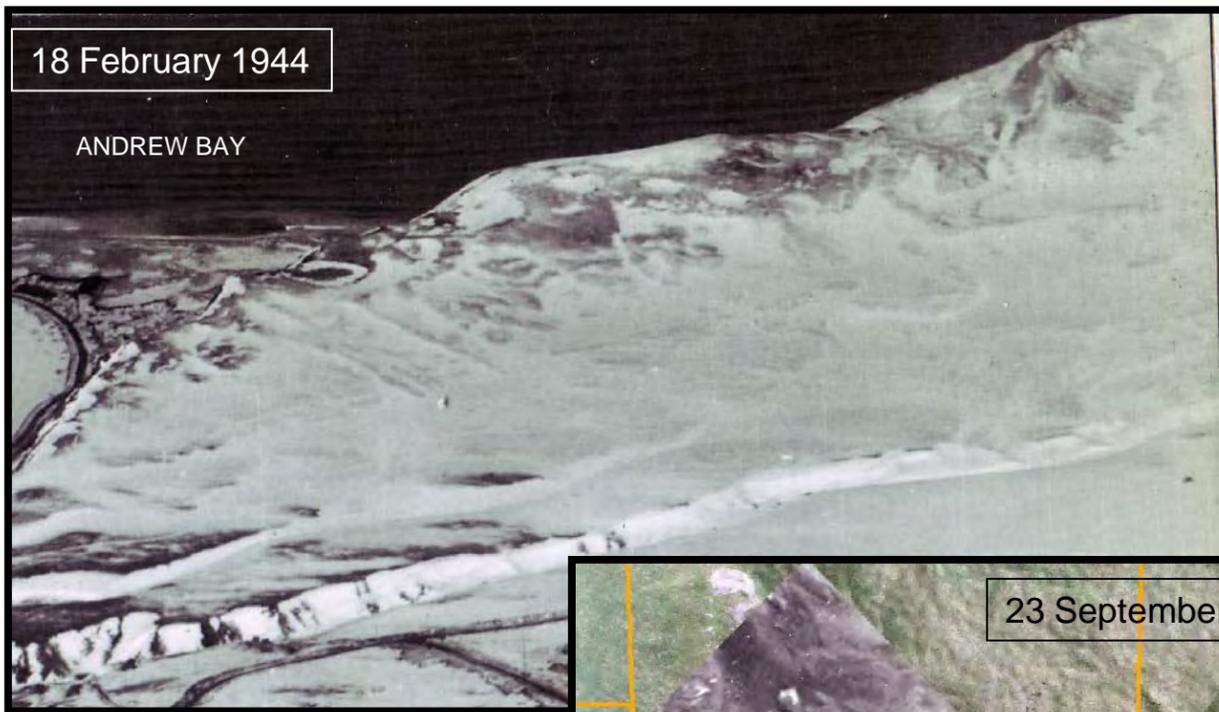
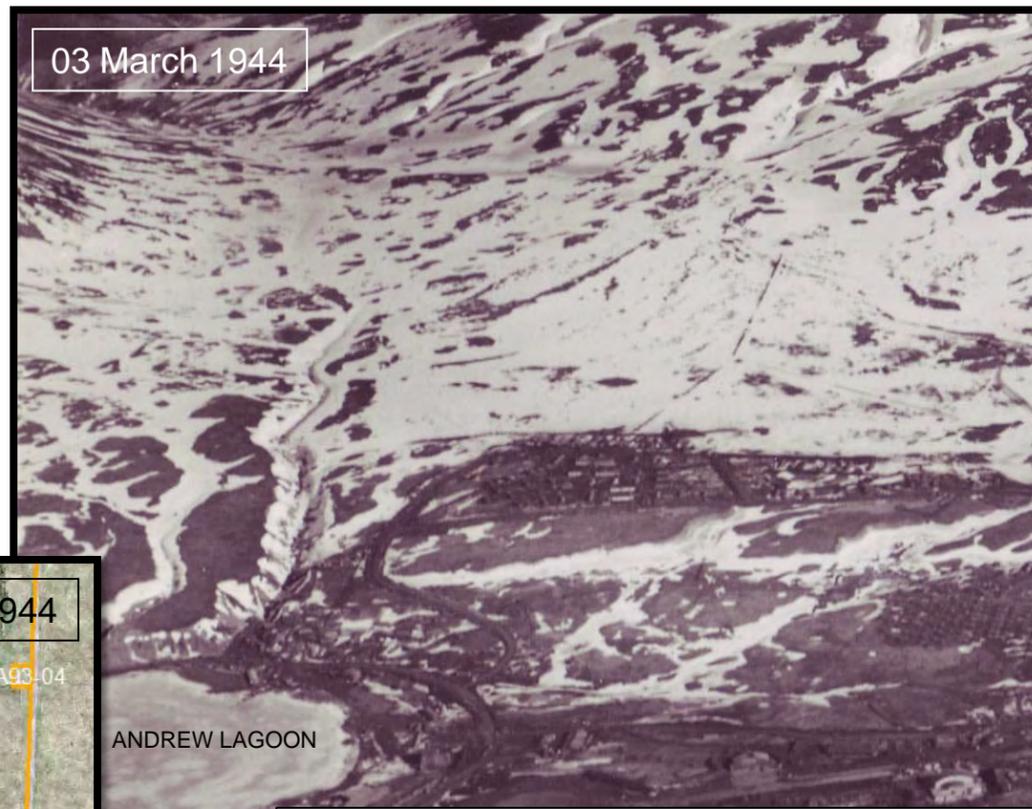
NORTHEAST LAGOON – POTENTIAL IMPACT AREA INVESTIGATION 1944 OBLIQUE, VERTICAL AERIAL AND STILL PHOTOGRAPHS

Potential impact areas are not clearly observed on these 1944 photos due to snow coverage, poor resolution and oblique angle of photography.

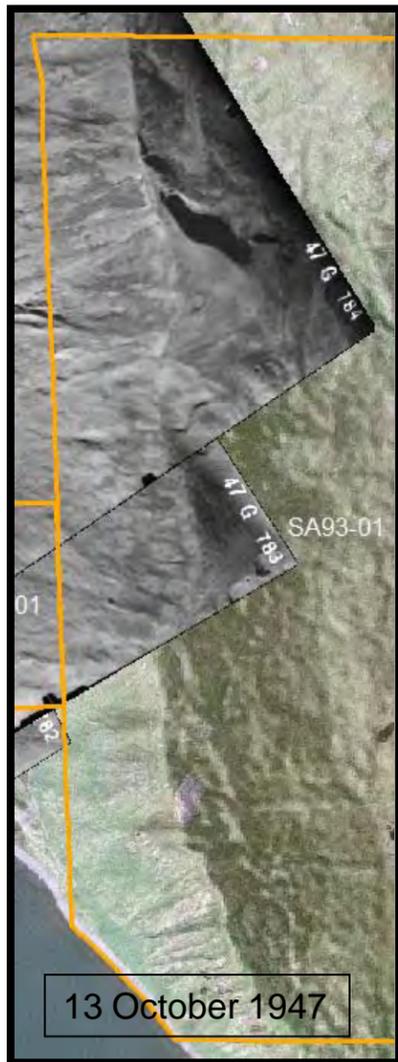
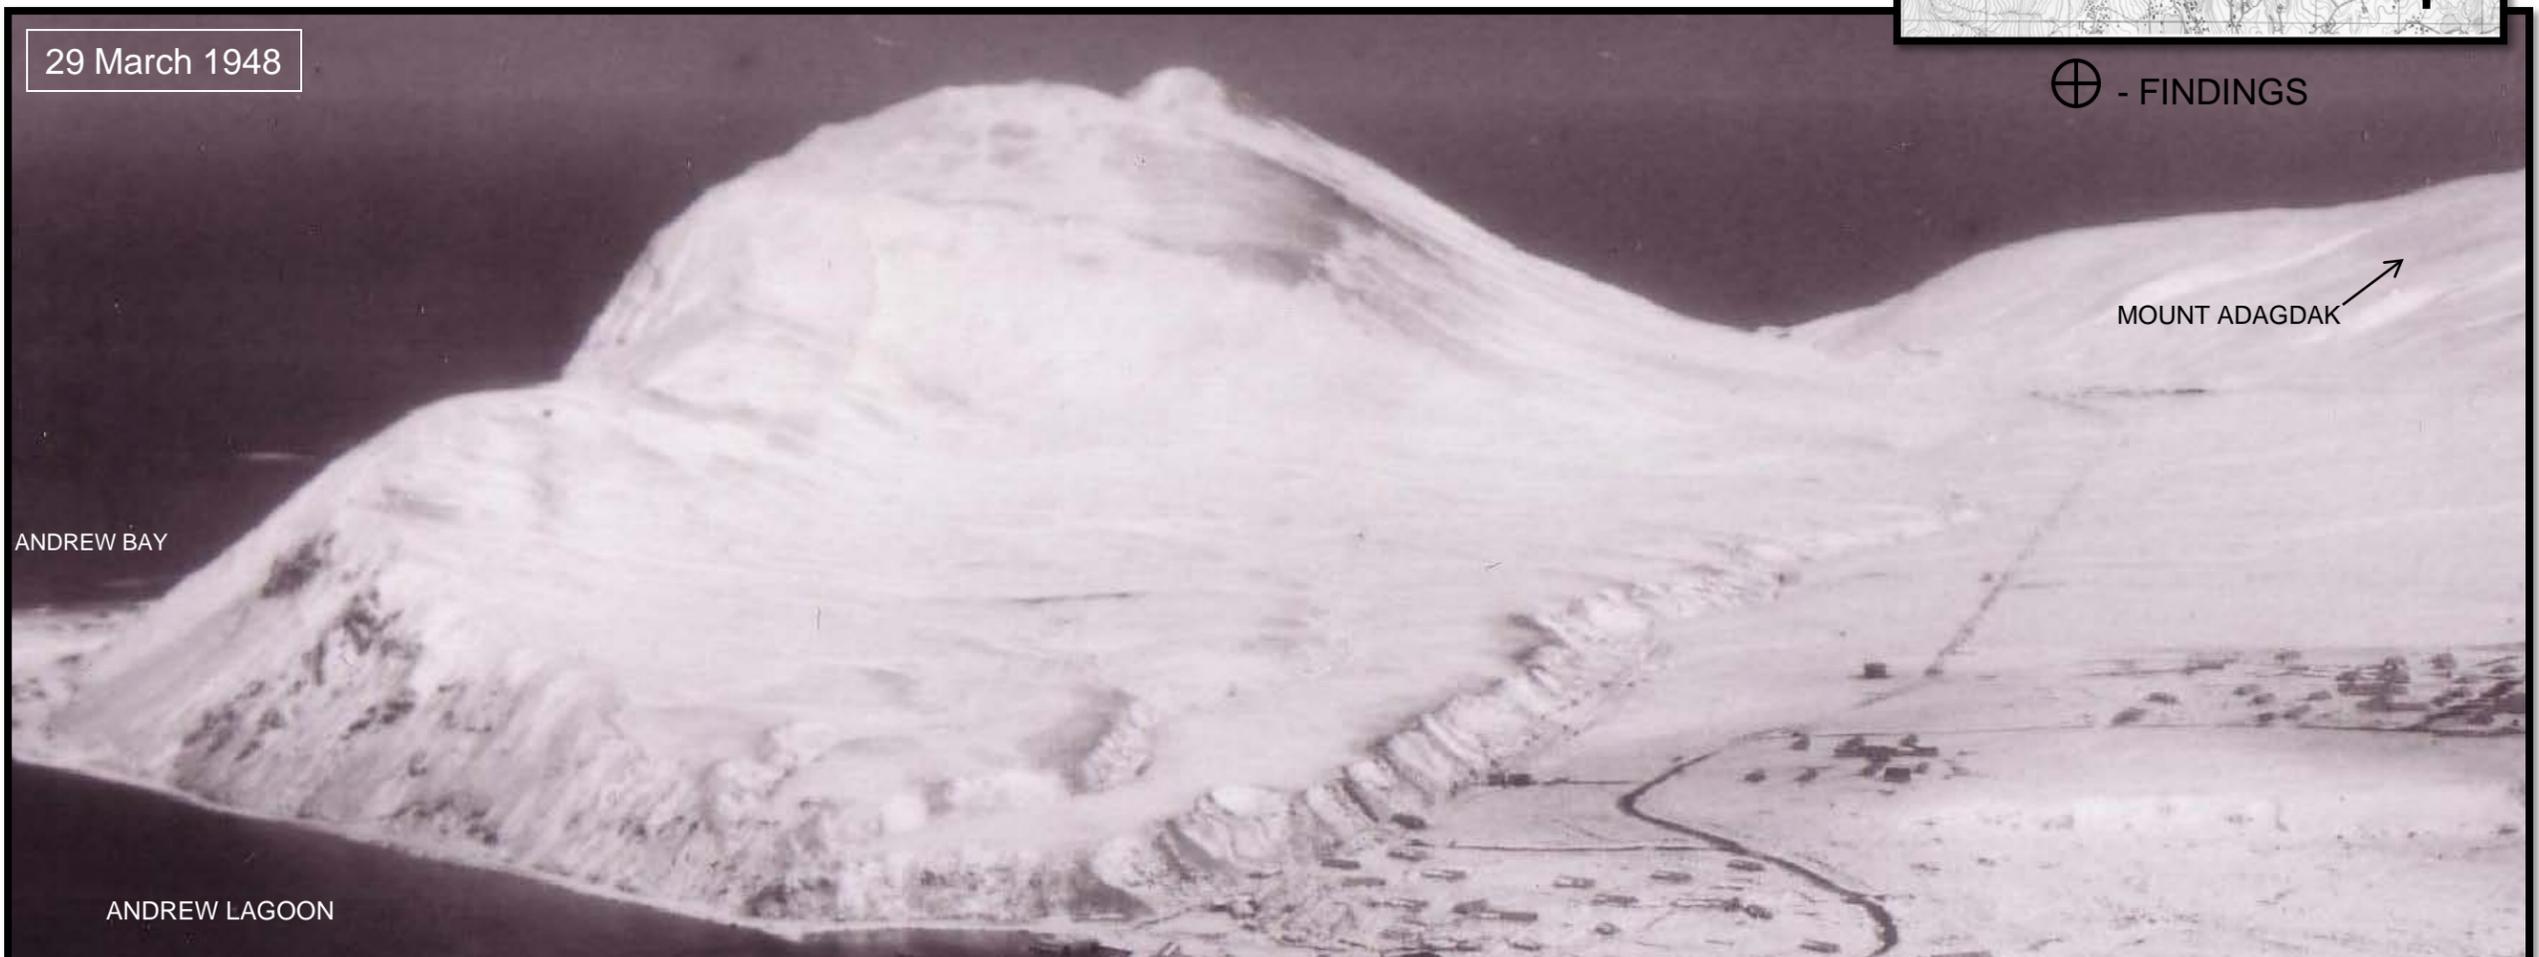
NORTHEAST LAGOON – POTENTIAL IMPACT AREA INVESTIGATION 1947-1948 OBLIQUE, VERTICAL AERIAL AND STILL PHOTOGRAPHS

Potential impact areas are not clearly observed on these 1947-1948 photos . Factors which limit the identification and capture of impact areas include:

- a) Spatial resolution of photography,
- b) Oblique angle of photography,
- c) Snow coverage,
- d) Lack of aerial coverage.

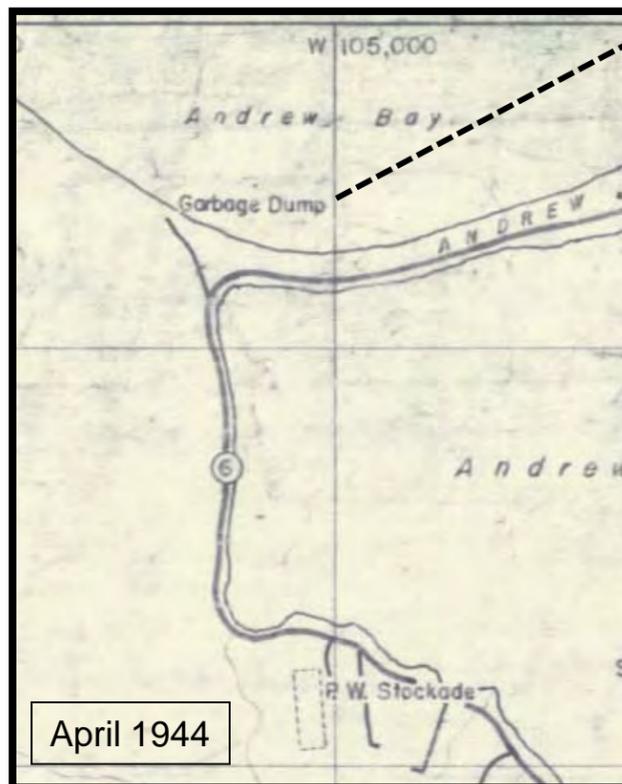
The dashed box signifies the approximate vicinity of the dumping grounds based on the disturbed area found in the above 1943 photograph. April 1944 and June 1945 maps declare the area, but not the boundary of the garbage dump.

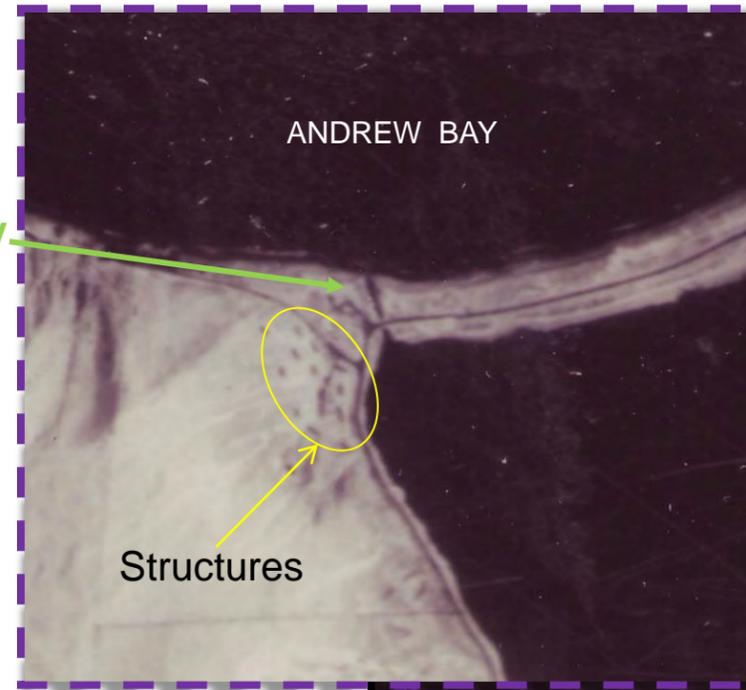
WEST SEAWALL – LAGOON AND SPILLWAY HISTORY 1942 AND 1944 AERIAL PHOTOGRAPHS AND 2009 SATELLITE IMAGE

Earliest visual documentation of the spillway. The below and inset aerial photo show the existence of the spillway as of 11 April 1944.

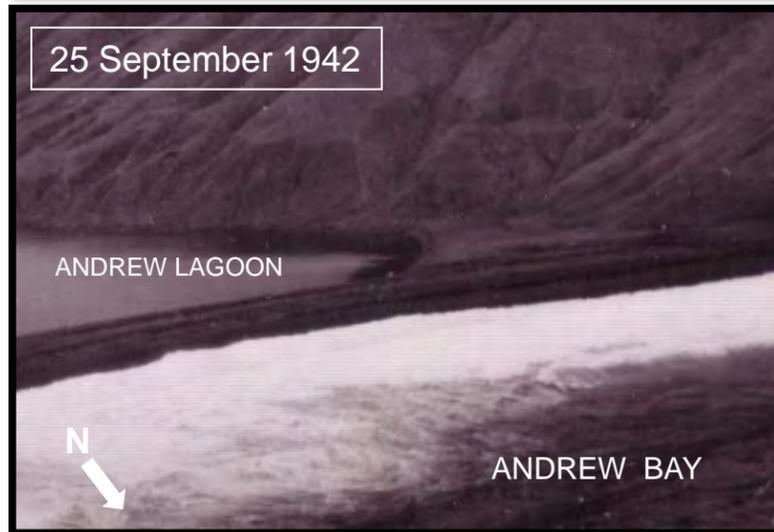
Andrew Lagoon is a fresh water lake and was formed from a shallow glacial trough formed during the Pleistocene glaciation of Adak Island (Waythomas 1995, USGS).

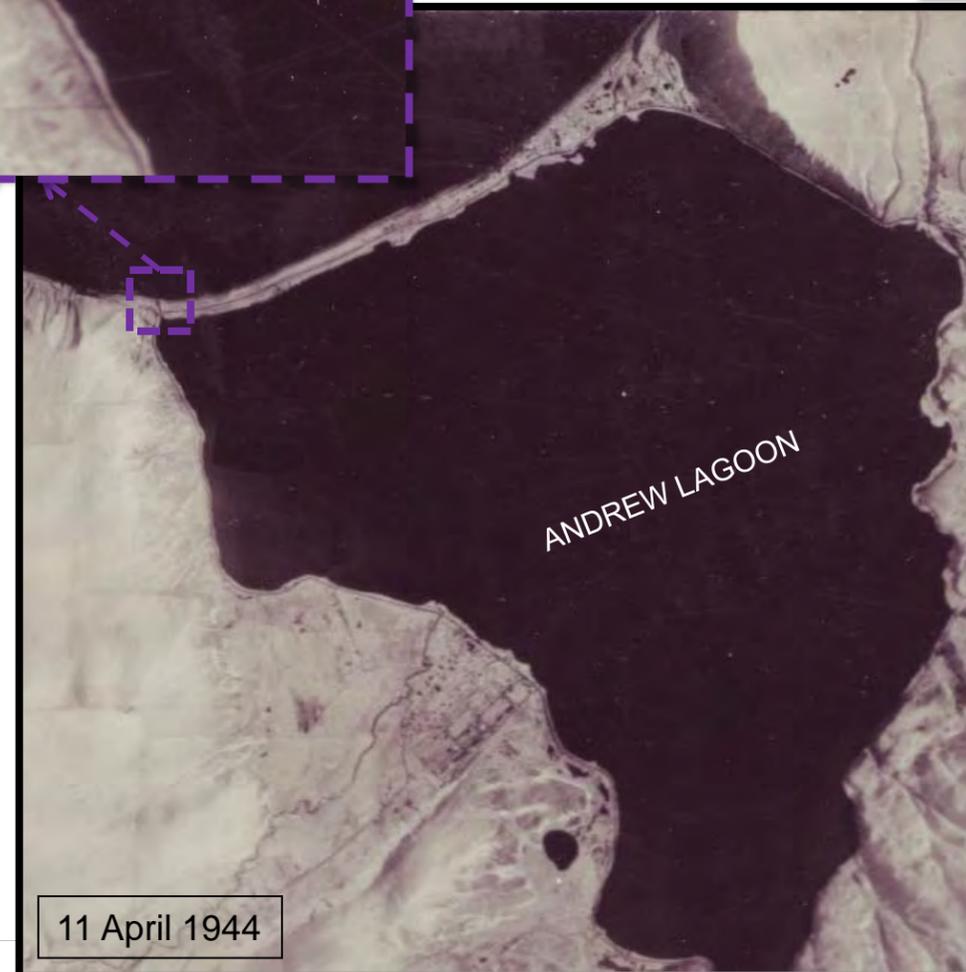
The Andrew Lagoon Seawall is a natural feature closing in the lagoon (see far left 1942 pre-spillway photo). A spillway in the western seawall appeared after July 1943 (see above in April 1944 photo). This spillway is believed to be man-made.

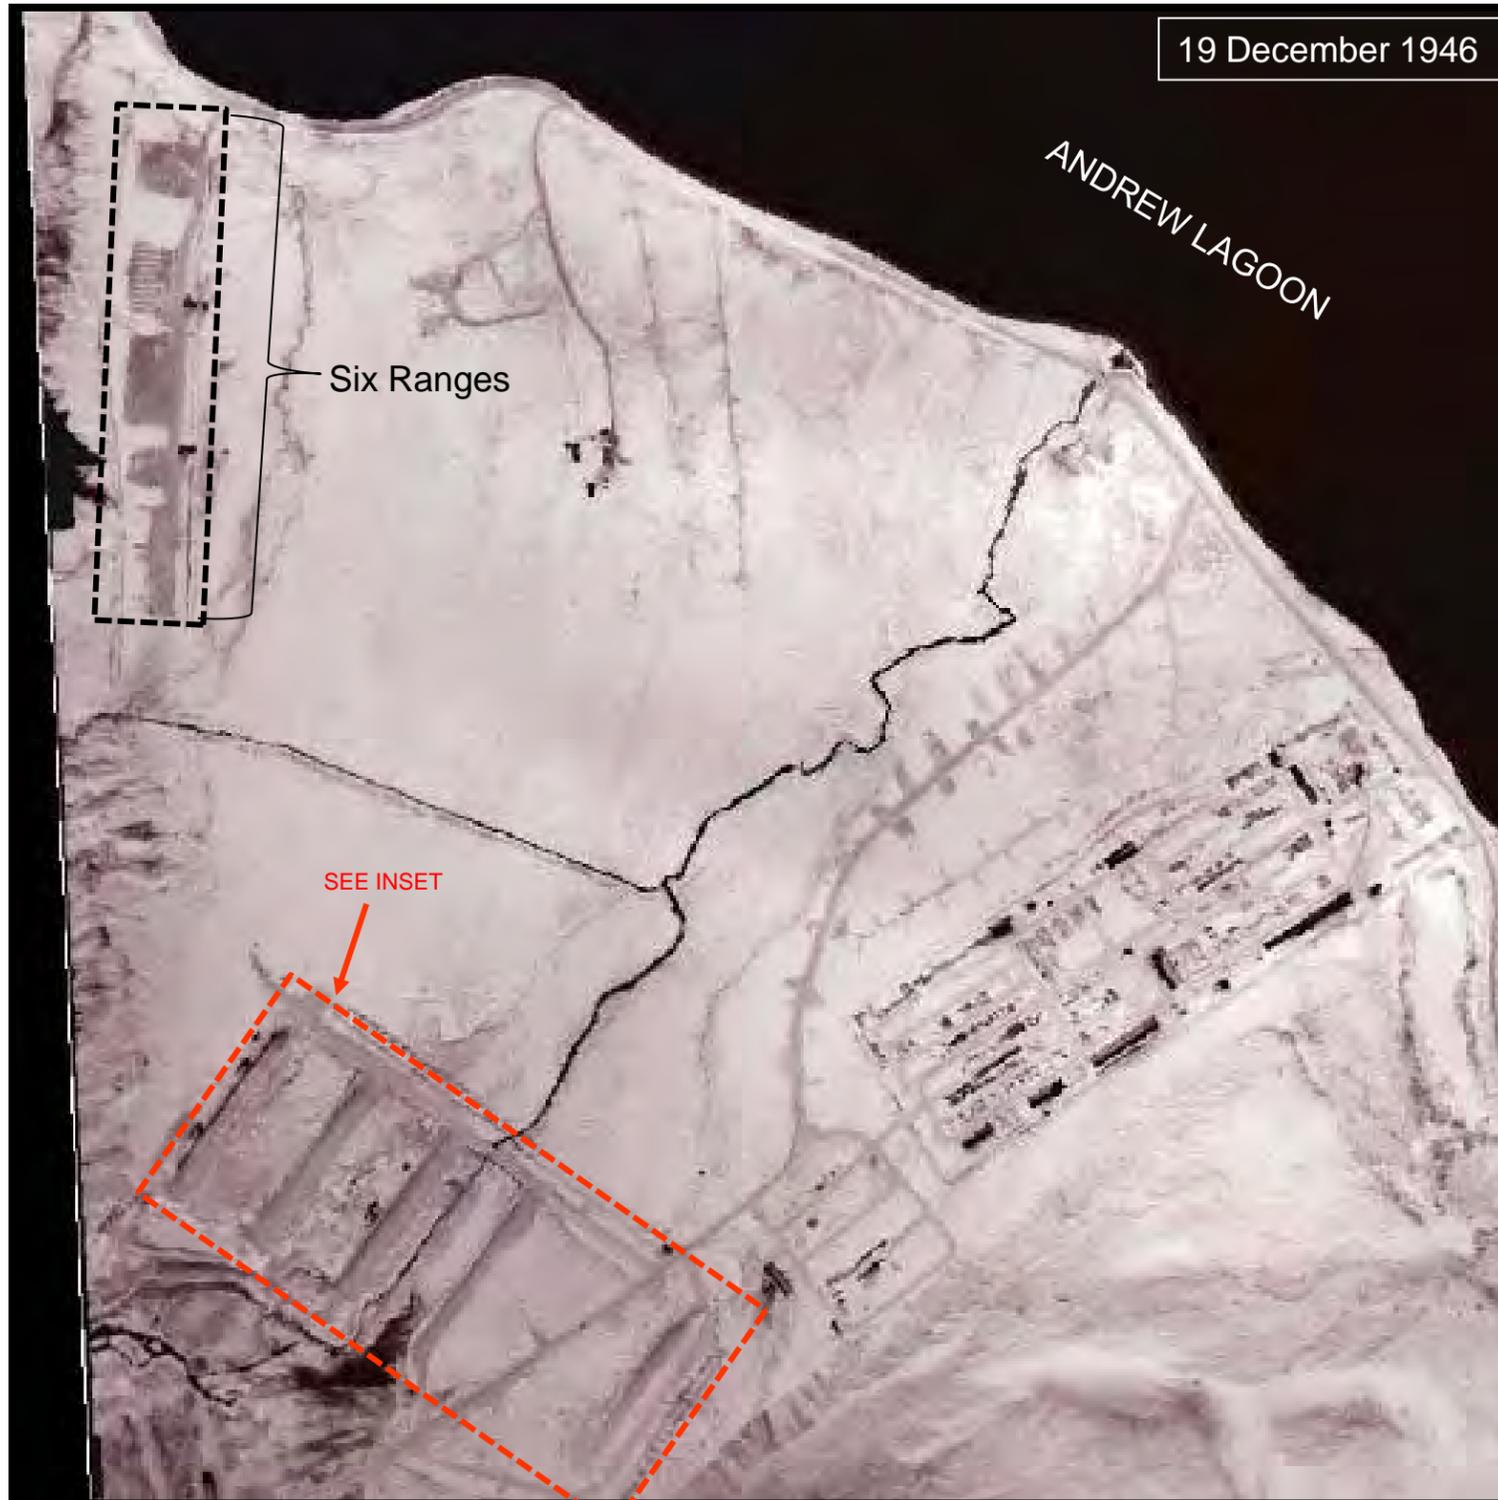
WEST LAGOON – KNOWN DISTANCE RANGE 1946 VERTICAL AERIAL PHOTOGRAPH

Note: An additional 300 yards was added between September 1944 and December 1946 when comparing the below with photography on the next slide.

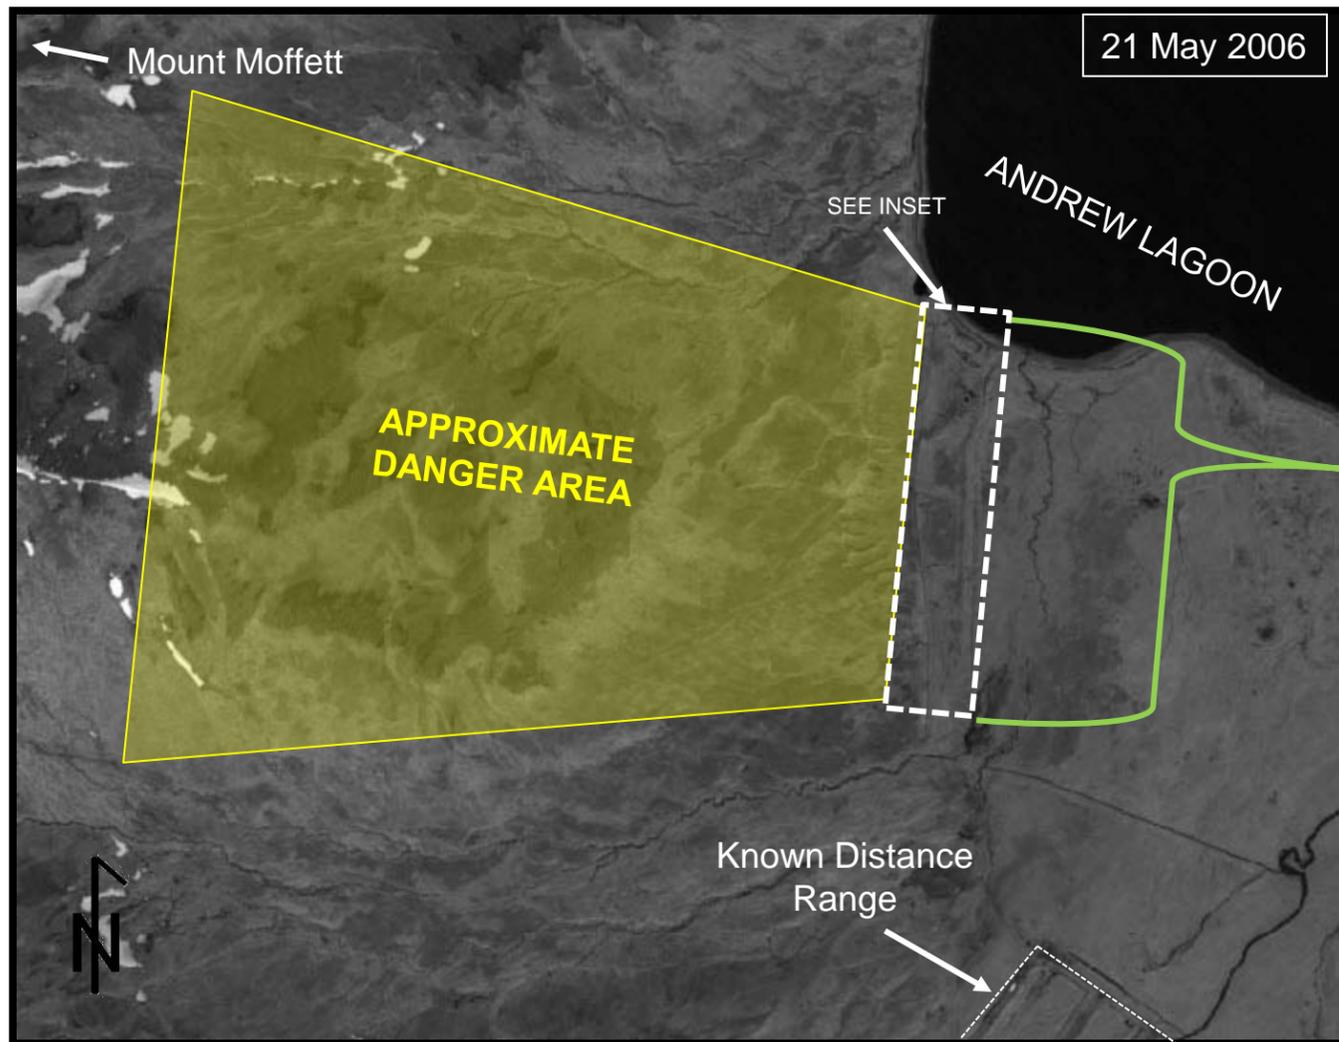
WEST LAGOON – SIX RANGES

1. Pistol Range
2. 1000" Machine Gun Range
3. 1000" Landscape and Small Bore Range
4. 1000" Anti-Tank Range, Cal. 22
5. 1000" Anti-Aircraft Range, Cal. 22
6. Sub-Machine Gun Range

The range list and titles above are from a 28 September 1944 memo.

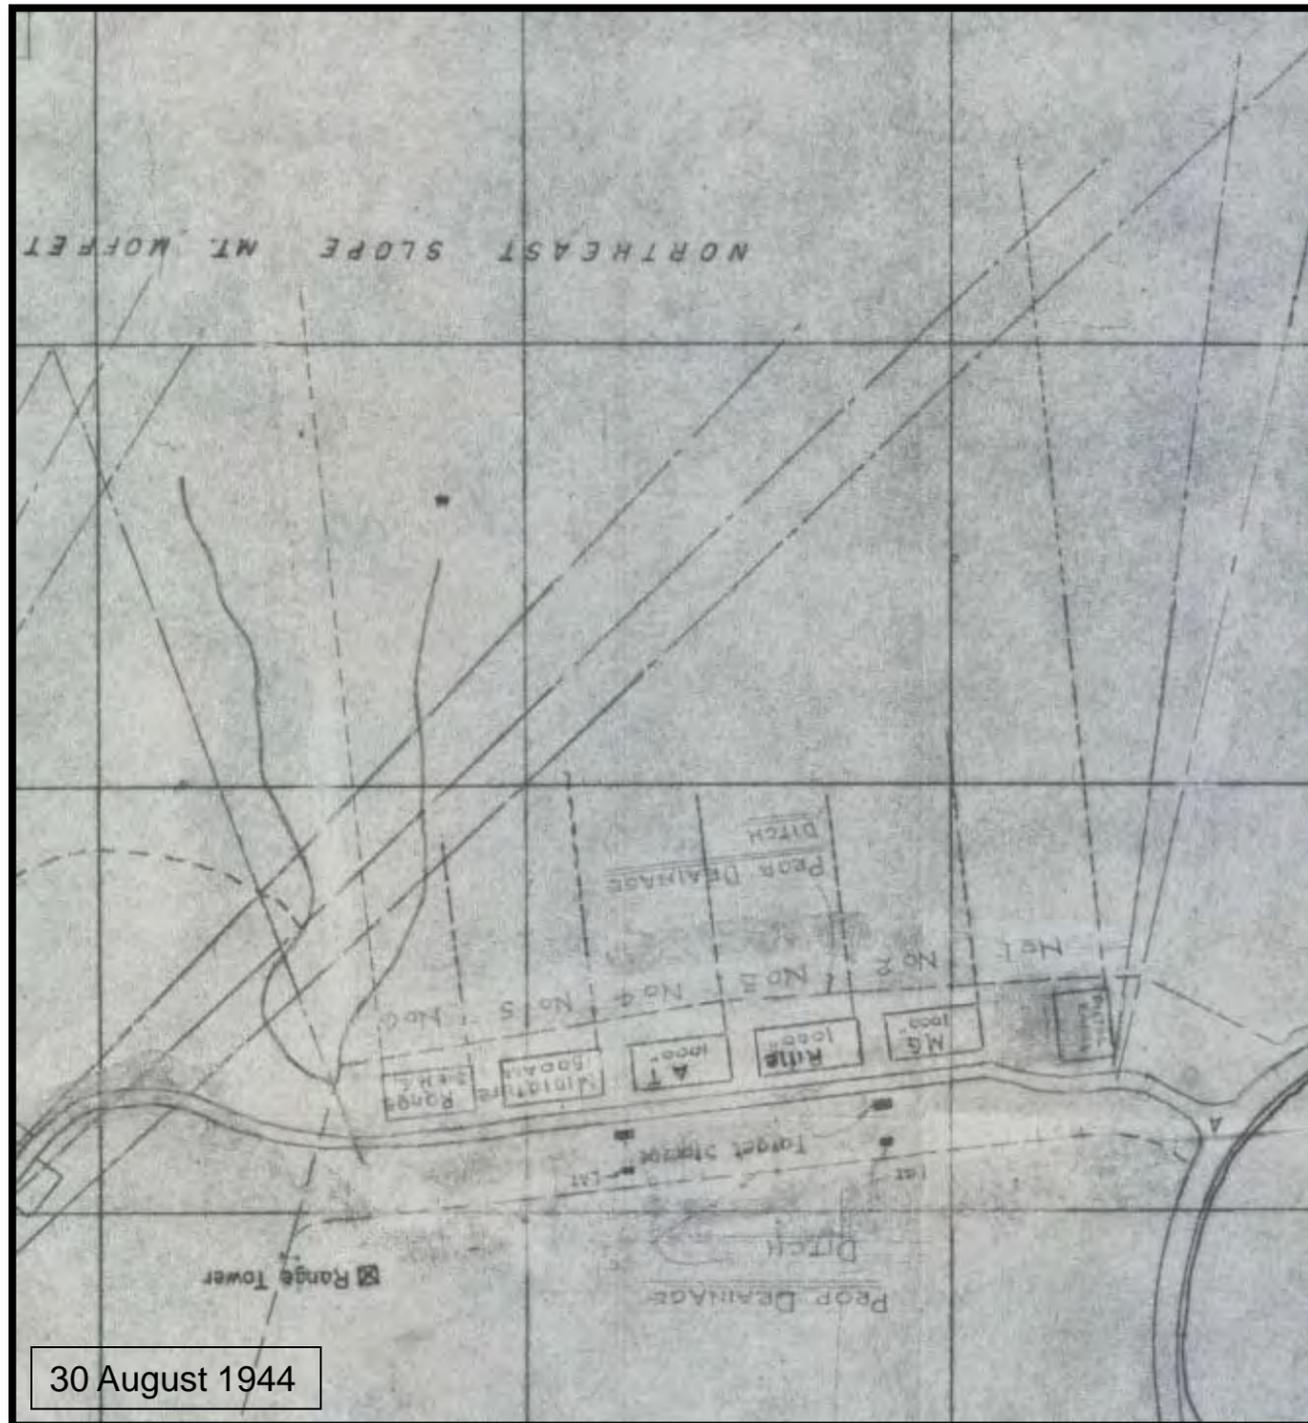
WEST LAGOON – SIX RANGES

The below six ranges were started early in the war, but were not completed until a February 1945 request was submitted stating the six ranges were required for Infantry School.

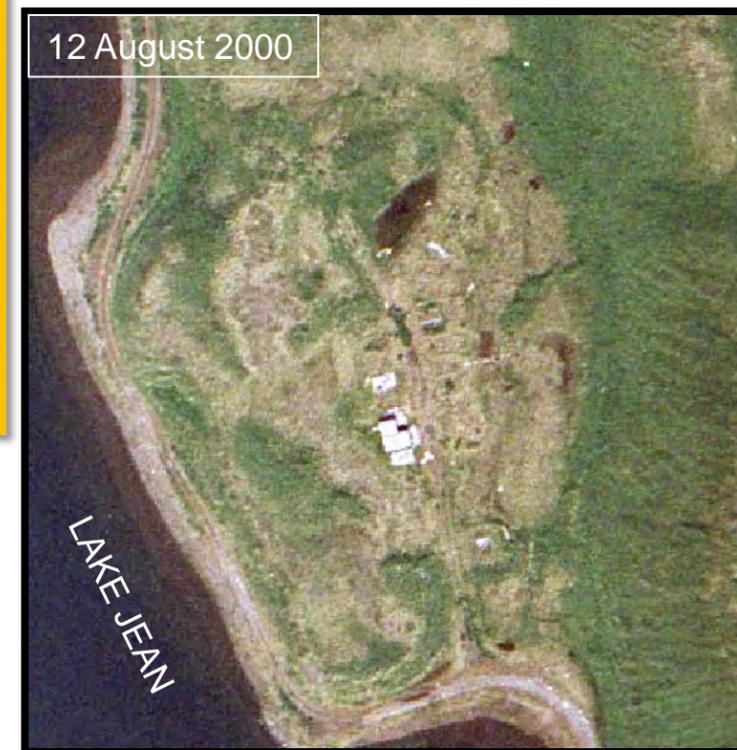
12 August 2000

Same area present day
