NORTHERN ADAK ISLAND – ALASKA AREA 1, OPERABLE UNIT B-2 HISTORICAL PHOTOGRAPHIC ANALYSIS

FINAL REPORT
DECEMBER 2011

Prepared for the U.S. Navy, Naval Facilities Engineering Command

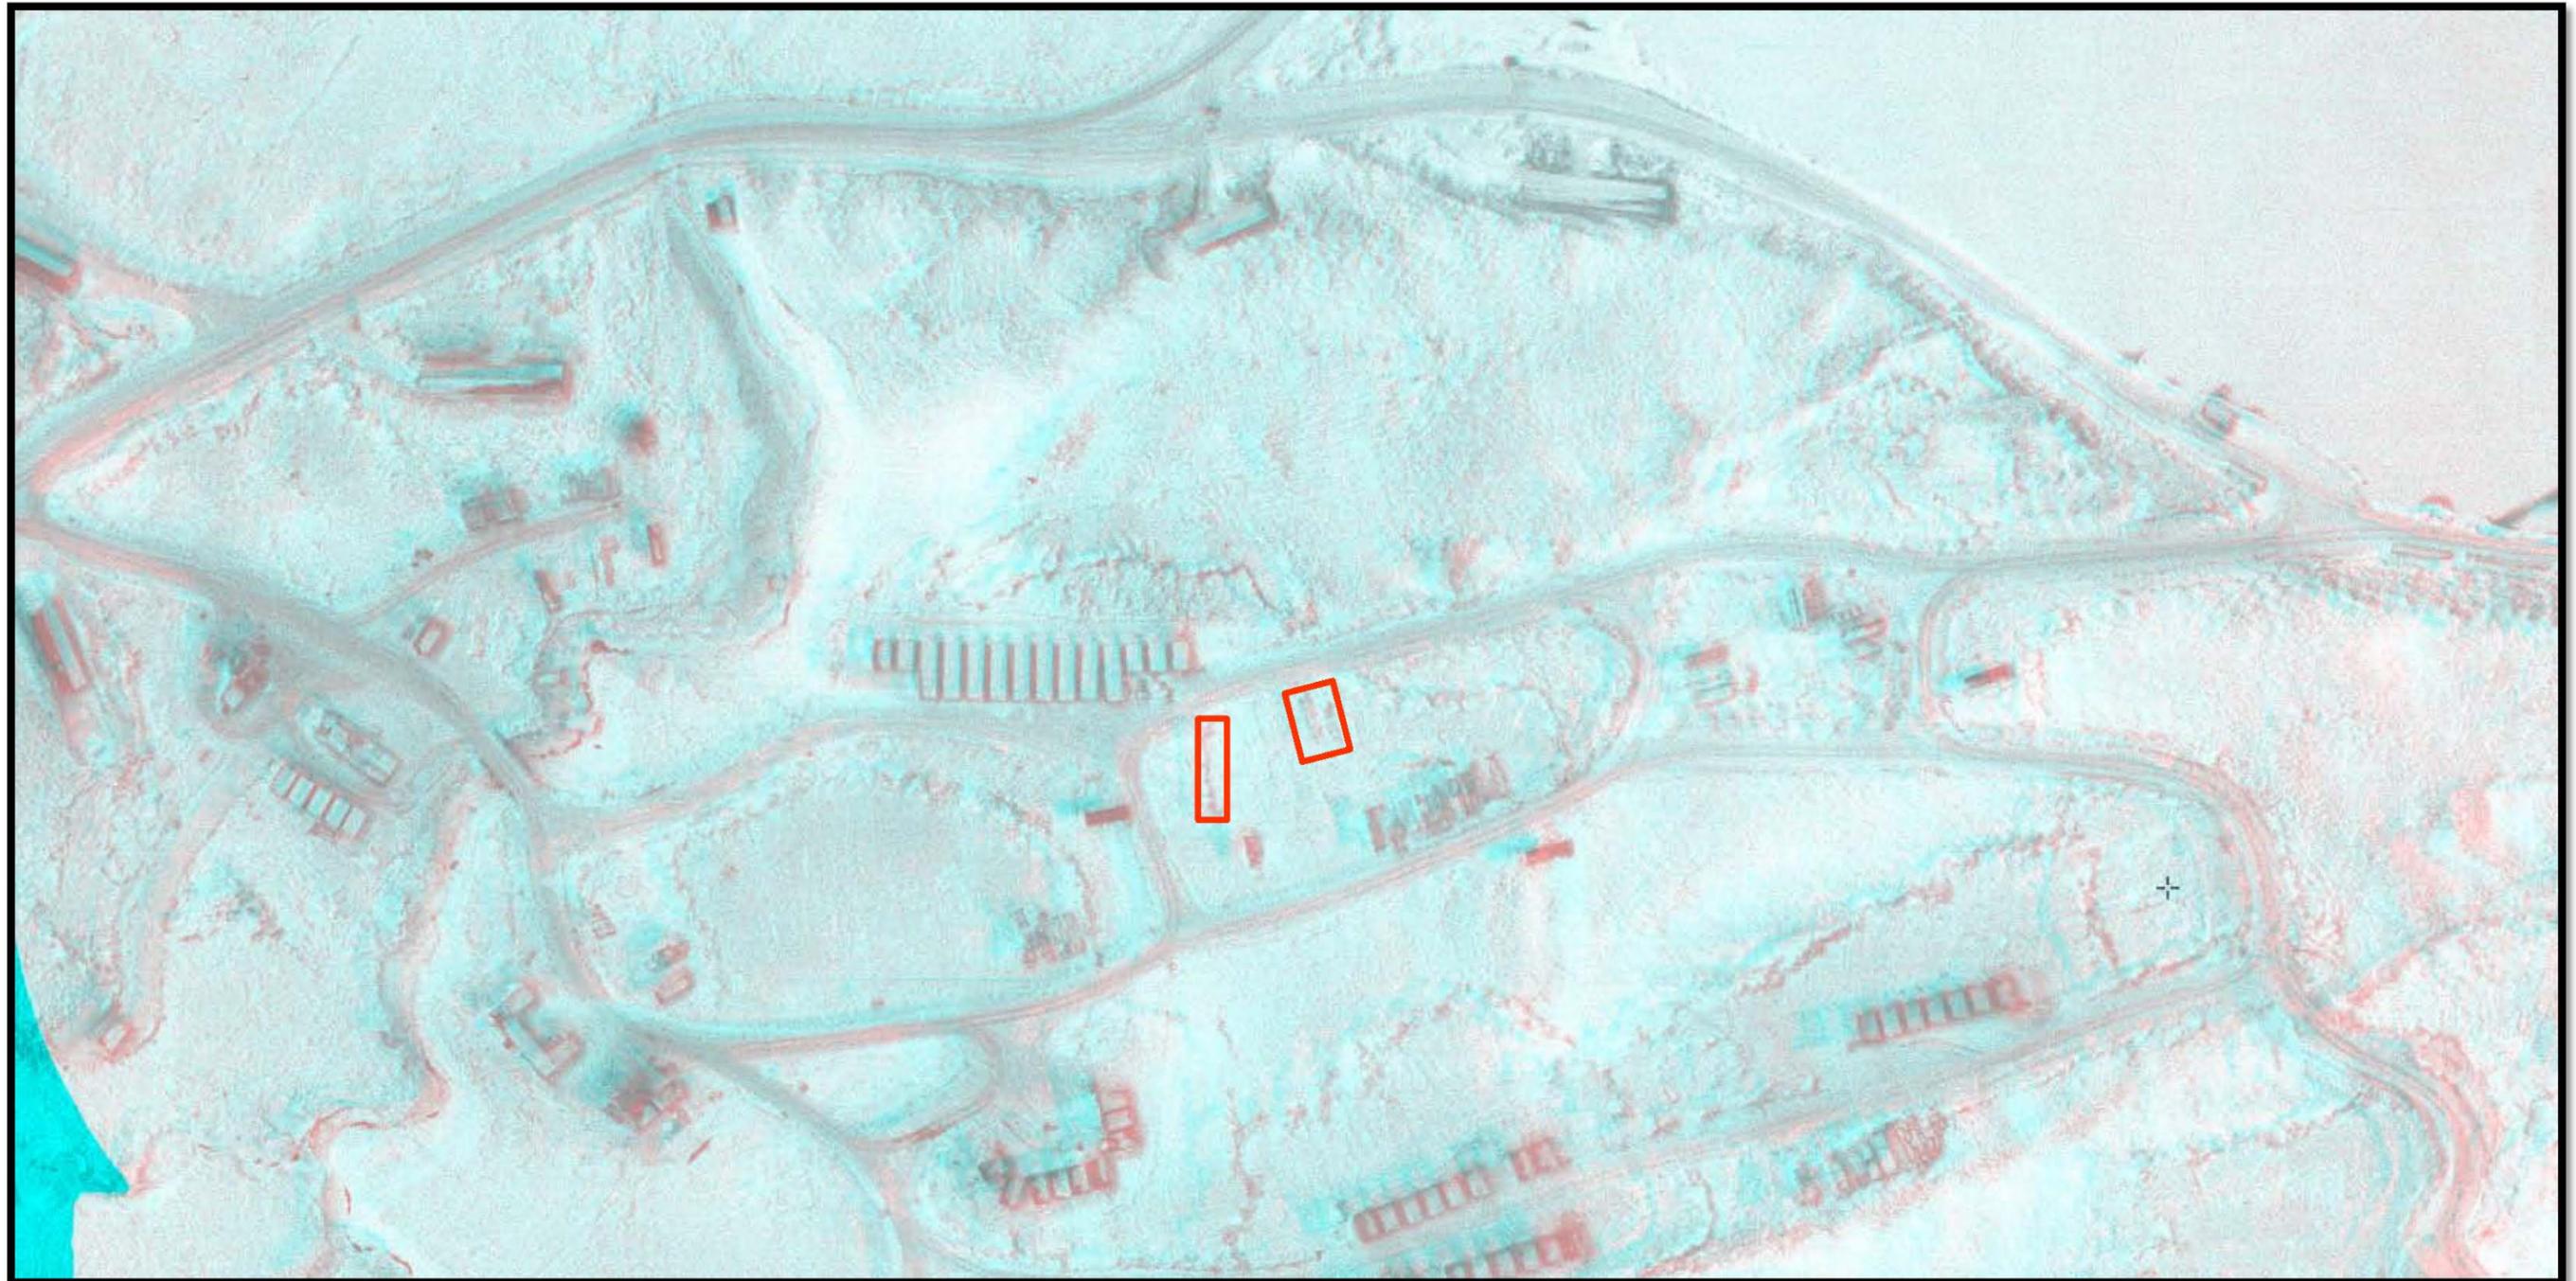
19 December 1946 anaglyph showing probably trenches documented in an earlier 2002 study in the Lake Jean Ammo Storage/Dump area

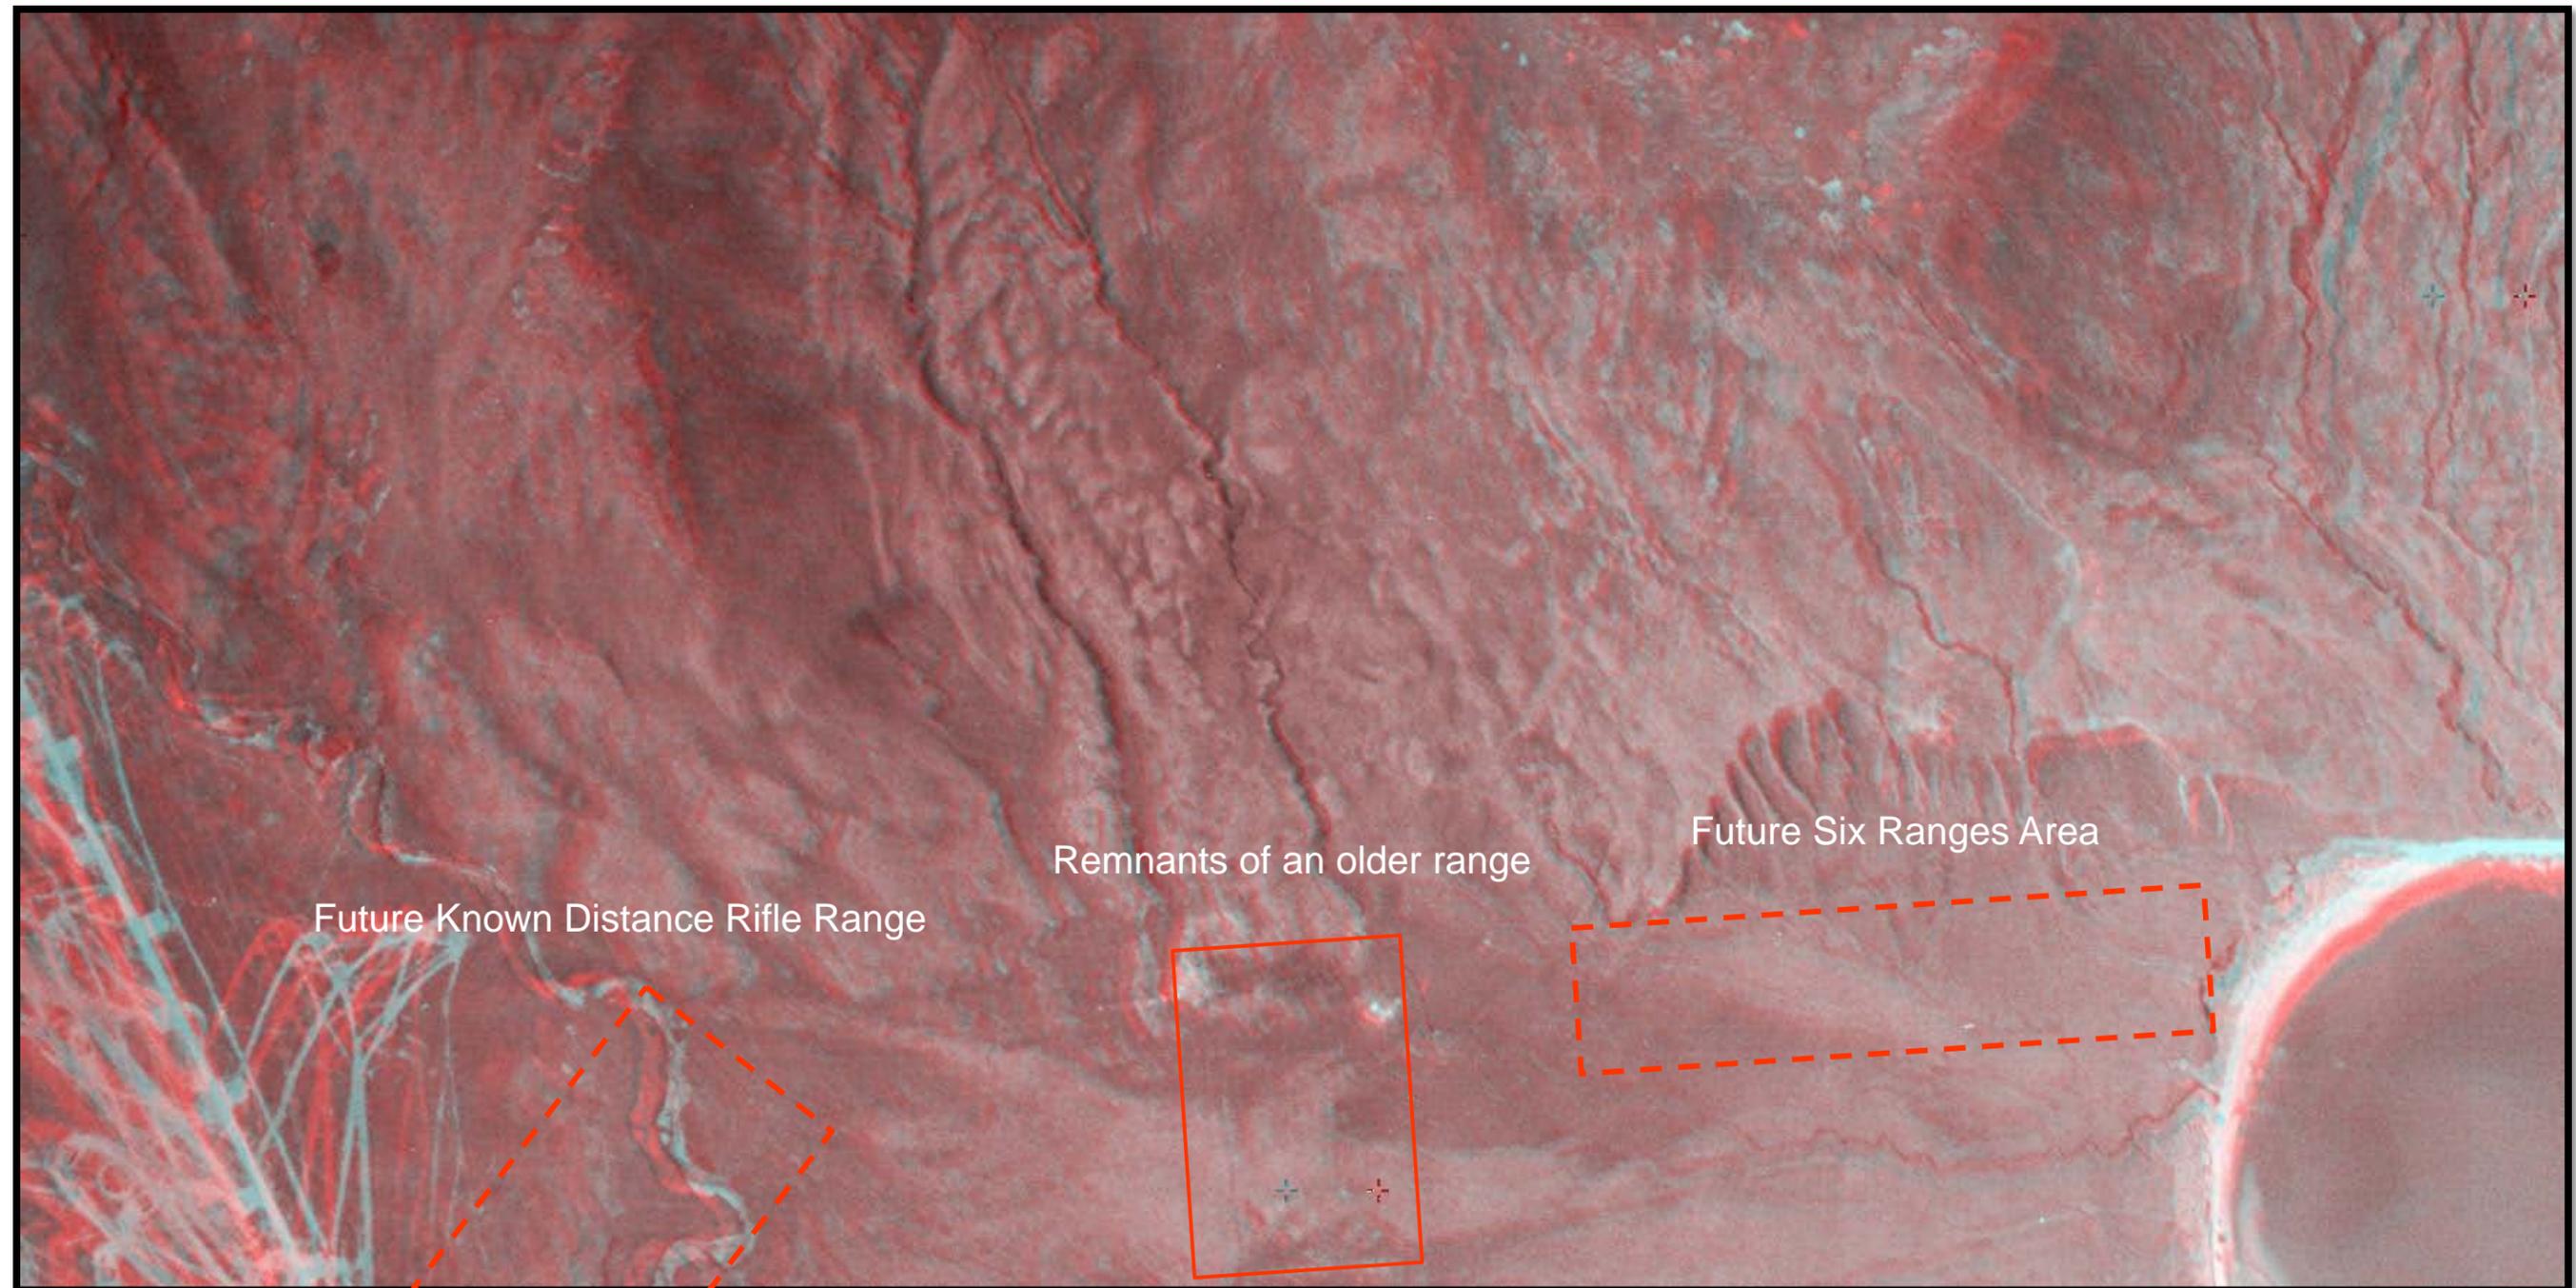
27 July 1943 anaglyph showing relief north of ranges built (or later built) in the Army Supply Depot and Range area

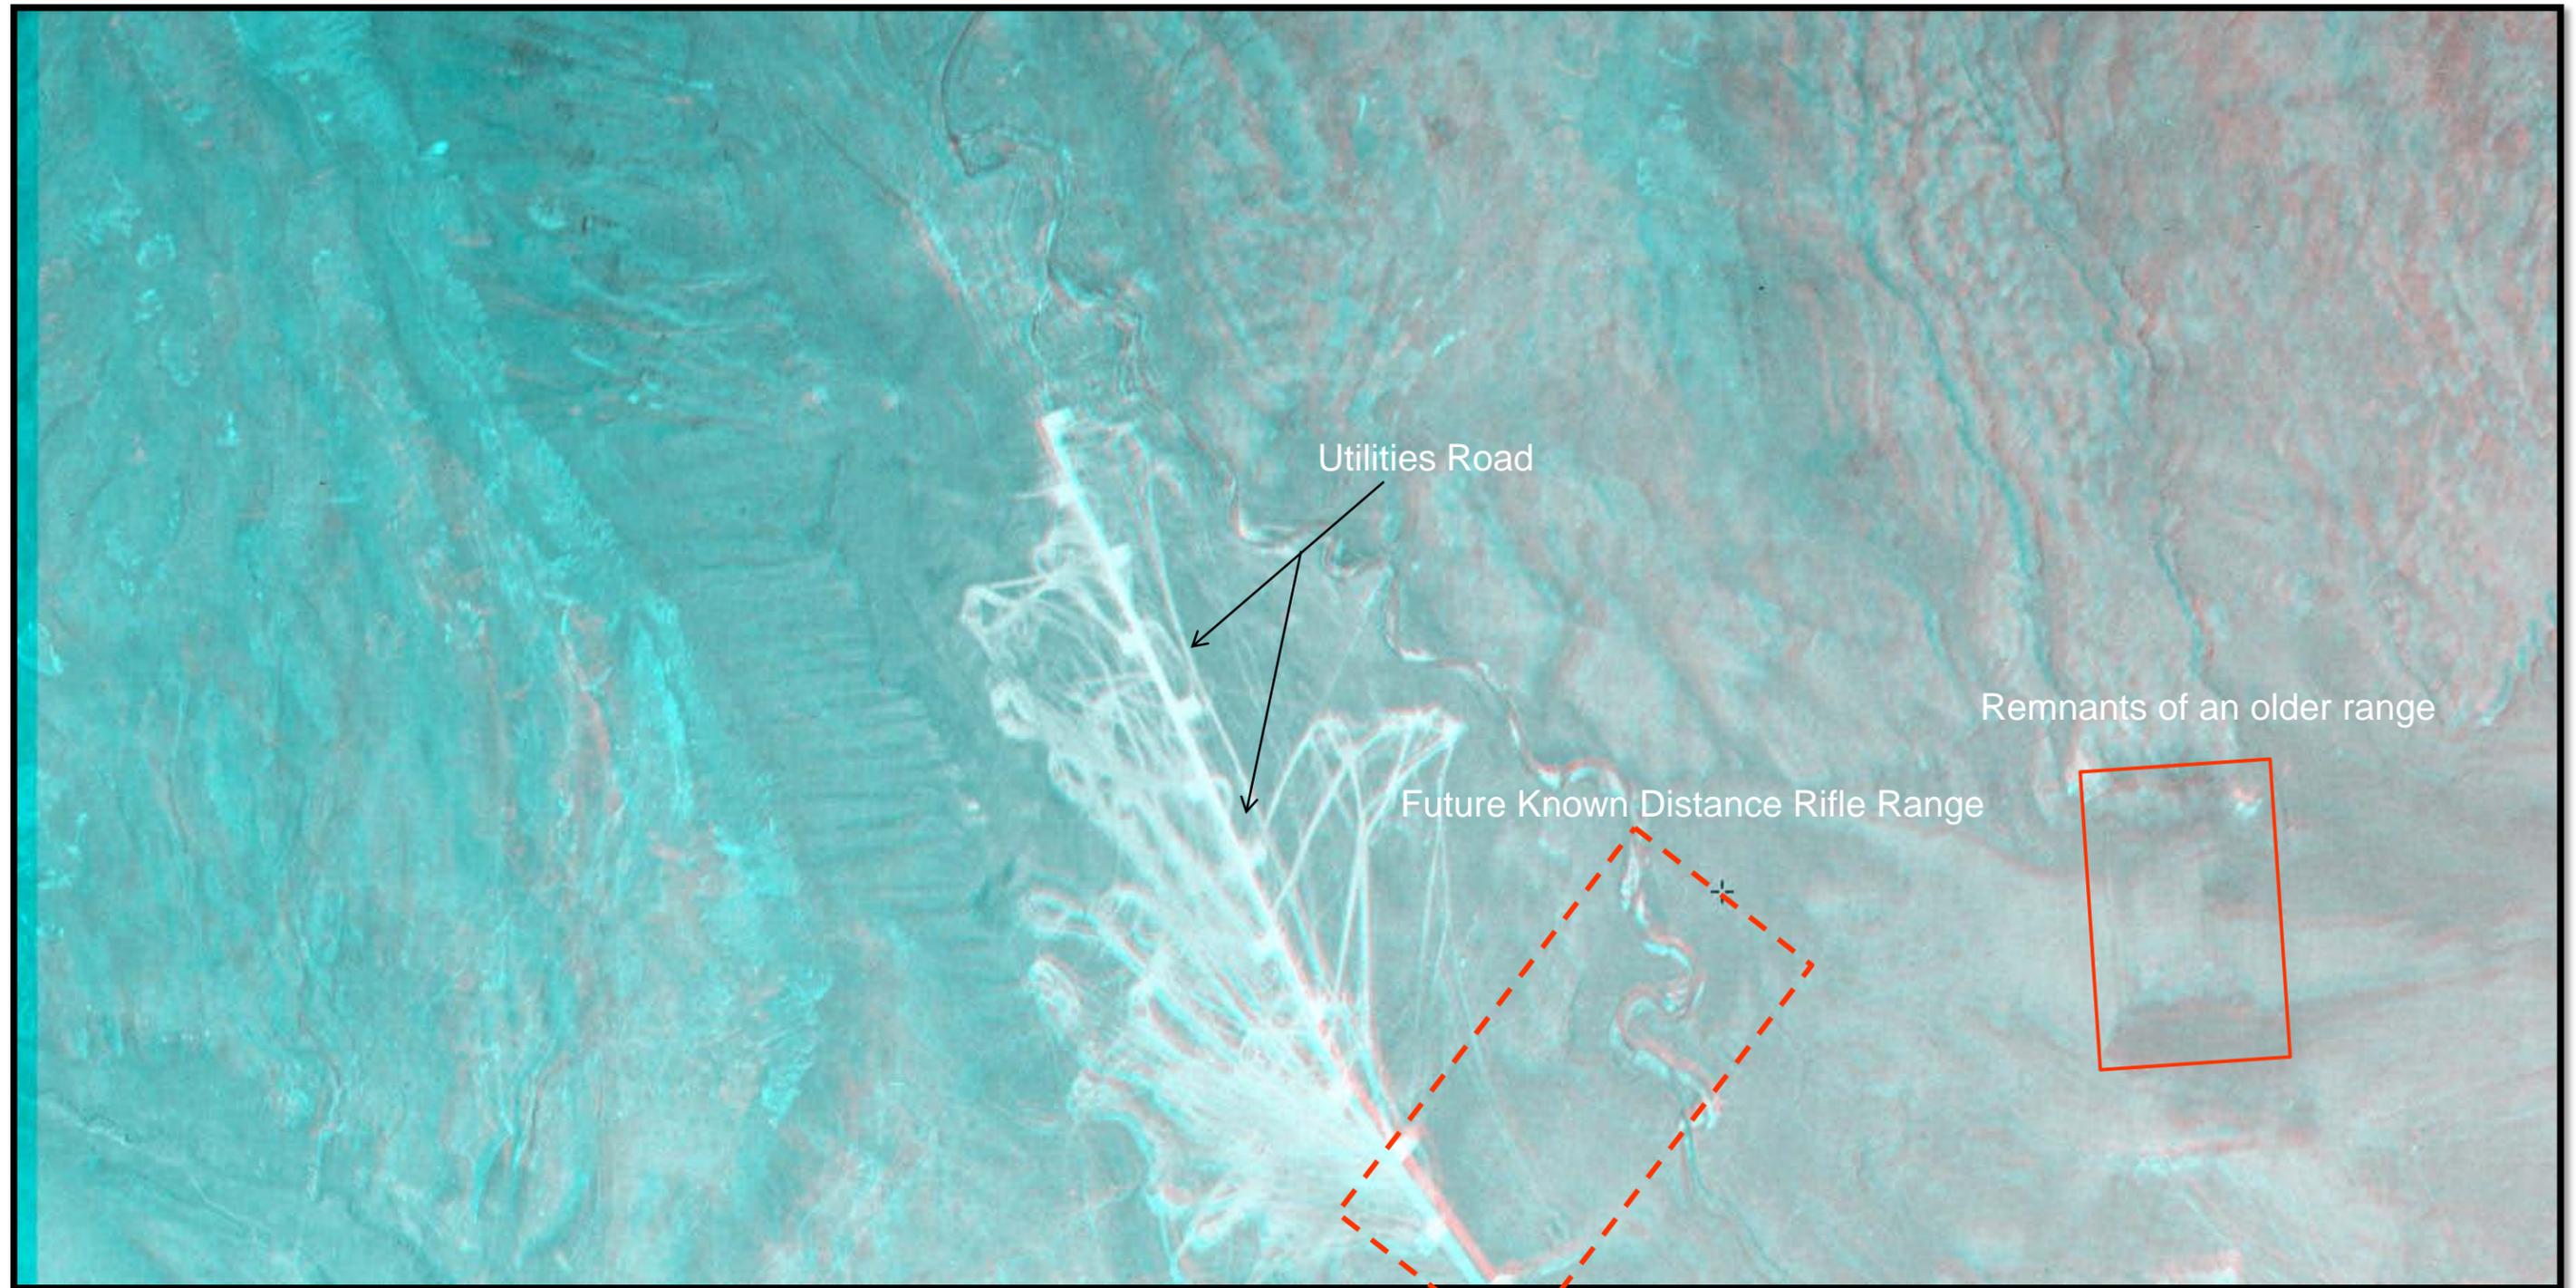
27 July 1943 anaglyph showing relief in the RR-01, OBOD-01 and HG-01 areas in the Army Supply Depot and Range area

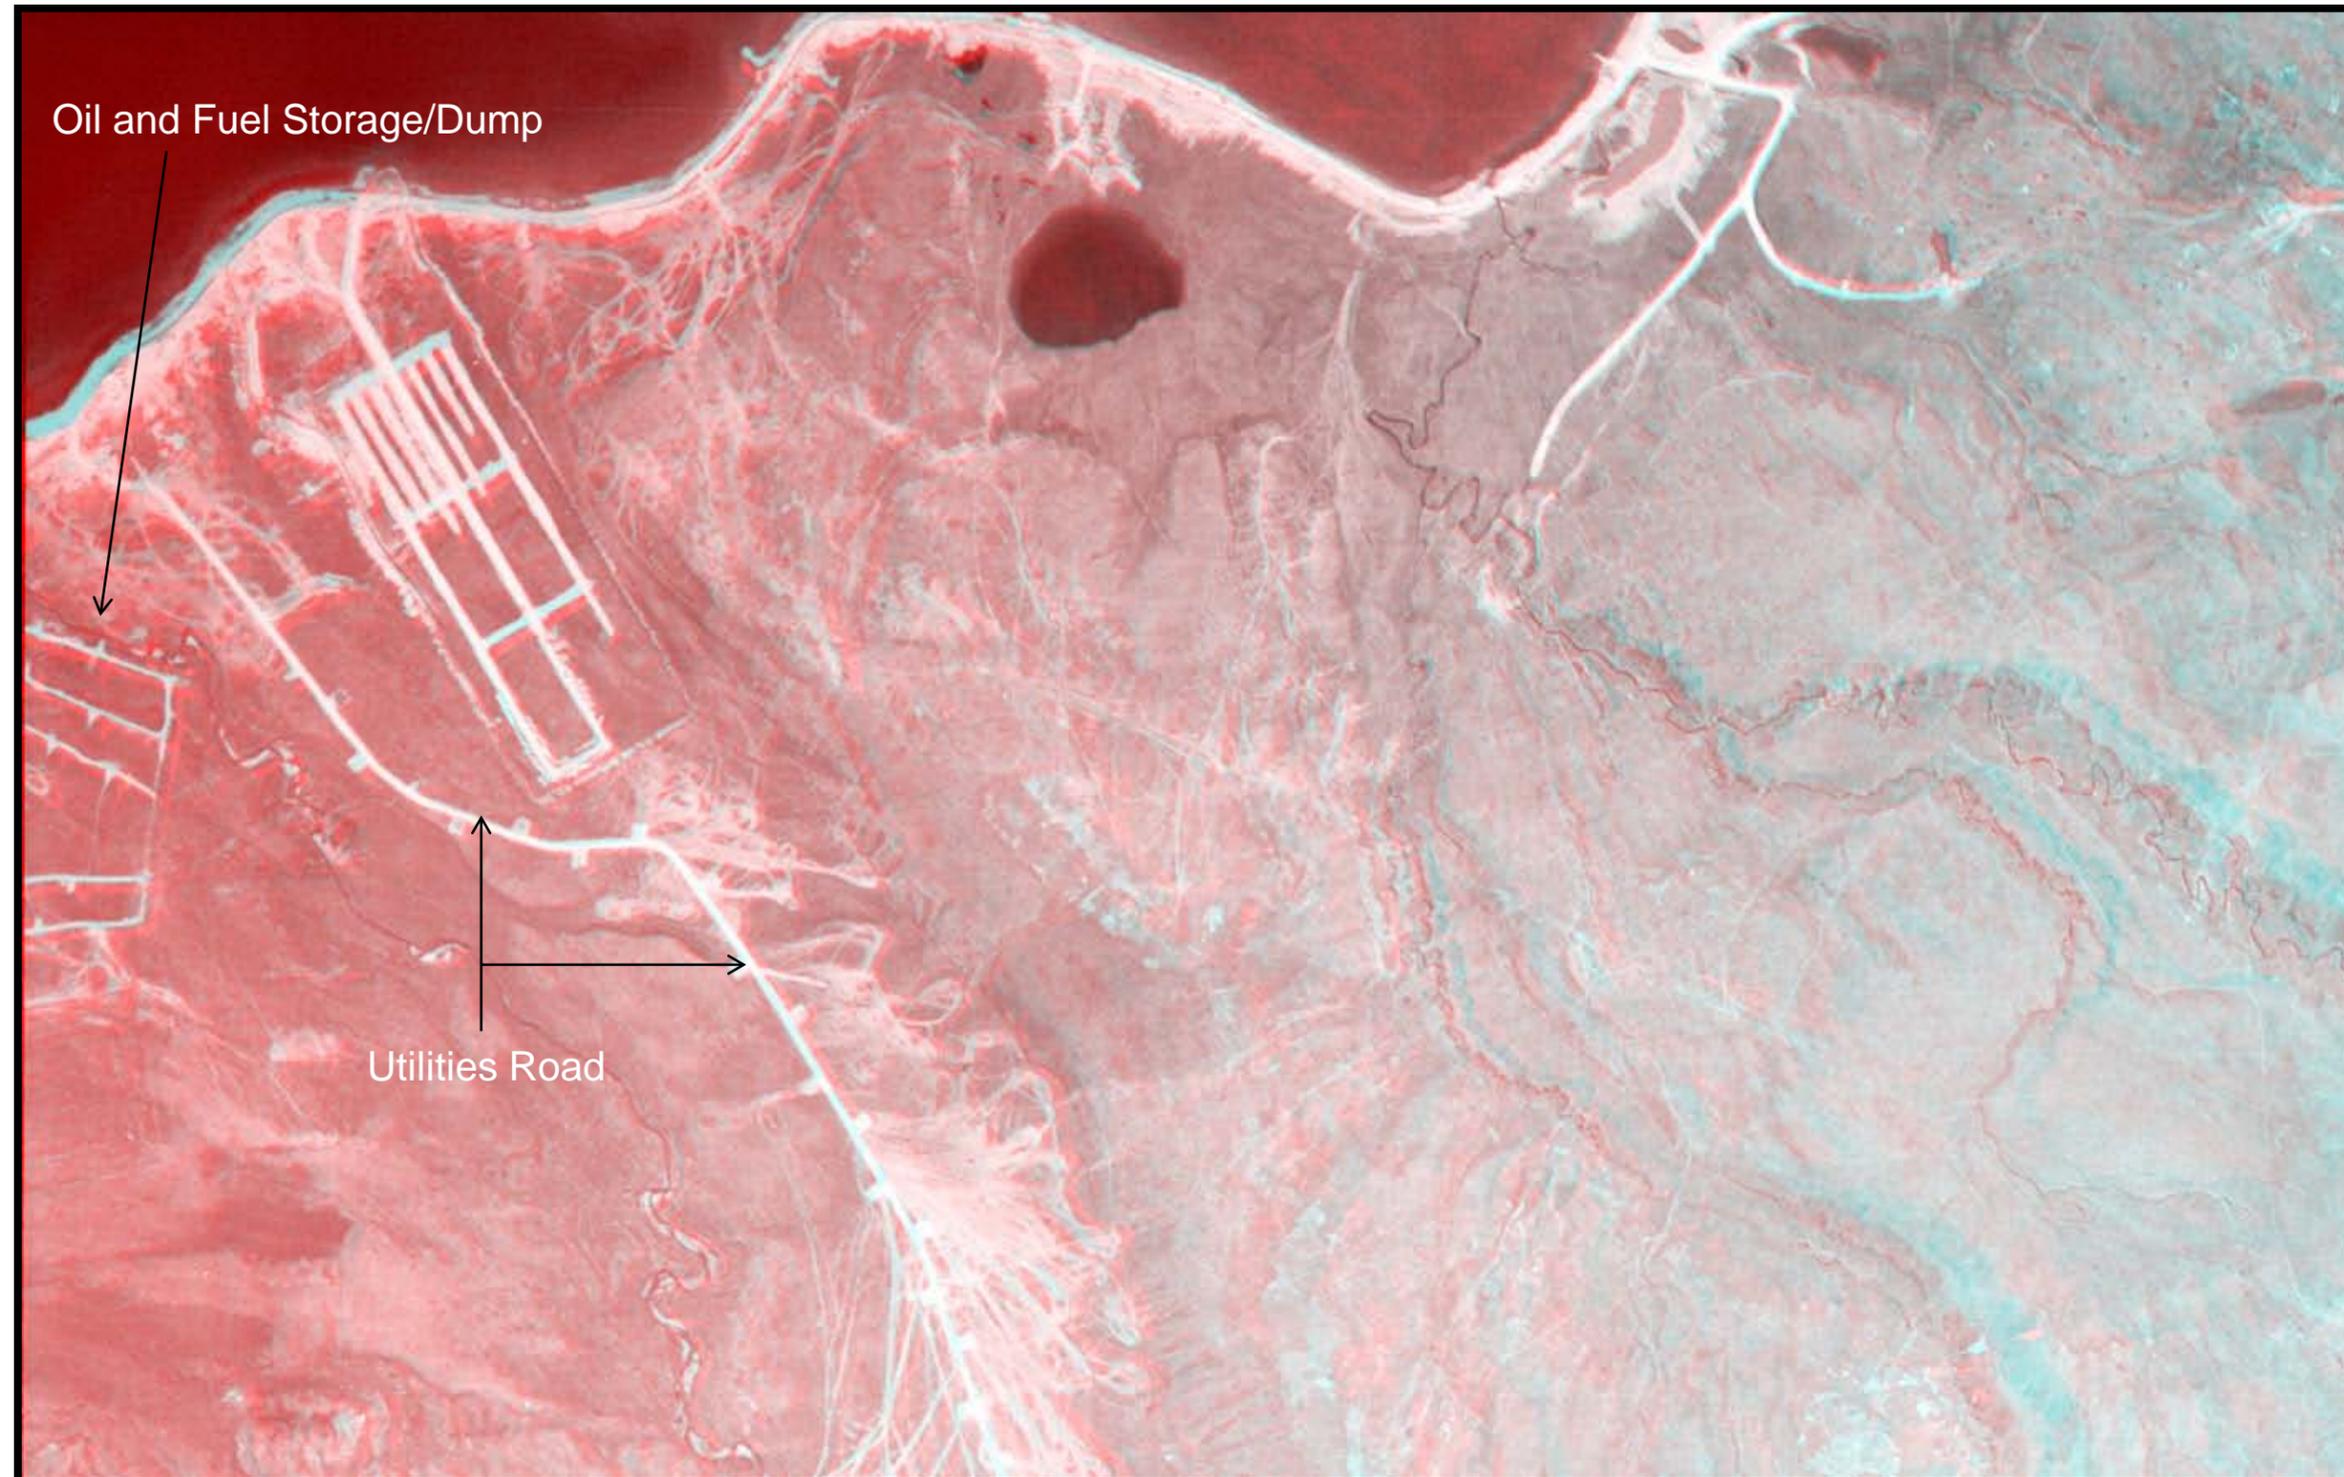
27 July 1943 anaglyph showing relief in Area 3 of the Project area

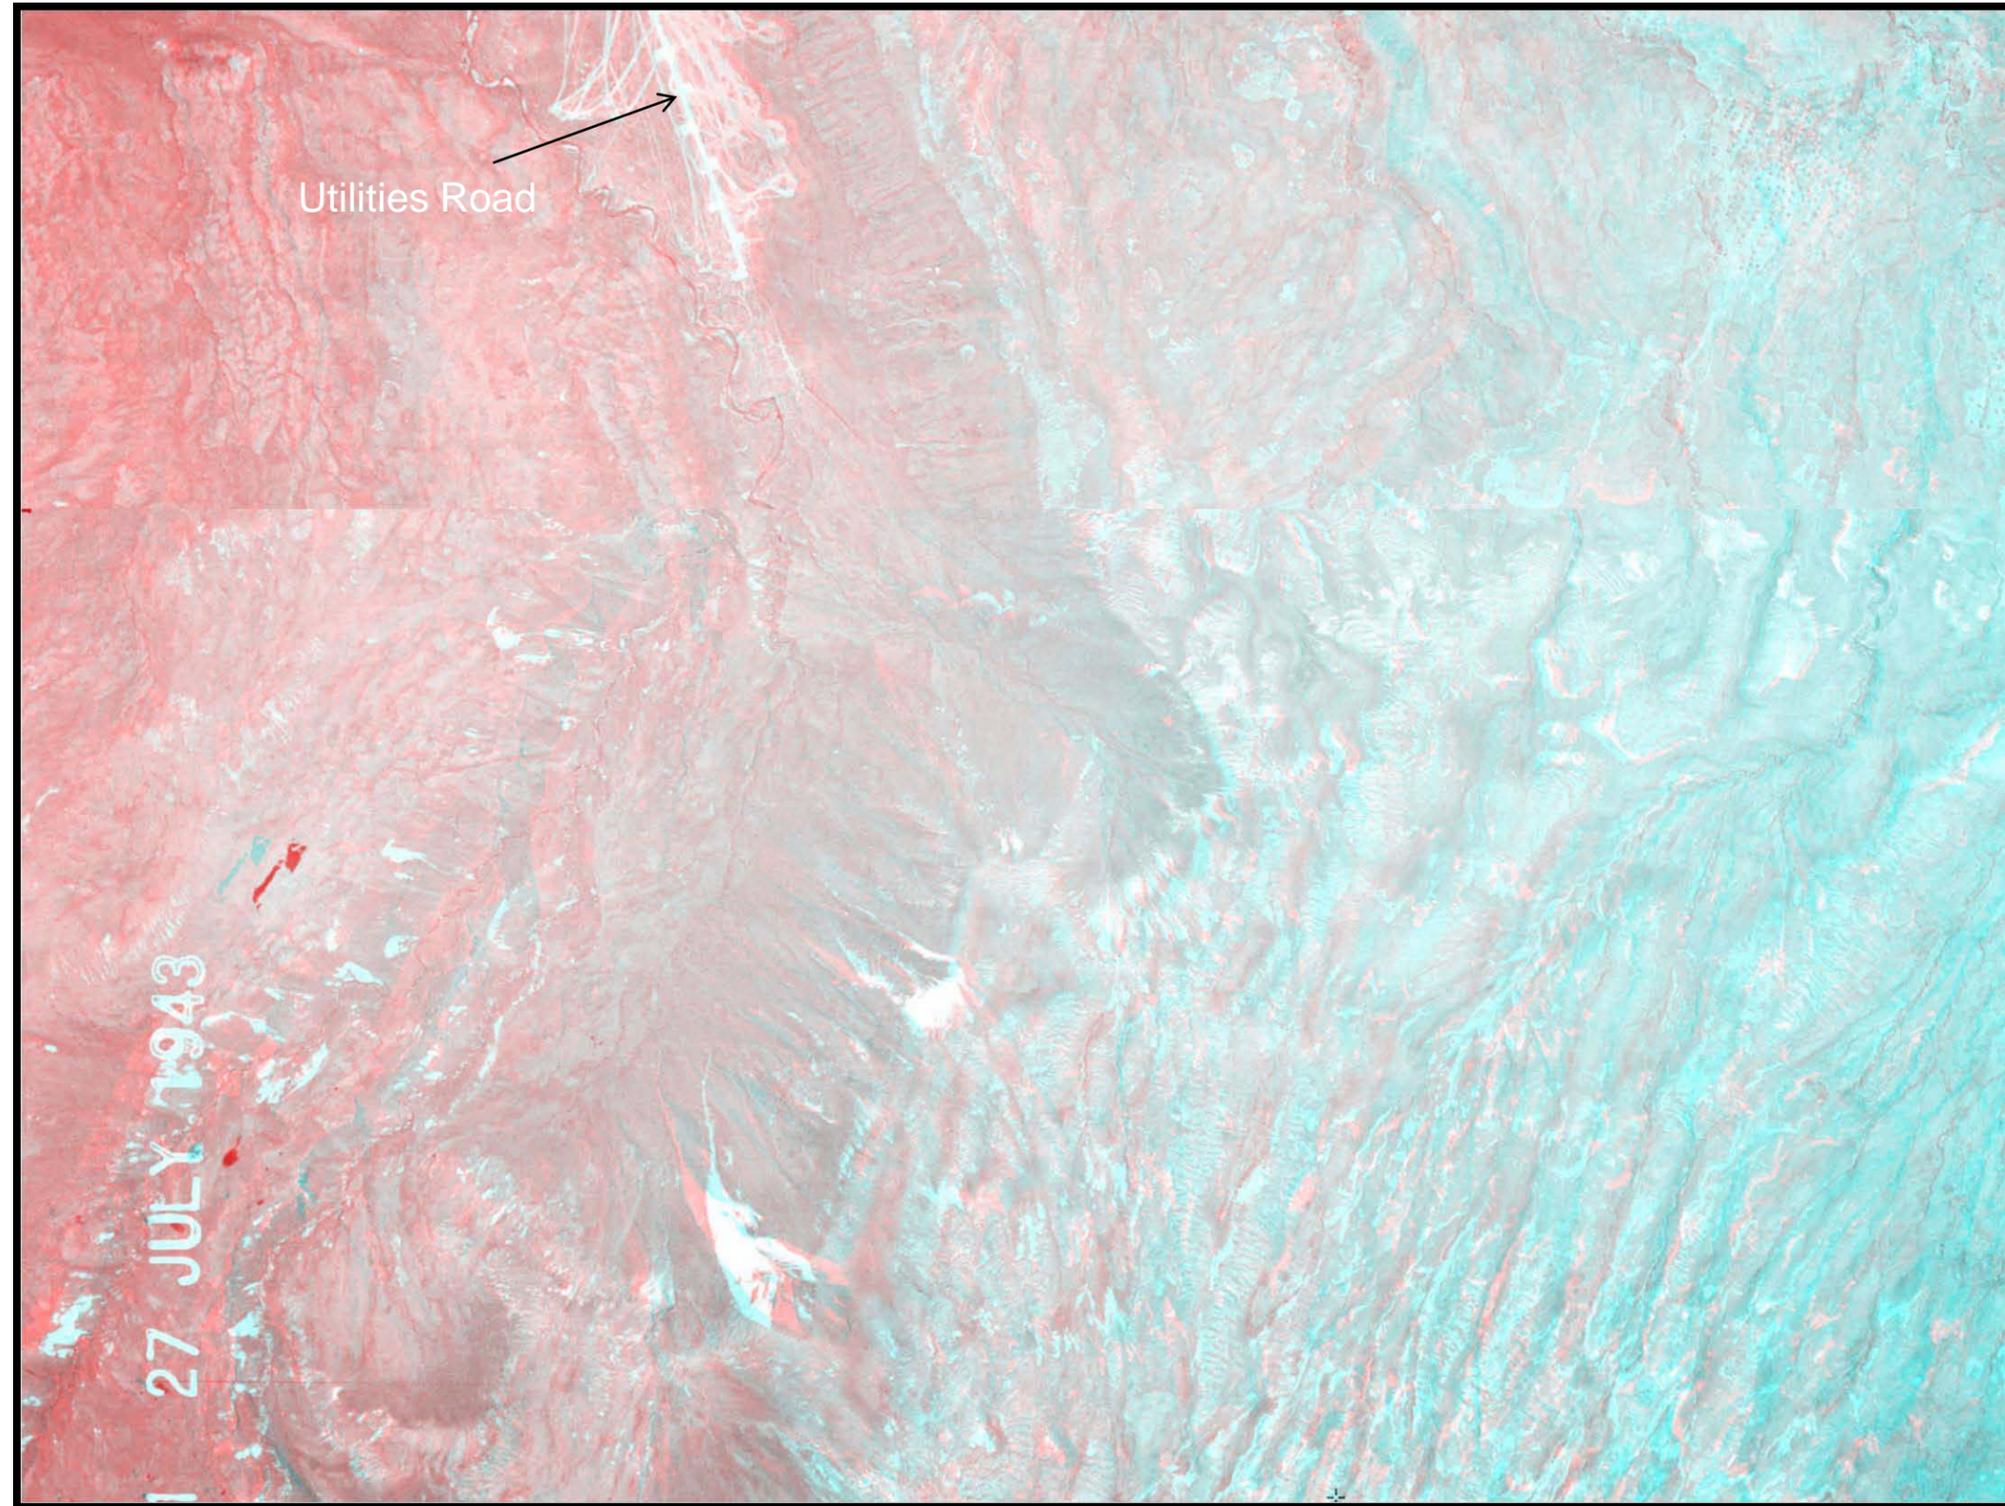
27 July 1943 anaglyph showing relief in Area MI-03 and beyond in Area 3 of the Project area
