**NORTHERN ADAK ISLAND – ALASKA  
ANDREW LAKE SEAWALL AND MOFFETT VALLEY AREAS  
HISTORICAL PHOTOGRAPHIC ANALYSIS**

**FINAL REPORT  
OCTOBER 2012**

Prepared for the U.S. Navy, Naval Facilities  
Engineering Command Northwest

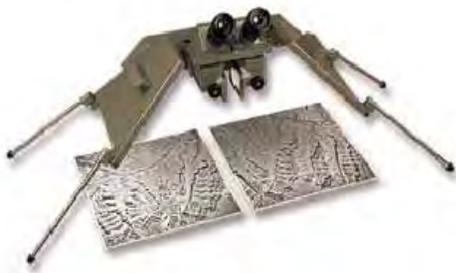
Overlap between adjacent photographs

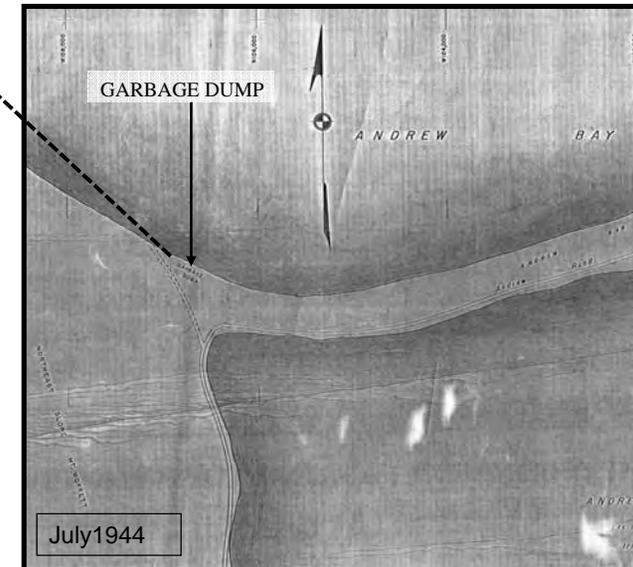
The dashed box signifies the approximate vicinity of the dumping ground based on the cleared area and ground scars found in the above 1951 photograph. April 1944 and July 1944 maps declare the area, but not the boundary of the garbage dump.

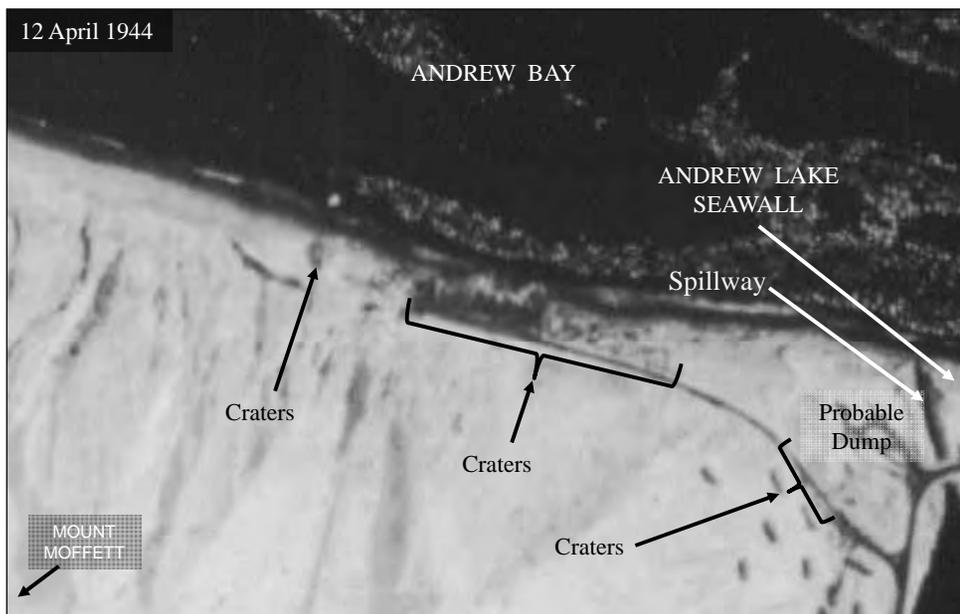
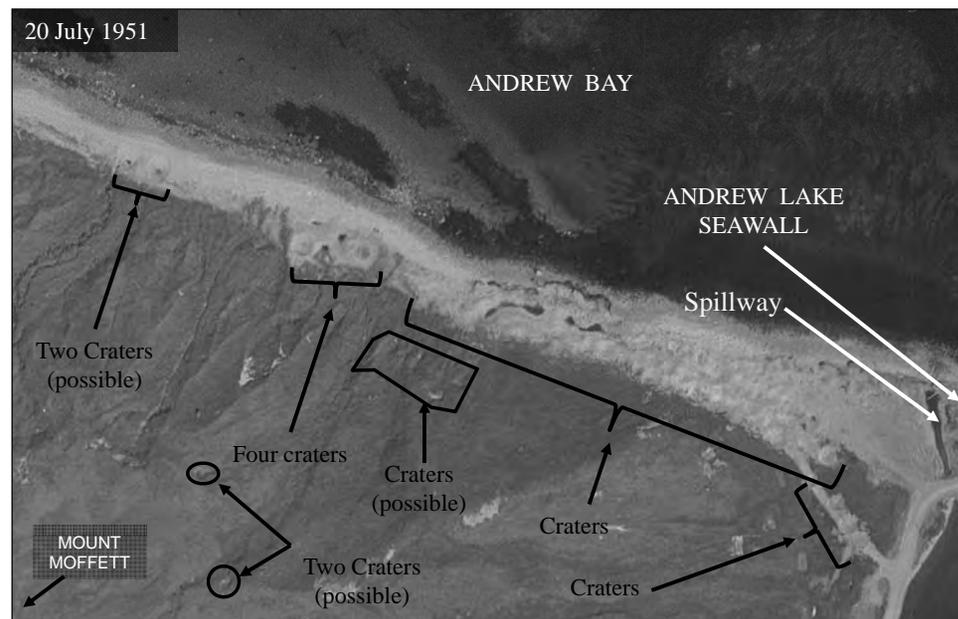
### WEST SEAWALL & SHORELINE AREA – CRATERS 12 APRIL 1944 AND 20 JULY 1951

Craters are evident just west of the seawall area as early as April of 1944. Due to limits of image scale, resolution, seasonal variations, and sun angle, not all craters are visible on the available aerial photography.

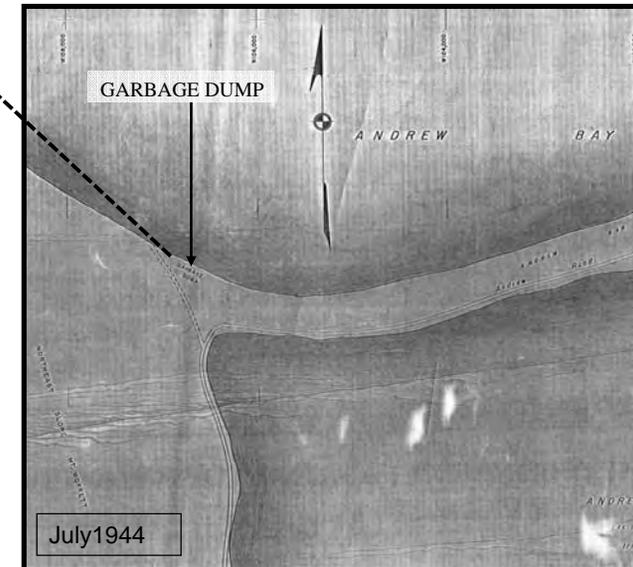
The dashed box signifies the approximate vicinity of the dumping ground based on the cleared area and ground scars found in the above 1951 photograph. April 1944 and July 1944 maps declare the area, but not the boundary of the garbage dump.

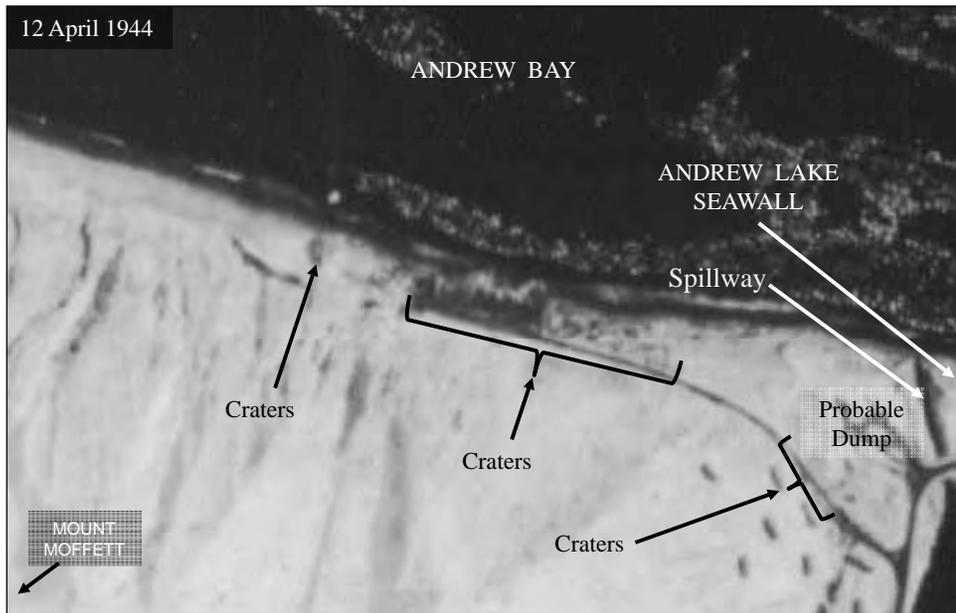
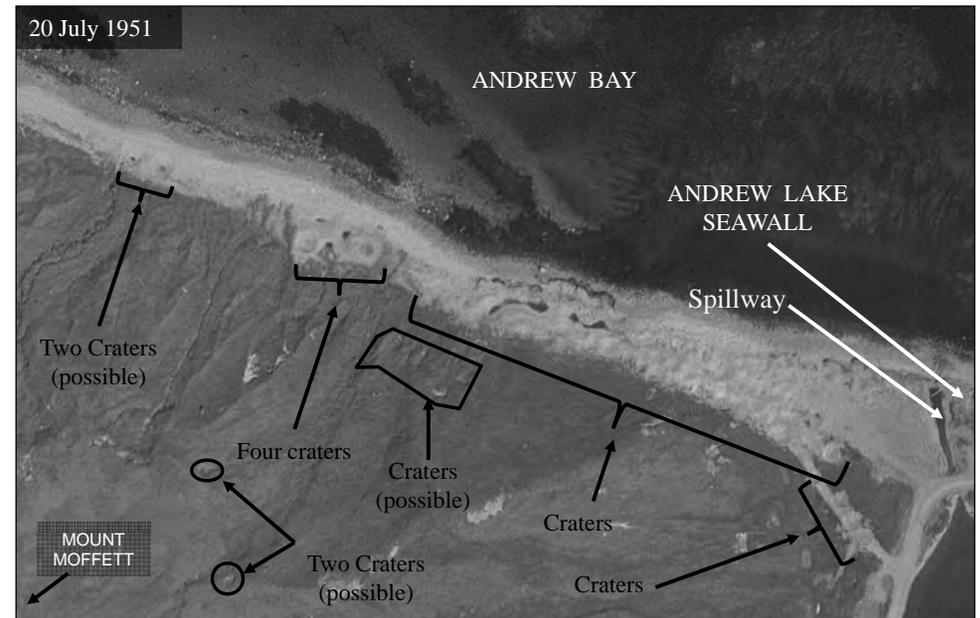
### WEST SEAWALL & SHORELINE AREA – CRATERS 12 APRIL 1944 AND 20 JULY 1951

Craters are evident just west of the seawall area as early as April of 1944. Due to limits of image scale, resolution, seasonal variations, and sun angle, not all craters are visible on the available aerial photography.

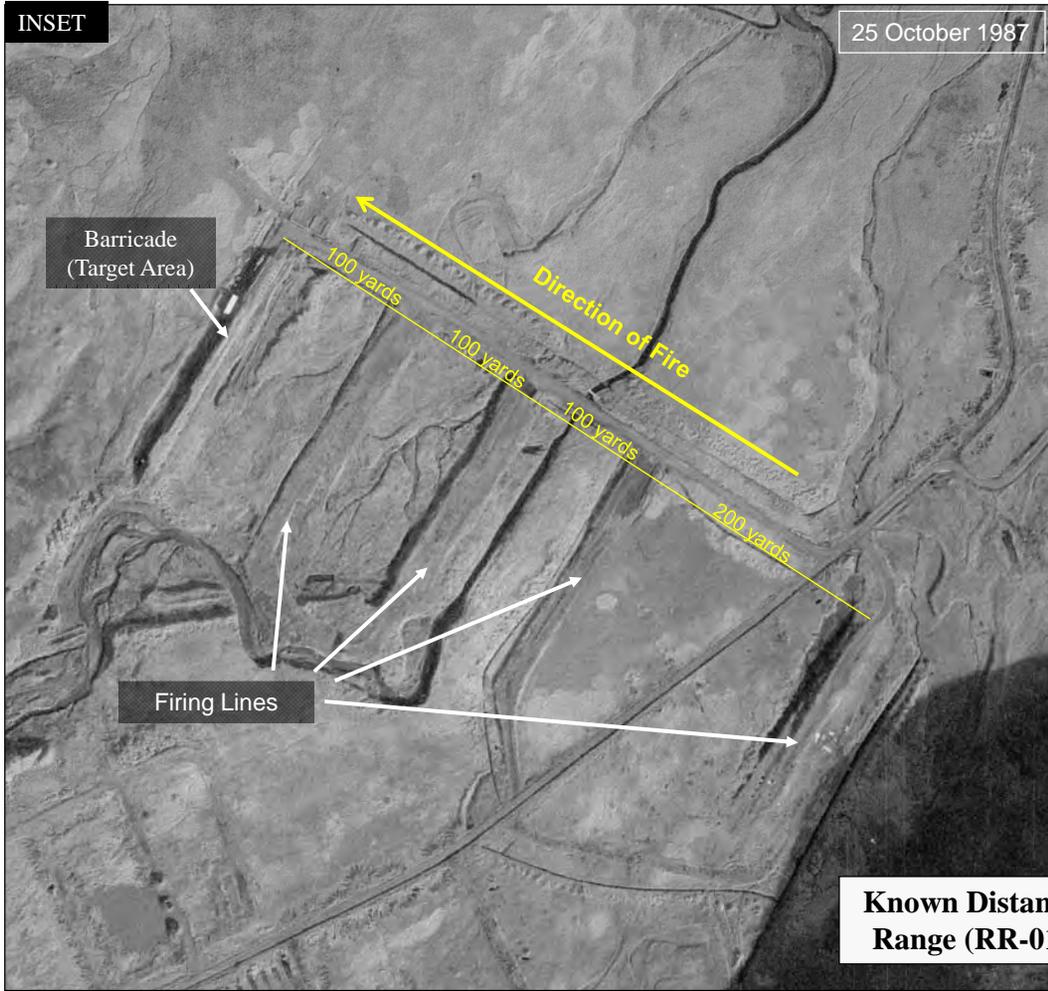
## MOFFETT VALLEY - KNOWN DISTANCE RANGE (RR-01) 1987 AERIAL PHOTOGRAPHY

Note: No significant changes to the Known Distance Range compared to July 1951 aerial coverage.

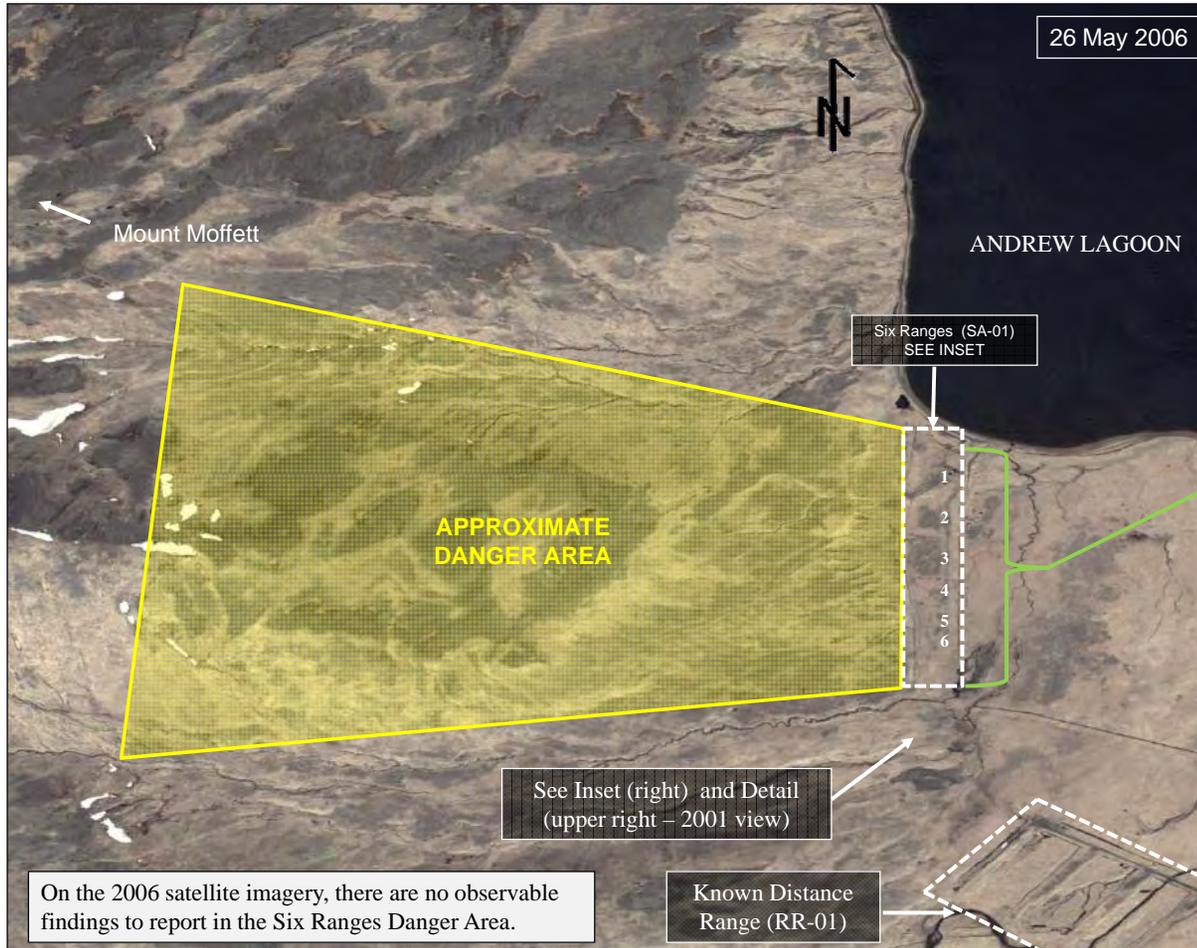
## MOFFETT VALLEY - SIX RANGES (SA-01) 2006 SATELLITE IMAGERY & 2001 DETAIL VIEW

1. Pistol Range
2. 1000" Machine Gun Range
3. 1000" Landscape and Small Bore Range
4. 1000" Anti-Tank Range, Cal. 22
5. 1000" Anti-Aircraft Range, Cal. 22
6. Sub-Machine Gun Range

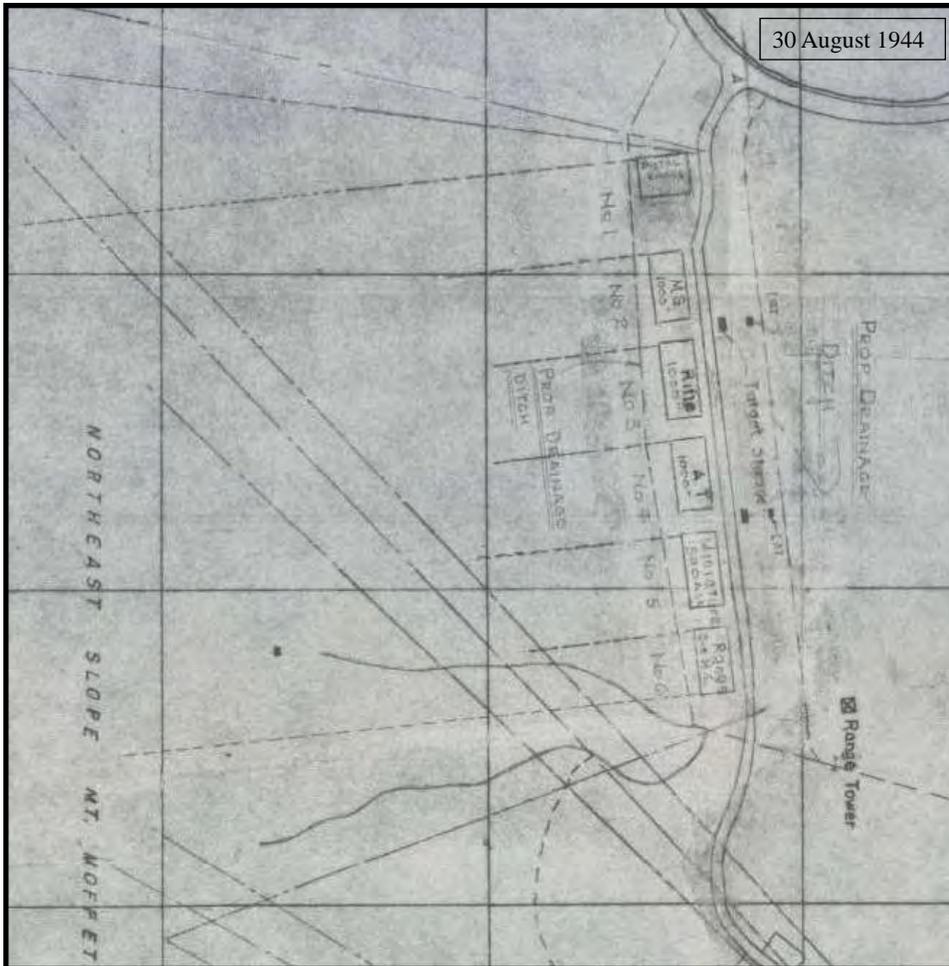
## MOFFETT VALLEY - SIX RANGES (SA-01) 1944 MAP AND 1946 AERIAL PHOTOGRAPHY

1. Pistol Range
2. 1000' Machine Gun Range
3. 1000' Landscape and Small Bore Range
4. 1000' Anti-Tank Range, Cal. 22
5. 1000' Anti-Aircraft Range, Cal. 22
6. Sub-Machine Gun Range

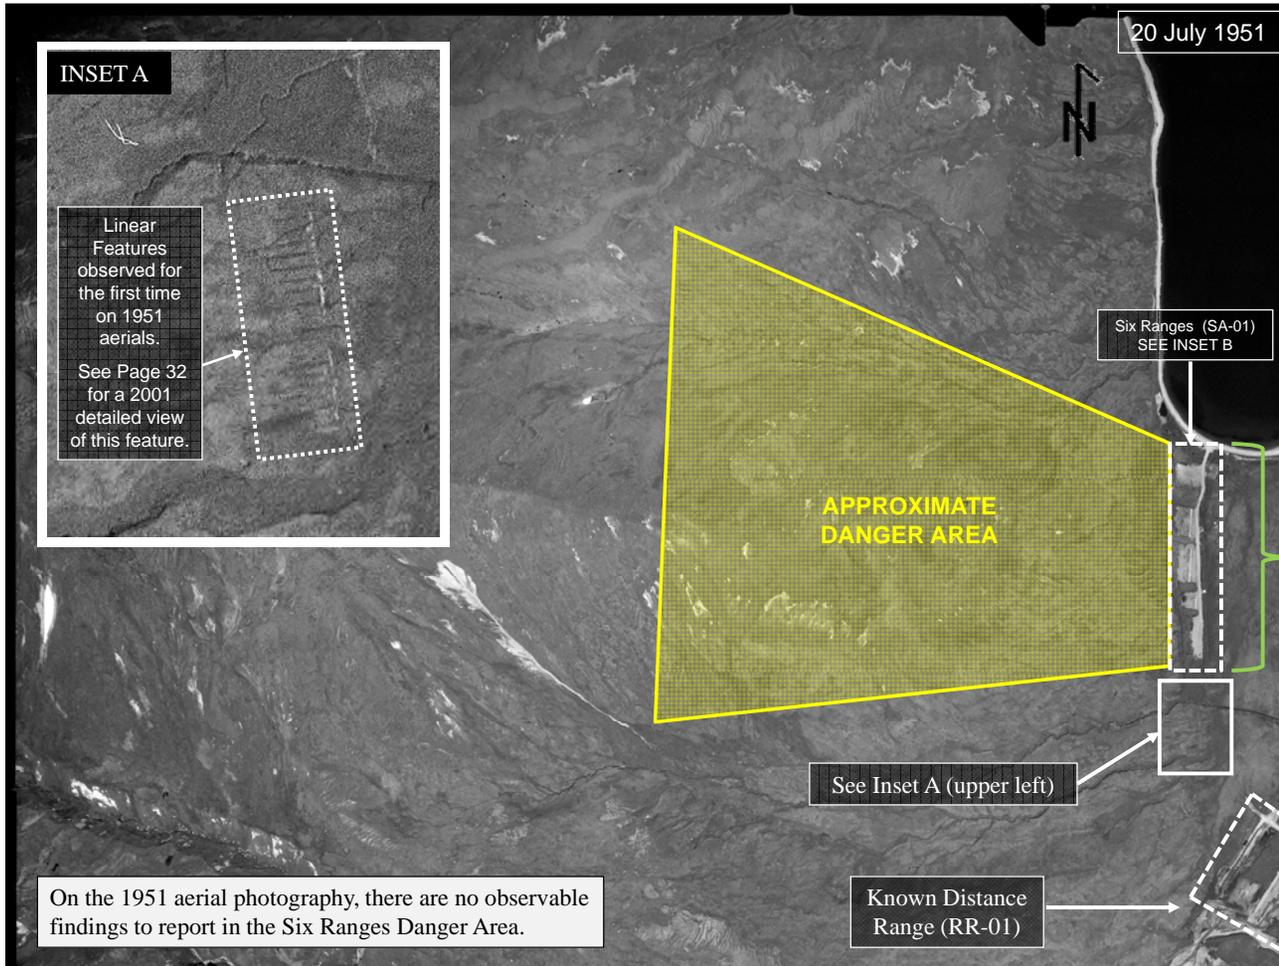
## MOFFETT VALLEY - SIX RANGES (SA-01) 1951 AERIAL PHOTOGRAPHY

New developed area.

1. Pistol Range
2. 1000" Machine Gun Range
3. 1000" Landscape and Small Bore Range
4. 1000" Anti-Tank Range, Cal. 22
5. 1000" Anti-Aircraft Range, Cal. 22
6. Sub-Machine Gun Range

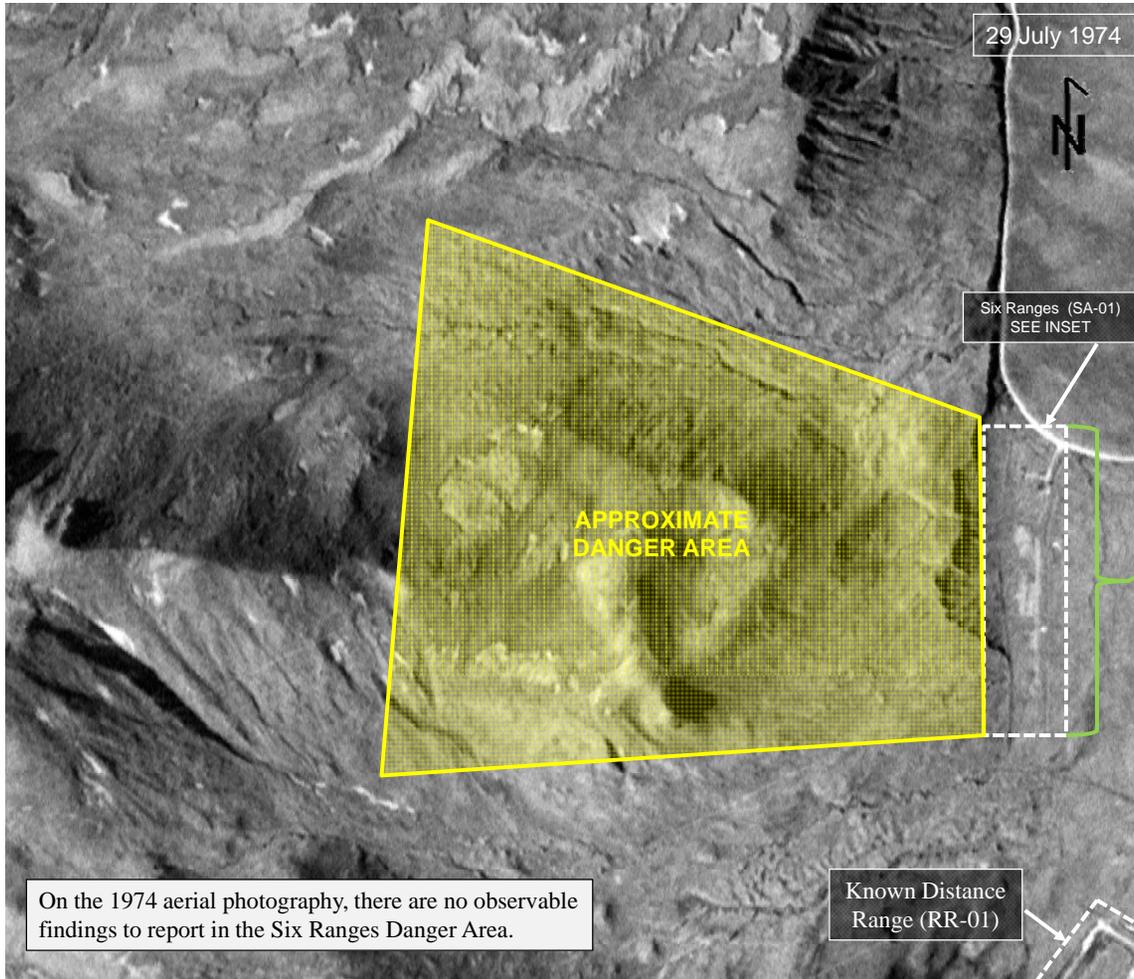
## MOFFETT VALLEY - SIX RANGES (SA-01) 1974 AERIAL PHOTOGRAPHY

Note: the six ranges appear to be abandoned. The road running parallel to the range area appears to be in disrepair. Also, visual signatures of the actual ranges appear somewhat weak.

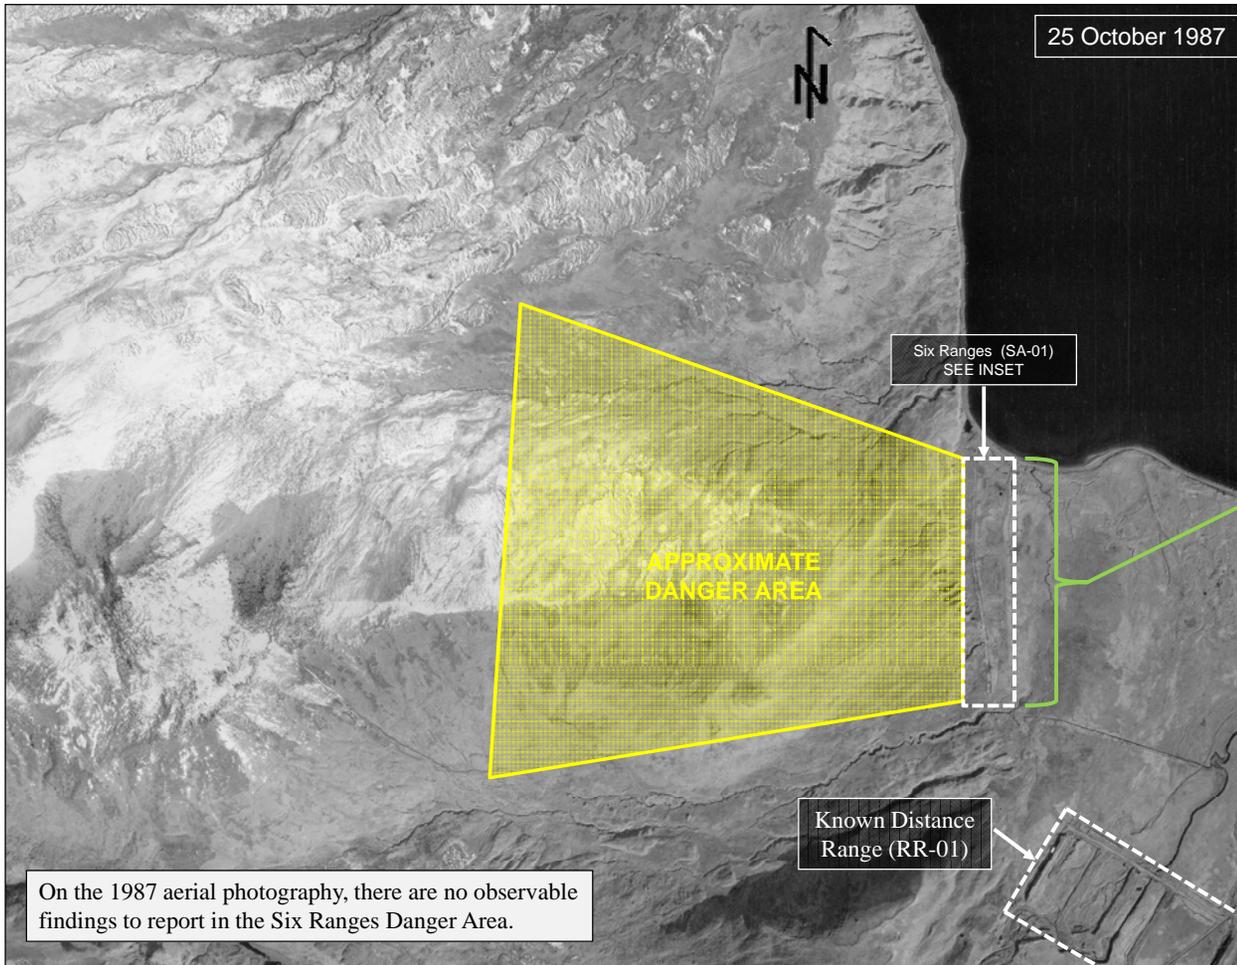
## MOFFETT VALLEY - SIX RANGES (SA-01) 1987 AERIAL PHOTOGRAPHY

Note: the six ranges appear to have been abandoned for several years. The signature of the six ranges appears very weak on the 1987 aerials.

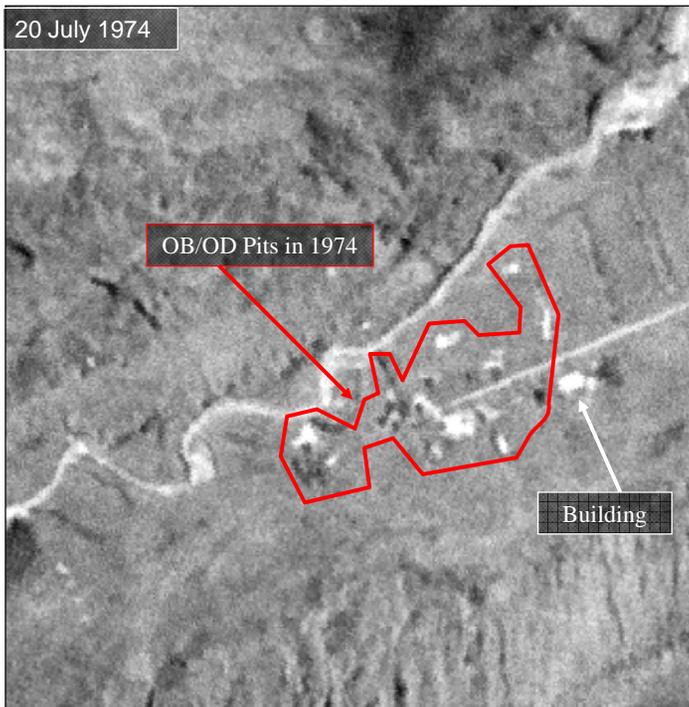
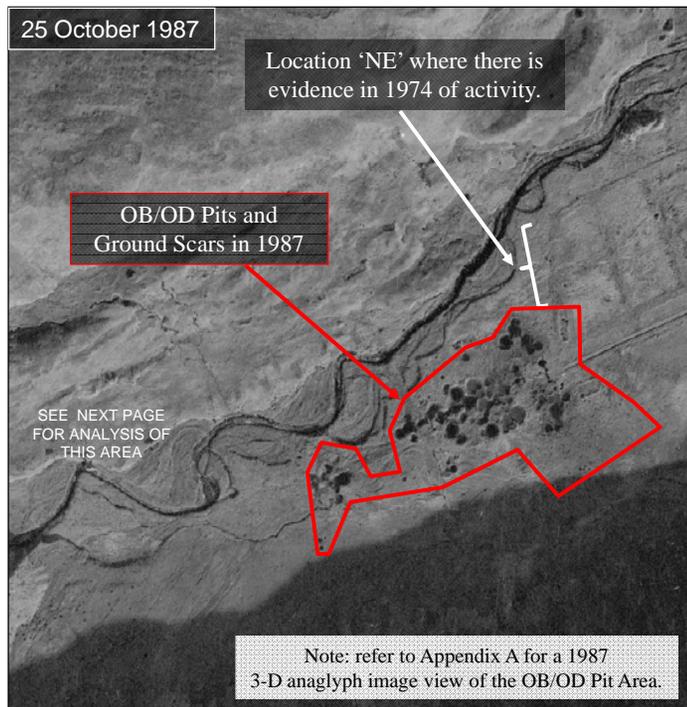
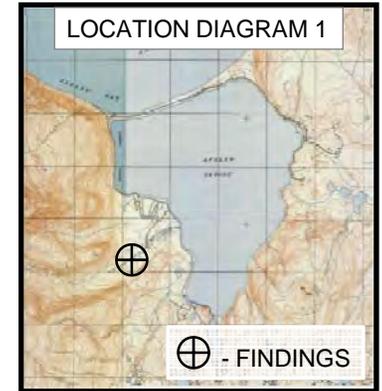
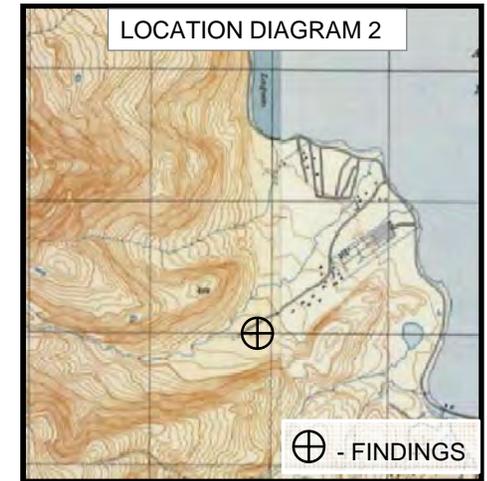
## MOFFETT VALLEY – OPEN BURNING/OPEN DETONATION (OB/OD) EXPLOSIVE ORDNANCE DISPOSAL: 1974 AND 1987 AERIAL PHOTOS.

Note: the OB/OD pit area displays a far more dense pattern of circular-shaped pits in 1987, however, the 1974 aerial photography indicates a further extent of the area to the northeast direction (see location 'NE').

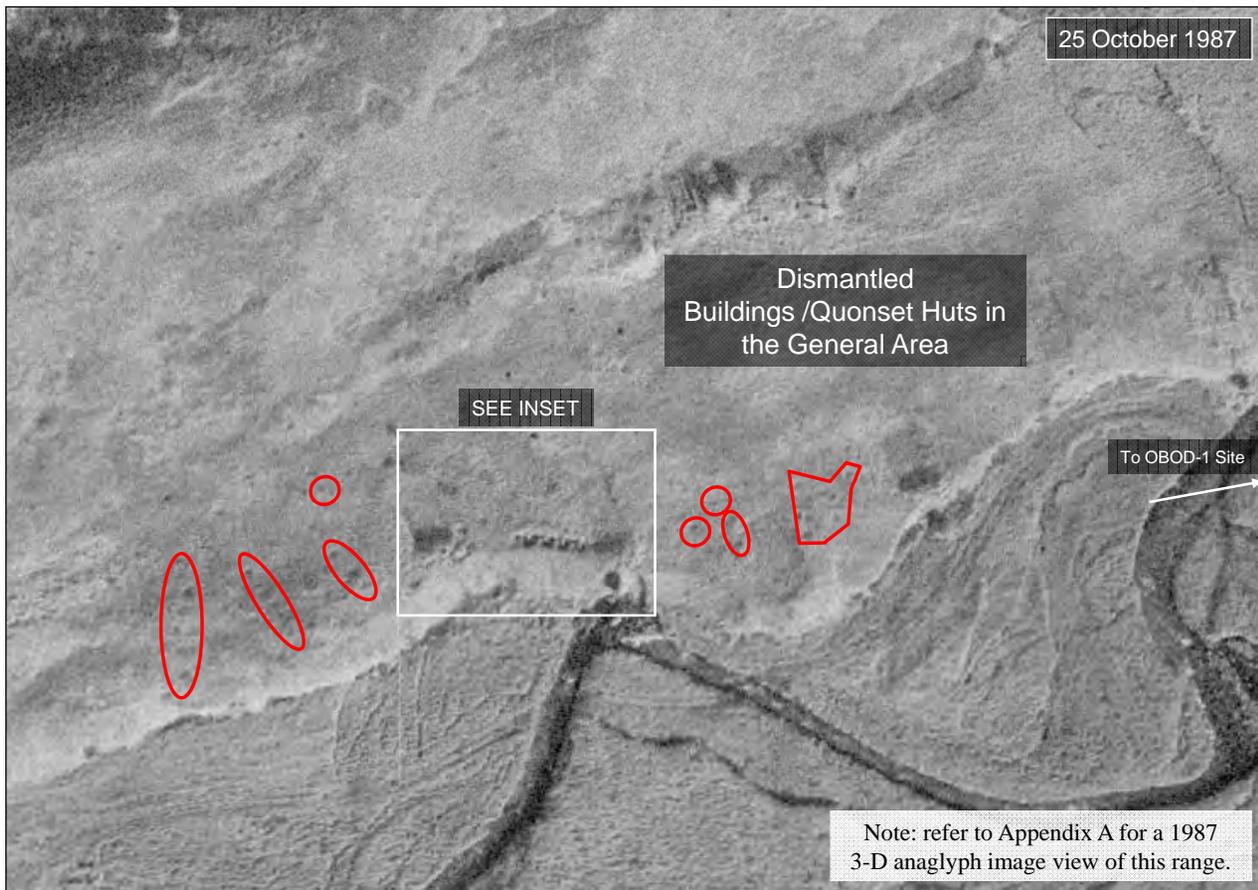
MOFFETT VALLEY - TRAINING RANGE AREA LOCATED JUST WEST OF THE OB/OD EXPLOSIVE ORDNANCE DISPOSAL AREA: 1987

○ = possible impact crater(s)

Note refer to Appendix A for an anaglyph of this area.

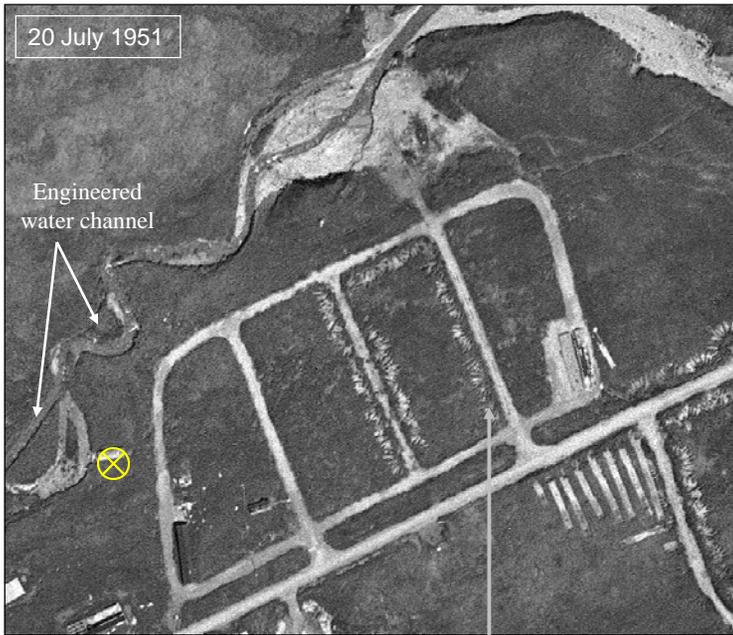
## HAND GRENADE RANGE (HG-01) AREA 20 JULY 1951 AND 29 JULY 1979

No evidence of a grenade range in July 1951.

⊗ - Indicates the same location on vertical aerial photography.

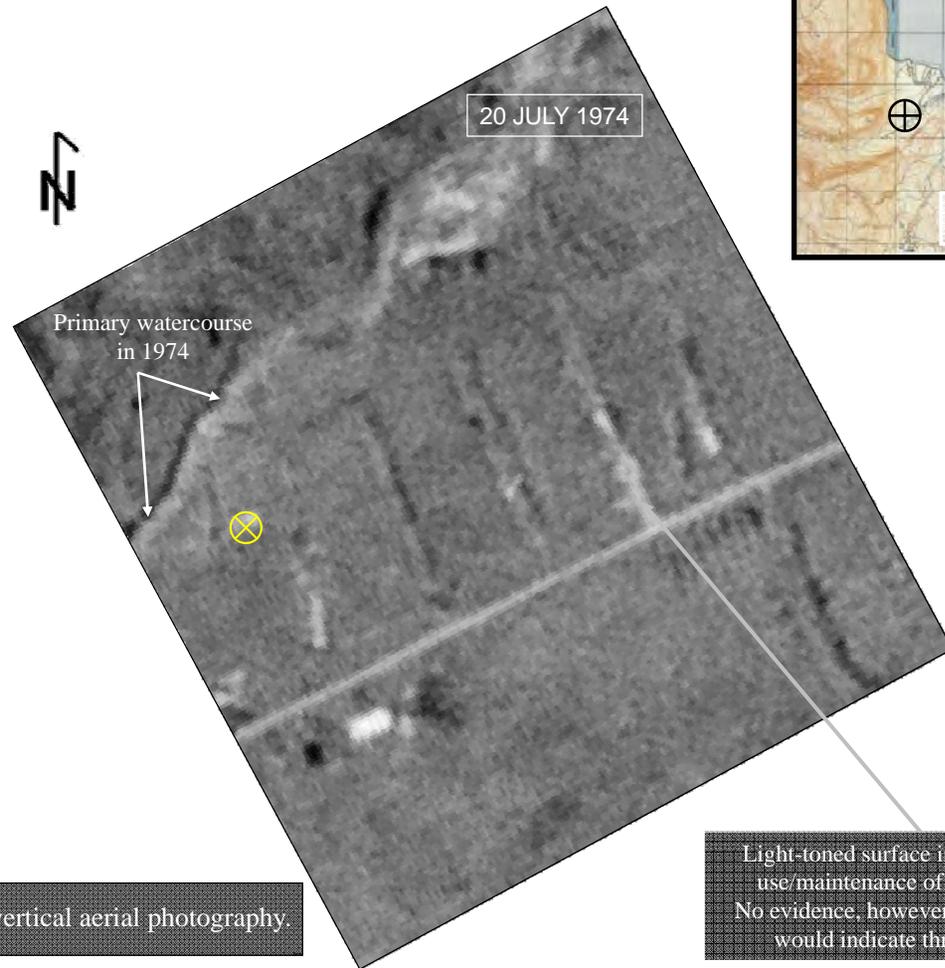
Light-toned surface indicates recent use/maintenance of the roadway. No evidence, however, of a berm that would indicate throwing pits.

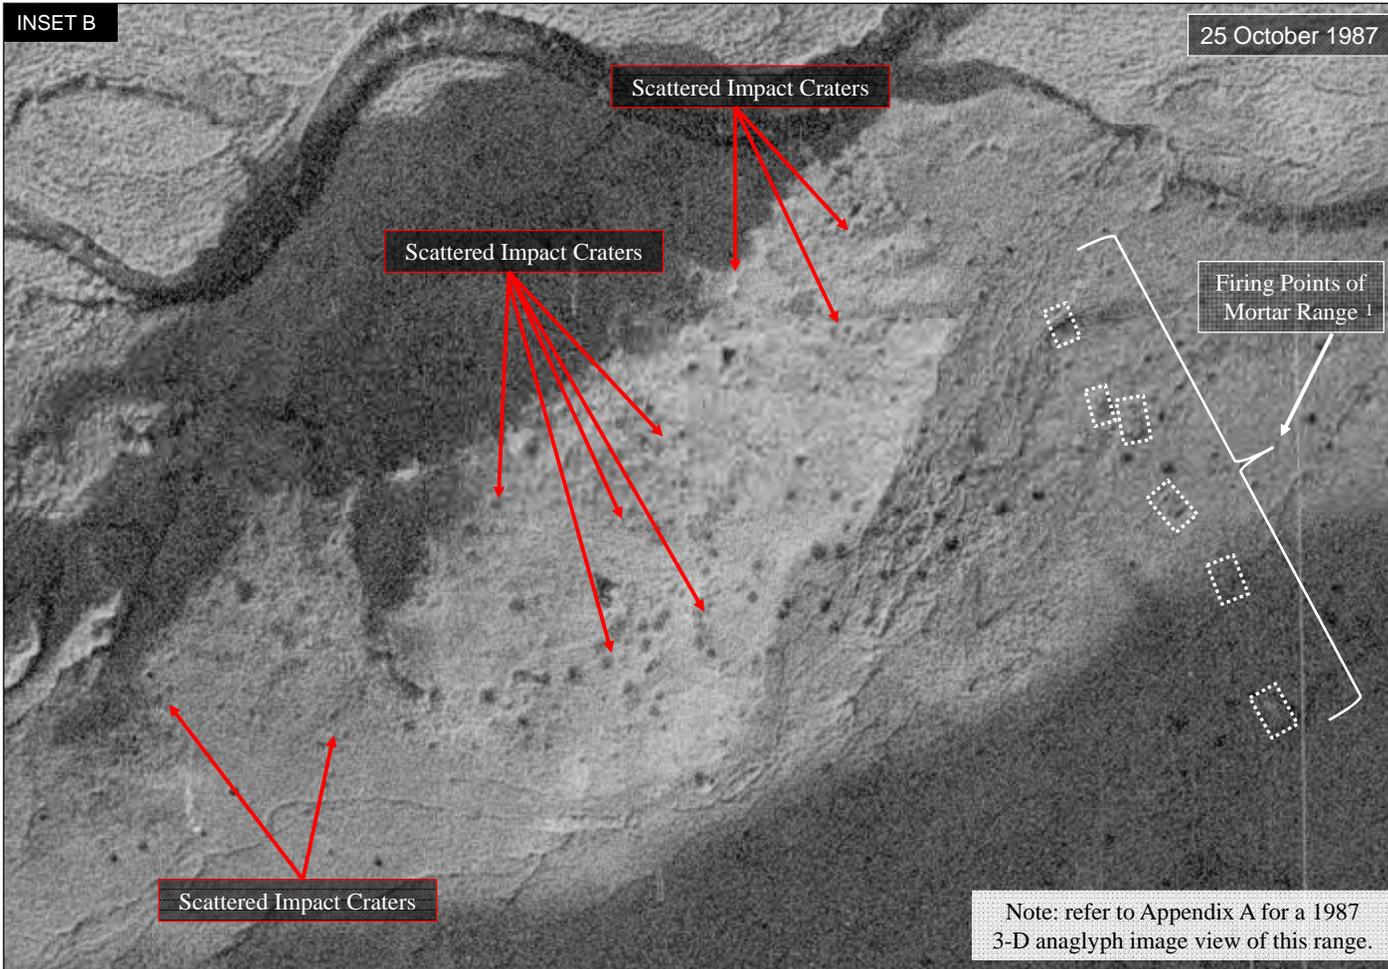
## MORTAR IMPACT AREA (SWMU 1-D): 25 OCTOBER 1987, CONTINUED

Note: some or many of the dark small patches appearing on the surface, in and around the vicinity of the mortar impact area (see example below), may be impact craters that have been seeded by natural plant communities.

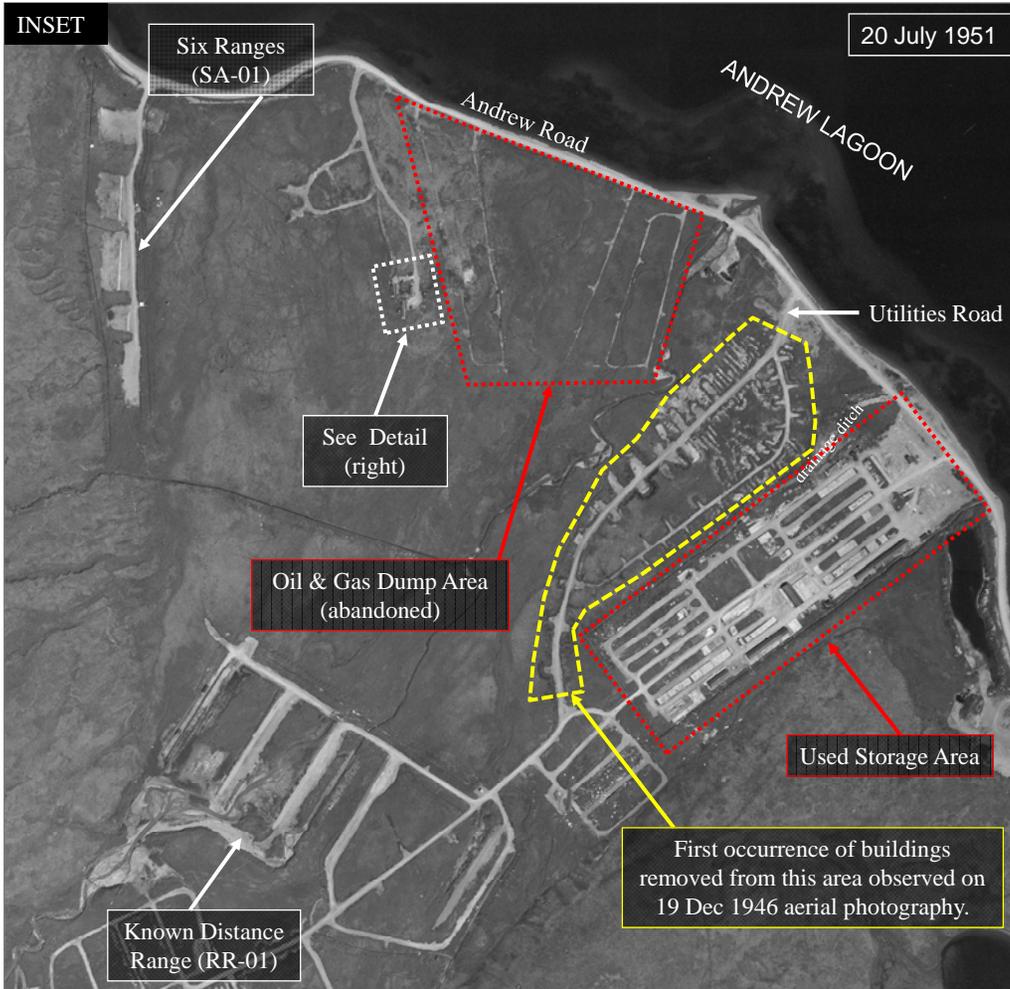
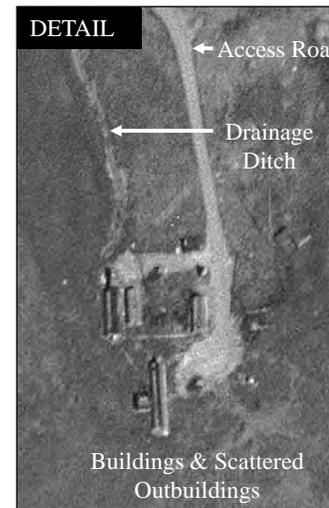
## MOFFETT VALLEY – OIL & GAS DUMP AREA AND USED STORAGE AREA 1951 AERIAL PHOTOGRAPHY

Unknown facility first observed on 19 Dec 1946 aerial photography.

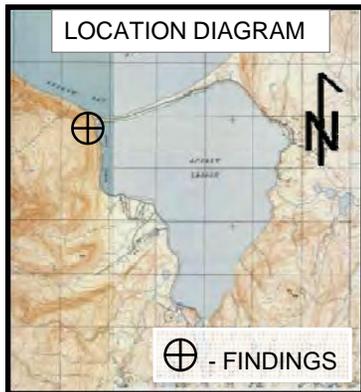
### 3-D IMAGE NO. 1

Western section of Andrew Lake Seawall and shoreline along Andrew Bay. Numerous craters are evident in this area (left side of image).

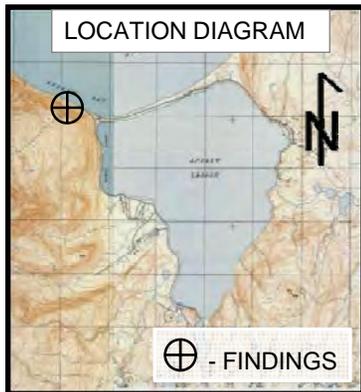
### 3-D IMAGE NO. 2

Section of shoreline just west of Andrew Lake Seawall. Numerous craters are evident in this area (left side of image).

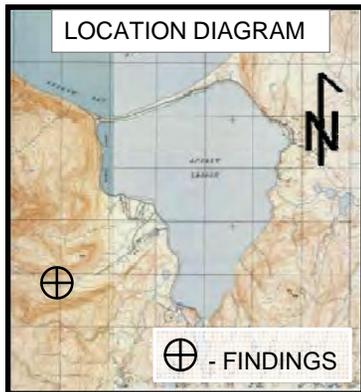
## 3-D IMAGE NO. 3

Elevated bluff above riverbed channel (upper right side of photo), just west of the OB/OD Area.

Depicted are both C-shaped and Zig-zag trenches, a possible L-shaped structure (situated in the center of an excavation), and possible impact craters.

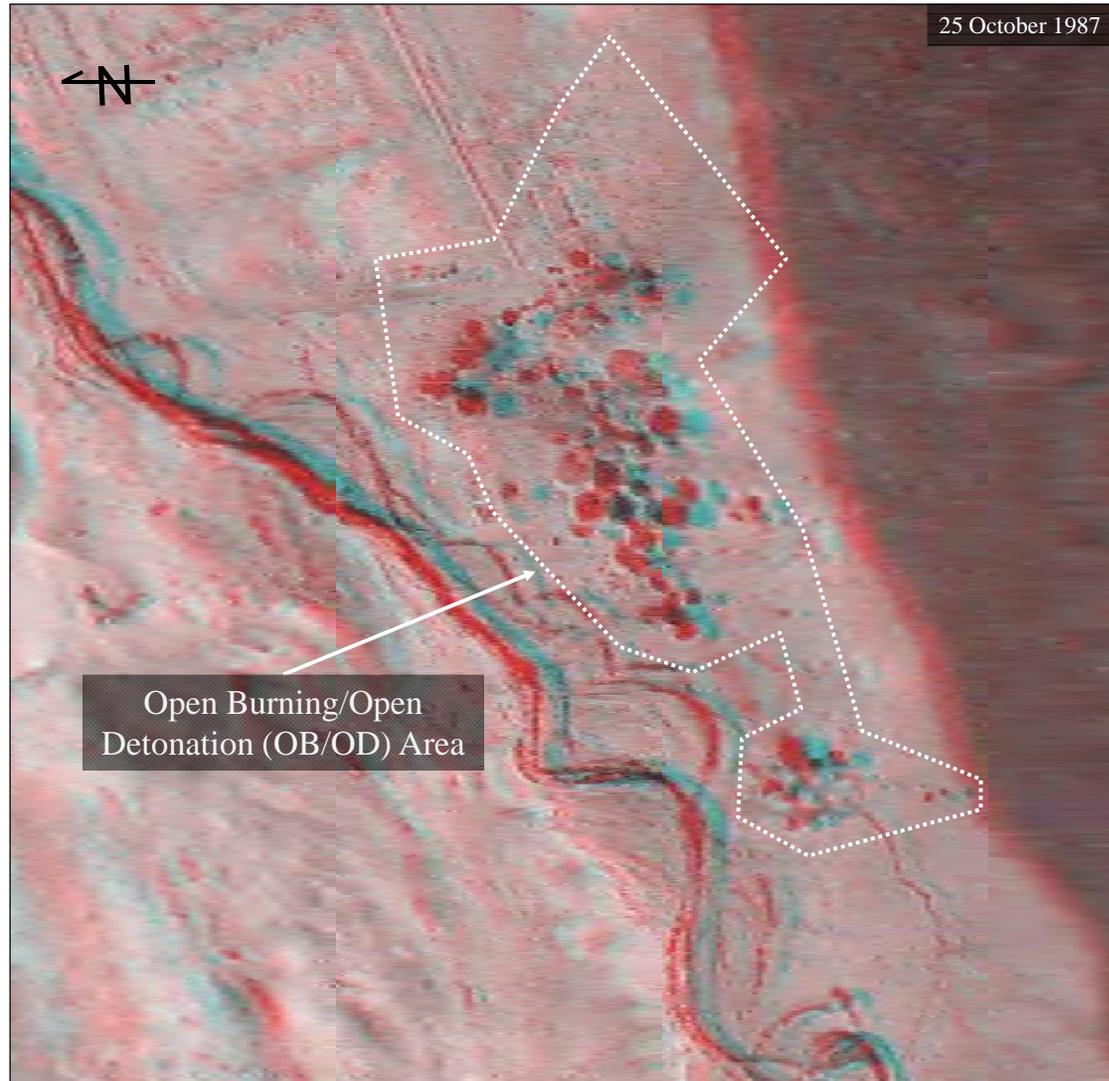
25 October 1987

Andrew Lake Open Burning/Open Detonation (OB/OD) area of Moffett Valley as it appeared in October, 1987.

This area was used to detonate or burn excess, waste, or out-of-service munitions in an open-air environment.<sup>1</sup>

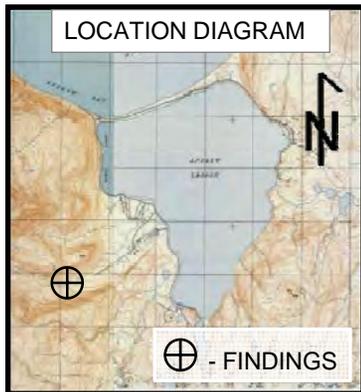
### 3-D IMAGE NO. 5

Andrew Lake Mortar Impact Area (SWMU 1-D) and mortar range in Moffett Valley as it appeared in October, 1987.

Impact craters are apparent on the 25 October 1987 aerial photography.

The occurrence of small dark patches appearing on the surface may indicate impact craters that have been seeded by natural plant communities.

Firing points of the mortar range were first observed on aerial photography dated 29 July 1974.

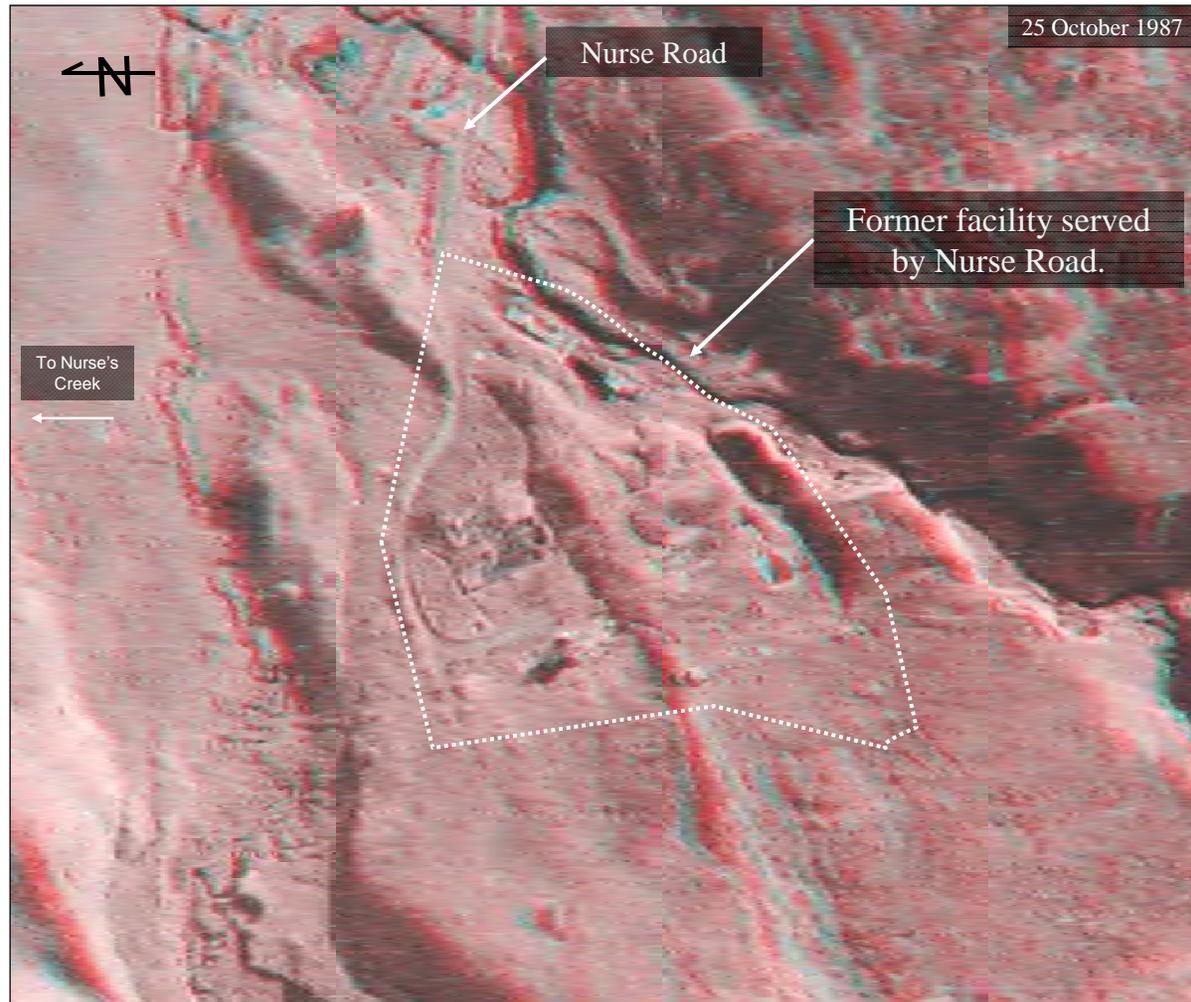
### 3-D IMAGE NO. 6

An unnamed former installation located just south of Nurse's Creek at the terminus of Nurse Road.
