After Action Report, 2013 Field Season

Non-Time Critical Removal Action (NTCRA)
Operable Unit B-2 (OU B-2)
Various Remedial Action Areas

Former Naval Air Facility

Adak, Alaska

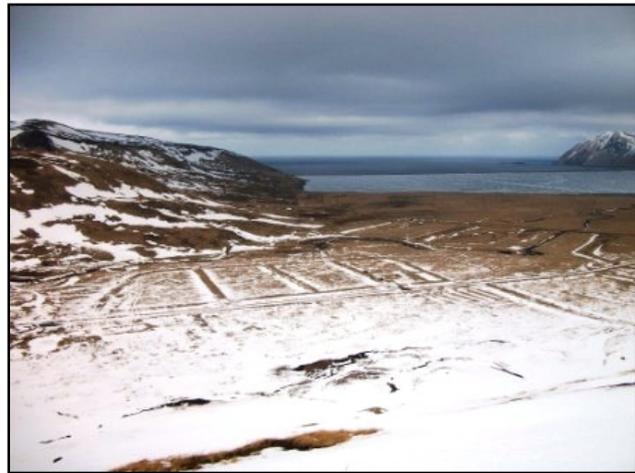
Figure 1-2: 2012-2013 Snowfall in RAA-03

Snowfall averages over 100-inches a year at sea level, but because of the relatively warm temperatures, snow depth rarely exceeds 1 to 2-ft (see Figure 1-2). The snow level (the elevation at which precipitation falls as snow instead of rain) varies with the temperature. Typically, snow occurs on Adak Island between November and April, but it melts fairly quickly at elevations less than 1,000-ft above mean lower low water (MLLW). At elevations greater than 1,000-ft above MLLW, snow that falls between November and April will generally remain as snowpack throughout the winter. Between May and October, snow rarely falls at sea level. From June through September, snow melts in the higher elevations, augmenting streamflow, and most precipitation falls as rain over the entire island. Permanent snowpack is not typical in the OU B-2 sites because most of the sites are at lower elevations.

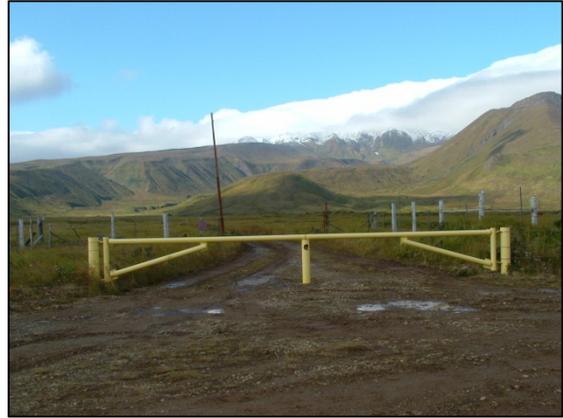
Figure 2-2: Gate Access to RAA-03

Access is indirect via the gravel range entry road, which branches from the main access road along the west side of Andrew Lake. This main road is gated (locked steel gate, see Figure 2-2) near the south end of the lake to deter general access. A locked cable barrier also deters access to the range entry road. It is relatively flat, but hummocky in some locations and marshy in others. Previous disposal events have resulted in several craters. It is generally covered in knee-high, grassy tundra; however, relatively barren areas surround some of the disposal craters. Moffett Creek runs from west to northeast through the northwestern portion. The center and southern portions of RAA-01 are occupied by wetlands.

RAA-03, which lies in a valley west of Andrew Lake, served as a target/impact area and small arms ranges. OB/OD operations may have also occurred within RAA-03W near the RAA-01 boundary, based on craters in the area and the degree of metallic saturation in the overburden. Soils in the lower elevations of the RAA are saturated within a few inches of the surface. The RAA encompasses about 144 acres including RAA-03E and RAA-03W. It is separated by the RAA-01 (OB/OD) in the middle. Access is via gravel range entry road that terminates at OB/OD, which branches from the main access road along the western side of Andrew Lake. This main road is gated (locked steel gate) near the south end of the lake to deter general access. A locked barrier also deters access to the range entry road (see Figure 2-2 and Figure 2-4).

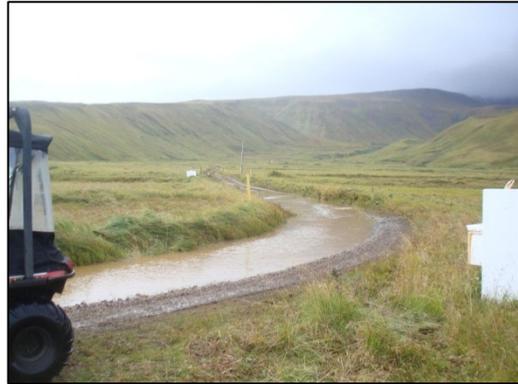
Figure 2-4: RAA-03 Entry Road

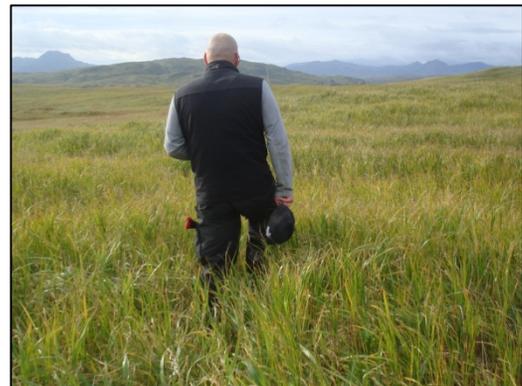
Figure 2-5: RAA-04 Tundra Grass

The existing access road runs north to south along a large canyon that prevents access to the site from the eastern end. The only access is one-half mile up the road to the west, through the locked gate to RAA-04. RAA-04 is predominantly covered with spongy tundra to the east and dense knee-high grass to the west (see Figure 2-5). The site, which is generally dry on the western end and wet/marshy to the east, is bounded by the steep cliffs that drop into Andrew Lake to the south and by a 150-ft deep canyon to the north. A couple of shallower canyons run up the center of RAA-04, gradually becoming a small, passable creek/stream toward the western end of the site where the terrain is relatively flat. A small, "L" shaped partial grid is located near the access road on the eastern side.

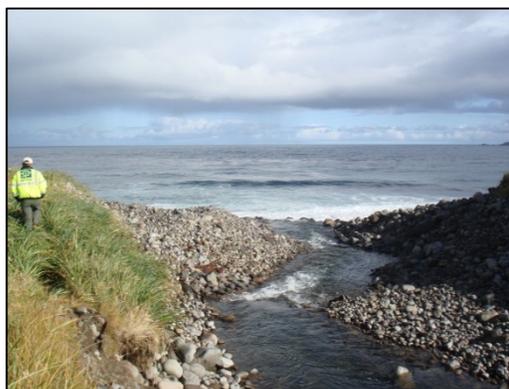
Figure 2-7: ALSW Seawall Spillway

There is a man-made main drainage (spillway) (see Figure 2-7) from Andrew Lake to the bay located near the southern end of the seawall at the end of the main access road. The main drainage is improved by Navy Explosive Ordnance Disposal (EOD) one to two times per year. The portion of ALSW-01 where MEC is deposited along the shoreline and seawall is approximately 21 acres.

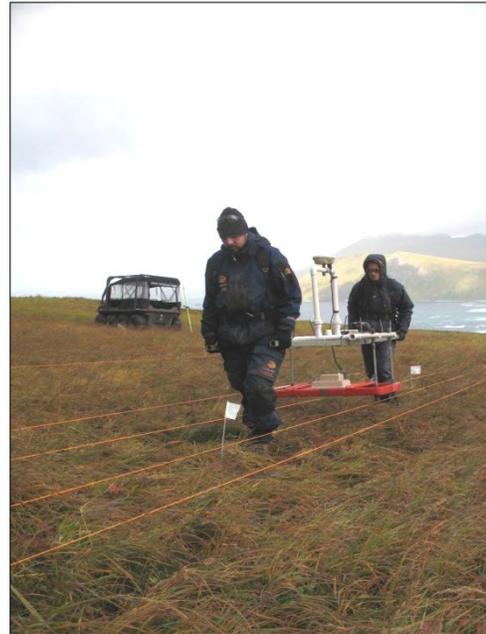
Figure 3-1: Establishing the IVS

- The IVS/GSV Team consisted of the Site Geophysicist, a UXO Technician II (UXOTII) and a geophysical instrument operator (refer to Figure 3-1).
- The BSI Team consisted of a UXO Quality Control Specialist (UXOQCS), a UXOTII, and a QC Geoscientist.
- The Site Assessment Team consisted of the Project Managers (PMs) from USA and AGVIQ (construction subcontractor) and the Site Manager (SM) acting as a UXO Safety Officer (UXOSO) for all three field tasks.

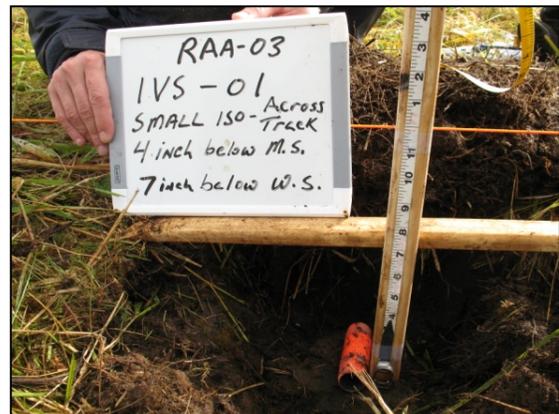
Figure 3-2: Installing ISO in IVS

- The installation and testing of an IVS in the vicinity of three RAAs (RAA-02, RAA-03, and RAA-04) to verify that the DGM instrumentation (sensors and positioning), instrument operators, data acquisition methodologies, and data processing and analysis procedures meet the specific DQOs established for the project. Each test strip consisted of a center line with five small industry standard objects (ISOs) and an offset

background noise line. Secondary lines were installed at 2.5-ft and 1.25-ft offsets to simulate data collection and to verify half line response amplitude for blind seed verification (see Appendix G).

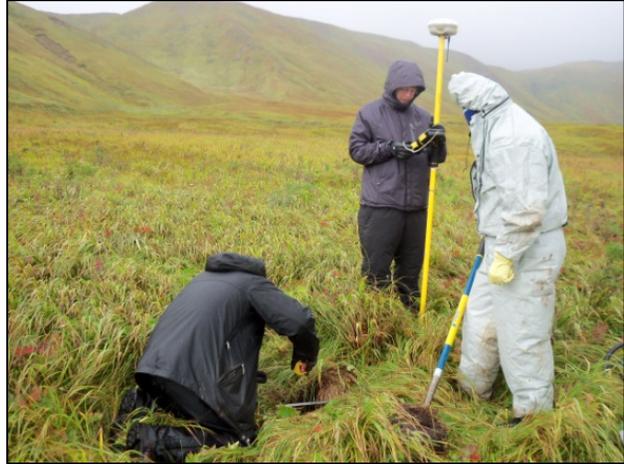
Figure 3-3: BSI Installation

- The installation of BSIs in the survey areas of each RAA as a QC measure for geophysical data collection, target selection, and anomaly resolution (see Appendix G, GSV Report for procedures). The BSI effort was carried out by the two-man BSI team consisting of a UXOTII and a QC Geoscientist. The UXOQCS accompanied the BSI team. The effort took place from Friday, 21 September through Thursday, 27 September 2012, over three RAAs: (RAA-02, RAA-03, and RAA-04). On Friday, 21 September, the BSI team, in conjunction with the IVS team (led by the geophysicist), established survey control points and back-check points at RAA-03 and RAA-04. BSI installation in RAA-03 was completed over the course of five production days (21-25 September 2012), using the RAA-03 survey control point. BSI installation in RAA-04 was completed over the course of two production days (25 and 26 September 2012). BSI installation in RAA-02 was completed in one production day (27 September 2012). The RAA-04 and RAA-02 BSI effort used the Adak Recreation Area (ARA) survey control point. The locations of all BSIs were recorded and provided to the USA QC Department and the Navy QA contractor. The listing and locations are not available to USA production personnel.

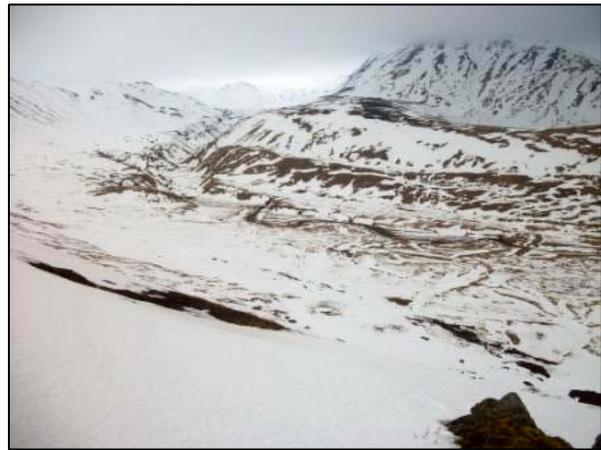
Figure 4-1: Snow in RAA-03

USA shipped equipment and vehicles by air freight and barge beginning in February 2013 in anticipation of an early start. However, a late season snowfall (as depicted in Figure 4-1) resulted in mobilization delays. Rather than mobilize a full crew, USA mobilized the SM from 2 to 16 March 2013 to inventory and store explosives in the magazine; receive and inspect vehicles and equipment; and arrange for secure storage of USA gear.

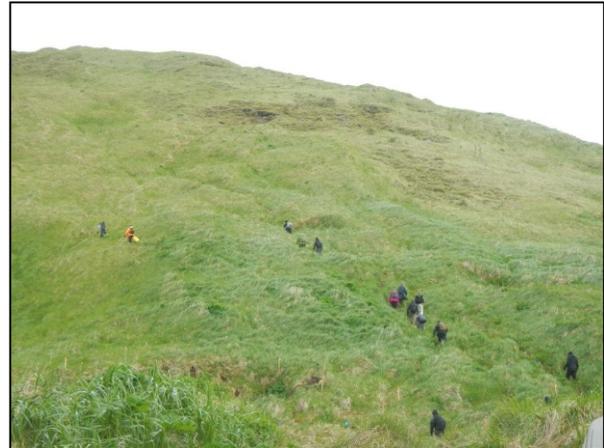
Figure 5-3: Foot Trail to RAA-02

Initially RAA-02 access involved traversing access paths across RAA-03 to then cross Moffett Creek and proceed to RAA-02. Eventually, it was determined the best route to the RAA was on foot from RAA-05. Although this route was strenuous and steep (see Figure 5-3), it was the one teams used to perform operations. RAA-02 primary construction activities involved access path layout along the slope that would best facilitate Argo access and avoid slopes greater than 30°. The access paths were first cleared for MEC in accordance with SOPs. Prior to laying in the access path, UXO teams performed a detector-aided surface clearance to remove any potential surface MEC, MPPEH, or other metallic debris. The path was cleared for the construction crew to follow. No access paths were constructed without being first MEC screened and cleared.

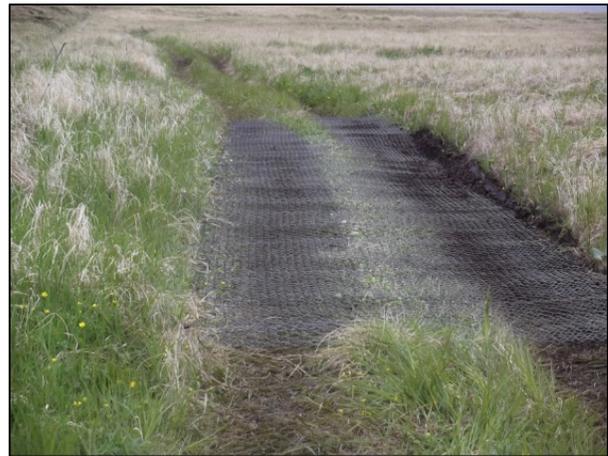
Figure 5-4: Argo Path Chain Link Fencing

Access paths crossed tundra, mineral surface, grasses, and marshy areas. Where access paths for Argos were most difficult was across seasonal marshy areas, which required chain link fencing to be put down to help prevent surface disturbance, assist in traction, and possibly prevent rutting in paths (Figure 5-4).

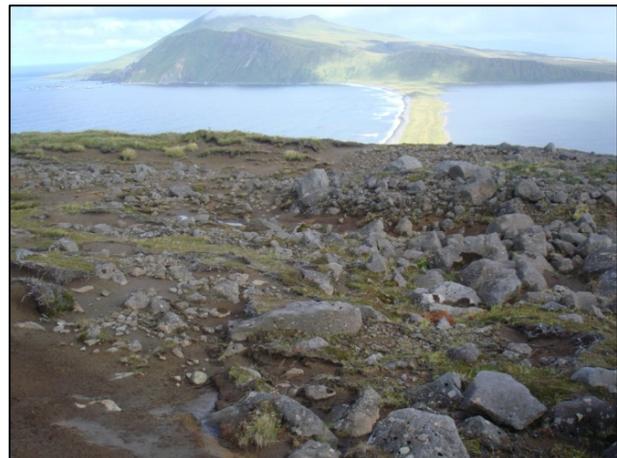
Figure 5-5: RAA-02 Terrain

Because the terrain in RAA-02 is rocky with bare soil areas and short tundra grass (see Figure 5-5), vegetation clearance was not performed.

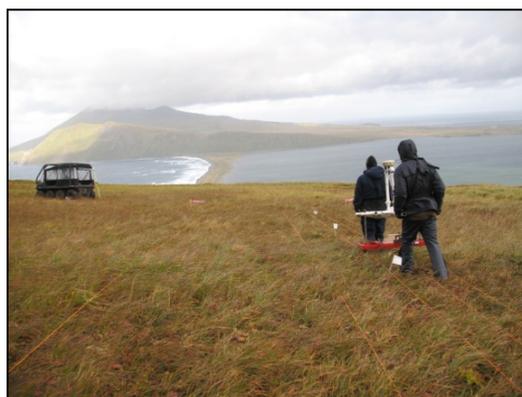
Figure 5-6: RAA-02 IVS Checkout

Each morning and afternoon, the DGM teams demonstrated acceptable system performance at the established RAA-02 IVS (see Figure 5-6). The Site Geophysicist reviewed the IVS results for each team prior to their mobilization to their production grids. His review of the results was in accordance with the Final GSV Report and two relevant FCRs: FCR-10, dated 2 May 2013, which officially revised the daily instrument checks and the IVS performance metrics; and FCR-16, Rev. 2, dated 24 March 2013, which revised the DGM field team's documentation of grid obstacles.

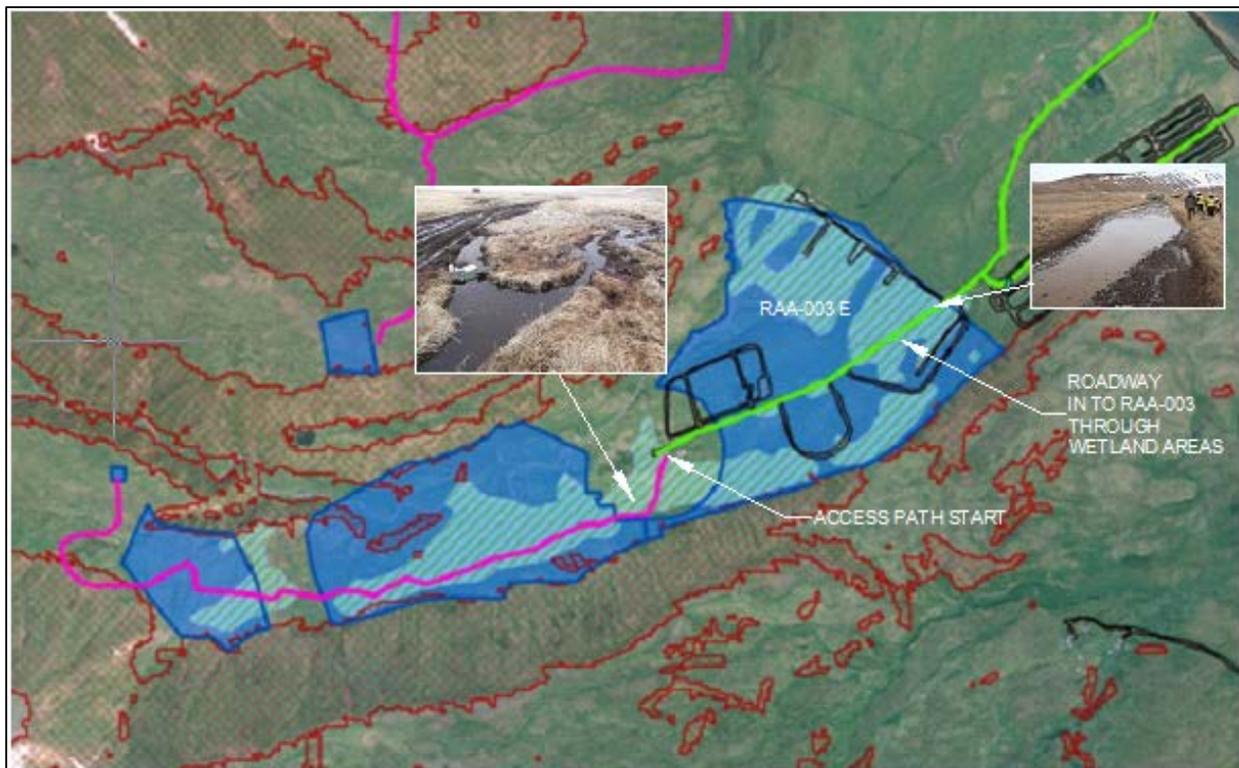
Figure 5-7: RAA-03 Roadway

USA's subcontractor (AGVIQ) initially started construction and road servicing activities at RAA-03 on 9 April 2013. The road off the western boundary road around Andrew Lake into RAA-03E and RAA-03W contained a number of low spots where run off from rain collected immediately adjacent to the seasonal marsh area on both sides of the access road. Initial efforts at a few low spot ditches were hand dug, allowing for the water to escape (Figure 5-7).

RAA-03 activities for the construction crew involved draining low spots on the road leading into and adjacent to RAA-03. Gravel from excess shoulder areas along the road was collected and used to fill the depressions initially. Additional material was later placed along the main entrance into the RAA-03 area off the road along Andrew Lake to eliminate the low spots. On-going maintenance throughout FS1 was conducted on roads and access paths as the work and duration of NTCRA activities continued.

Access path construction into RAA-03 was completed from the existing road traversing west – southwesterly into the RAA. The access path followed the approximate location as indicated on Figure 5-7; however, final placement was dictated by field conditions at the time of construction. The location of the path was dictated by minimizing impact to existing surface conditions and vegetation, as well as considerations for topography and appropriate drainage.

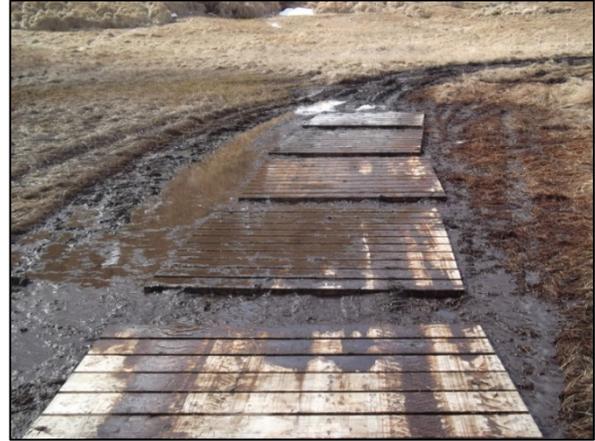
Figure 5-8: Swamp Mats in High Impact Areas

The access paths were first cleared for MEC. Preceding the laying in of the access path, UXO teams performed a detector aided surface clearance to remove any potential surface MEC, MPPEH, or other metallic debris. The path was cleared for the construction crew to follow. No access paths were constructed without being first MEC screened and cleared. The initial access path construction required the use of some narrow swamp mats to facilitate crossing very wet areas and to minimize the impact of the pathway (Figure 5-8).

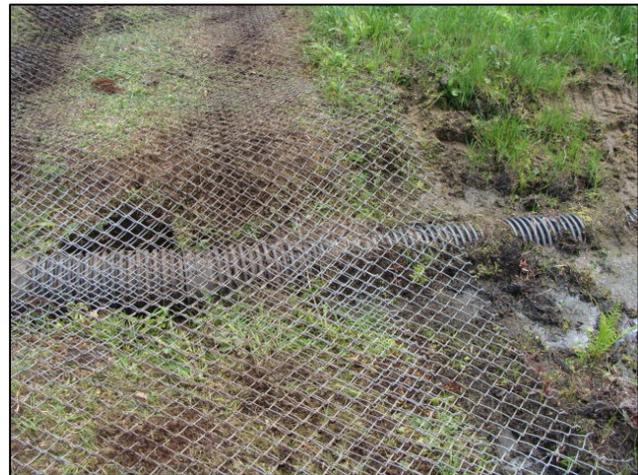
Figure 5-9: Fencing with Drainage Culverts

Additional pathway improvements included placing biaxial grid down to minimize rutting and assist with stabilization of the underlying material. Chain link fencing was used frequently along access paths to assist in providing stabilization and prevention of rutting. In certain areas where water traversed across paths temporary culverts were placed underneath the chain link fence to assist the conveyance of water so as not to collect in or on the access path (see Figure 5-9).

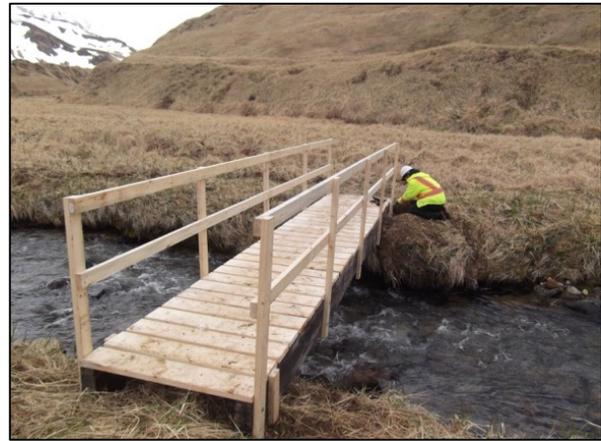
Figure 5-10: Temporary Bridge

The construction crew also built a temporary foot bridge (see Figure 5-10) across Moffett Creek at a lower elevation than the Argo path to provide access to the northern RAA-03 grids.

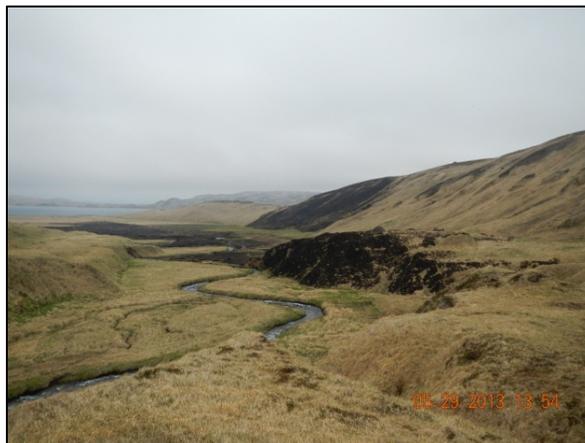
Figure 5-12: Burned Area in RAA-03

On 16 May 2013, another fire started from a demolition shot at grid E18. Again, site personnel evacuated and monitored the fire until no fire or smoke was visible.

One consequence of the fires was that they burned off most all of the tundra mat and uncovered more metallic items not removed during the instrument-assisted surface clearance. Figure 5-12 shows the burned area in RAA-03.

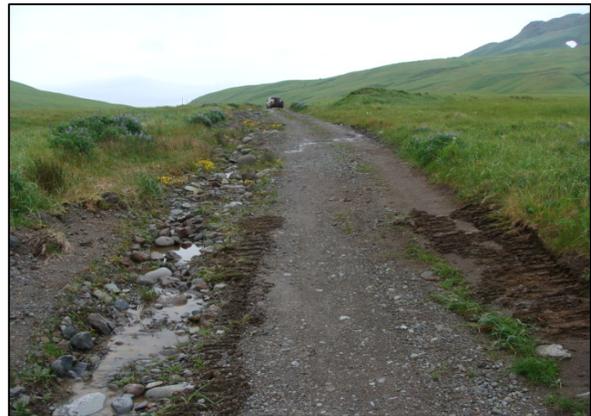
Figure 5-13: Access Road Prior to Repair

Similarly to the construction work performed at RAA-02 and RAA-03, the access road leading up to the gate into RAA-04 needed repair and maintenance. The road at RAA-04 had several hundred yards of wash out that required repair and re-grading. An excavator was used to re-establish grades, remove small boulders and cobbles from the wash-out areas, and reconstruct the road grade. The road was scraped and re-graded using an excavator and skidsteer (see Figure 5-14).

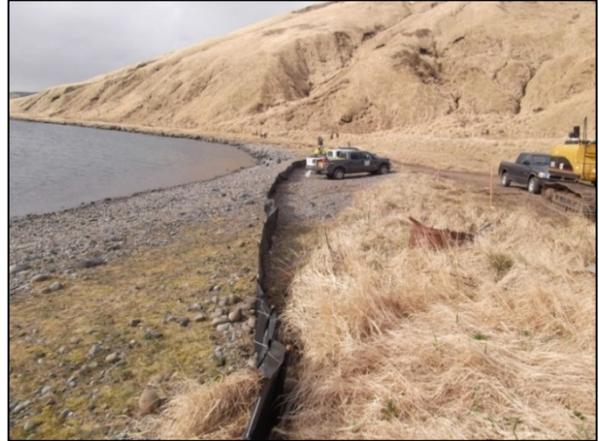
Figure 5-16: Silt Fence

The access road into RAA-05 along Andrew Lake required maintenance and some pothole filling and minor grading. Holes and low spots were filled with gravel that was available from along the shoulder of the main road leading in. Along a portion of the road, silt fence (see Figure 5-16) was placed to prevent any direct siltation run-off coming off the road and work areas at the entrance to RAA-05.

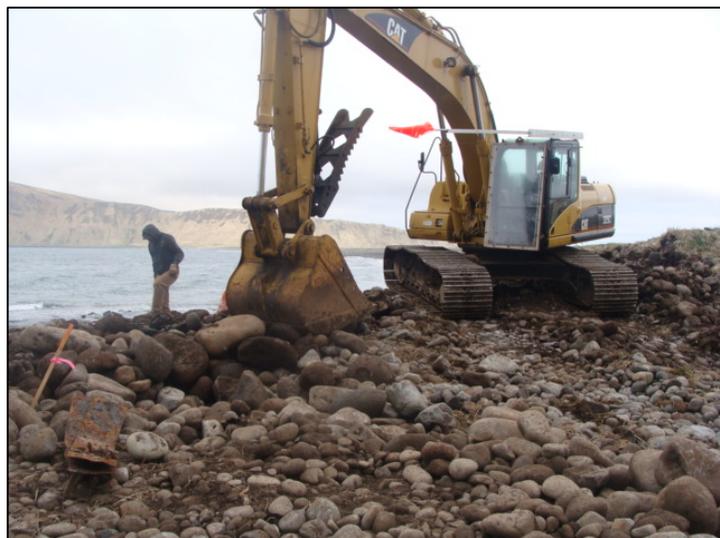
Figure 5-17: Armored Excavator in Cobble Area

Excavation activities with an armored tracked excavator (see Figure 5-17) were conducted within the northern portion of ALDA-01. On 21 May 2013, excavation of timbers was performed at the entrance area into RAA-05. This removal allowed for better access and egress. On 22 May 2013, digging operations began. The excavator removed soil, rock, and debris to varying depths in the grid area being excavated. The material would be removed and laid out for the UXO technicians to then screen for metal and remove metal debris. The depth of each grid excavated varied due to the presence of metal being observed and/or detected. On 23 May 2013, an 81mm High Capacity (HC) mortar was encountered. As the Minimum Separation Distance (MSD) for the item was larger than the 81mm HE

Mortar MGFD, excavations ceased for coordination with NOSSA. On 24 May 2013, after concurrence by NOSSA, excavation continued. When demolition of MEC/MDEH was required, the construction equipment was moved away 600-ft from the site.

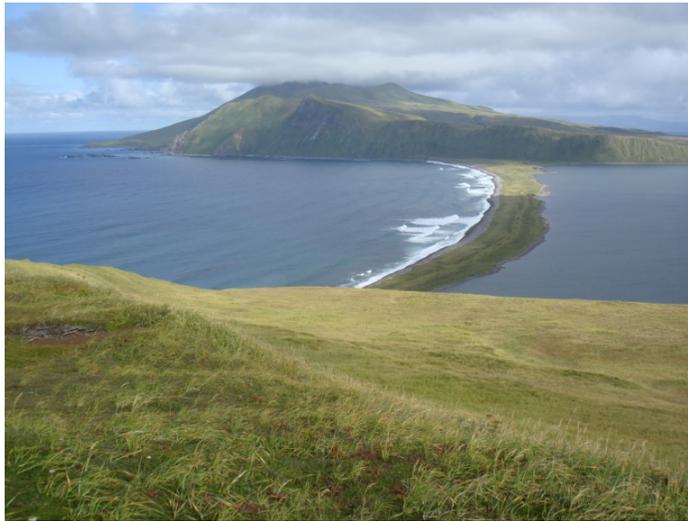
Figure 5-18: ALSW-01 looking down from RAA-02

The SOW required monthly Seawall MEC/MPPEH surface sweeps (see Figure 5-2 for the location of the ALSW-01) during field operations (also see Figure 5-18). Starting on 19 April 2013 through 18 September 2013, USA performed six Seawall sweeps and recovered 33 MEC/MDEH items. The MEC/MDEH items were disposed of by demolition. Appendix A contains a map of the RAA showing recovery locations and Appendix I contains a description of the recovered items, including nomenclature, GPS coordinates, depth and photographs.
