**FINAL**  
JANUARY 2013

Quality Assurance Surveillance Report for  
Contractor Geophysical System  
Verification Installation and Quality  
Assurance Blind Seed Installation  
In Support of the Non-Time Critical Removal  
Action for Operable Unit B-2

**Former Adak Naval Complex**

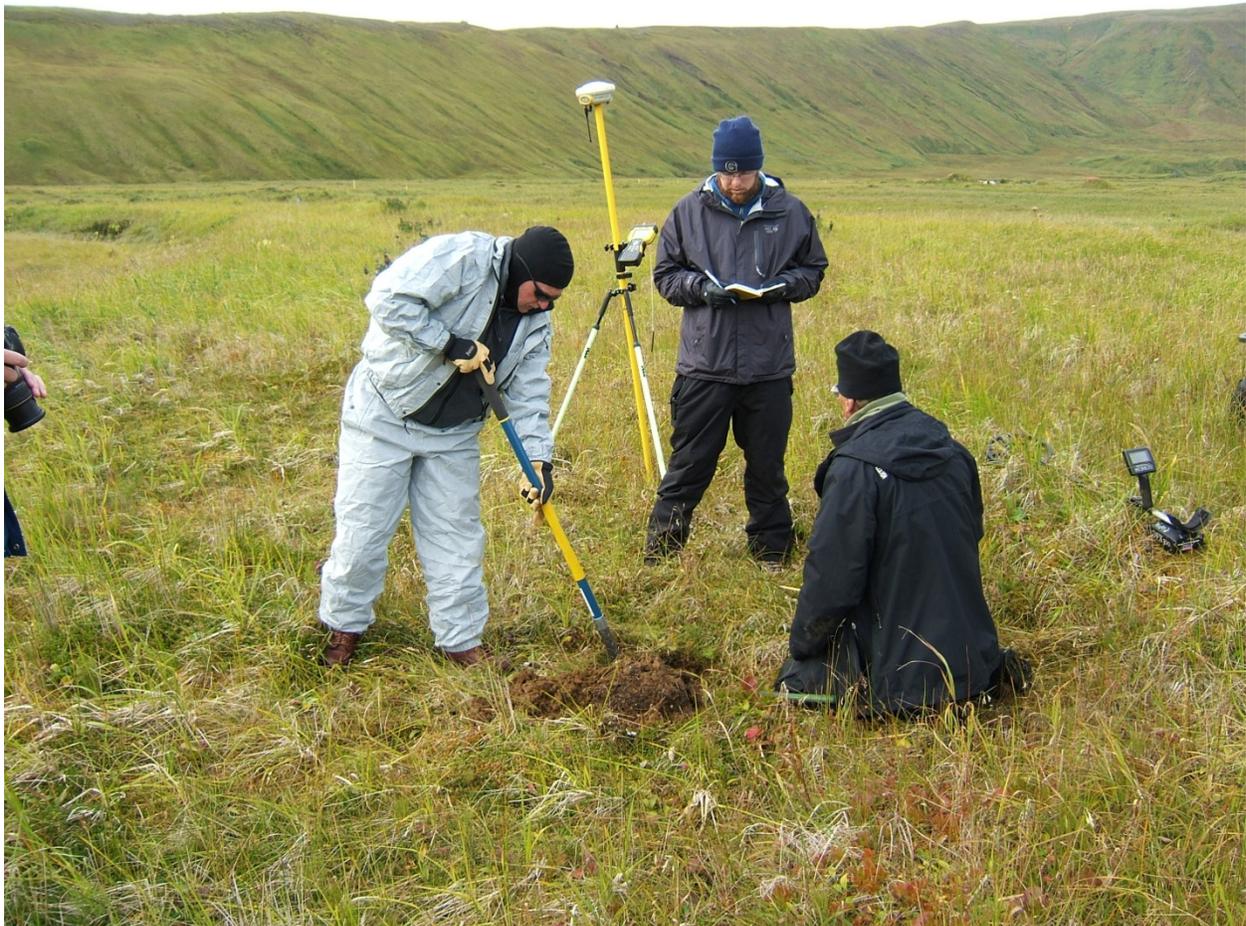
**Figure 2-1. USA BSI Team in RAA-03**

Figure 2-1 shows an example of the USA BSI team in RAA-03, and Figure 2-2 shows an example of the USA DGM team running the IVS in RAA-02.

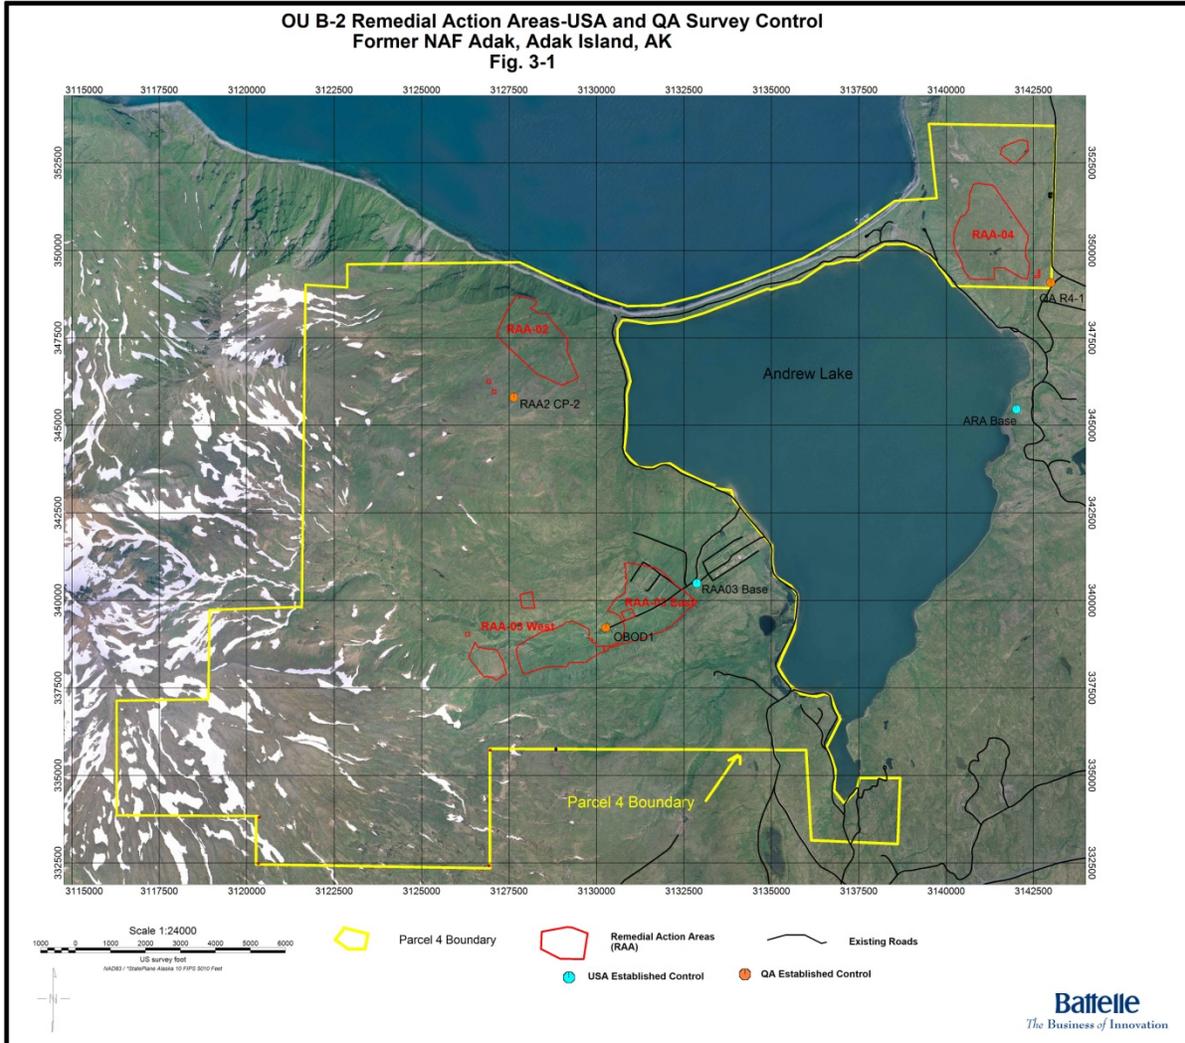
**Figure 3-1. OU B-2 Remedial Action Areas-USA and QA Survey Control Former NAF Adak, Adak Island, AK**

Figure 3-1 shows the locations of the USA and QA survey control points established during this field effort.

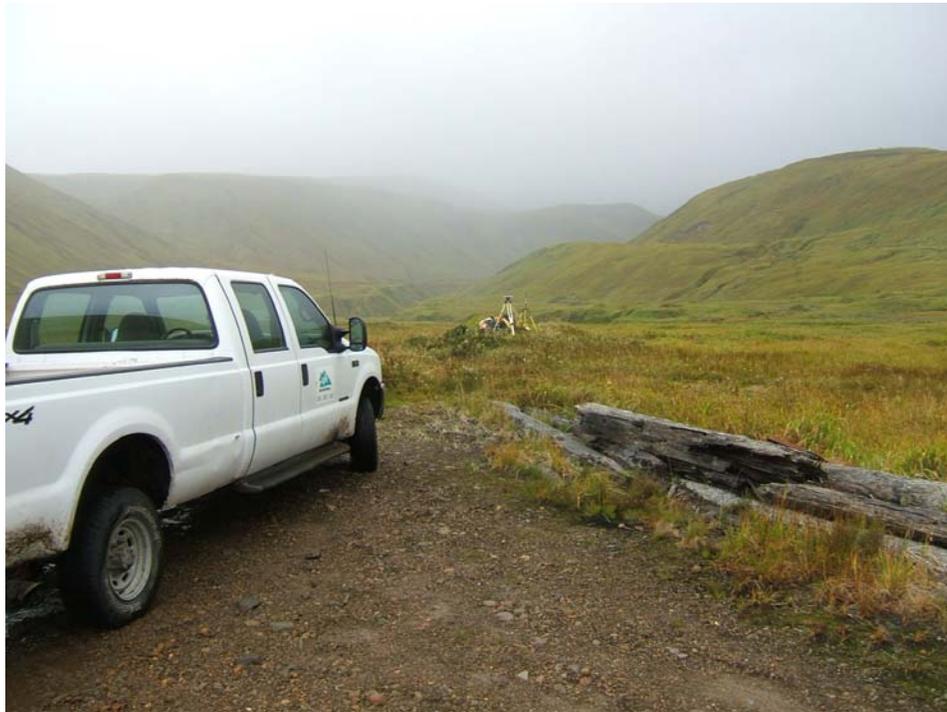
**Figure 3-2. Photograph of QA Survey Control Point (OBOD1) at RAA-03  
(Point is about 50 ft west of end of road into OB-OD)**

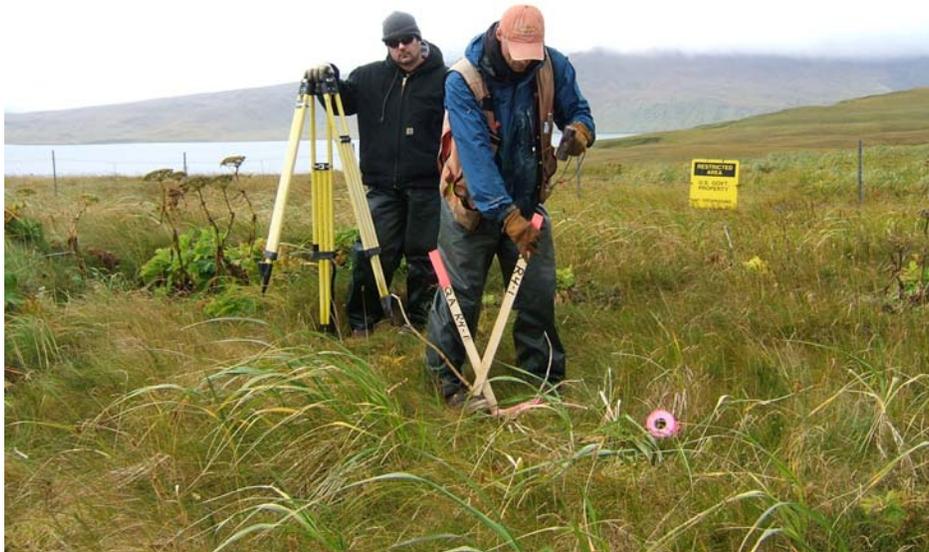
**Figure 3-3. Photograph of QA Survey Control Point (QA R4-1) at RAA-04  
(Point is about 20 ft. off of road junction accessing RAA-04)**

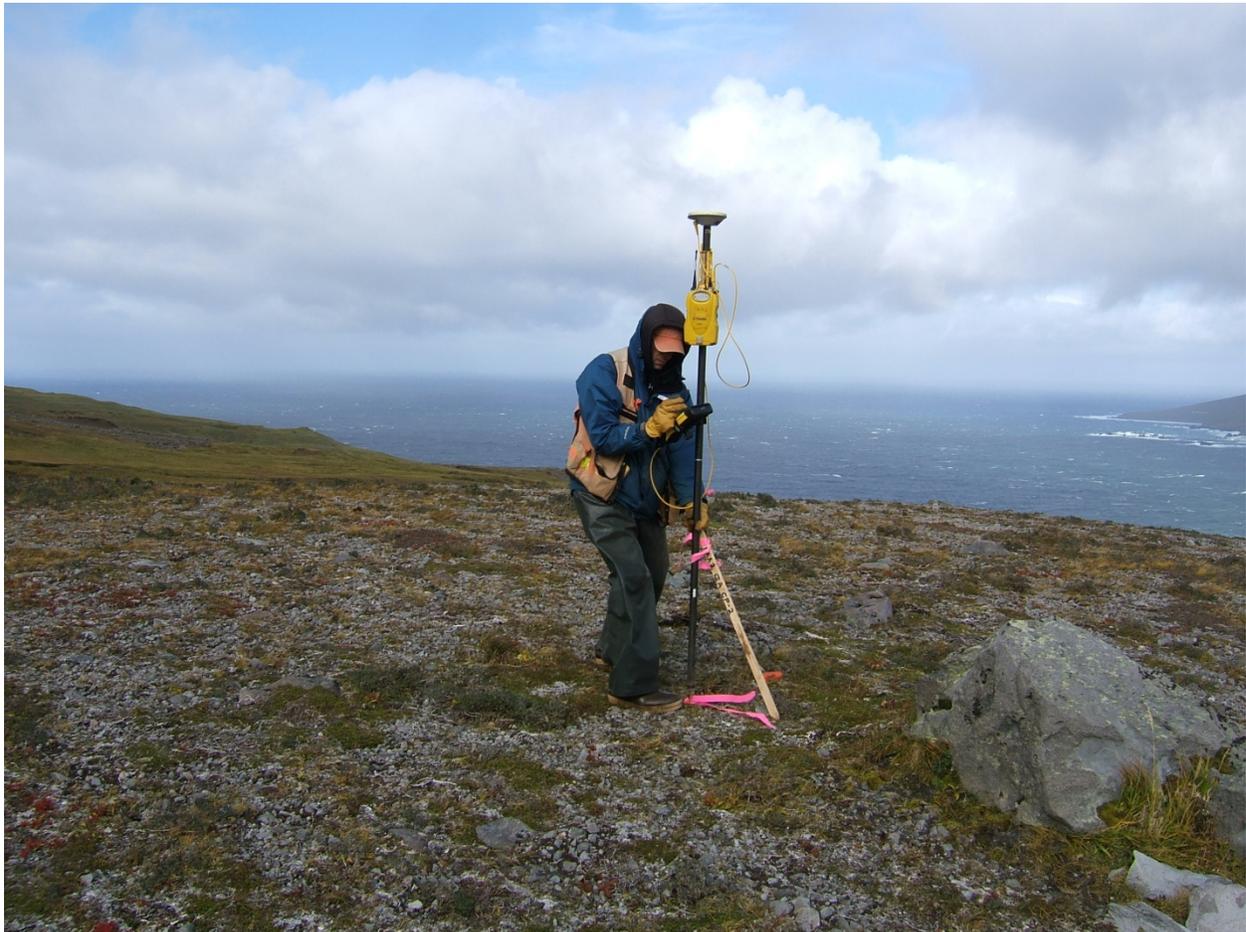
**Figure 3-4. Photograph of QA Survey Control Point (RAA2 CP-2) at RAA-02  
(Point is about 250 ft. north of IVS, on hill near big rock)**

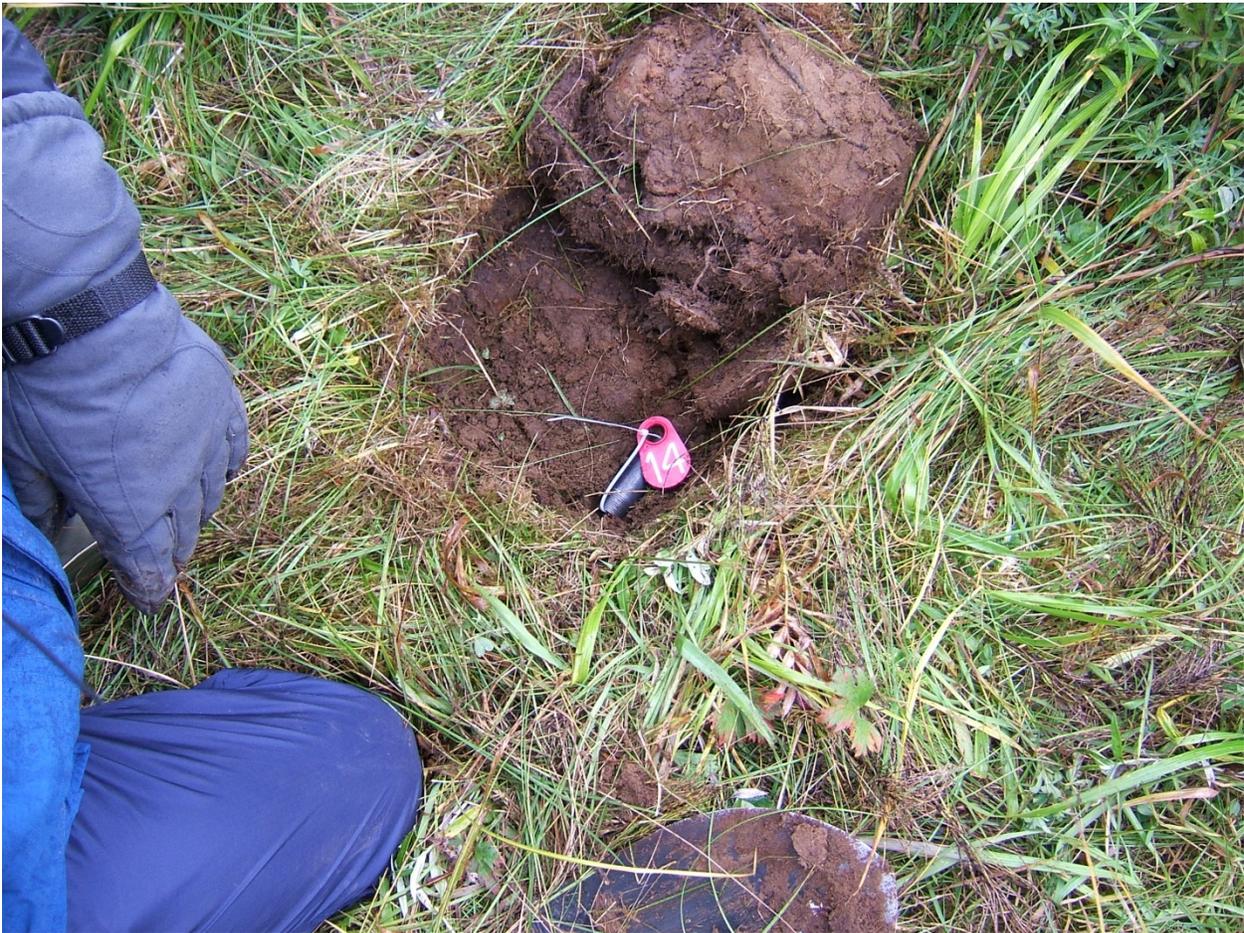
**Figure 4-1. Photograph of Example (#14) QA BSI**

QA installed 10 BSIs in each of the three RAAs associated with this NTCRA (RAAs -01, -02 and -03). QA also installed five BSIs in RAA-001 (OB OD-1) for use in potential future DGM surveys there. These seeds were installed randomly (both location and depth) in each of the RAAs. All seeds were comprised of the small ISO (1 × 4 inch nominal, ASTM Specification A53/A773) as used in the USA IVS and BSI work. Each QA BSI was labeled with a large plastic numbered tag, secured by plastic tie wraps. Figure 4-1 shows an example of a QA BSI in an open excavation.

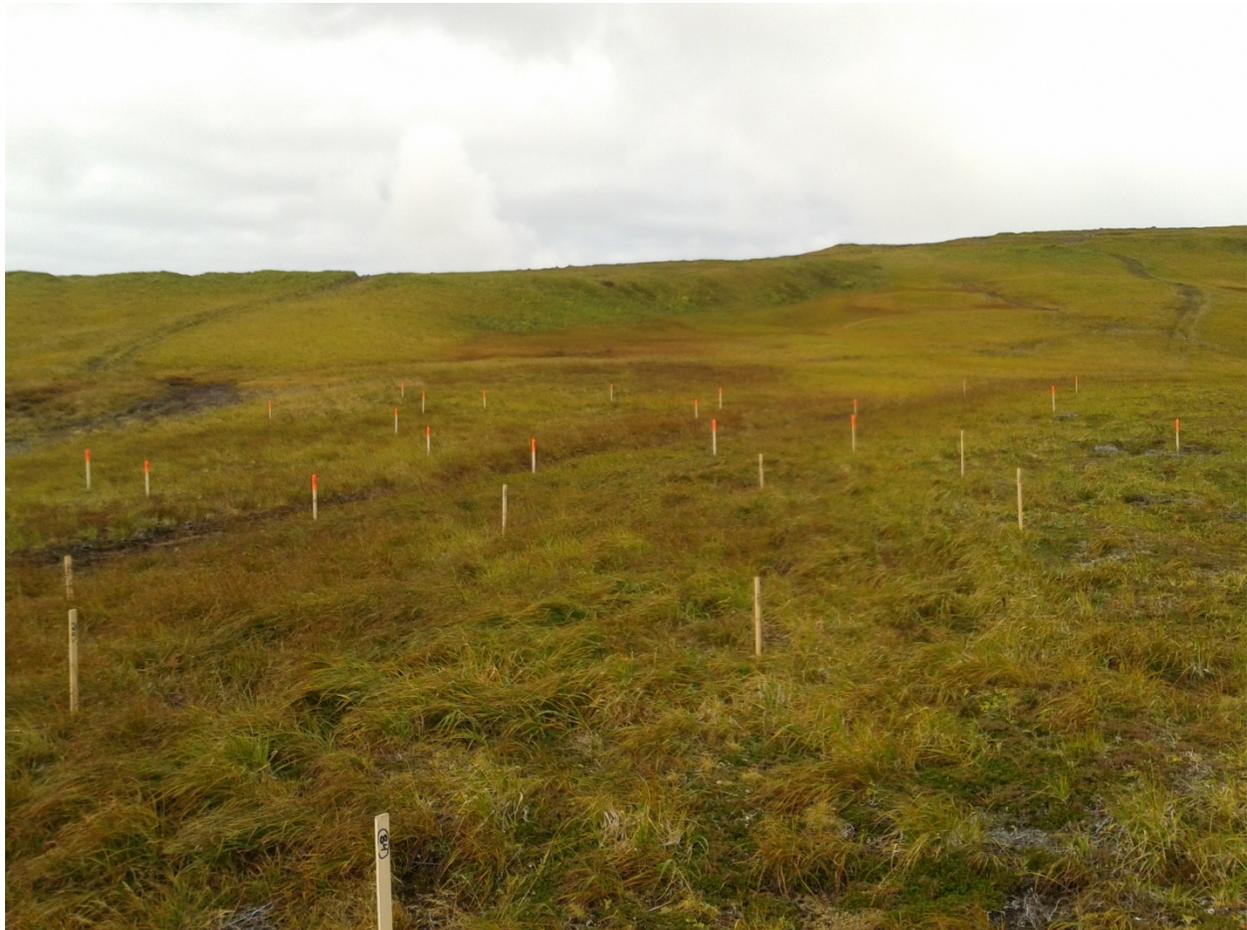
**Figure 5-1. Photograph of OU B-1 East GPO Staked Seed Locations**

During this field effort, QA personnel began removal of BSIs in the OU B-1 GPO grids. A total of 12 seeds were removed from the OU B-1 calibration grid, and all of the remaining seeds (calibration, east and west grids) were surveyed and staked for future removal. Appendix D provides a listing of the status of seeds in these GPO grids. Figure 5-1 shows a photograph of the staking done in the vicinity of the OU B-1 East GPO Grid.
