Third Five-Year Review of Remedial Actions

Hunters Point Naval Shipyard San Francisco, California

May 13, 2013

Prepared by:
TriEco-Tt, a Joint Venture of TriEco LLC and
Tetra Tech EM Inc.
1230 Columbia Street, Suite 1000
San Diego, California 92101

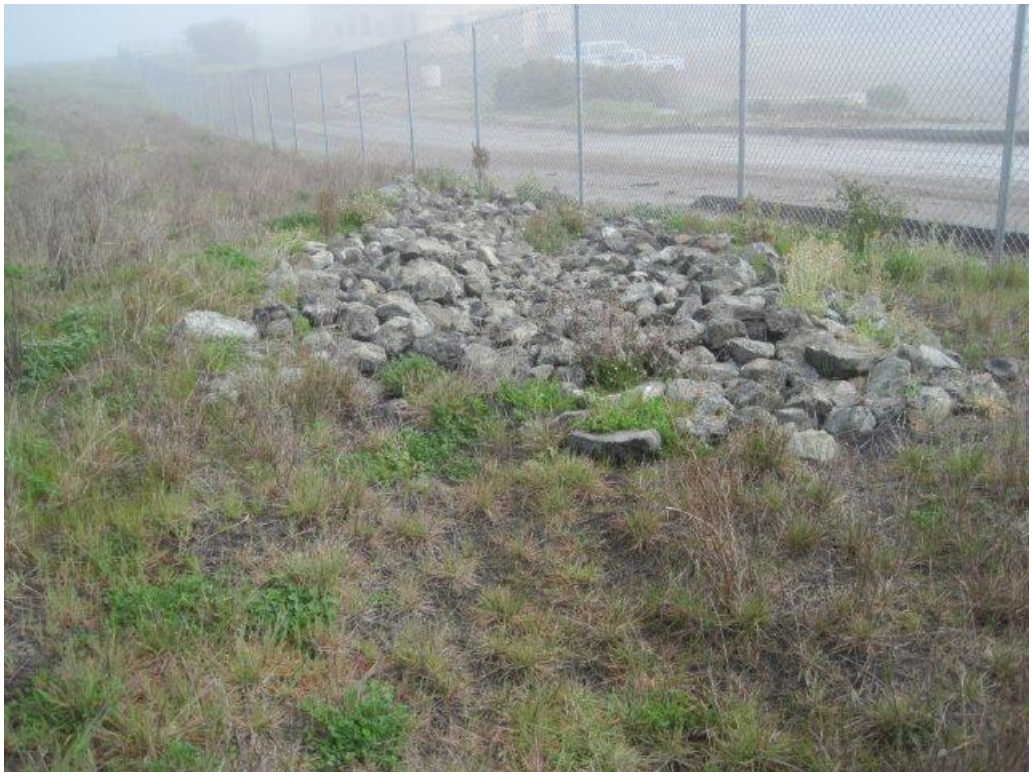
Photograph 24. Outfall protection at the end of the drainage swale. Perimeter fence and Donahue Street in the background.

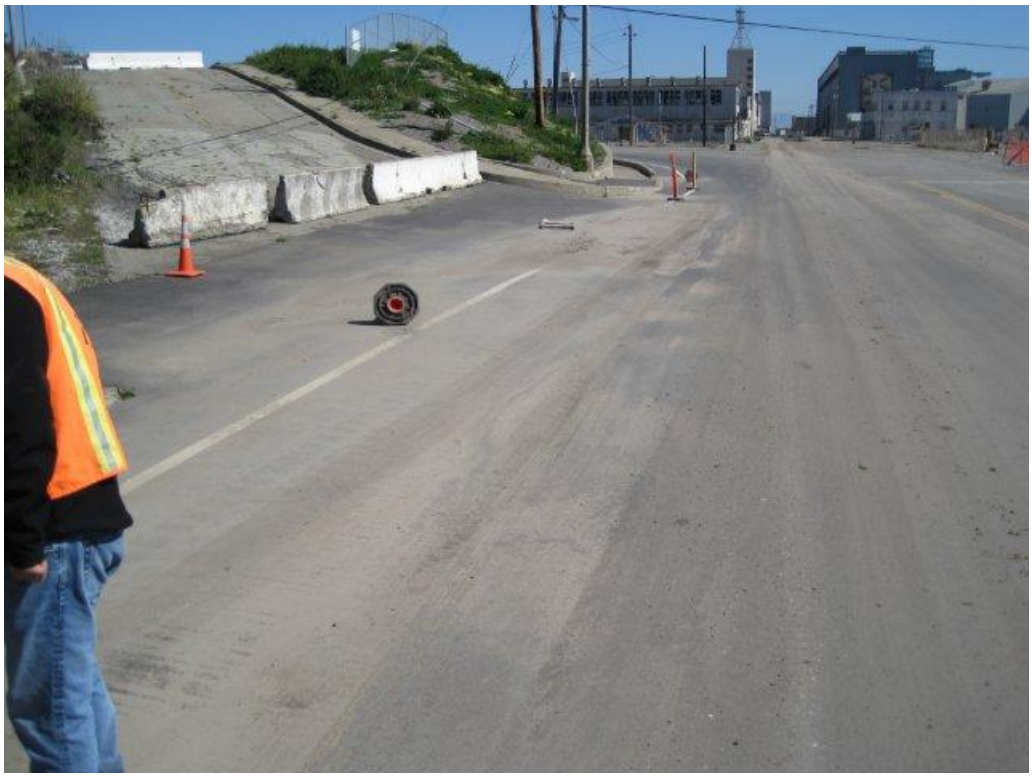
Photograph 43. Roadway at Parcel UC-1 (Spear Avenue) looking northeast. Lighter color on left is silt deposited from previous storm water ponding on the north side of the roadway.

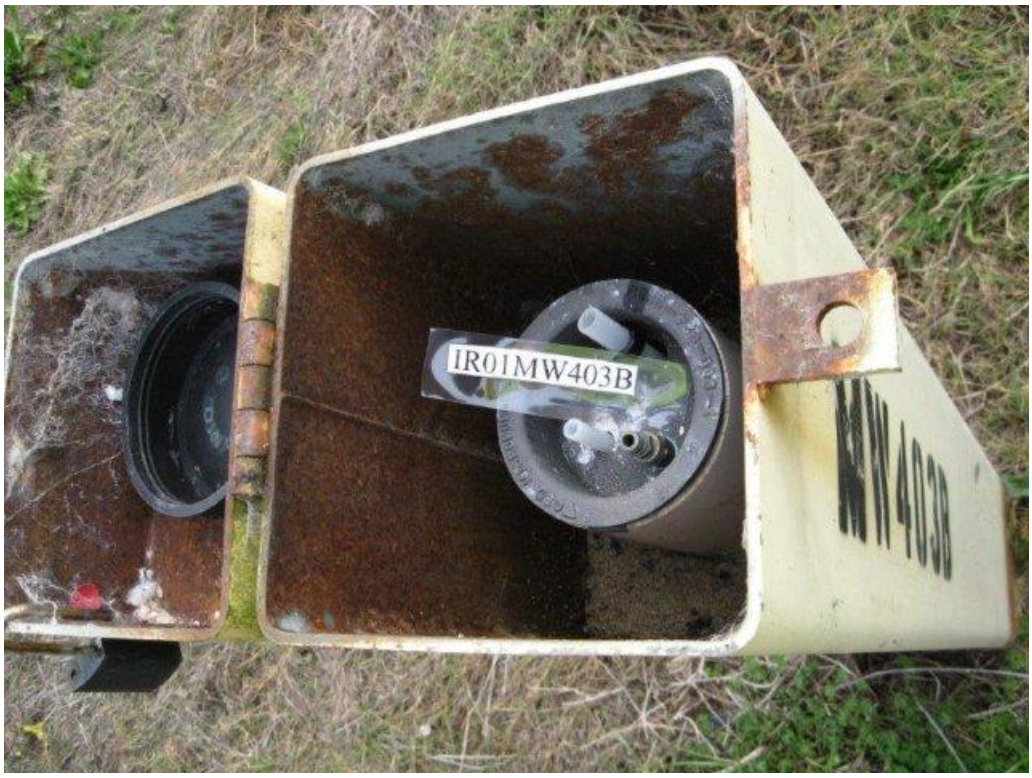
Photograph 48. Well IR01MW403B at Parcel E-2.

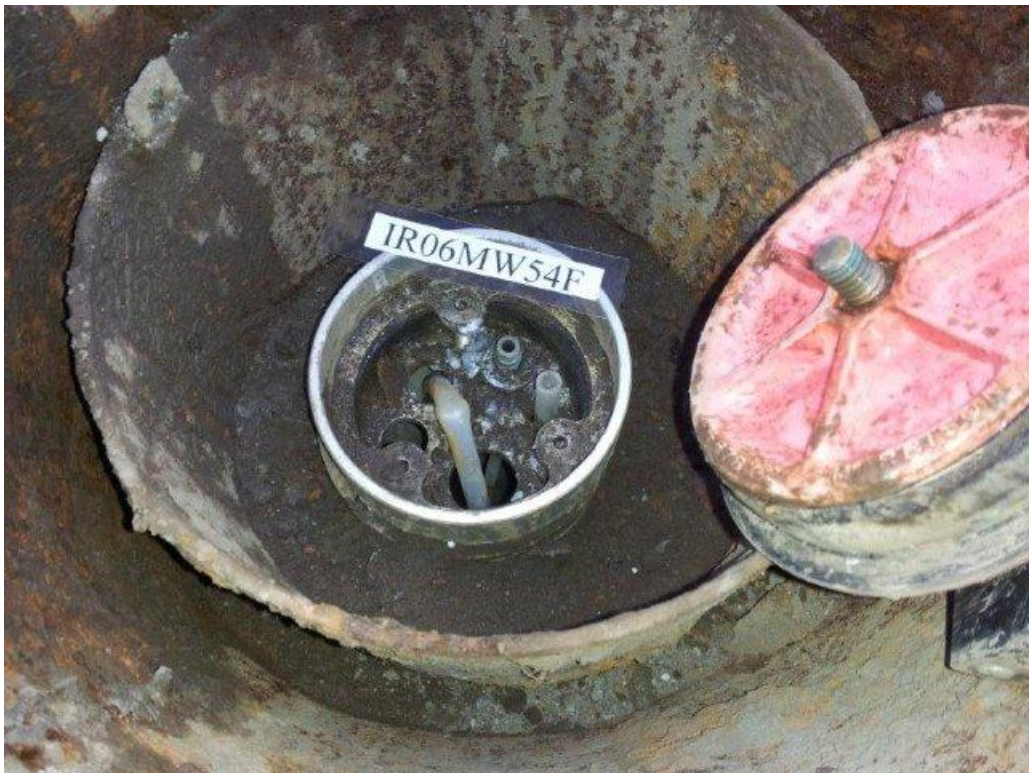
Photograph 49. Well IR06MW54F at Parcel UC-2.

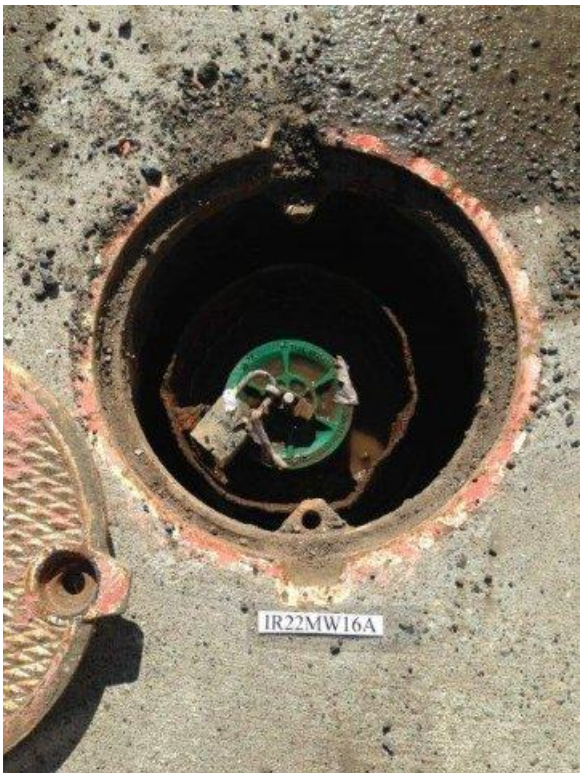
Photograph 59. Well IR22MW16A at Parcel D-1.

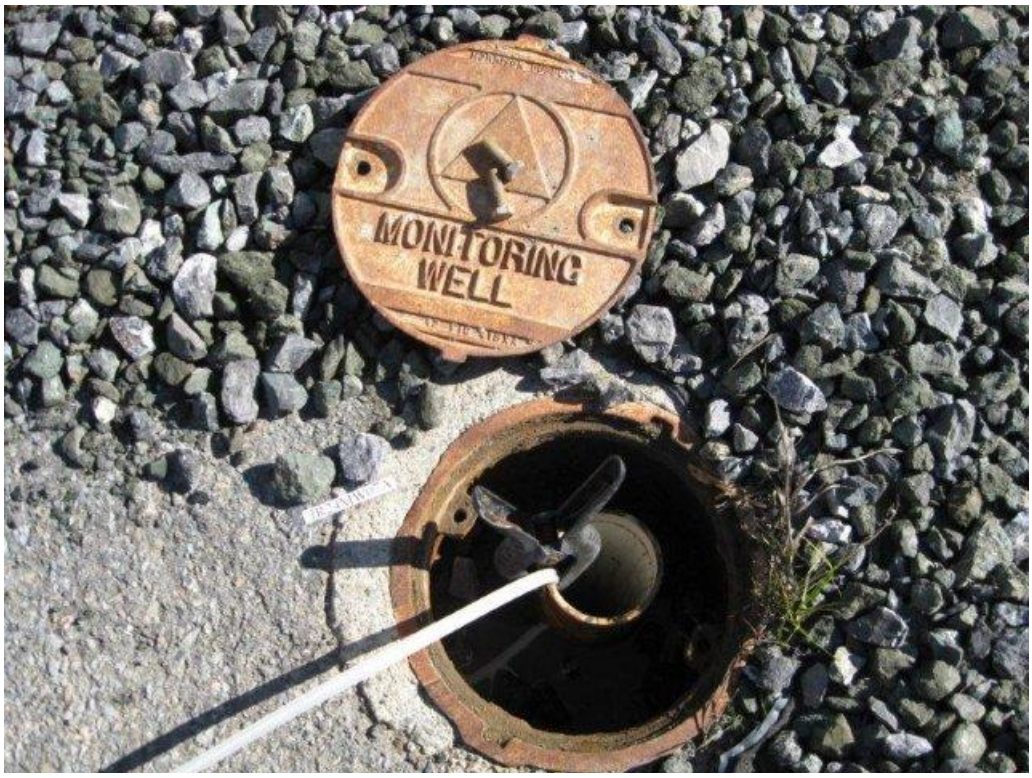
Photograph 60. Well IR24MW07A at Parcel B.

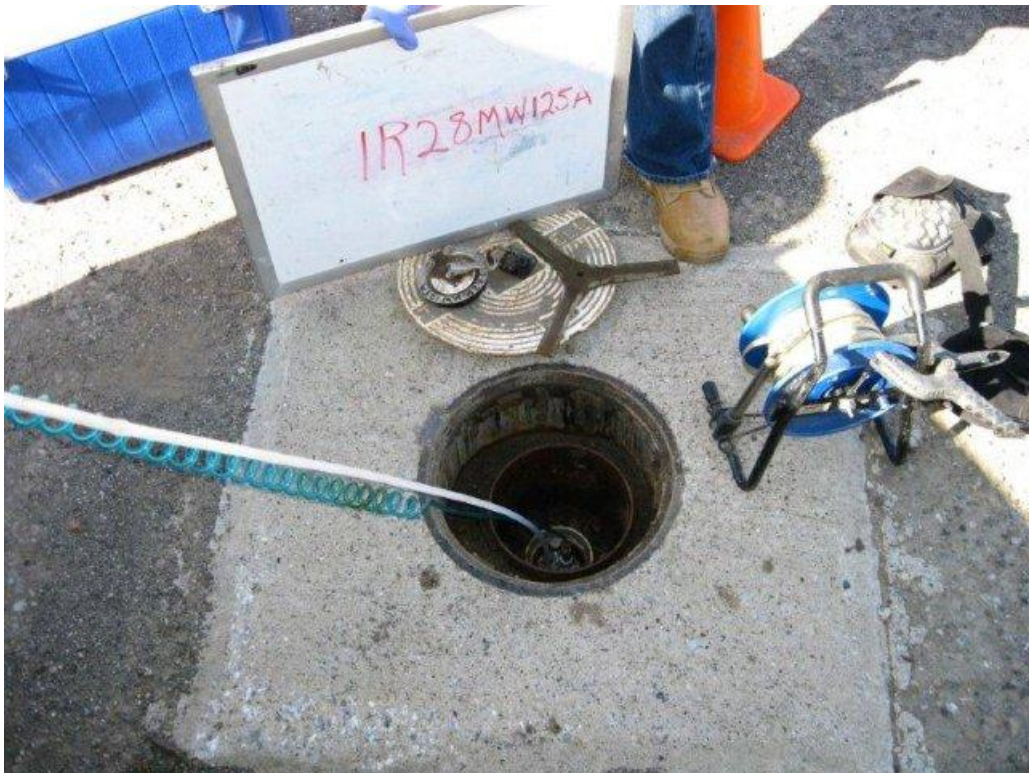
Photograph 62. Well IR28MW125A at Parcel C.

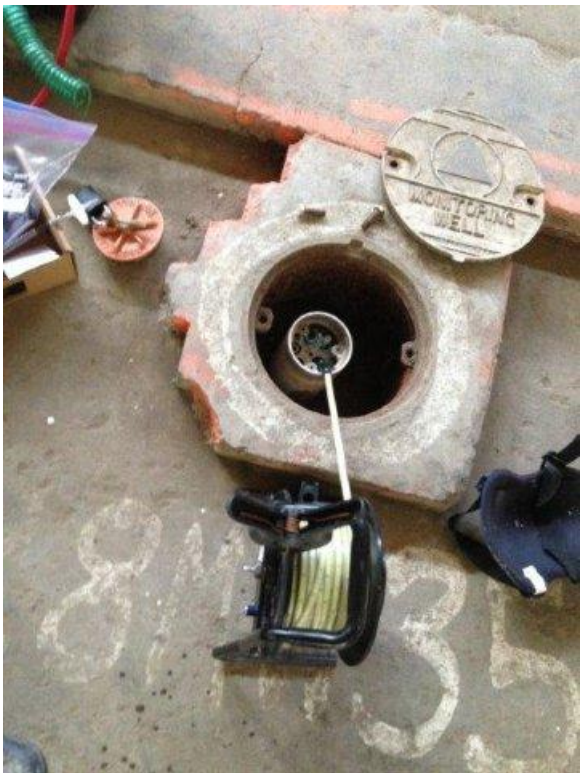
Photograph 63. Well IR28MW355F at Parcel C.

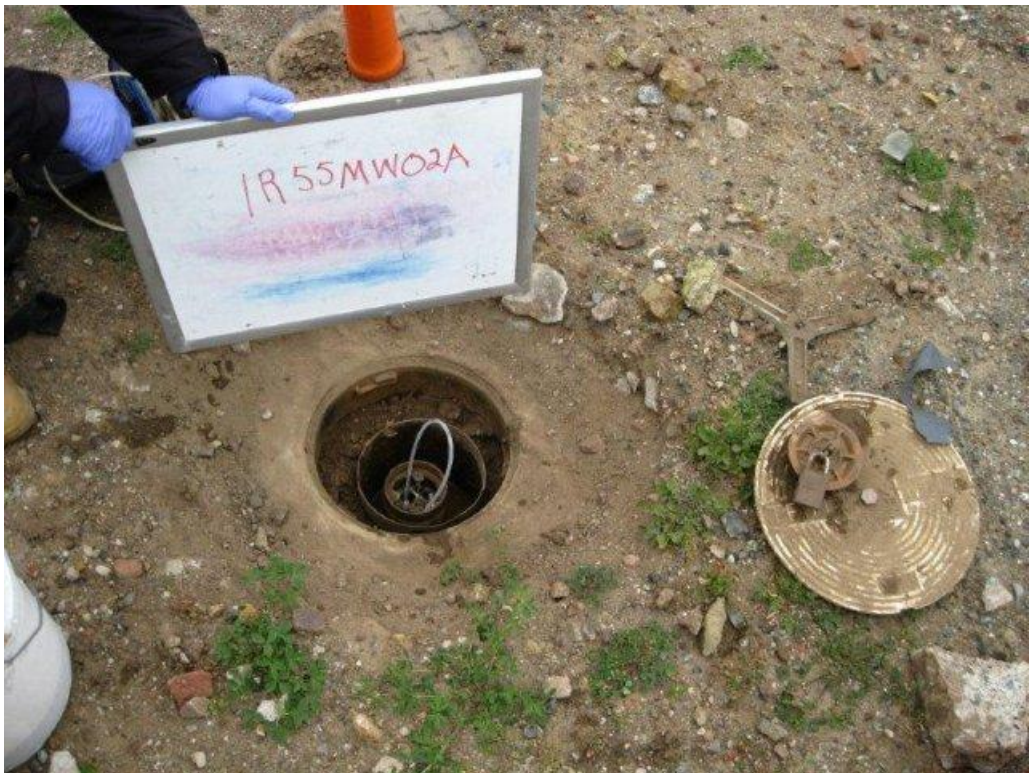
Photograph 66. Well IR55MW02A at Parcel D-1.
