2013 Institutional Controls Site Inspection Report

Operable Units A and B-1

Former Naval Complex

Adak, Alaska

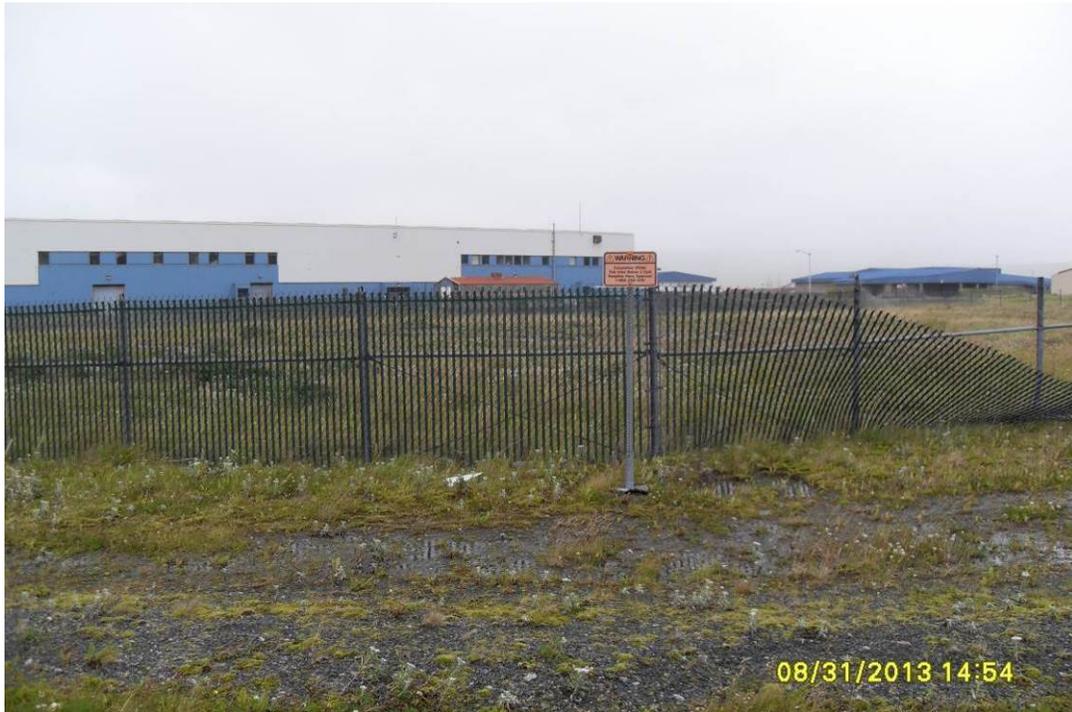
During the August 31, 2013 inspection, no changes to the site were observed compared to the 2012 inspection results. The site appeared to be used as a storage location for cement

cinder blocks. No residential construction had occurred at the site (Photograph 2-1). No indications of groundwater use or excavation activities were found. The ICs required at this location include soil excavation restrictions. Two signs were present at the site. One is located along Bay Shore Drive and the other is located northwest of the site.

Photograph 2-1. SWMU 10, Old Baler Building – looking northwest. The fence in the photograph was installed by the land user and is not an IC requirement.

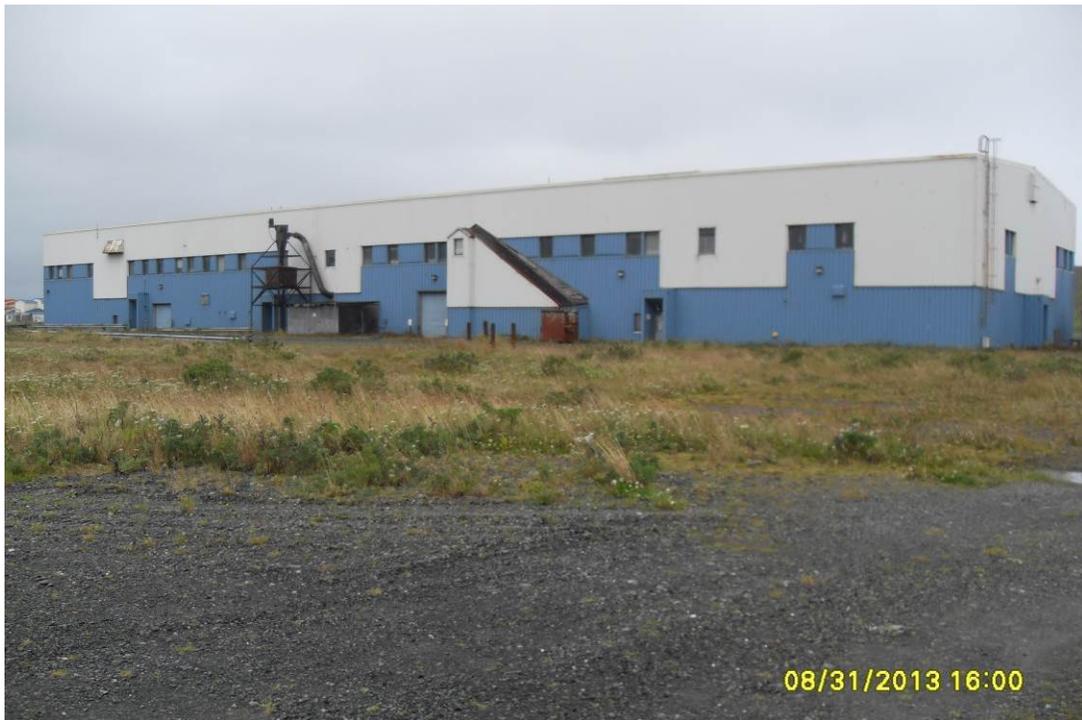
Photograph 2-2. SWMU 14, Old Pesticide Disposal Area – looking east

During the inspection on August 31, 2013, no changes to the site were observed compared to the 2012 inspection results. The site did not appear to be in use. No residential construction had occurred at the site. No indications of groundwater use or excavation activities were found at the site. The ICs required at this location include soil excavation restriction. There were no signs present on the site, but several signs were located in the immediate vicinity of the site. Therefore, all ICs appear to be functioning as intended.

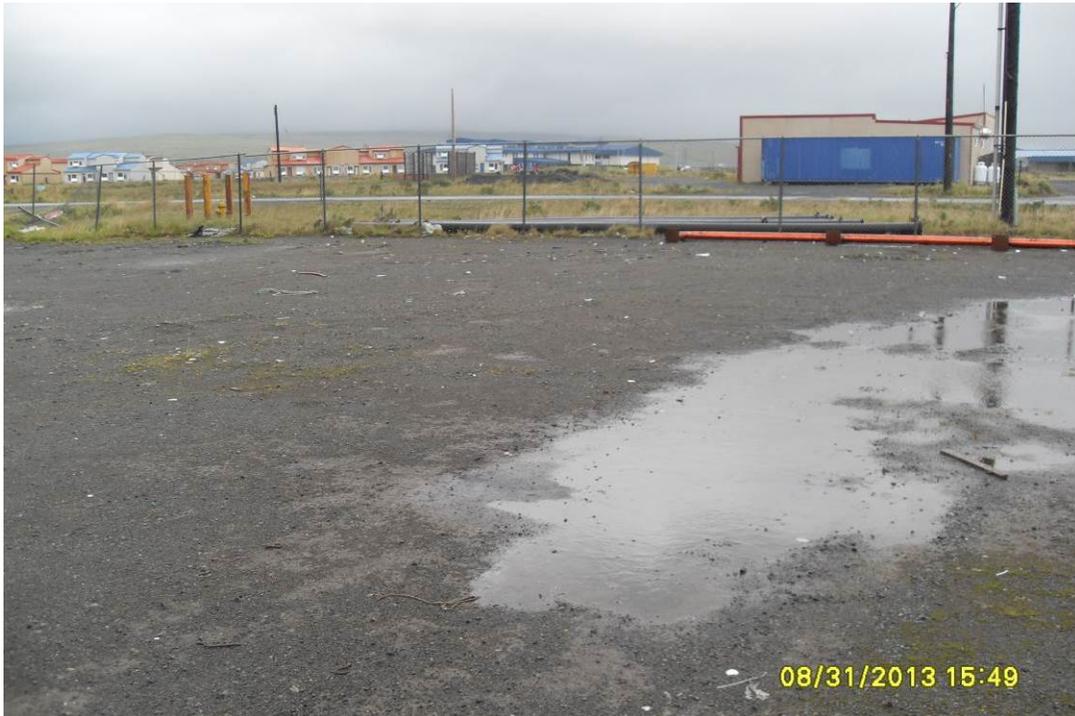
The site is currently being used to store fishing equipment. During the inspection on August 31, 2013, puddles of water with slight petroleum sheen were observed in same area as the oily stained areas observed in 2011 (Photograph 2-3). The puddles prevented observing if the petroleum staining remains at this location that was observed in the past but sheen was observed on the puddled water.

Photograph 2-3. SWMU 15, Future Jobs/Defense Reutilization Marketing Office – looking northwest at the location where drums were stored onsite and staining was observed in 2011. Sheen was observed in the puddles in the foreground.

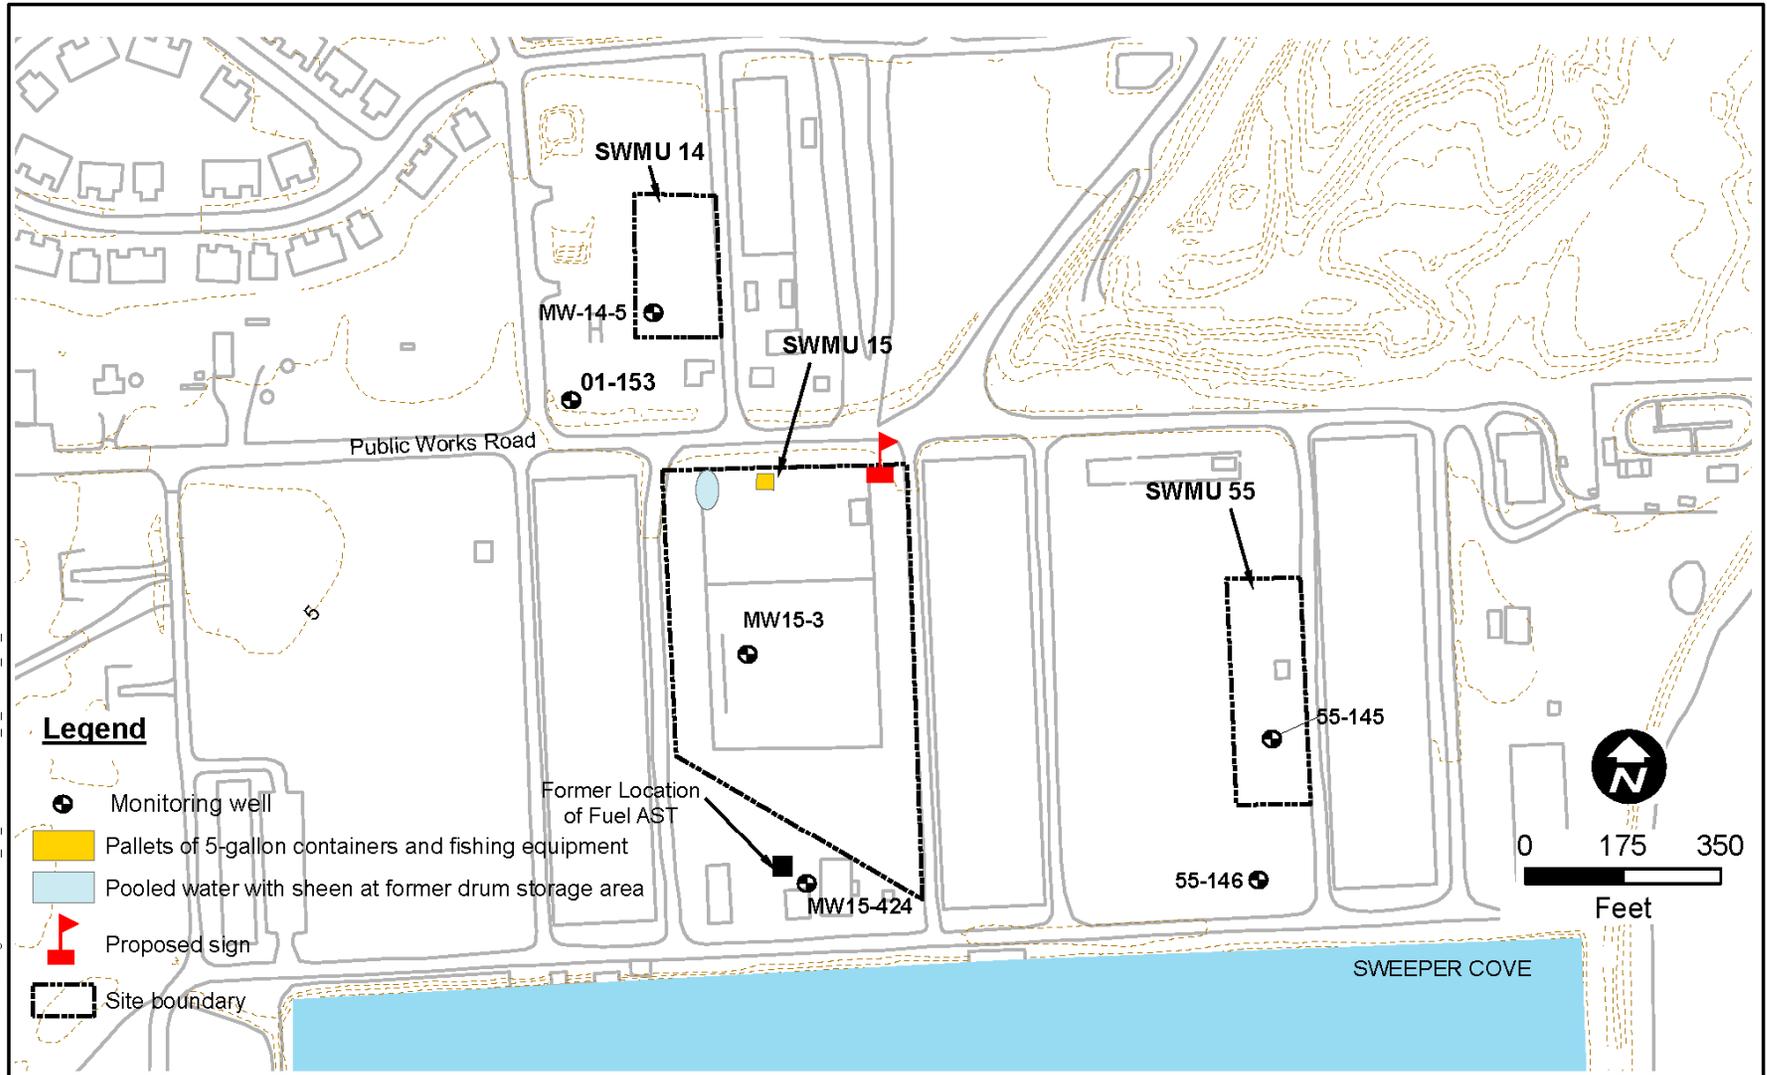
<p>U.S. NAVY</p>	<p>SEALASKA</p>	<p align="center">Figure 2-1 SWMU 15, Future Jobs/Defense Reutilization Marketing Office</p>	<p align="center">Task Order 66 Adak Island, AK 2013 IC Inspection Report</p>
-------------------------	------------------------	---	---

As observed in 2012, the aboveground storage tank (AST), and 55-gallon drums of fuel (not associated with Navy activities) located south of the site and near well MW15-424 is offsite. The pile of gravel fill covered by poly-sheeting observed last year remains onsite (Figure 2-1). The oily stained soil observed at this location during the 2011 inspections was not observed during the 2013 inspection (Photograph 2-4).

Approximately 15 containers of various size (5-gallons to 15-gallons) of paint and oil were observed stored on pallets on the north side of the site along the fence (Figure 2-1). Fishing equipment was also observed stored at this location. The excavation restriction sign installed in 2010 is missing, and it is recommended that it be replaced. No indications of groundwater use or excavation activities were found. Housekeeping practices onsite are improved and appear adequate. However, potentially contaminated soil remaining onsite may be impacting underlying groundwater. It is recommended that housekeeping practices continue to be monitored at this site.

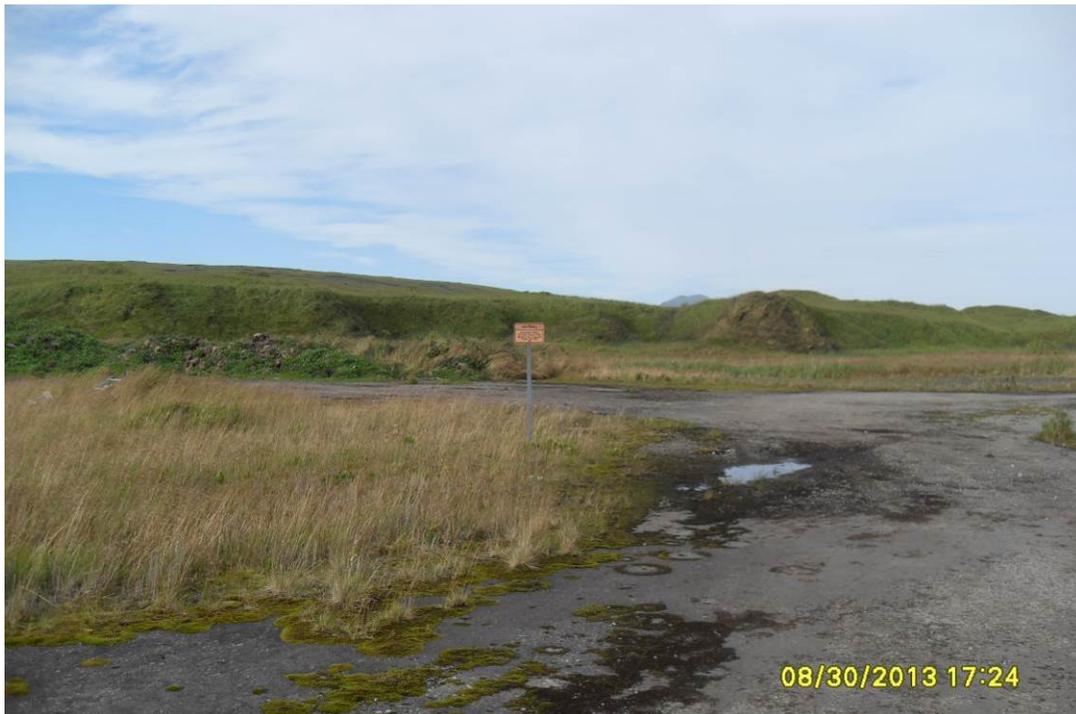
During the August 30, 2013 inspection, no changes to the site were observed compared to the 2012 inspection results. The site did not appear to be in use. No residential construction had occurred at the site. No indications of groundwater use or excavation activities were found. The sign is located approximately 100 feet from the road and is legible (see Photograph 2-5). The ICs appear to be functioning as intended in the OU A ROD to protect human receptors from exposure to contaminated soil or groundwater.

Photograph 2-5. SWMU 16, Former Firefighting Training Area – looking northwest

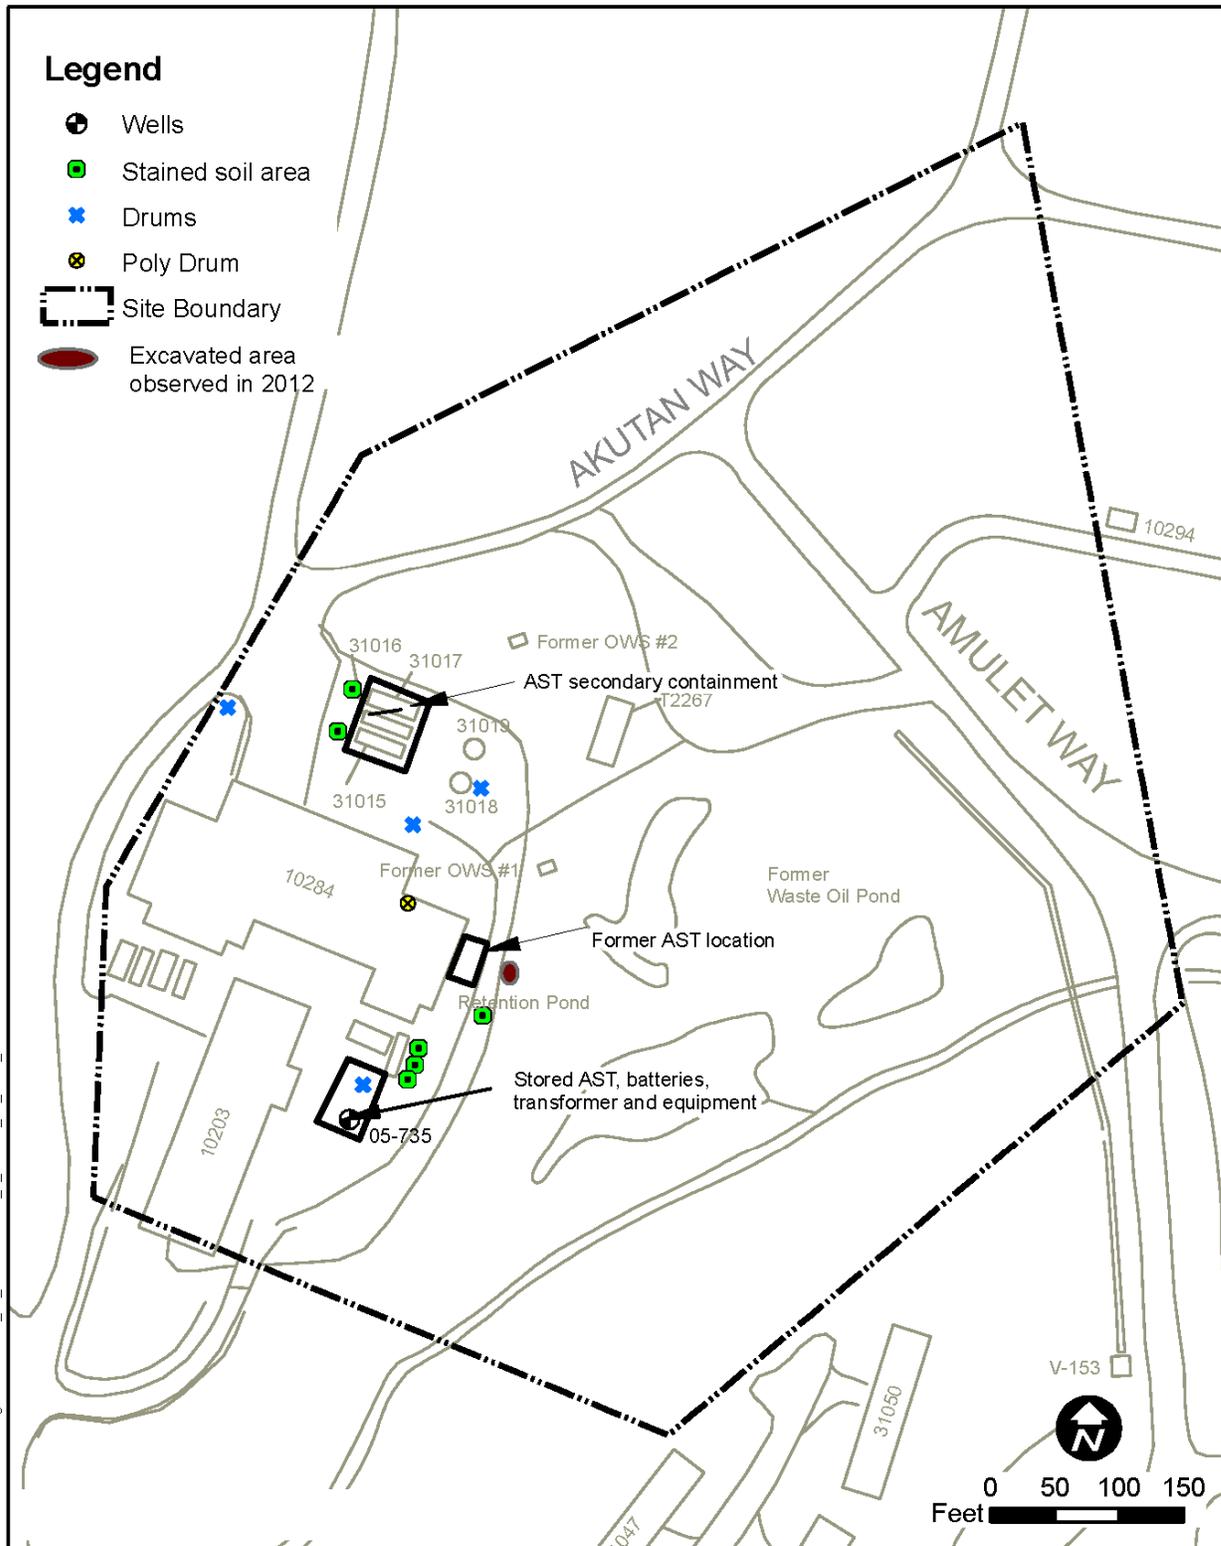
U.S. NAVY	SEALASKA	<p align="center">Figure 2-2 SWMU 17, Power Plant 3 Area</p>	<p align="center">Task Order 66 Adak Island, AK 2013 IC Inspection Report</p>
-----------	----------	---	---

The oily soil approximately 6 feet in diameter that was observed during the 2011 inspection and located west of the AST secondary containment was not observed in 2013 only two small stained soil areas (less than 3 feet in diameter total), were observed. The crushed drums and nine large transformers observed in the AST secondary containment in 2012 were removed from site and disposed. A power plant employee reported that the transformers were drained of oil prior to being removed off site and the oil was given to the fuels facility to be recycled. One transformer remains onsite and the employee reported that it will also be disposed of in a similar fashion (Photograph 2-6, Figure 2-2).

All of the crushed 55-gallon drums on pallets previously observed along the east side of building 10203 were no longer present in 2013. Three small stained areas (largest 4 feet in diameter) were observed in the fenced area where the drums were stored in 2011. One small oil-stain area three feet in diameter was observed in the roadway northeast of the former drum storage area. The yard on the east side of building 10203 is being used to store equipment, the gray AST formerly located on the west side of the building, and the remaining transformer. Several drums were observed scattered around the site (Figure 2-2).

A leaking drum was observed near monitoring well 05-735. The city was notified of the drum and in October 2013, it was observed that the City had removed the drum.

No other changes to the site were observed compared to the 2012 inspection results. No residential construction had occurred at the site. No indications that groundwater was being used. Excavation restriction signs were clearly visible. Housekeeping practices have improved at this site but should continue to be monitored and it is recommended the owners are notified to remove the on-site wastes, address the areas of actual or potential spills and improve housekeeping practices. It is further recommended that the City be notified that the open excavation observed at the site be filled in.

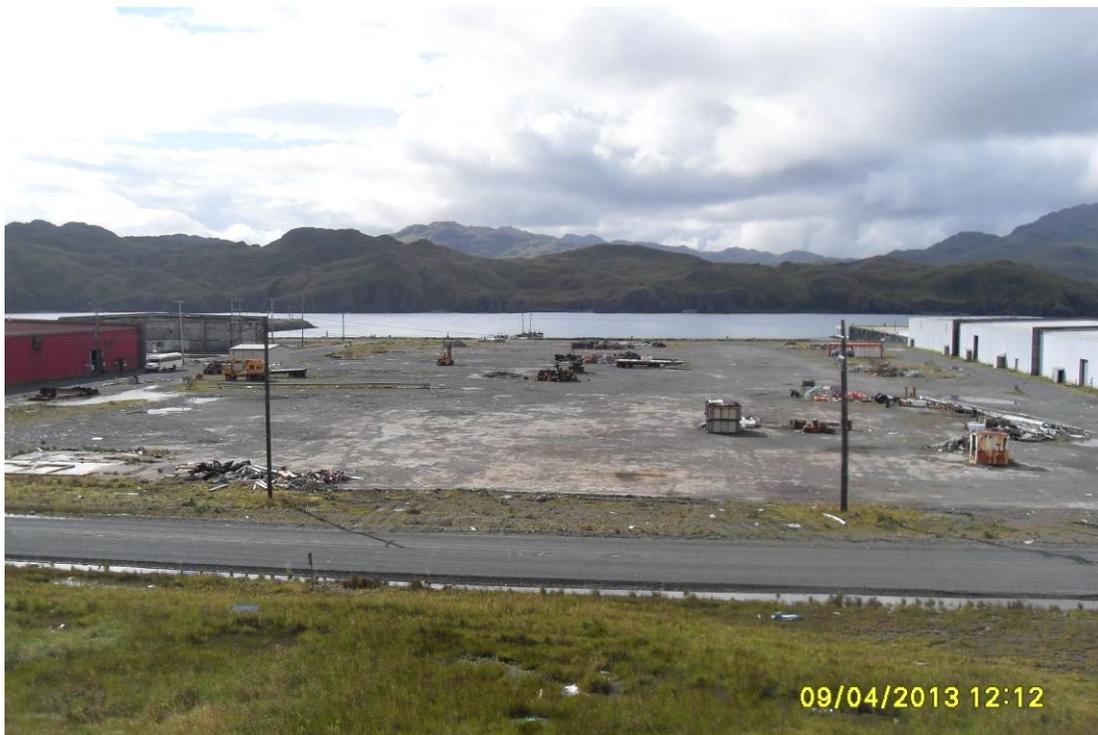
Photograph 2-7. SWMU 55, Public Works Transportation Department Waste Storage Area – overview south of Recycling Center

After the property was transferred to TAC, the site was used for vehicle and equipment storage. New oil, hydraulic and transmission fluids, and other vehicle-care products were also stored at the site. In 2010 the community began using the area as a “Recycling Center” at which large quantities of wooden and metal debris, appliances and various other materials were observed to be loosely segregated and piled on the ground. During the August 31, 2013 inspection, the area was no longer being used as a “Recycling Center” (Photograph 2-7). Large amounts of the materials and debris observed in previous years have since been removed and little remains onsite. The majority of materials stored onsite have been moved to the Contractors Camp Area.

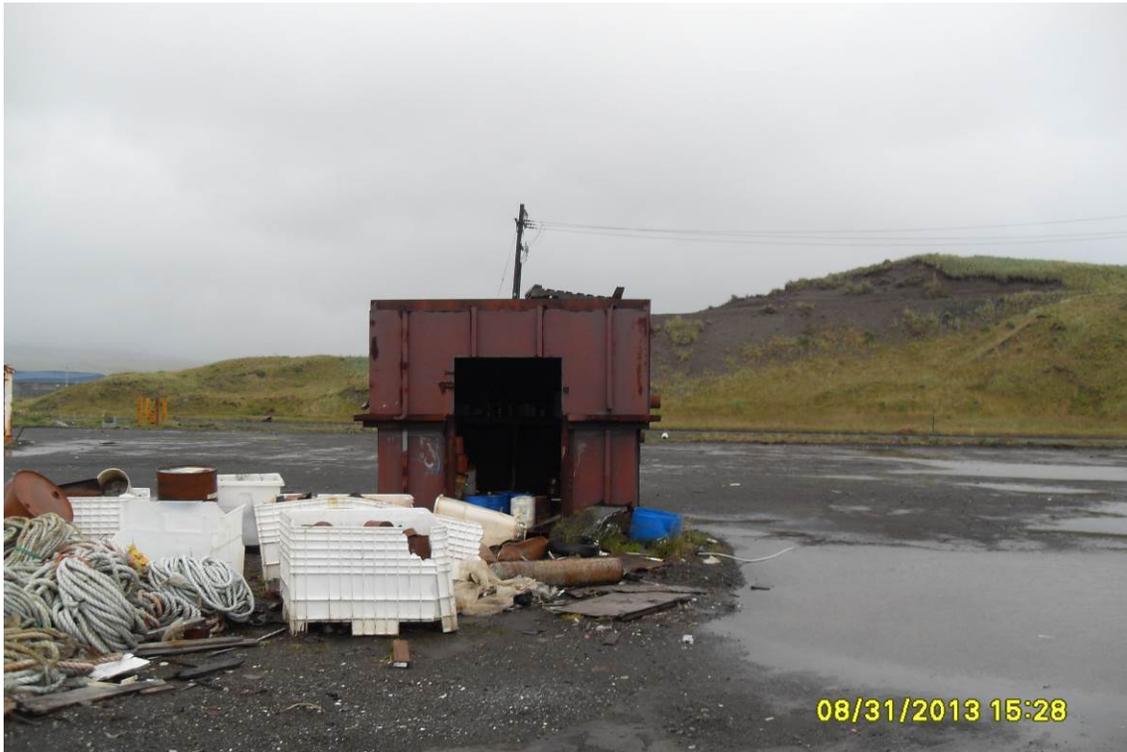
Photograph 2-8. SWMU 55, Public Works Transportation Department Waste Storage Area - looking at conex box, poly containers with rusted paint cans, ponded water, and debris

Several drums, poly boxes full of rusty paint cans, creosote logs and cylinders (propane, fire extinguishers, etc.) remain onsite. Due to recent rain, standing water was observed throughout the site and a slight sheen was observed where drums and soil staining was observed during the previous inspections (Photograph 2-8, Figure 2-3). The pink conex box containing 5-gallon containers and underlying stained soil still remains at the site. There is no restricted access or soil barrier at the site.

the previous inspections (Photograph 2-8, Figure 2-3). The pink conex box containing 5-gallon containers and underlying stained soil still remains at the site. There is no restricted access or soil barrier at the site.

No evidence of excavation was noted during the inspection. The soil excavation restriction sign is missing and needs to be replaced. There was no evidence of groundwater use. Due to the wastes and conditions observed at this site in the past, there is a concern that contaminants associated with on-site wastes are a threat to residents and are potentially impacting site soils and underlying groundwater. However, landowners have been notified in the past by both the Navy and ADEC that they should improve housekeeping practices and the volume of wastes stored onsite have diminished significantly since to 2012. Therefore, further notification to landowners is not necessary and it is recommended that the housekeeping of the site continue to be monitored.

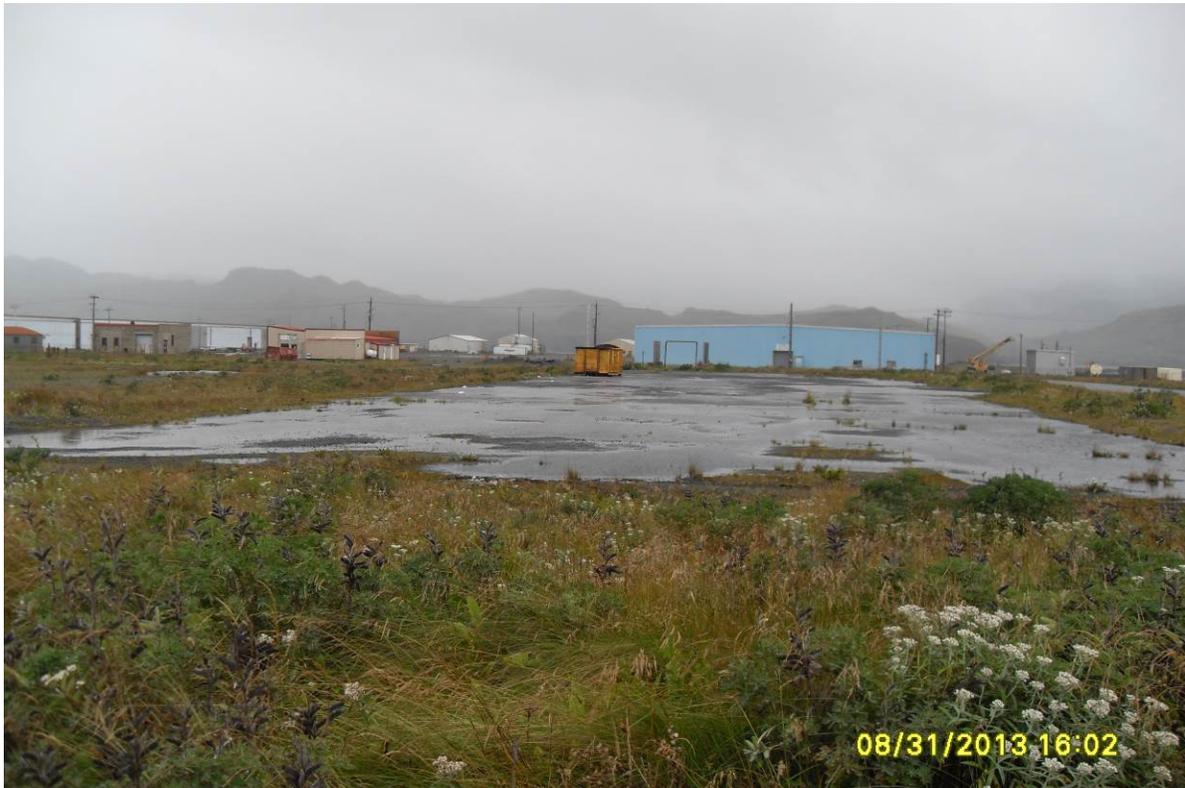
Photograph 2-9. SA 76, Old Line Shed Building – looking south

The City of Adak is currently using this site as a solid waste transfer station. During the inspection on August 31, 2013, one dumpster was observed on site. No residential construction had occurred at the site. No indications of groundwater use or excavation activities were found. No changes to the site were observed compared to the 2012 inspection results. Usage of the site remains within the IC requirements of commercial/industrial. No soil excavation restriction sign was present onsite but several signs were located in the near vicinity of the site. Therefore, all ICs appear to be functioning as intended.

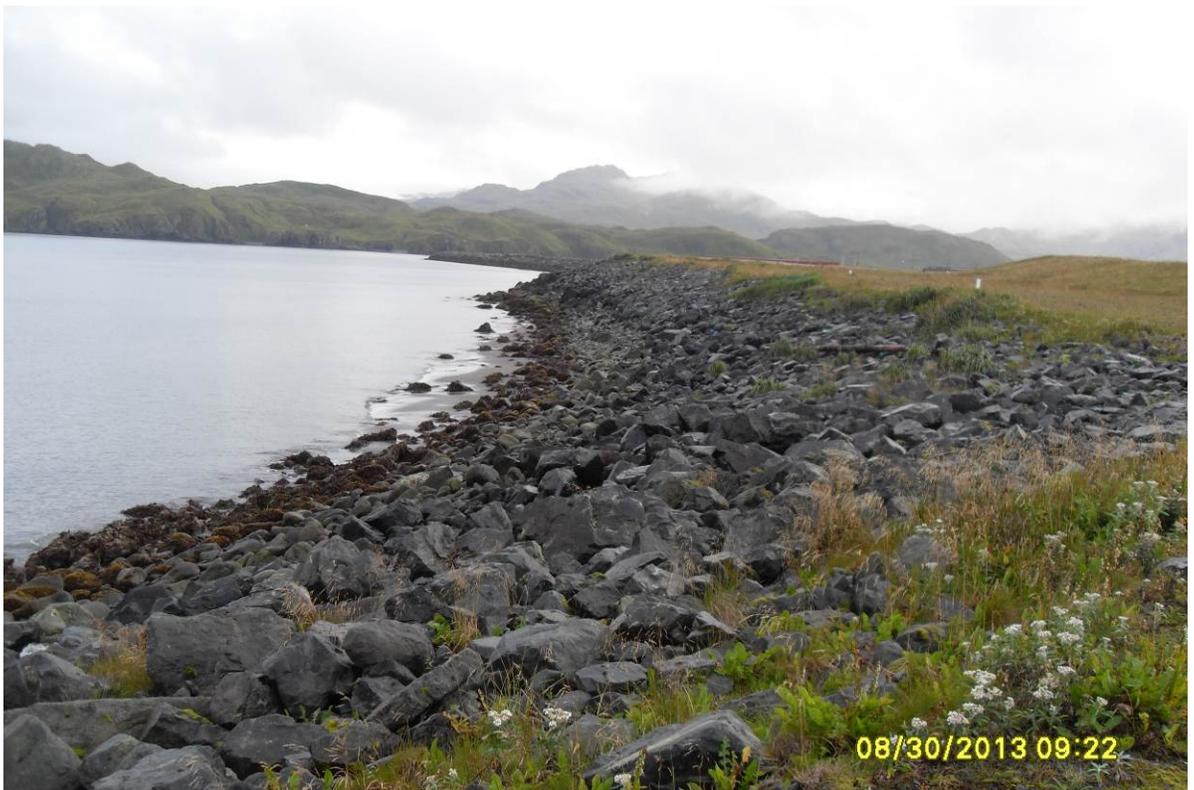
Photograph 2-12. SWMU 13, Metals Landfill – looking south along the landfill armor wall

In addition, large amounts of metal debris that have been observed in the past remain on the cliffs on the northeastern boundary of the landfill. This debris is not feasible to cap due to the steep terrain and is not impacting the integrity of the armor wall. A second area of metal debris is located further north of the landfill and has been observed here since inspections commenced in 2005. This debris lies outside of the landfill boundaries and is not associated with Metals Landfill.

ICs appear to be functioning as intended to protect human receptors from exposure to contaminated soil or groundwater. The four eroded areas along the armor wall are recommended for repair.

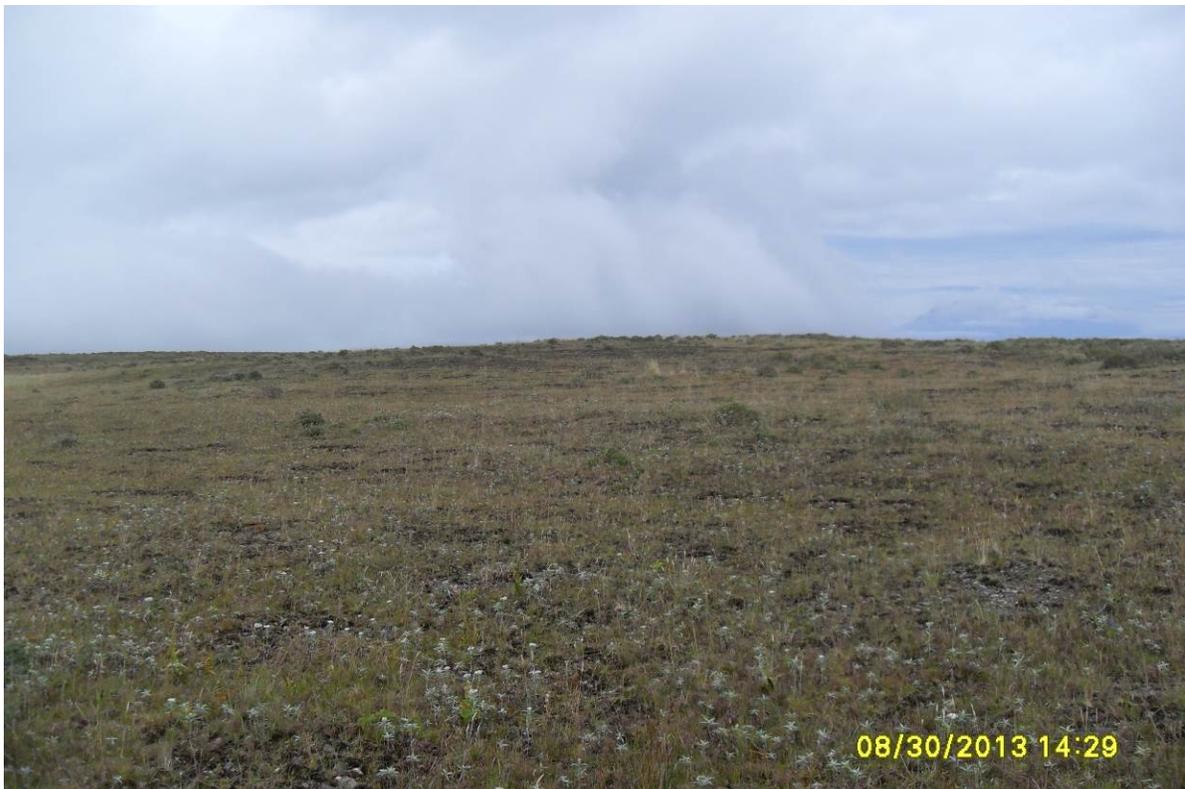
Photograph 2-14. SWMU 25, Roberts Landfill – central portion of landfill with improved vegetated cap

During the 2009 through 2011 inspections, a large, sparsely vegetated area was noted in the central portion of the landfill. Vegetation in this area shows improvement in that the vegetation was generally thicker and taller than in previous inspections (Photograph 2-14). The two sparsely vegetated areas in the southern portion of the landfill were not observed during the August 30, 2013 inspection. In general, the remainder of the vegetative cap appears adequate.

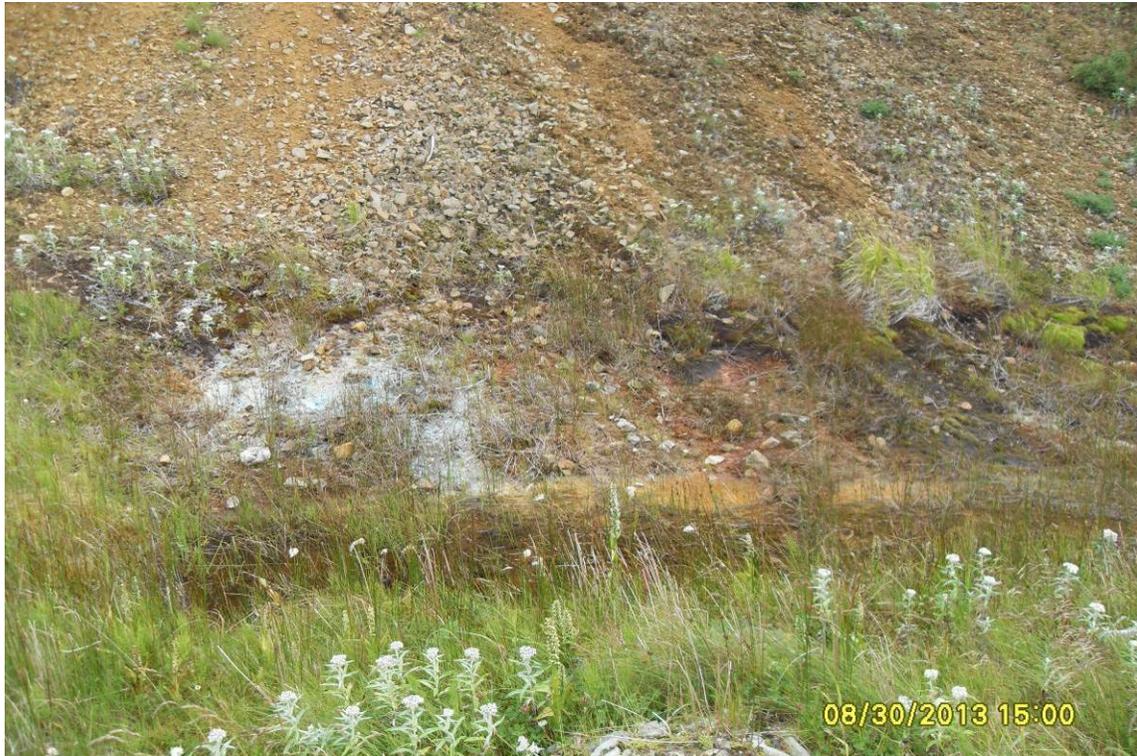
Photograph 2-16. SWMU 25, Roberts Landfill – looking southeast at the blue and white groundwater seep northwest of the landfill

A groundwater seep observed during the 2010 inspection on the Mitt Lake access road down gradient from the landfill and uphill from sample location RLSW05 is still present. The seep was sampled in 2010 (NL-13), and the sample results did not exceed endpoint criteria. A groundwater seep observed in 2011 northwest of the landfill in the Adak Fuels Facility adjacent to the landfill is still present. The seep is characterized with blue and white precipitate (Photograph 2-16). Surface water sample NL-14 was collected in 2013 from a ditch immediately below the seep and analyzed for total and dissolved priority pollutant metals plus aluminum, volatile organic compounds, and water quality parameters. Total aluminum and copper exceeded the endpoint criteria in this surface water sample but respective dissolved concentrations did not. Recommendations to continue to collect surface water sample at this location are presented in the 2013 Annual Long-Term Monitoring Report.

- Sample surface water at the blue seep on the northwest side of the landfill (NL-14) in 2014 to determine if contaminants are migrating from the landfill. Take appropriate actions as determined by ADEC, EPA and the Navy if needed. (pending results)
- Repair the perimeter fence and replace the perimeter sign.
- Replace the three asbestos warning signs located on the buried bunkers west across the road from the landfill. These bunkers are not part of the landfill.
- Repair or replace the northern gate adjacent to the Adak Fuels Facility.
- Notify Adak Fuels Facility to keep the northern gate locked to prevent vehicle access to the site.
- The sinkhole located near monitoring well B-1 is not located on the landfill cap or impacting the integrity of the cap but will continue to be monitored.

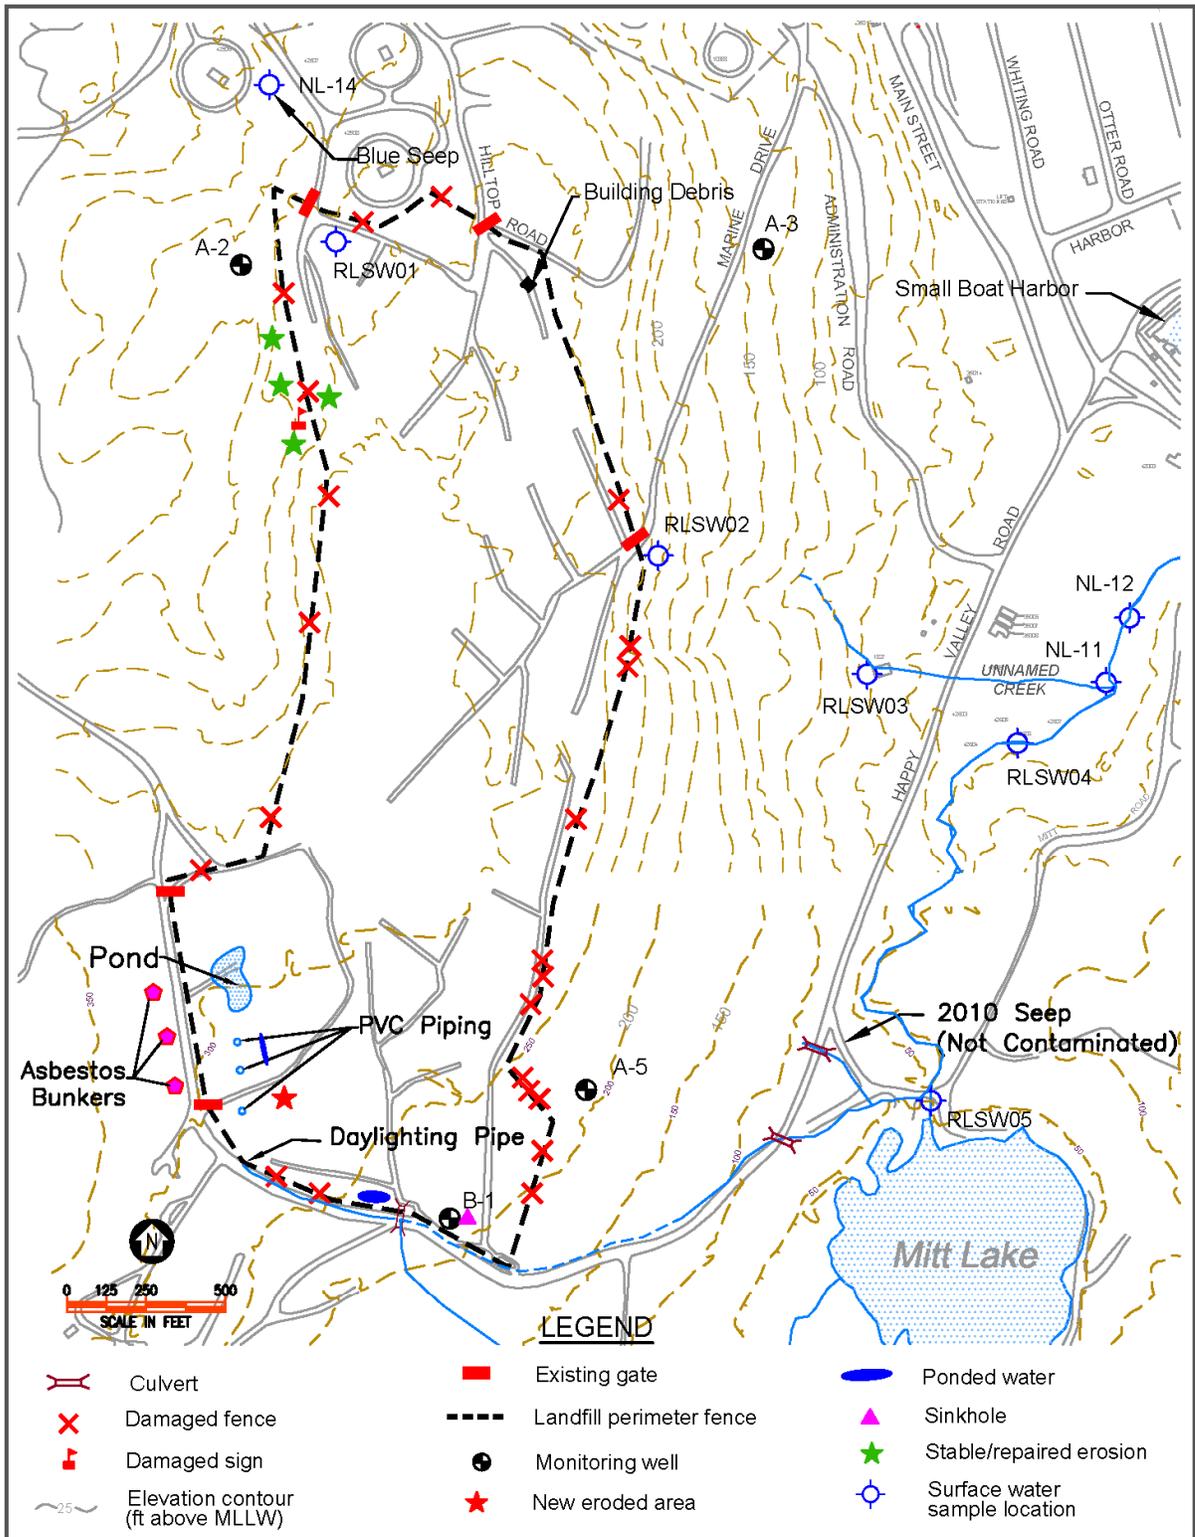
<p>U.S.NAVY SEALASKA</p>	<p align="center">Figure 2-5 SWMU 25, Roberts Landfill</p>	<p align="right"> Task Order 66 Adak Island, AK 2013 IC Inspection Report </p>
---------------------------------	--	---

Four areas of erosion along the western perimeter fence which were repaired in 2010 appeared to be stable and showed no further erosion during the August 30, 2013 site inspection. The area of erosion observed in 2012 in the southwestern portion of the site near the end of a swale was observed again in during the 2013 inspection. The area is approximately 5 feet by 10 feet and along the top of a steep embankment. The swale liner is exposed at the southern end of the swale (Photograph 2-15, Figure 2-5).

The truck tracks observed in 2012 on the southern portion of the cap were not visible in 2013. Wooden and metal debris associated with a collapsed building was again observed on the northeast side of the landfill; however, this debris is not located on the landfill cap (Figure 2-5).

The north gate at the Fuels Facility was open and unlocked at the time of the inspection. As observed in 2012, the gate was not able to close because the locking bars would not align and need to be repaired. One sign on the western perimeter is faded and needs to be replaced. The three asbestos signs located on the buried asbestos bunkers located west across the road from the landfill are faded and need to be replaced. These asbestos bunkers are not part of the landfill and are shown on Figure 2-5. Thirteen sections of fence along the western perimeter and are in need of replacement or repair. Fourteen sections of fence along the eastern perimeter are also in need of replacement or repair. One section of fence along

the northern perimeter fence and six along the south perimeter fence are also in need of replacement or repair (Figure 2-5).

- Continue to monitor the four small eroded and repaired areas along the western fence line for future threat to the landfill cap.
- Repair the observed eroded area and swale liner on the southern portion of the landfill.

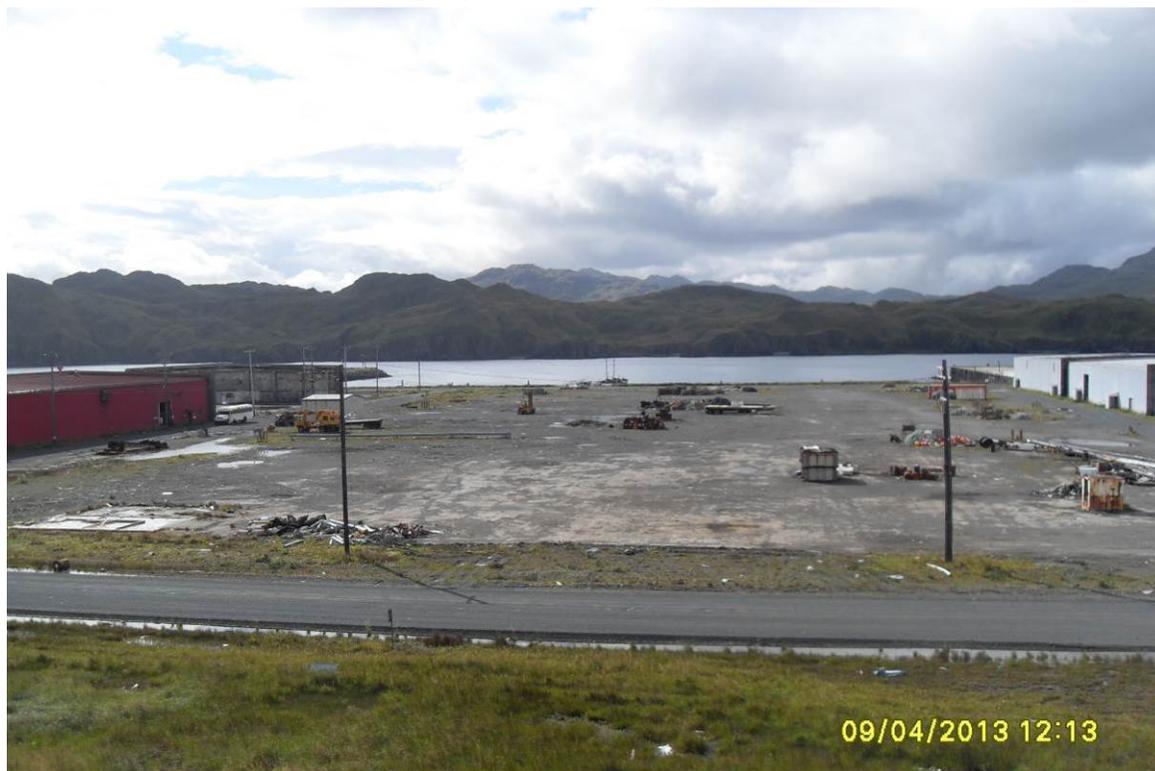
During the August 31, 2013 inspection, much less debris was observed in and around the Recycling Center than was observed during the previous inspections. Large amounts of the materials and debris observed in previous years have since been removed and little remains onsite. The majority of materials stored onsite have been moved to another part of the island.

Several drums, poly boxes full of rusty paint cans, creosote logs and cylinders (propane, fire extinguishers, etc.) remain onsite. Due to recent rain, standing water was observed throughout the site and a slight sheen was observed where drums and soil staining was observed during

The soil excavation restriction sign is missing and needs to be replaced. There was no evidence of groundwater use. Due to the wastes and conditions observed at this site and in the past, there is a concern that contaminants associated with on-site wastes are a threat to residents and are potentially impacting site soils and underlying groundwater. It is therefore recommended that the housekeeping of the site continue to be monitored.

Photograph 2-18. SWMU 24, Hazardous Waste Storage Facility – looking south

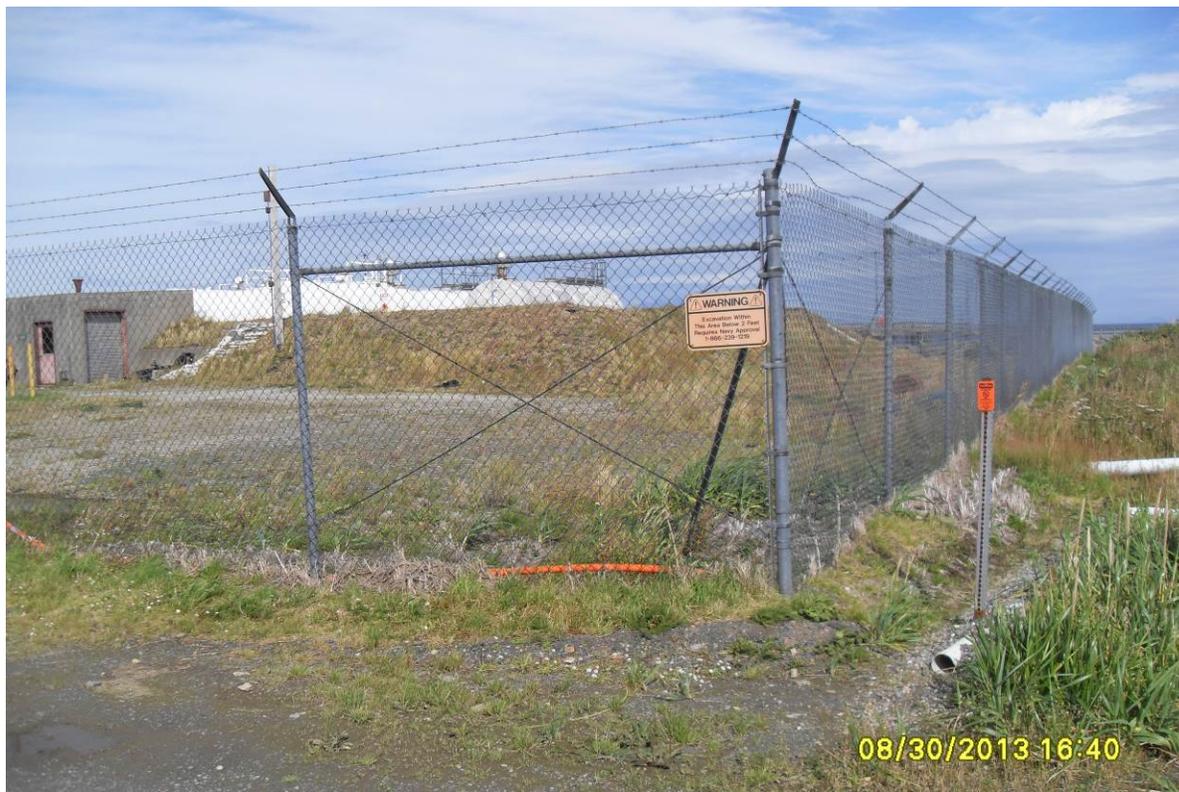
Photograph 2-19. SA 77, Fuels Facility Refueling Dock, Small Drum Storage Area – looking northeast

The site was closed under RCRA in 1995 because the data collected during the RCRA closure showed that RCRA-regulated hazardous wastes were not present at the SDSA at concentrations warranting corrective action. The area is currently used as a parking apron for Adak Fuels trucks and fuel drums (Photograph 2-19).

During the inspection on August 30, 2013, no changes to the site were observed compared to the 2012 inspection results. The site is currently being used for a commercial purpose, which is allowed under CMP, Revision 5 (Navy 2012a). No residential construction had occurred at the site. No indications of groundwater use or excavation activities were found. Excavation restriction signs were clearly visible. Therefore, ICs appear to be functioning as intended to protect human receptors from exposure to contaminated soil or groundwater.

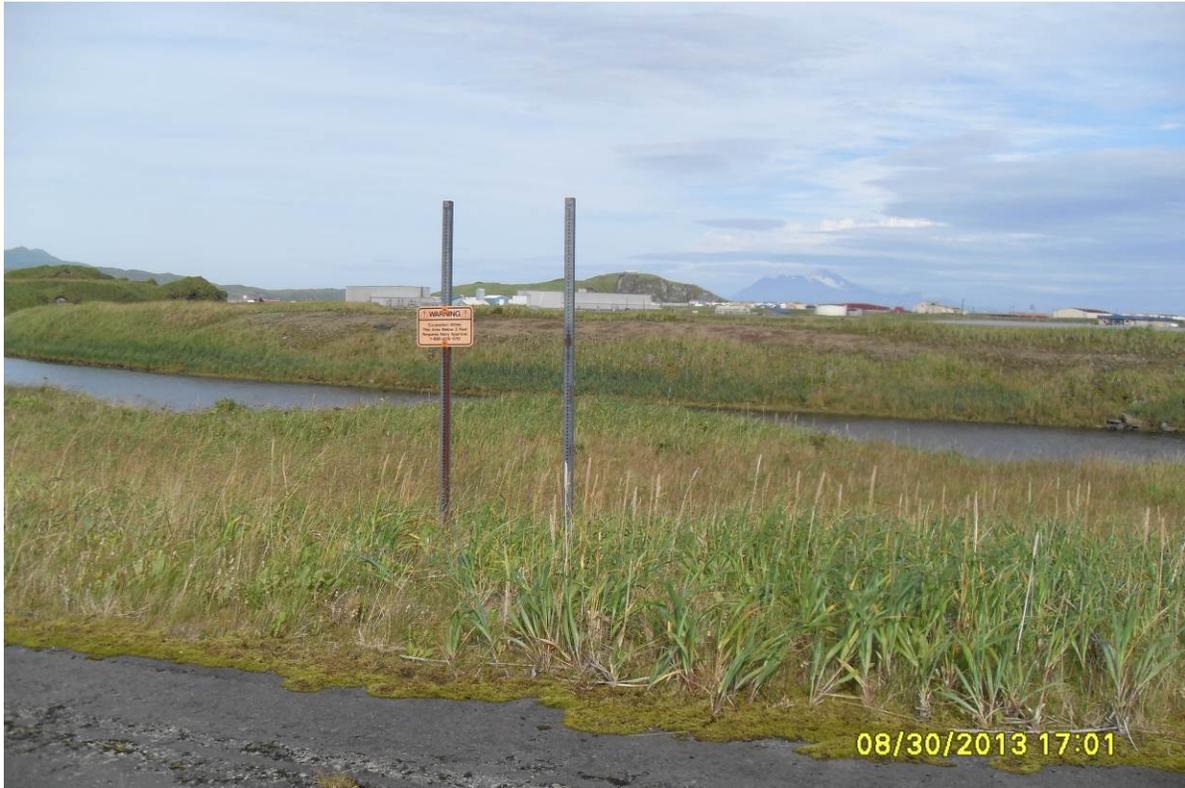
Photograph 2-20. Amulet Housing, Well AMW-706 – looking northeast at Sweeper Creek

During the inspection in August 30, 2013, no changes to the site were observed compared to the 2012 inspection results. The site is currently not being used. No indications of groundwater use or excavation activities were found. Excavation restriction signs were clearly visible. Therefore, ICs appear to be functioning as intended to protect human receptors from exposure to contaminated soil or groundwater.

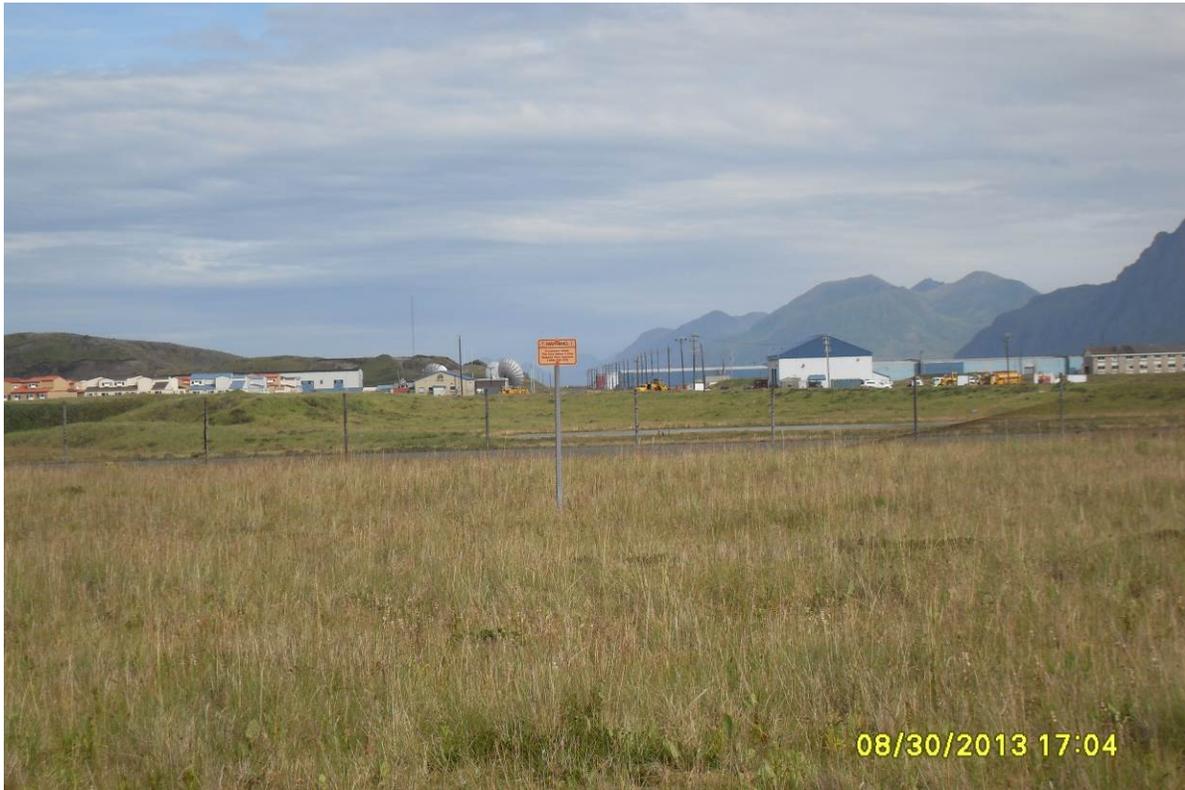
Photograph 2-21. Amulet Housing, Well AMW-709 – looking southeast

The ICs at Amulet Housing, Well AMW-709 Area are the restriction of land use to industrial or commercial activities and the restriction of groundwater use, which are included in an equitable servitude, and a requirement to complete an excavation notification before intrusive work to a depth greater than 2 feet is conducted (see Table 1-2). During the August 30, 2013 inspection, no changes to the site were observed compared to the 2012 inspection results. The site is currently not being used. No indications of groundwater use or excavation activities were found at this site. Excavation restriction signs were clearly visible. Therefore, ICs appear to be functioning as intended to protect human receptors from exposure to contaminated soil or groundwater.
