2013 Institutional Controls Site Inspection Report

Operable Units A and B-1

Former Naval Complex

Adak, Alaska

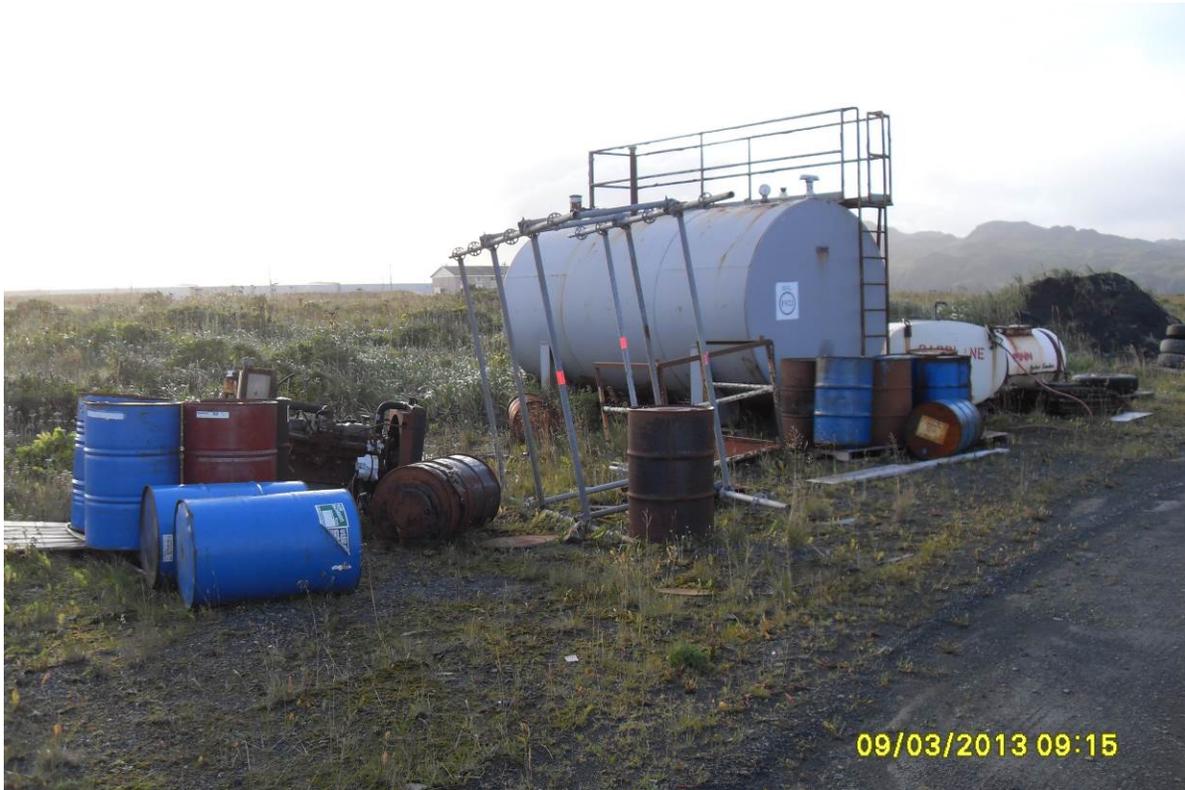
Photograph 2-22. Former Power Plant Building T-1451 – looking southwest

During the inspection on September 3, 2013, the site was being used as the City maintenance shop with numerous vehicles stored on the site which is allowed under CMP, Revision 5 (Navy 2012a). Several 55- gallon drums and various sized ASTs were observed onsite some drums were labeled used oil and non-hazardous waste with Icycle Seafoods listed as the contact (Figure 2-6, Photograph 2-22). A 250-gallon poly tank half-filled with oil was observed on the southeast side of the site without a lid or secondary containment (Figure 2-6). The Navy notified the City and in October 2013, it was observed that a piece of Plexiglas had been attached to the top of the poly tank as a lid. No residential construction had occurred at the site. There were no indications that groundwater was being used at the site. This site has an excavation restriction sign approximately 70 yards east of the building. Therefore, all other

ICs appear to be functioning as intended to protect human receptors from exposure to contaminated soil or groundwater. It is recommended that the land users be notified poor housekeeping practices should be corrected (i.e. proper storage of 55-gallon drums).

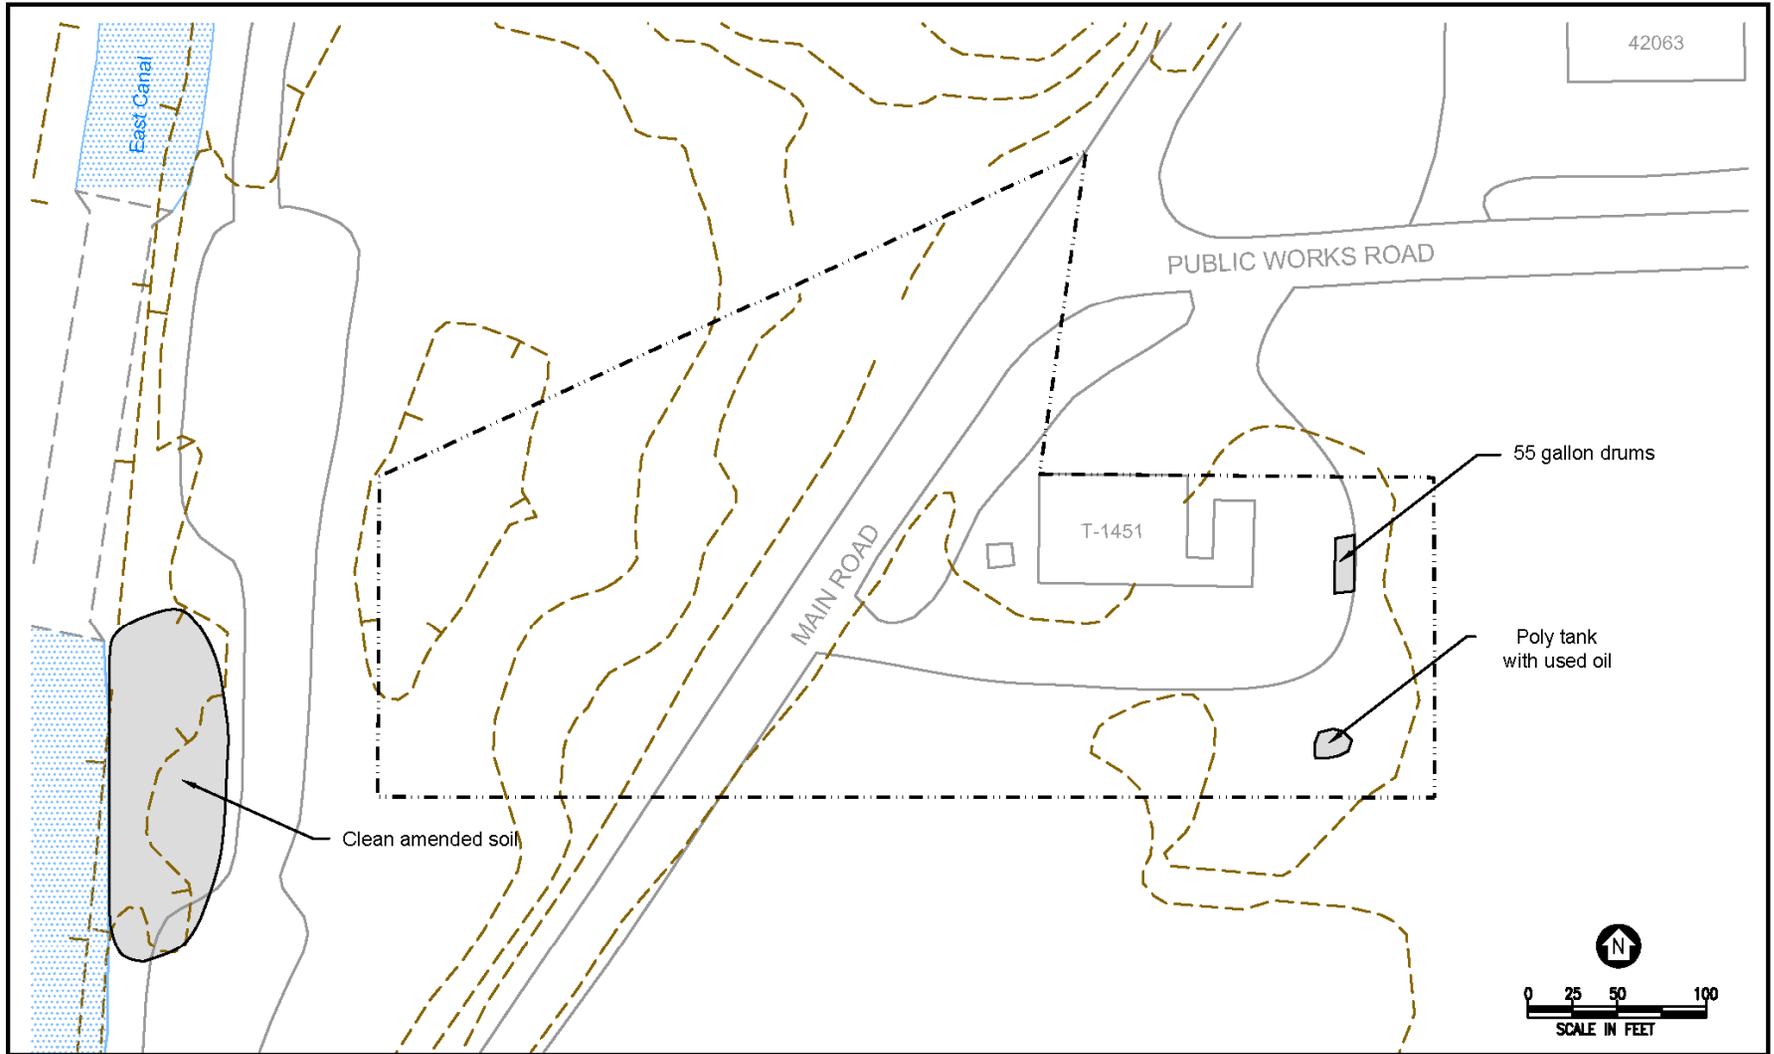
U.S.NAVY	SEALASKA	Figure 2-6 Former Power Plant Building T-1451	Task Order 66 Adak Island, AK 2013 IC Inspection Report
-----------------	-----------------	--	---

The Navy conducted remedial actions in July 2012 at the East Canal shoreline west of the property (Figure 2-6). Actions included limited soil removal, replacement with amended clean fill, and installation of monitoring wells; however, these actions were not performed within the site boundaries.

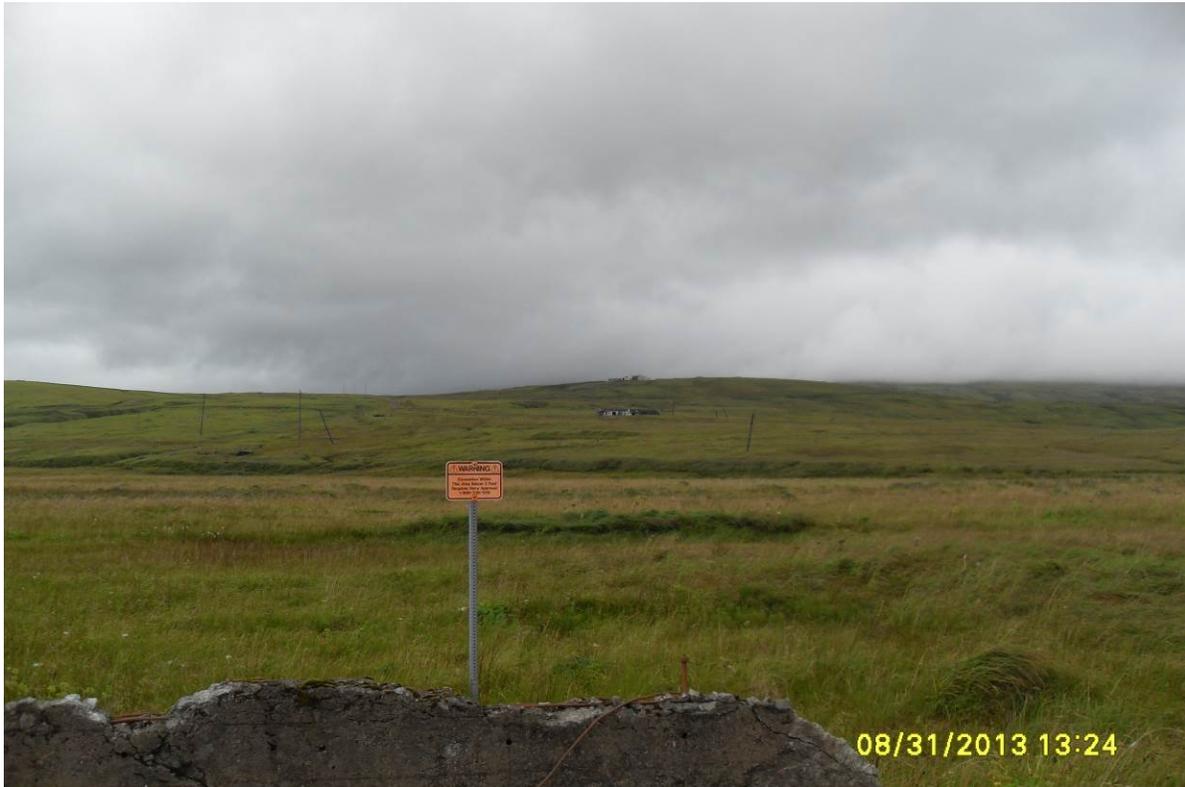
Photograph 2-23. ROICC Contractor's Area – looking west

During the inspection on August 31, 2013 no changes to the site were observed compared to the 2012 inspection results. The site is currently not being used (Photograph 2-23). No residential construction had occurred at the site. No indications that groundwater was being used and no indications of excavation activities were found. An excavation restriction sign

was present on site. Therefore, ICs appear to be functioning as intended to protect human receptors from exposure to contaminated soil or groundwater.

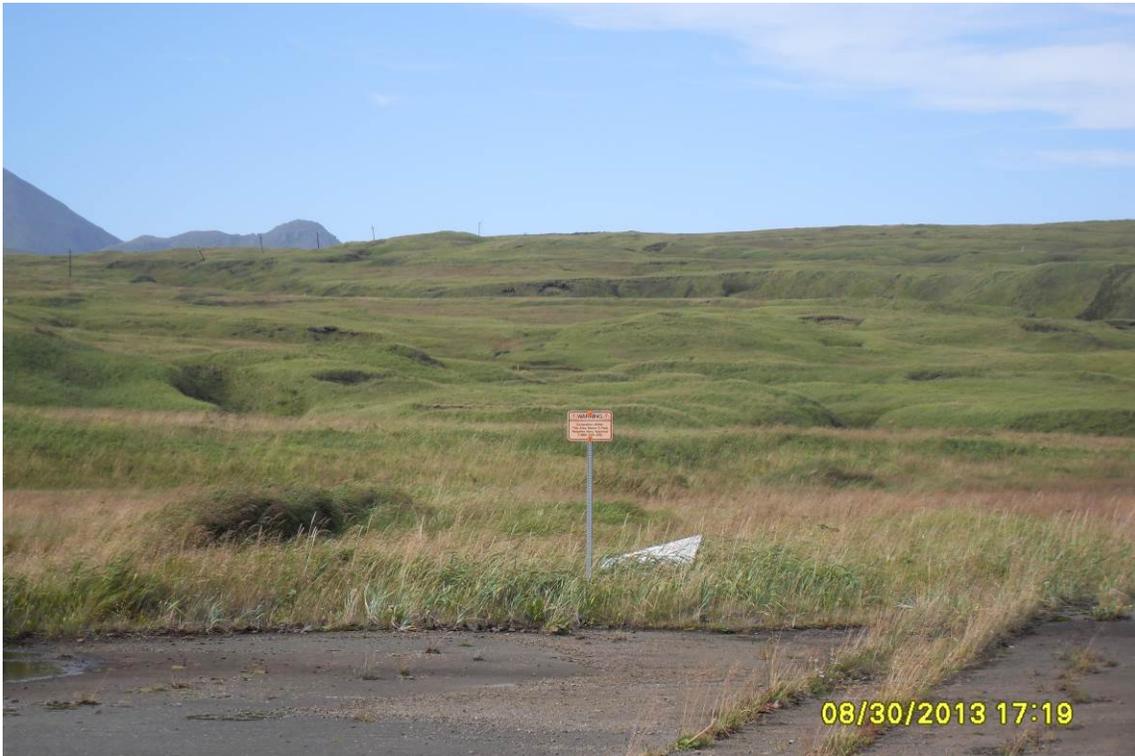
Photograph 2-24. Runway 5-23, Avgas Valve Pit – looking north at former route of avgas transfer pipeline

Runway 5-23, Avgas Valve Pit is associated with an abandoned 6-inch-diameter aviation avgas transfer pipeline that supplied fuel to the Runway 5-23 truck fill stand. The site is located approximately 800 feet south of the southern end of Runway 5-23 and 50 feet west of a former truck fill stand. The pipeline has been closed and the site is not currently used (Photograph 2-24). This site is approximately 0.42 acres.

During the August 30, 2013 inspection, no changes to the site were observed compared to the 2012 inspection results. The site is currently not being used. No residential construction had occurred at the site. No indications of groundwater use or excavation activities were found. An excavation restriction sign is present at the site. Therefore, ICs appear to be functioning as intended to protect human receptors from exposure to contaminated soil or groundwater.

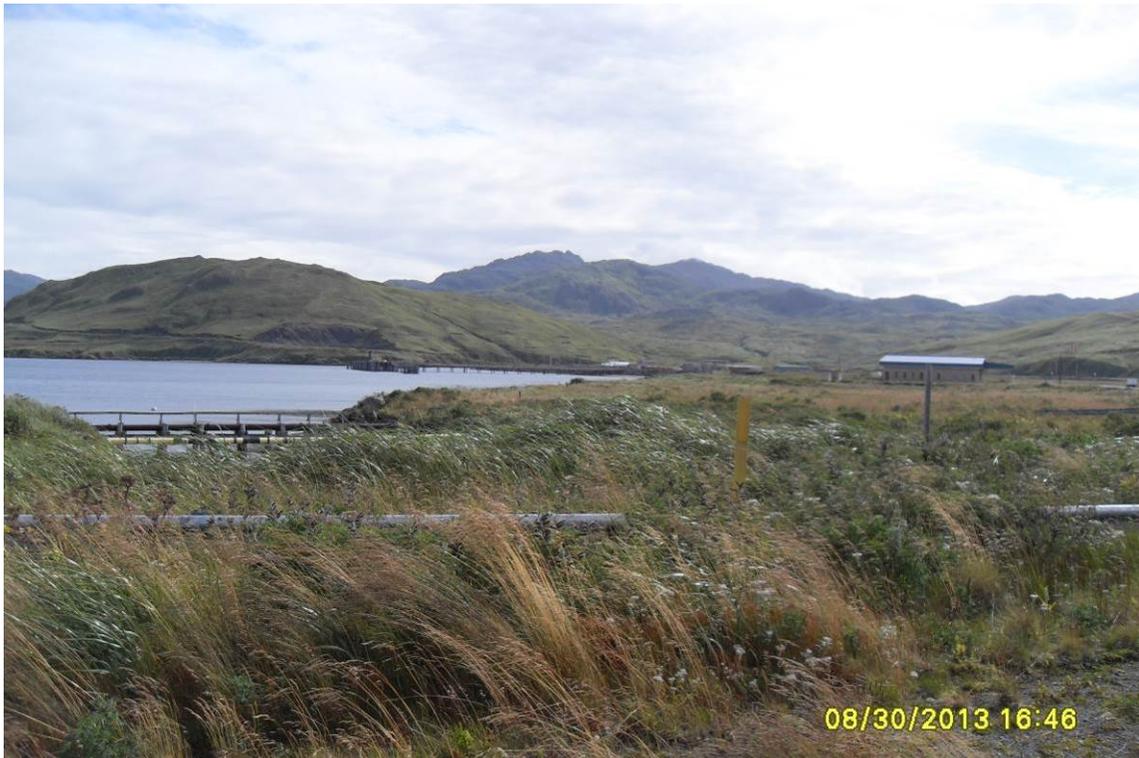
Photograph 2-25. SA 79, Main Road Pipeline - looking south across Sweeper Creek

During the August 30, 2013 inspection, no changes to the site were observed compared to the 2012 inspection results. The site is currently not being used. No residential construction had occurred, and no indications of groundwater use or excavation activities were found at the site. An excavation restriction sign was present on site and is located north of Sweeper Creek. ICs appear to be functioning as intended to protect human receptors from exposure to contaminated soil or groundwater.

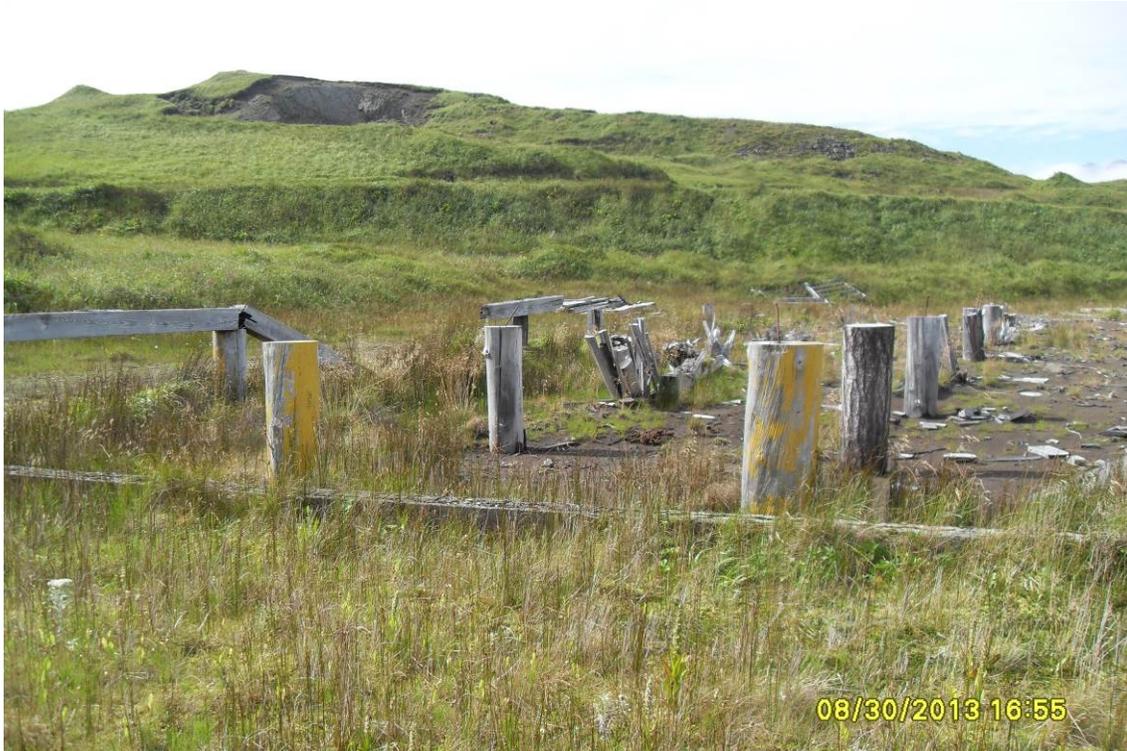
Photograph 2-26. SWMU 60, Tank Farm A - looking west at removed truck fueling platform

The fuel pipeline and seismic cable that were observed in 2011 were again observed during the August 30, 2013 inspection to be in operational use at this location, which is allowed under CMP, Revision 5 (Navy 2012a). No residential construction had occurred at the site, and excavation restriction signs were clearly visible. No indications that groundwater was being used and no evidence of excavation was observed at the site. Therefore, ICs appear to be functioning as intended to protect human receptors from exposure to contaminated soil or groundwater.

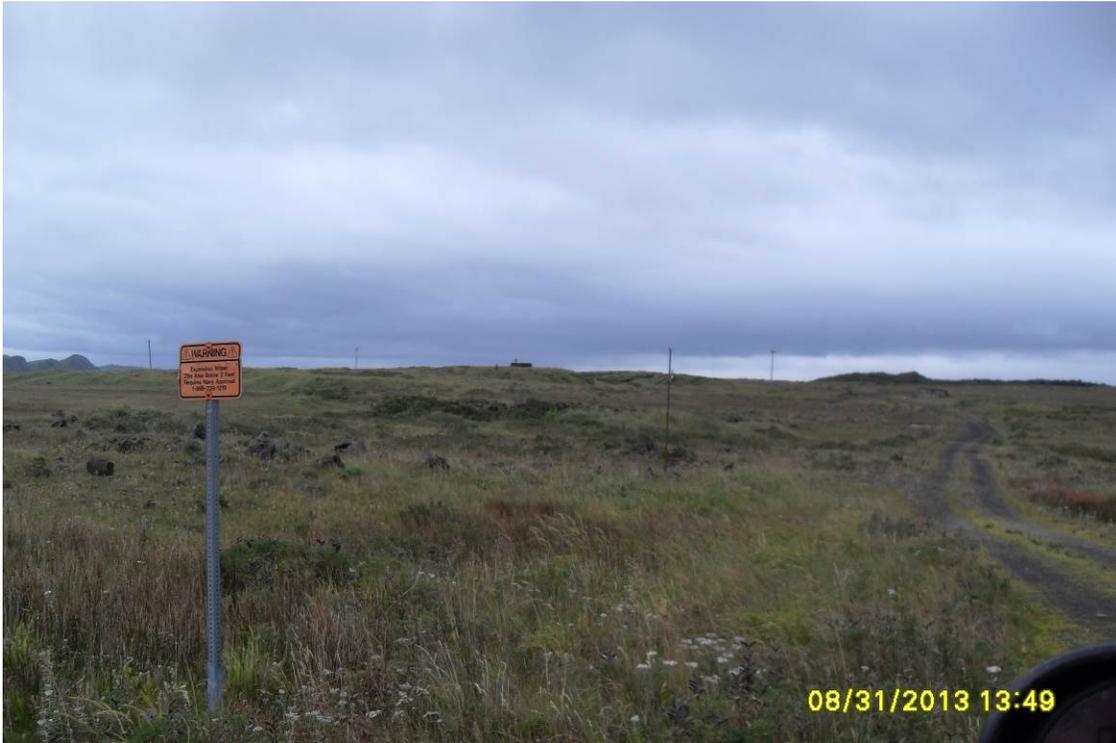
Photograph 2-27. SWMU 61, Tank Farm B – looking northeast

During the inspection on August 31, 2012, no changes to the site were observed compared to the 2012 inspection results. The site is currently not being used. No residential construction had occurred at the site. No indications that groundwater was being used and no indications of excavation activities were found at the site. Excavation restriction signs were clearly visible (Photograph 2-27). Therefore, ICs appear to be functioning as intended to protect human receptors from exposure to contaminated soil or groundwater.

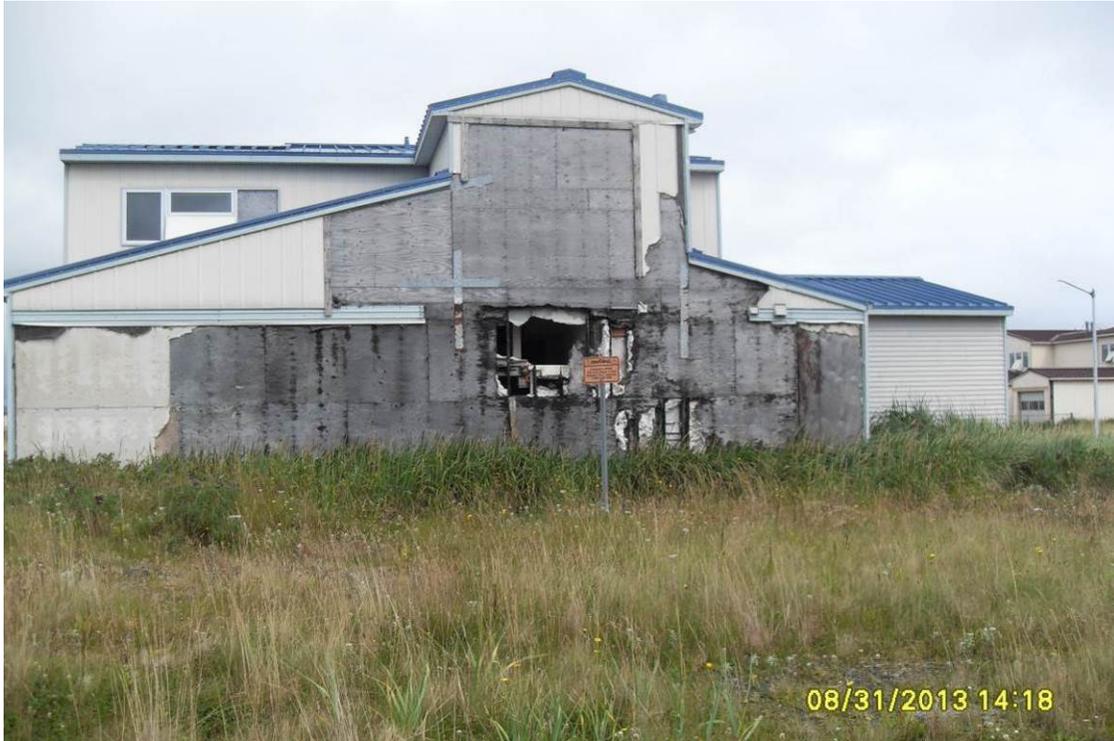
Photograph 2-28. Housing Area (Arctic Acres) – looking north

The housing units remain uninhabited, and the site is currently not being used. No excavations were observed at the site during the August 31, 2013 inspection. Excavation restriction signs are clearly visible (Photograph 2-28). No indications that groundwater was being used were observed. Therefore, ICs appear to be functioning as intended to protect human receptors from exposure to contaminated soil or groundwater.

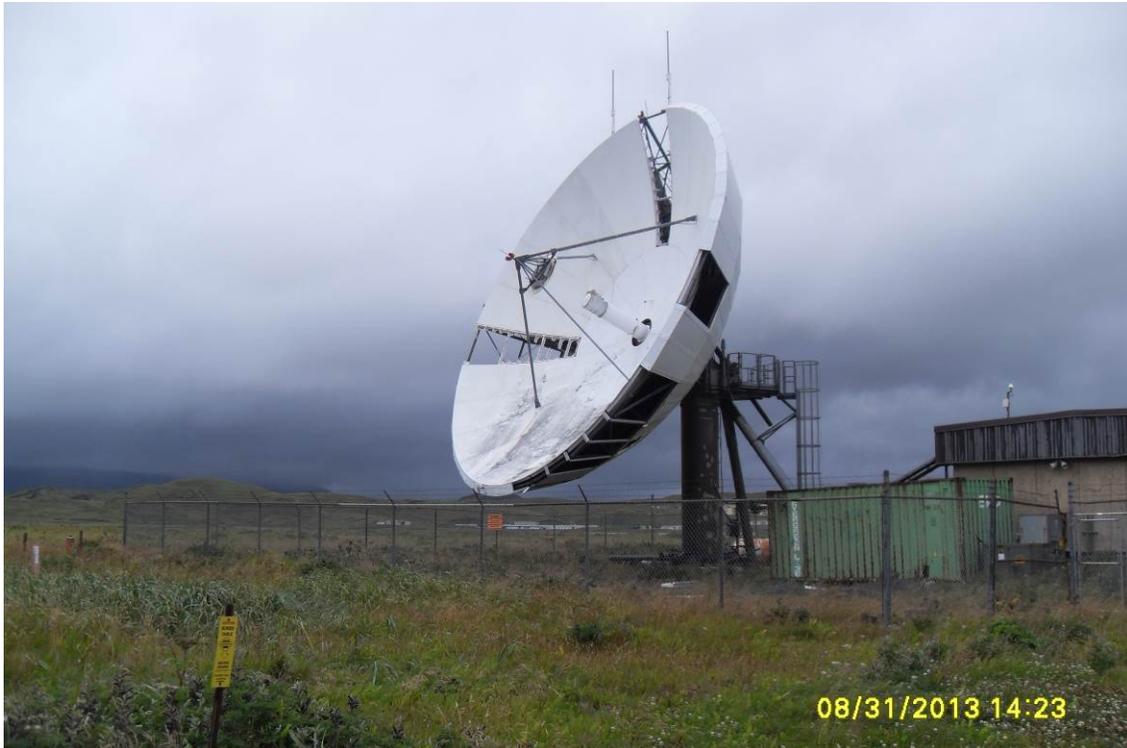
Photograph 2-29. GCI Compound (UST GCI-1) – looking southwest

The GCI Compound (UST GCI-1) site is located near the housing area and adjacent to the Main Road. The ground surface at this site consists of a level gravel lot with patches of grass within the fenced enclosure and an extensive level area covered with native grasses outside the fenced area (Photograph 2-29). The closest surface water body, East Canal, is located approximately 1,000 feet southwest of the site. A UST was removed from the site in 1995. Free product recovery has ceased at the site, and the final remedy for the GCI Compound is monitored natural attenuation.

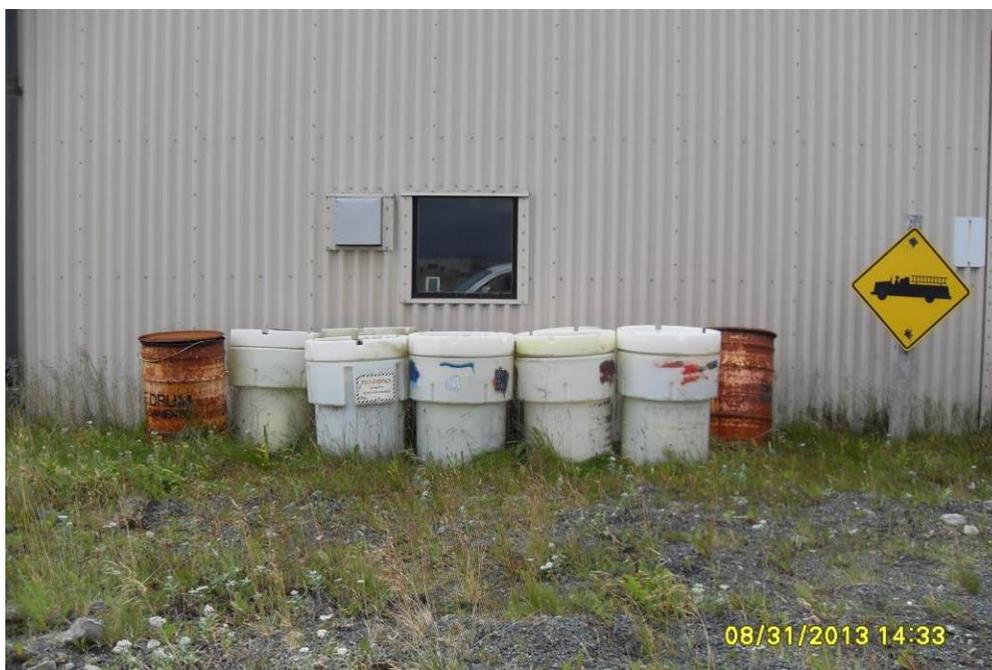
Photograph 2-30. Area 303 Poly over pack drums and rusted 55-gallon drums stored onsite – looking south

During the August 31, 2013 inspection, building T-2776 was being used by the city for emergency vehicle storage. Two 55-gallon drums were observed stored in secondary containment on the west side of the building and six poly over pack drums and two rusty 55-gallon drums were observed on the north side of the building. The drums were not labeled at the time of the inspection. No residential construction had occurred at the IC restricted area. No indications that groundwater use was occurring or excavation activities were observed at this site. One excavation restriction sign is located in the airport parking lot. Therefore, ICs appear to be functioning as intended to protect human receptors from exposure to contaminated soil or groundwater.

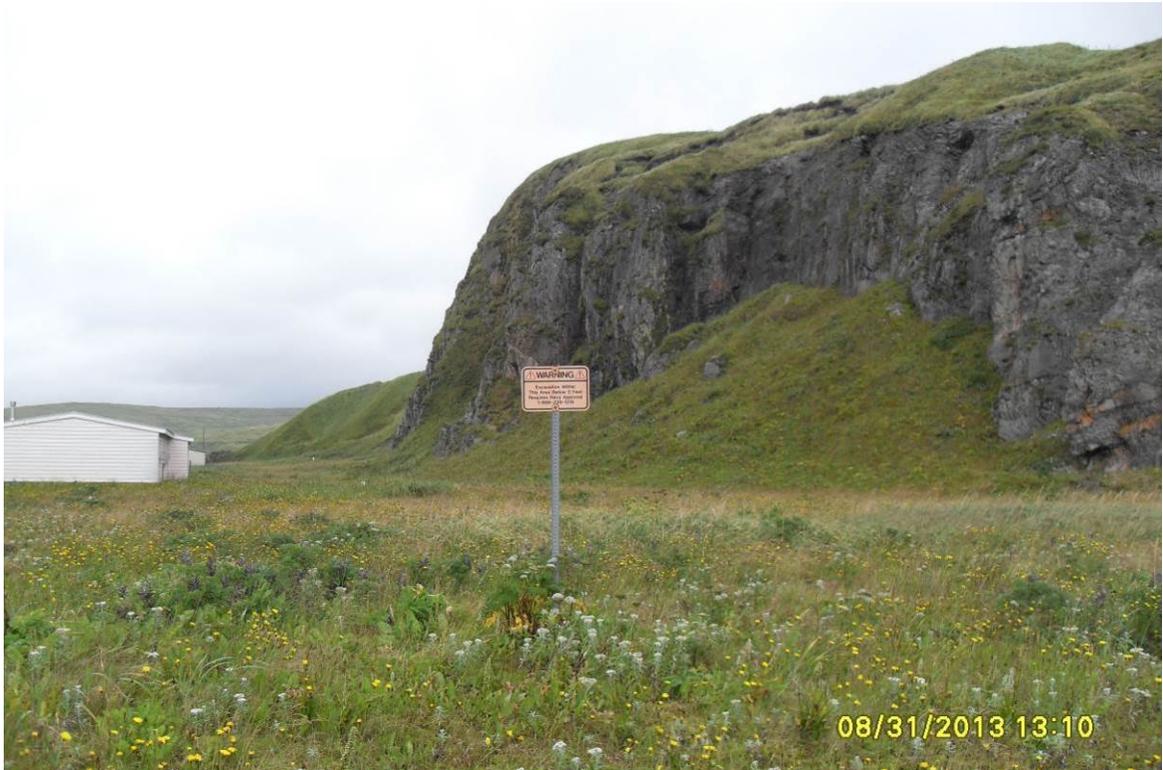
Photograph 2-32. NORPAC Hill Seep Area - looking west

During the inspection on August 31, 2013, no changes to the site were observed compared to the 2012 inspection results. No residential construction has occurred at the site, and no indications of groundwater use or excavation activities were found. Excavation restriction signs were clearly visible. Therefore, ICs appear to be functioning as intended to protect human receptors from exposure to contaminated soil or groundwater.

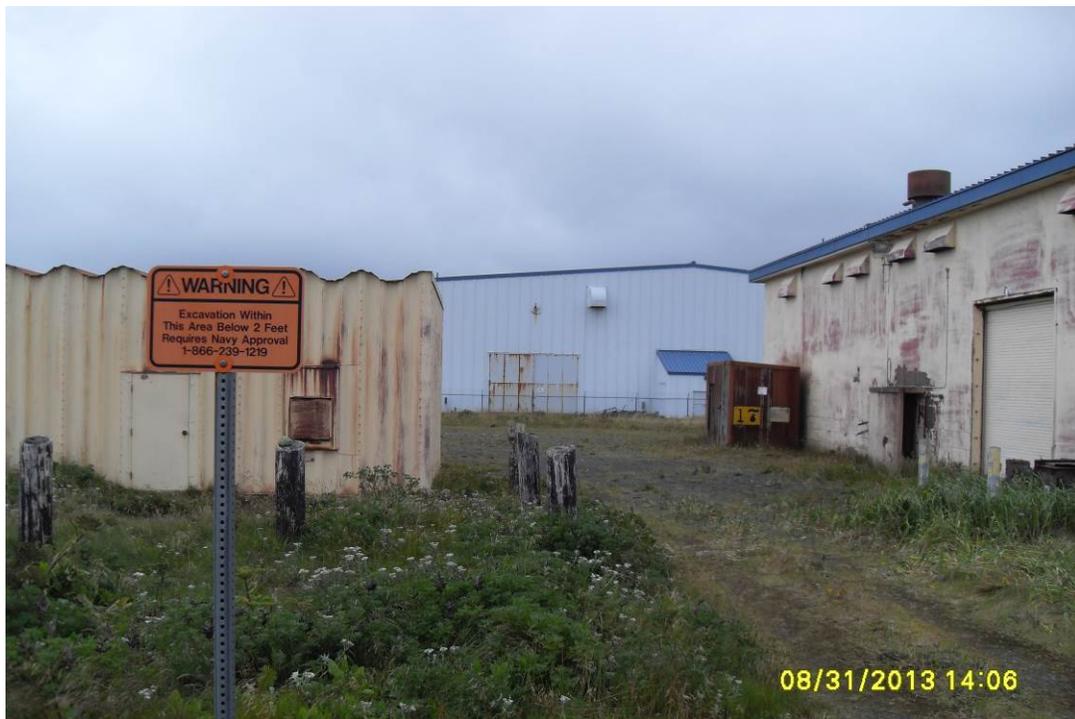
Photograph 2-33. SA 80, Steam Plant 4 – looking south

The final remedy for SA 80 is monitored natural attenuation and ICs. During the inspection on August 31, 2013, no changes to the site were observed compared to the 2012 inspection results. No residential construction had occurred at the site. No indications of groundwater use or excavation activities were found. Excavation restriction signs were clearly visible (Photograph 2-32). Therefore, ICs appear to be functioning as intended to protect human receptors from exposure to contaminated soil or groundwater.

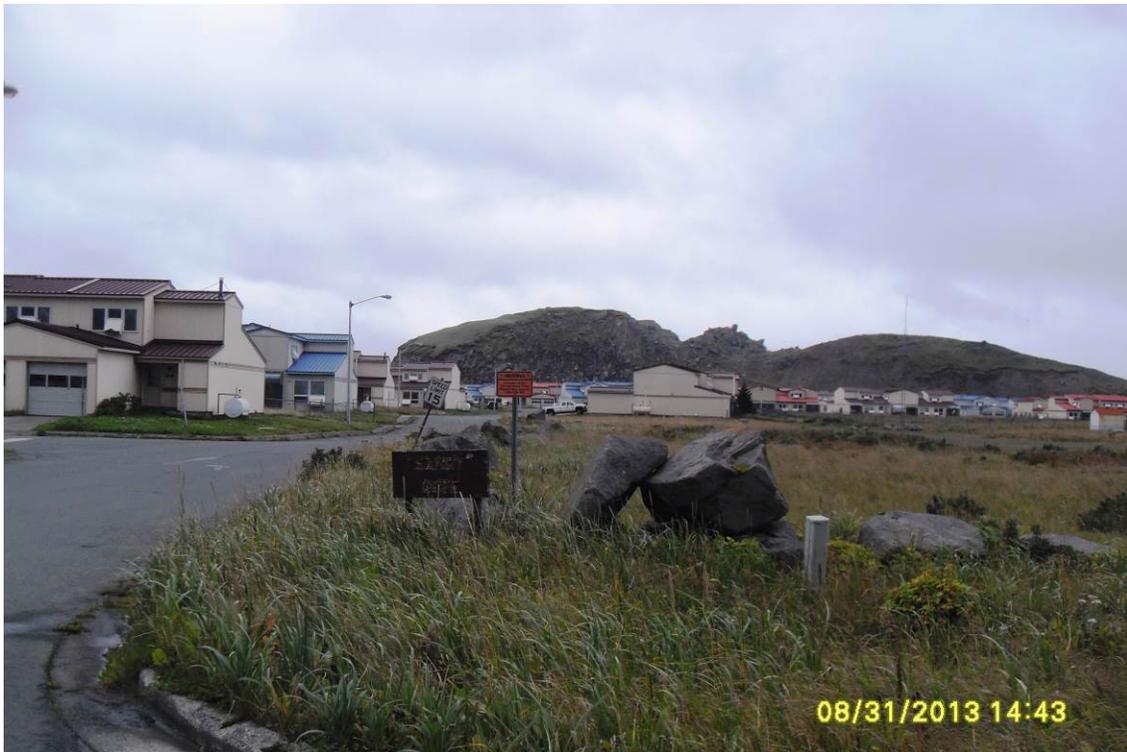
Photograph 2-34. SWMU 62, New Housing Fuel Leak – Housing area and sign looking southeast

During the August 31, 2013 inspection, the excavated area observed in 2012 in front of housing unit 140D was still visible but had some vegetation growth.

No changes to the site were observed compared to the 2012 inspection results. No excavations had occurred at the site. No indications of groundwater use were found. Excavation restriction signs were clearly visible. No indications of tampering with the product recovery trench were observed. All other ICs appear to be functioning as intended.

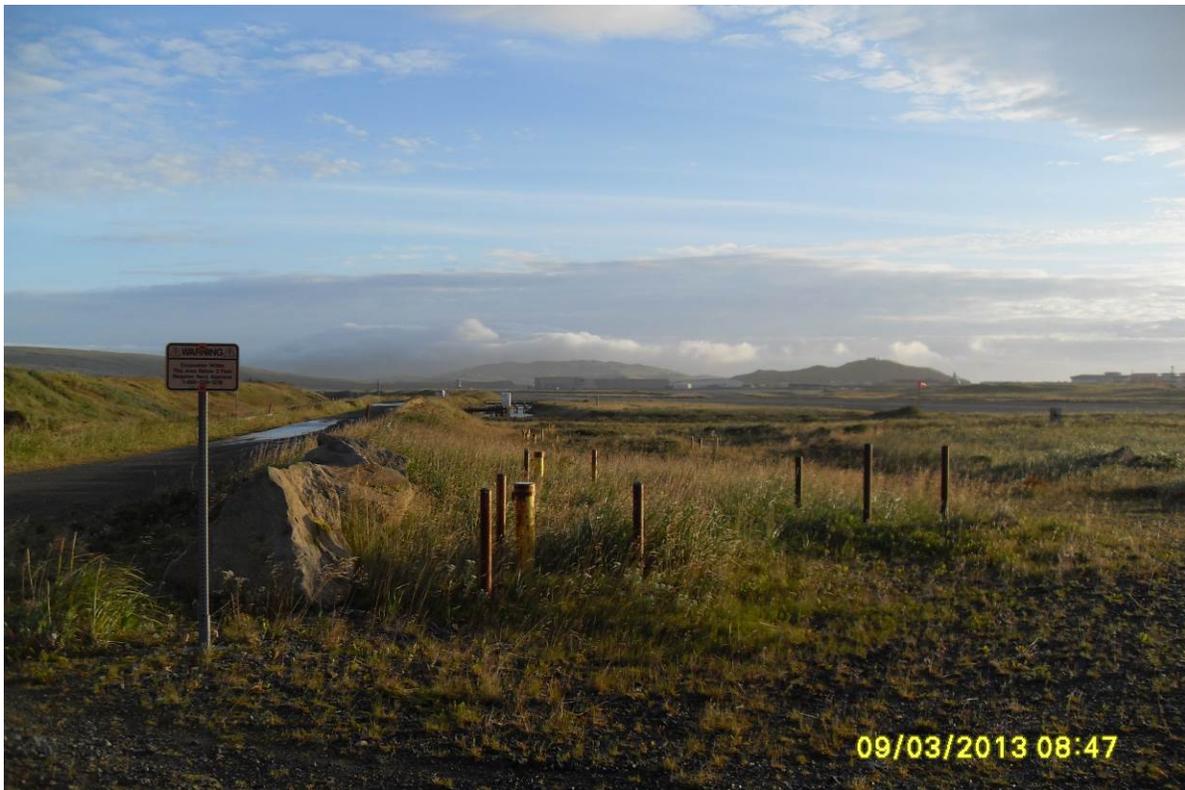
Photograph 2-35. South of Runway 18-36 - looking northeast from south end of Runway 18-36 at yellow recovery trench wells and sign

During the inspections on August 31, 2013, no changes to the site were observed compared to the 2012 inspection results. No residential construction had occurred at the site. No indications of groundwater use or excavation activities were found at the site. No excavations were identified during the inspection, and excavation restriction signs were clearly visible. The product recovery trench system located onsite is no longer in use as agreed upon with ADEC. ICs appear to be functioning as intended to protect human receptors from exposure to contaminated soil or groundwater.

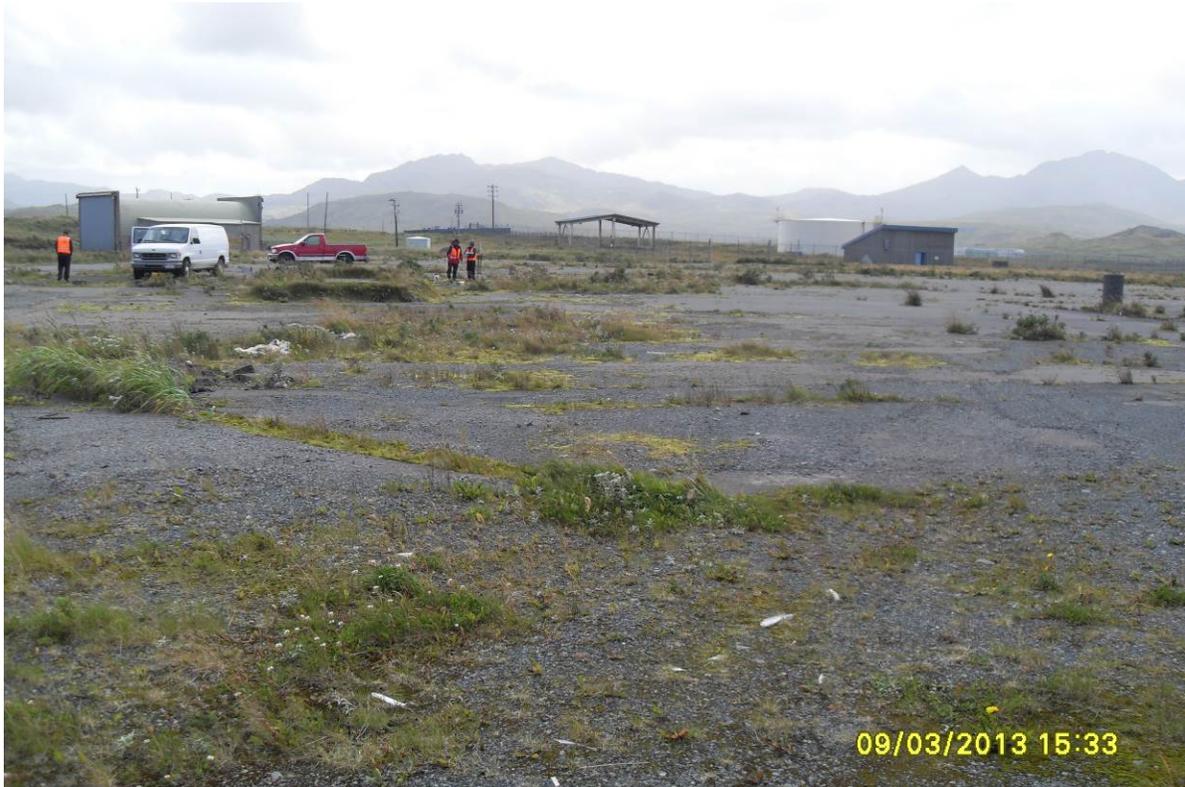
Photograph 2-36. Tanker Shed UST 42494 – looking south and sampling crew

The final remedy for the Tanker Shed site is monitored natural attenuation and continued free product recovery. During the inspection on August 31, 2013, no changes to the site were observed compared to the 2012 inspection results. The abandoned remediation system observed on site which contains two 55-gallon drums and hoses in a poly container was removed from the site in November 2012. The site appeared to not be in use. No residential construction had occurred at the site, and no indications of groundwater use or excavation activities were found. Excavation restriction signs were clearly visible at the site. Therefore, ICs appear to be functioning as intended to protect human receptors from exposure to contaminated soil or groundwater.

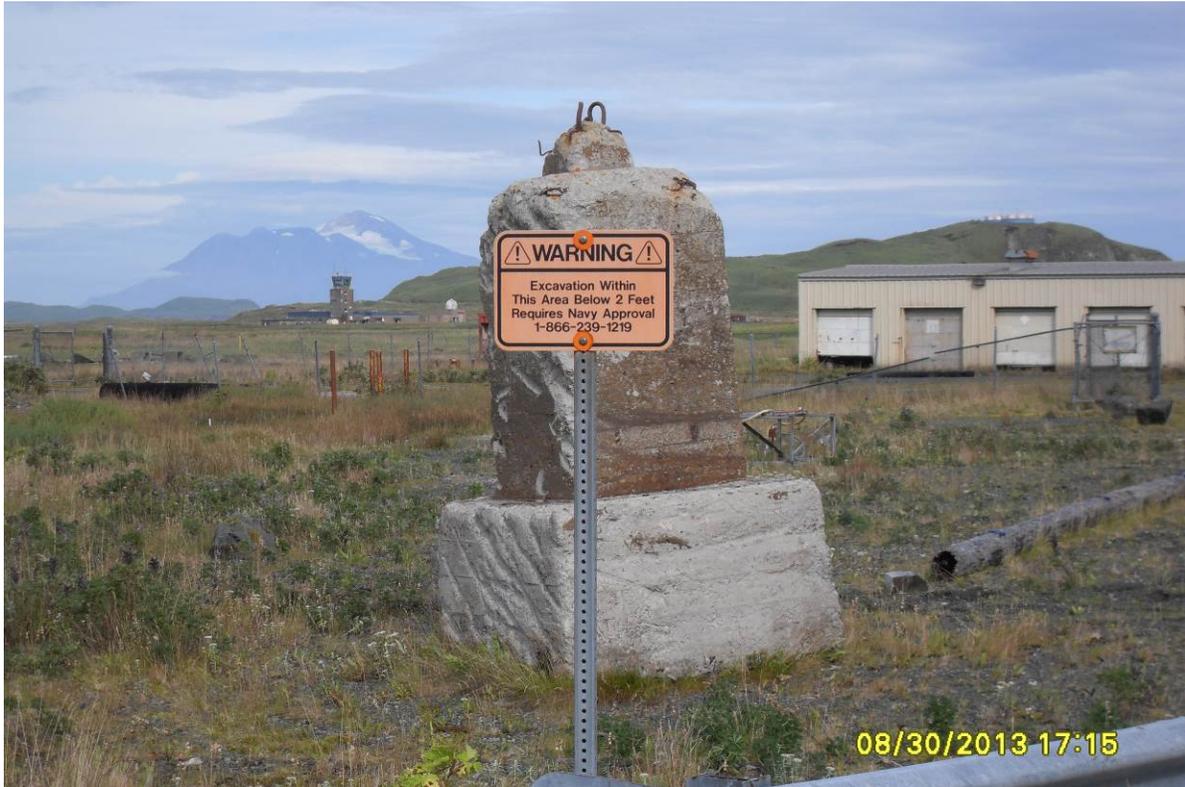
Photograph 2-37. Yakutat Hangar – looking southeast at excavation restriction sign

During the inspection on August 30, 2013, no changes to the site were observed compared to the 2012 inspection results and the site appeared to not be in use. No residential construction had occurred at the site. No indications of groundwater use or excavation activities were found. Excavation restriction signs were clearly visible (Photograph 2-37). Therefore, ICs appear to be functioning as intended to protect human receptors from exposure to contaminated soil or groundwater.

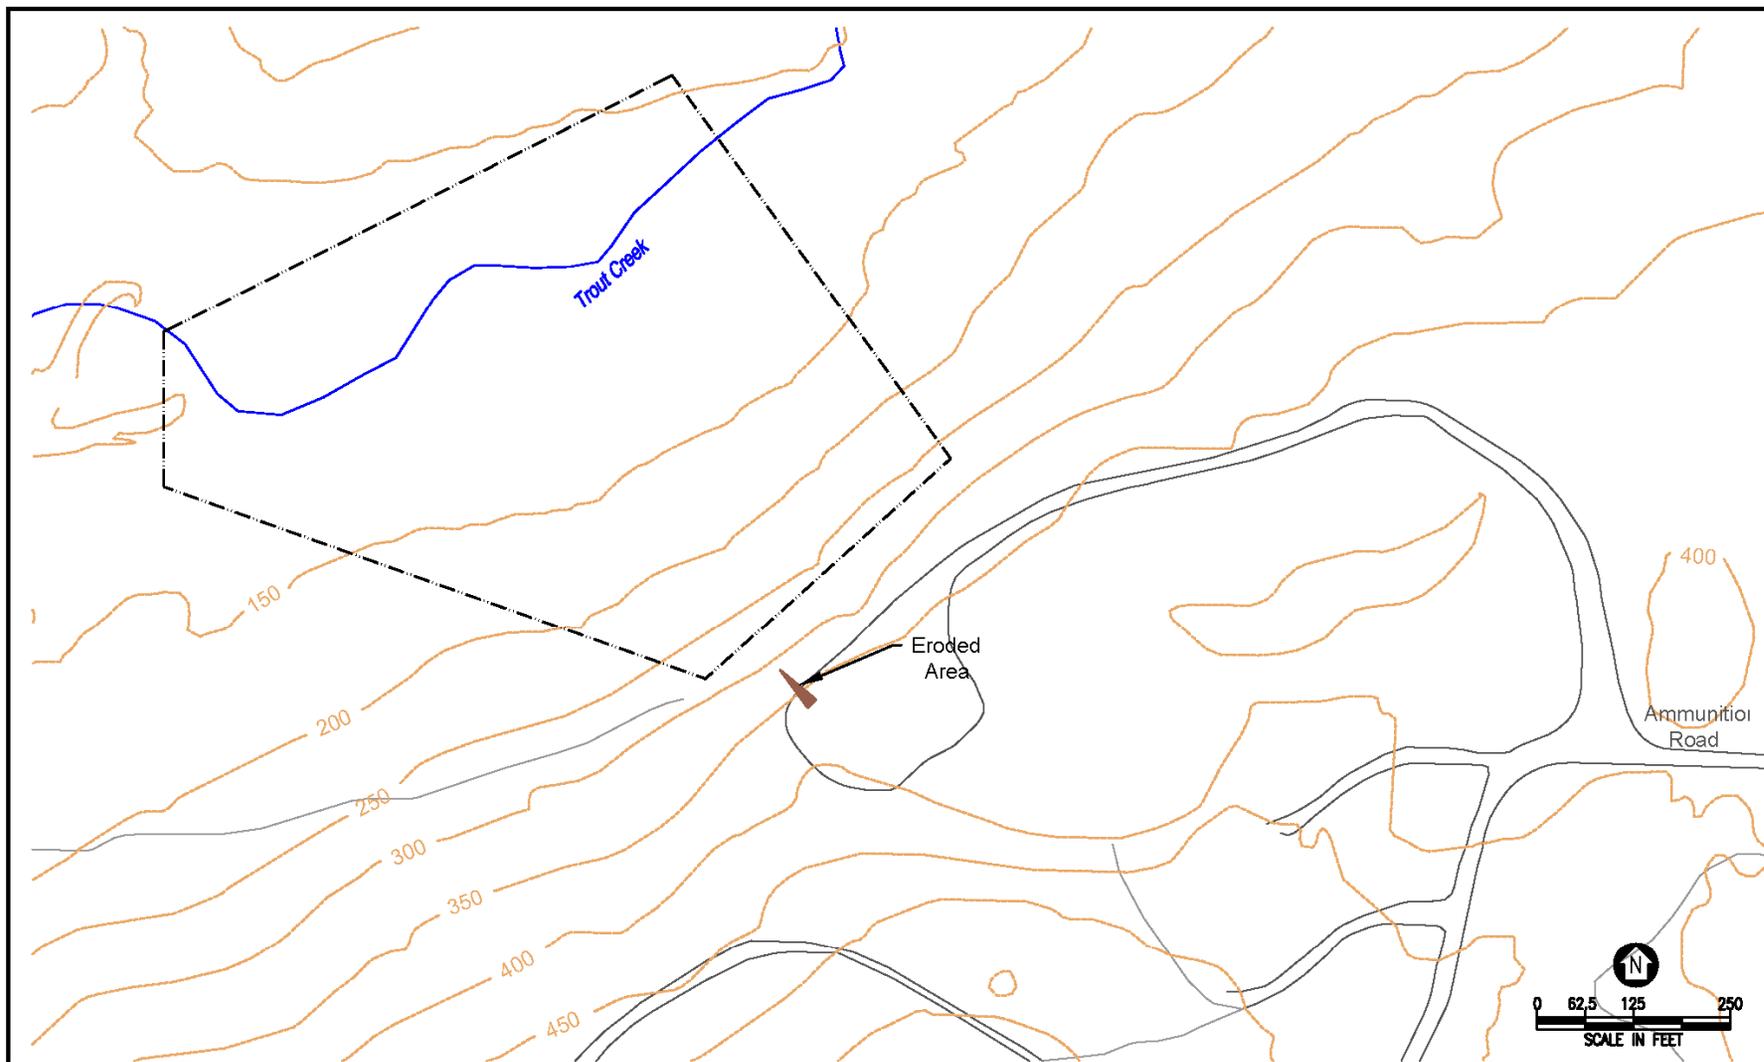
U.S.NAVY	SEALASKA	Figure 3-1 SWMU 20 White Alice Trout Creek Disposal Area	Task Order 66 Adak Island, AK 2013 IC Inspection Report
-----------------	-----------------	---	---

An eroded area approximately 60 feet long and 15 feet wide running down the cliff face was observed during the 2013 inspection (Photograph 3-1, Figure 3-1). ICs appear to be functioning as intended to protect human receptors from exposure to contaminated soil or groundwater. The eroded areas on the cliff face are recommended for repair.

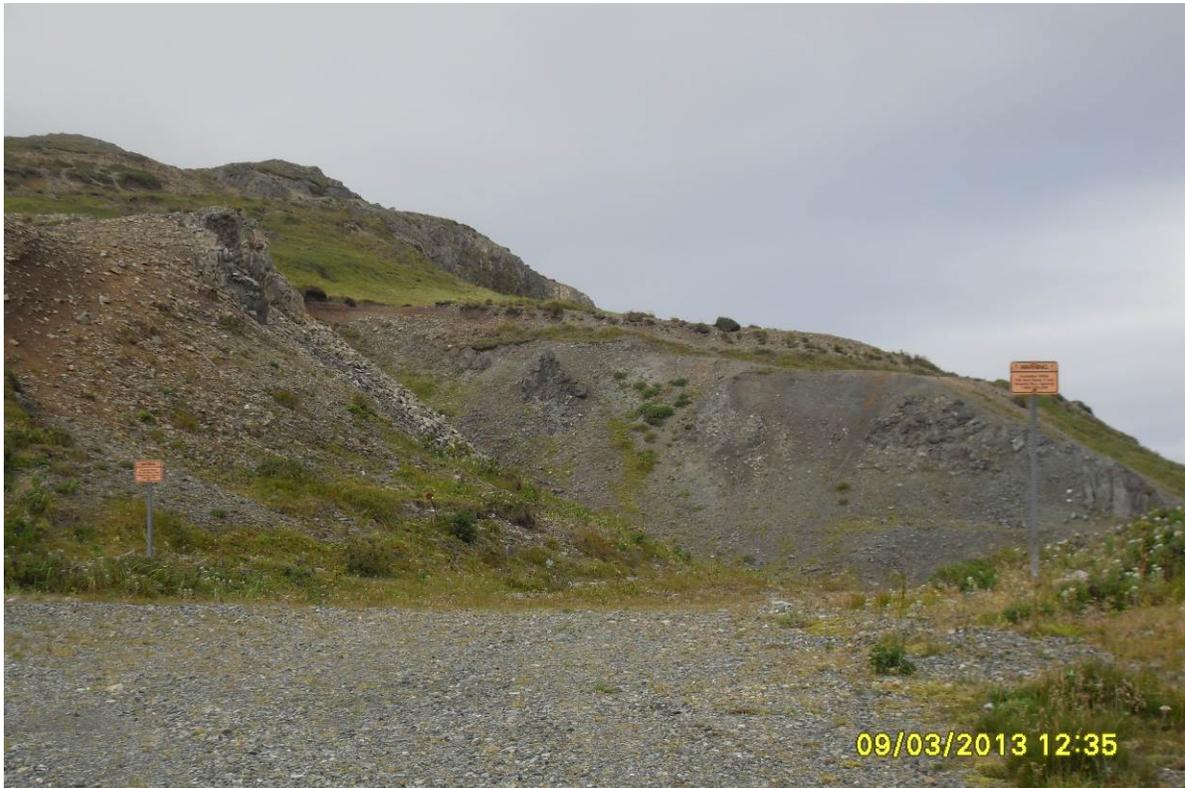
Photograph 3-2. SWMU 21A, White Alice Upper Quarry – looking west

During the inspection on September 3, 2013, no changes to the site were observed compared to the 2012 inspection results. No residential construction had occurred at the site. No excavations were identified during the inspection and excavation restriction signs were

clearly visible (Photograph 3-2). The site appeared not to be in use. Therefore, ICs appear to be functioning as intended to protect human receptors from exposure to contaminated soil or groundwater.

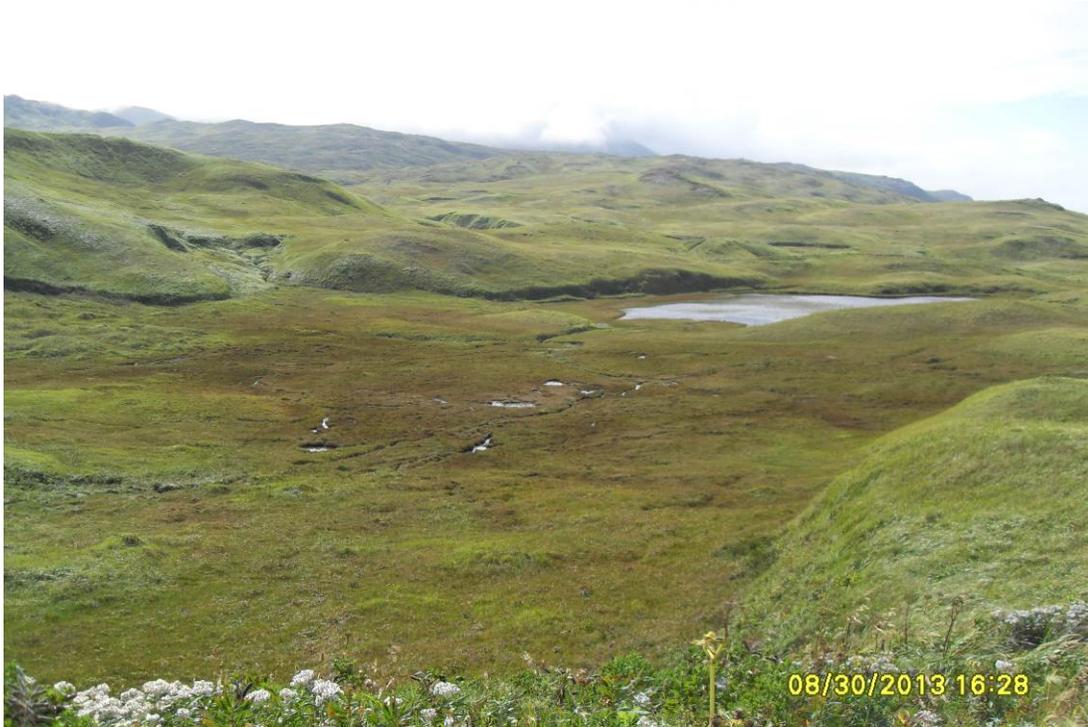
Photograph 3-3. SWMU 23, Heart Lake Drum Disposal– looking west

During the inspection on August 30, 2013, no changes to the site were observed compared to the 2012 inspection results. No residential construction had occurred at the site. The site appeared not to be in use. No excavations were identified during the inspection and excavation restriction signs were clearly visible. Therefore, ICs appear to be functioning as intended to protect human receptors from exposure to contaminated soil or groundwater.

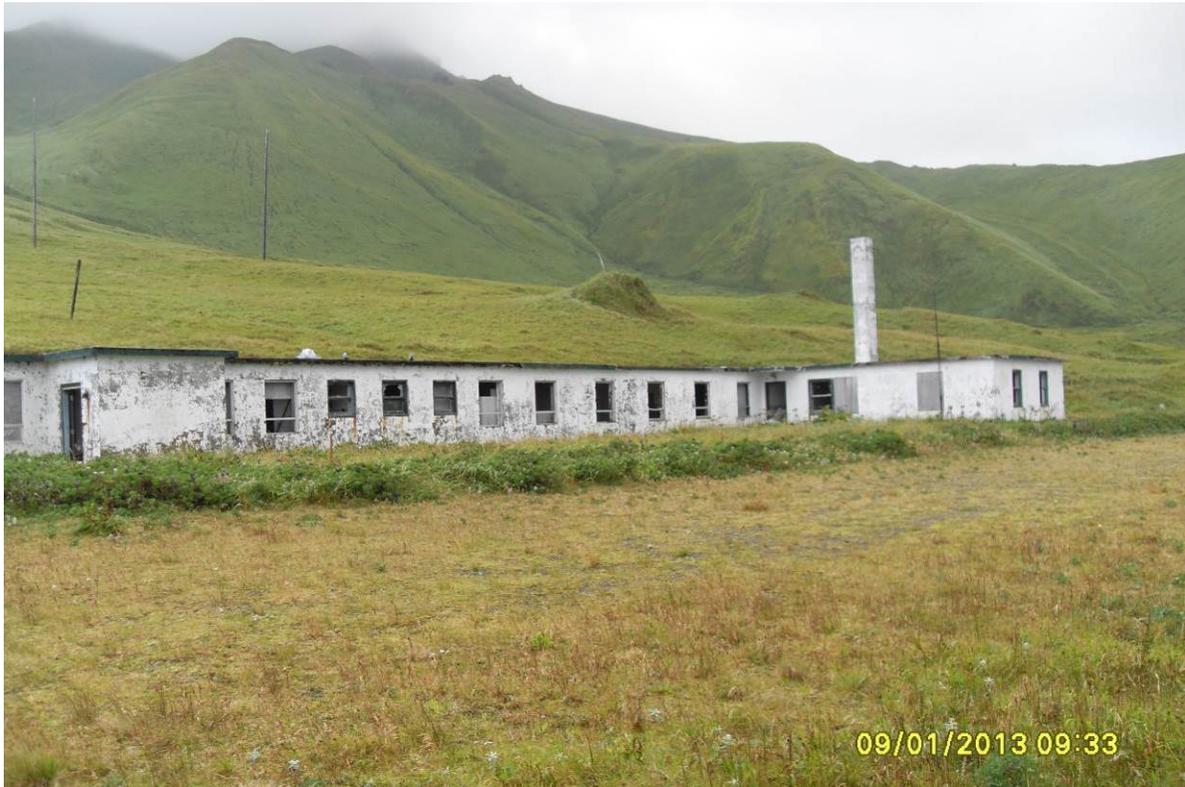
Photograph 3-4. SWMUs 52, 53, and 59, Former LORAN Station – looking northeast

During the inspection on September 1, 2013, no changes to the site were observed compared to the 2012 inspection results. No indications of excavation activities were found and excavation restriction signs are clearly visible. Some recreational use of the site was evident which included graffiti and empty beverage cans but was within the requirements of the ROD. The site is not accessible by on-road vehicles due to a landslide on the access road approximately a mile from the site. Therefore, ICs appear to be functioning as intended to protect human receptors from exposure to contaminated soil or groundwater.
