2013 Institutional Controls Site Inspection Report

Operable Units A and B-1

Former Naval Complex

Adak, Alaska

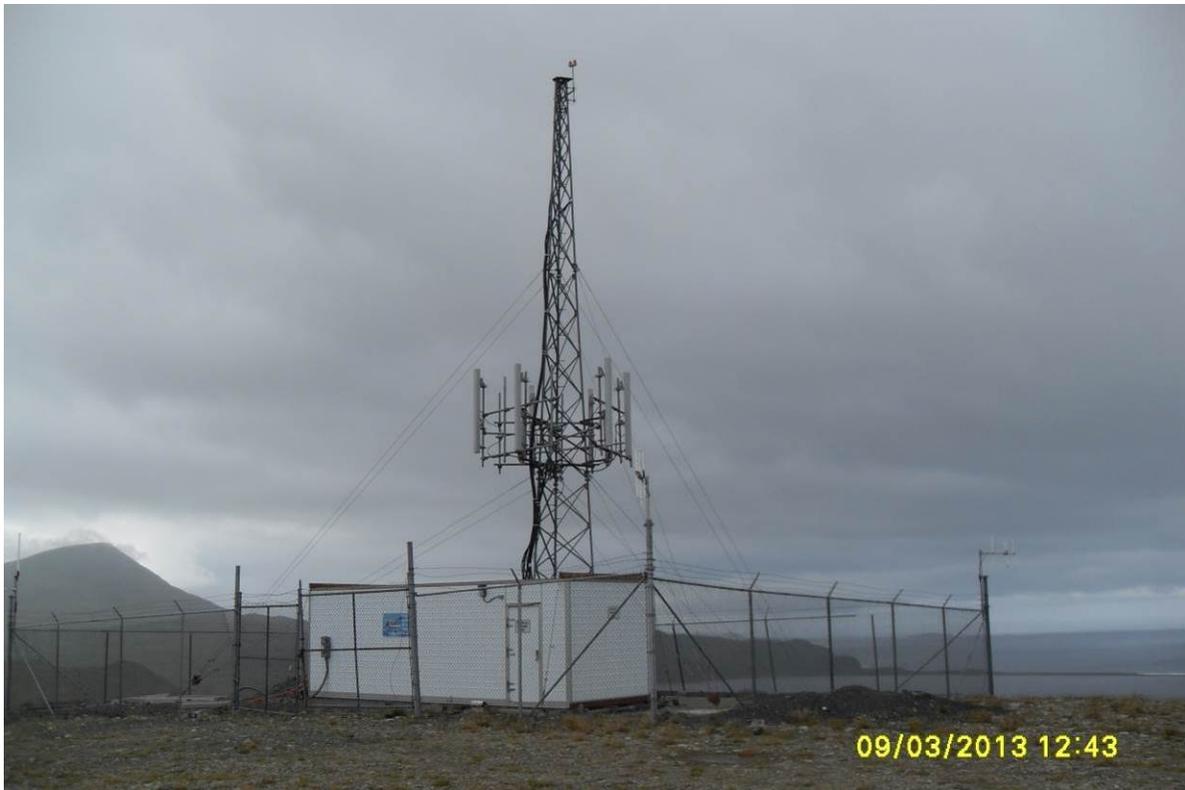
Photograph 3-5. SWMU 67, White Alice PCB Spill Area – looking southwest at the new cell tower

During the inspection on September 3, 2013, the cellular tower and building within a fenced area was observed on site (Photograph 3-5). No new excavation was observed at this site. The use of the communication equipment onsite is consistent with intended reuse. No indications of a change in land use in this area were found. Excavation restriction signs are clearly visible. Therefore, ICs appear to be functioning as intended to protect human receptors from exposure to contaminated soil or groundwater.

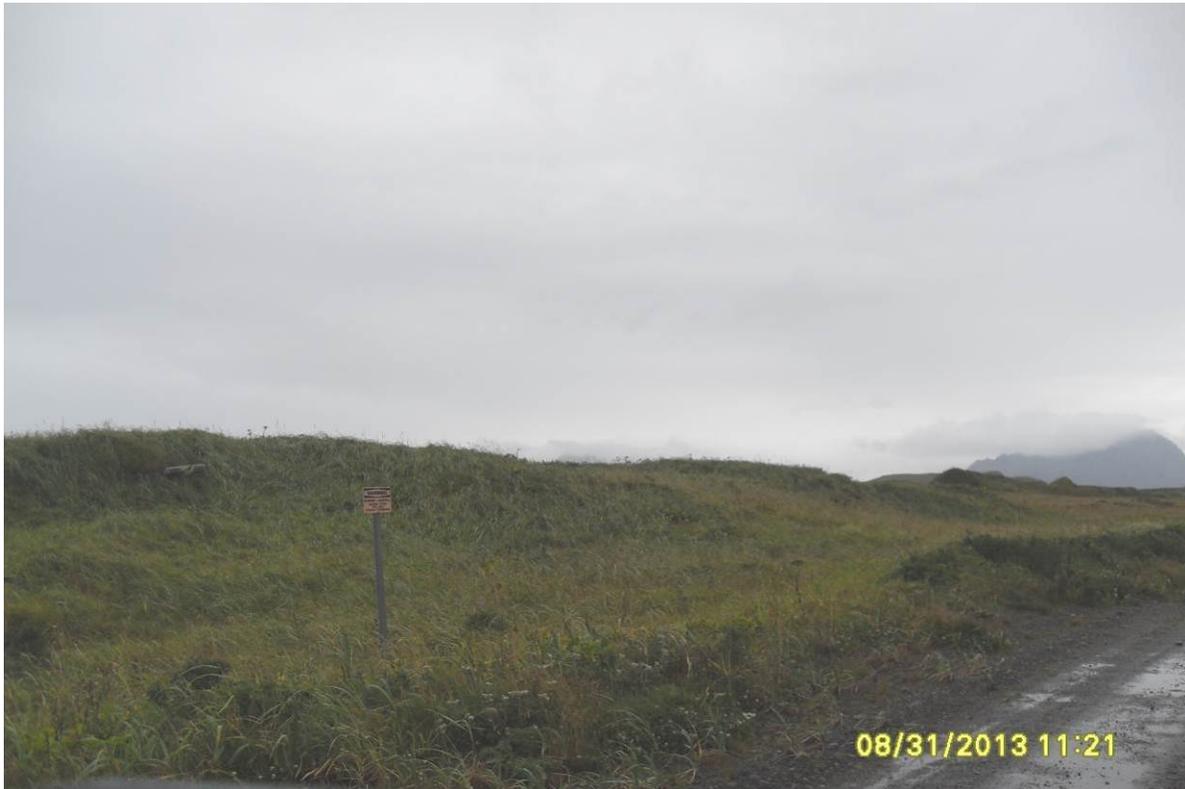
During the inspection on August 31, 2013, no changes to the site were observed compared to the 2012 inspection results. No residential construction or excavation had occurred at the site. Engineering controls that were implemented at SWMU 2 include signs and soil cover. At the time of inspection, the landfill cap appeared to be intact and undisturbed with good

vegetative cover and no evidence of ponding. Three landfill notification signs were intact and visible along the road (Photograph 3-6). Therefore, ICs appear to be functioning as intended to protect human receptors from exposure to contaminated soil or groundwater.

Photograph 3-6. SWMU 2, Causeway Landfill – looking southwest

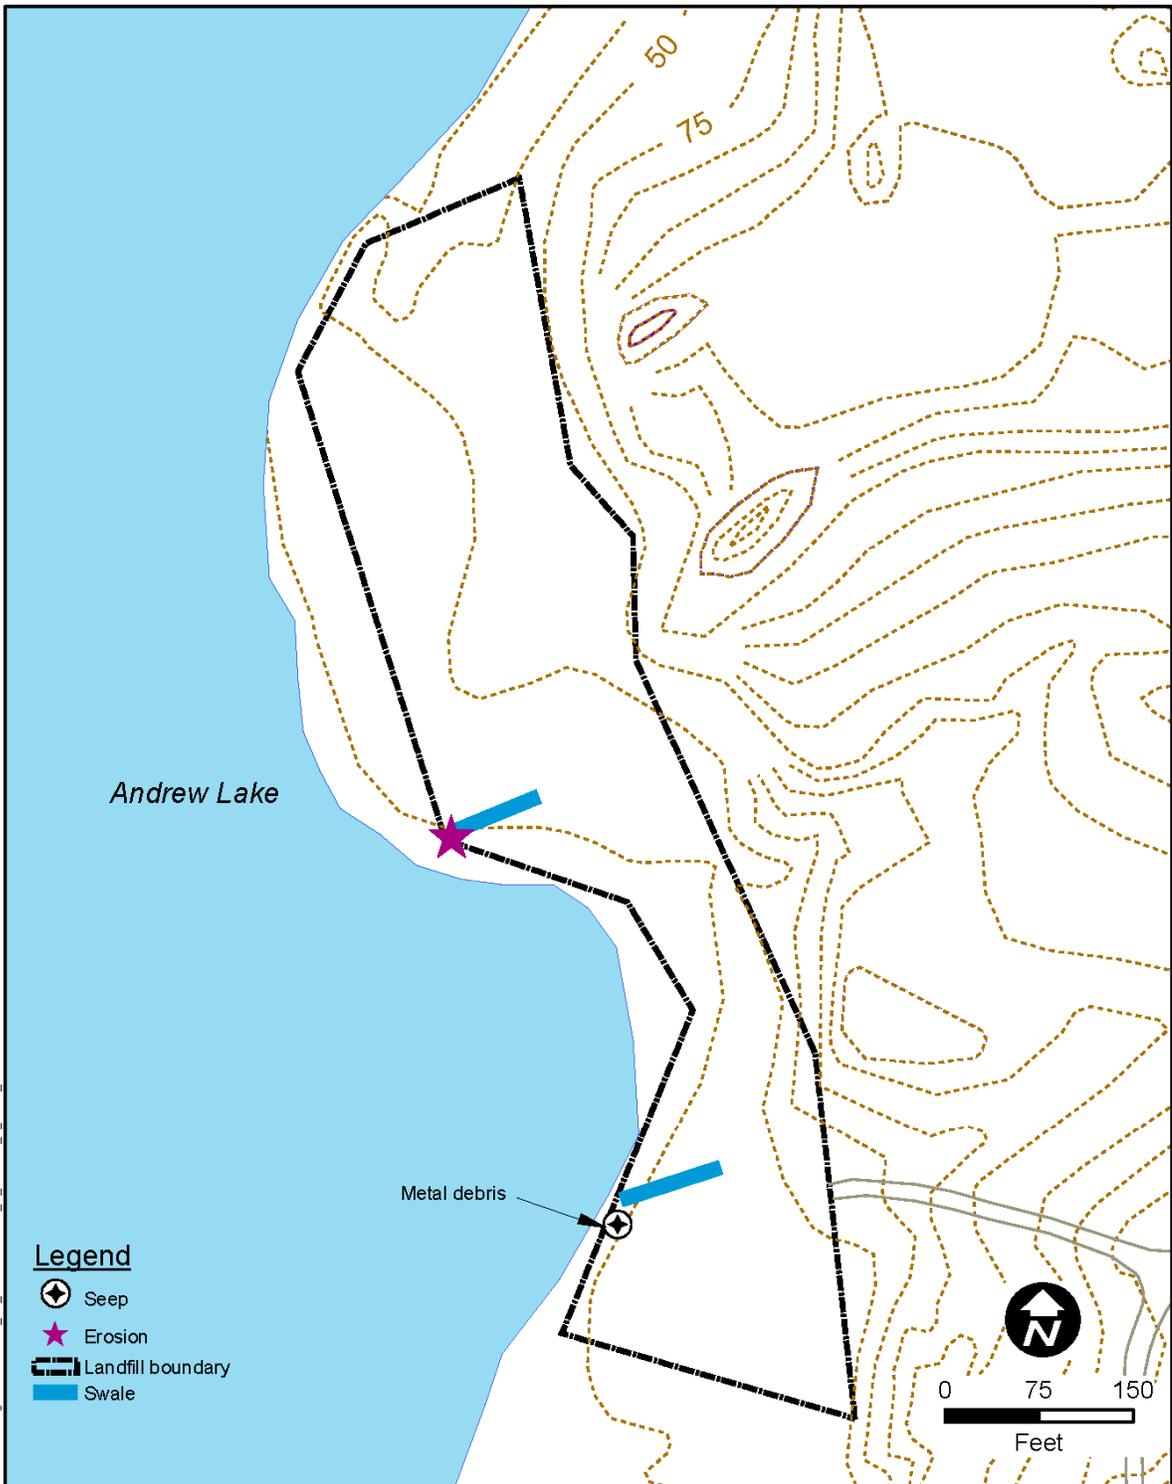
<p>U.S. NAVY SEALASKA</p>	<p align="center">Figure 3-2 SWMU 4, South Davis Road Landfill</p>	<p align="right">Task Order 66 Adak Island, AK 2013 IC Inspection Report</p>
----------------------------------	---	---

During the inspection on September 1, 2013, the erosion observed during previous inspections at the west end of the northern swale was still present (Figure 3-2). A silt fence that had been installed here was observed to be torn with rocks and sediment piled on top. It is recommended that the silt fence and eroded area be repaired. During the 2013 inspection a seep was observed at the southeast end of the landfill approximately 20 feet south of the southern swale (Photograph 3-7). The seep is approximately 8 feet wide and was observed to be flowing 0.5 liters per minute. The water was clear with no odor. Metal debris was observed below the seep on the beach. No other indications of a change in land use in this area were found and no residential construction had occurred at the site. No indications of excavation activities were found and restriction signs were clearly visible. The landfill cap was well vegetated.

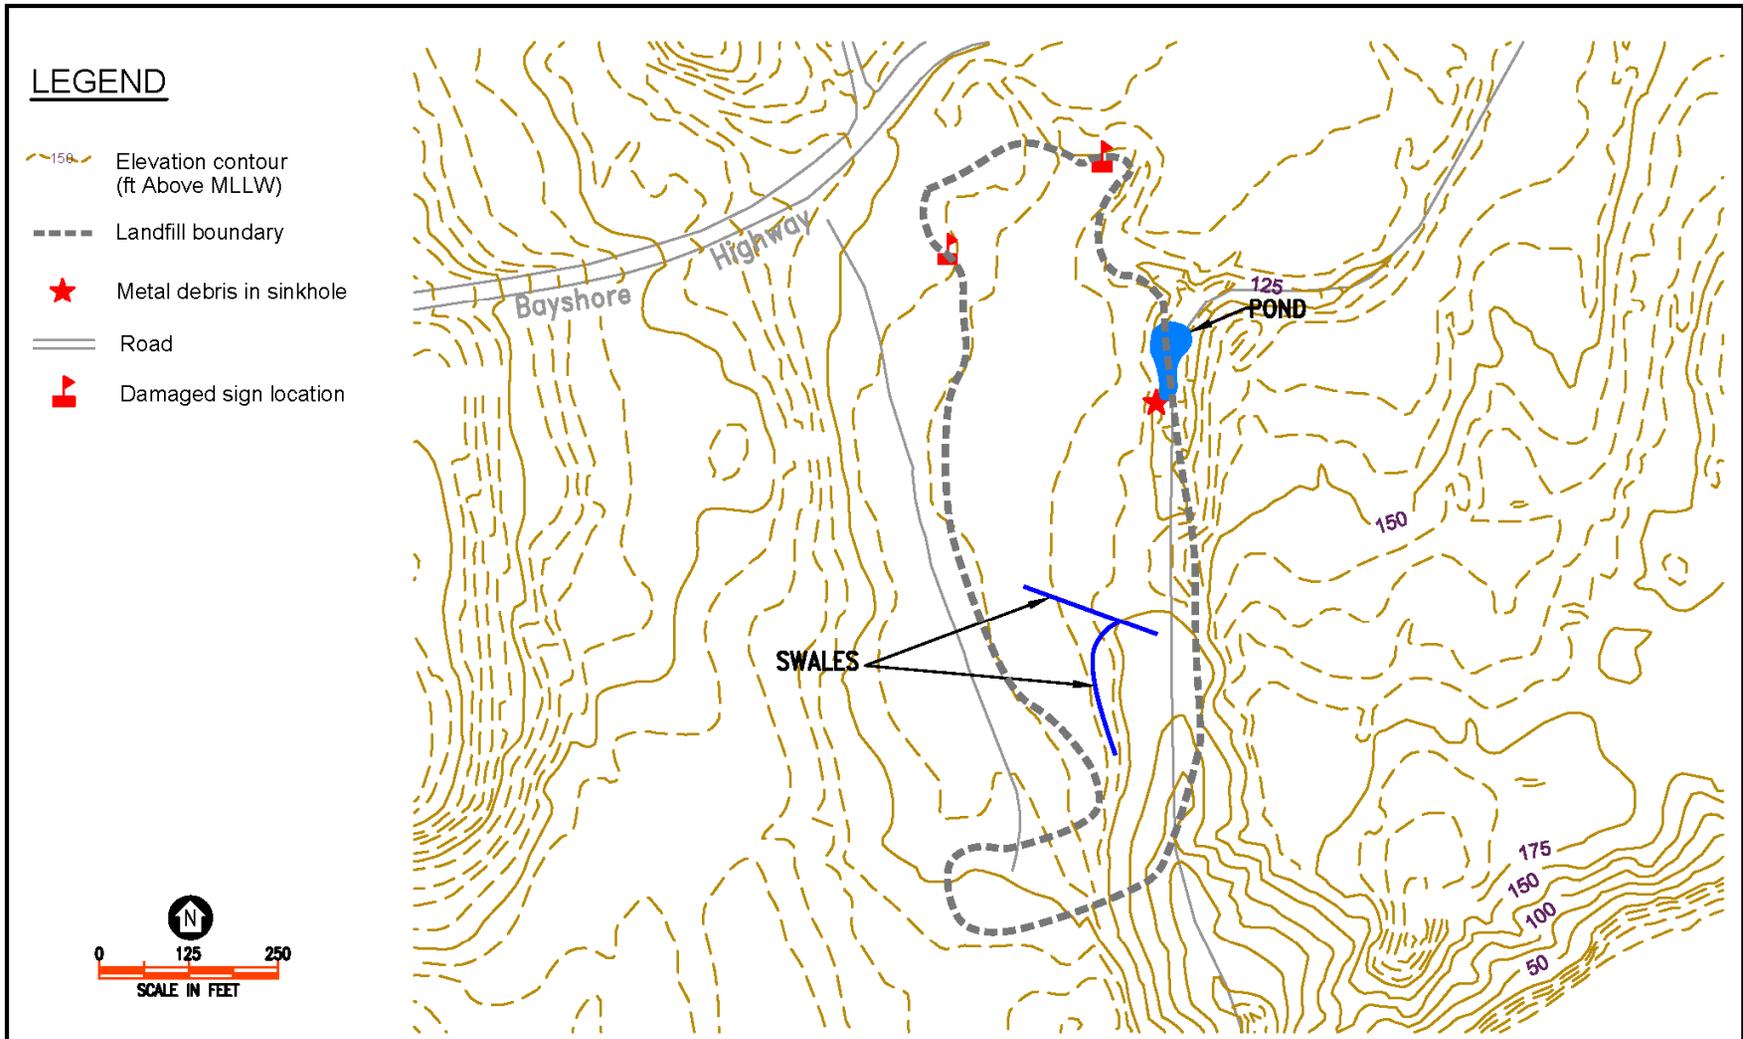
U.S.NAVY SEALASKA	Figure 3-3 SWMU 11, Palisades Landfill	Task Order 66 Adak Island, AK 2013 IC INSPECTION REPORT
--------------------------	---	--

The pond with metal debris located in the ravine on north central portion of landfill noted during previous inspections was observed during the 2013 inspection, but it was much smaller with lower water levels than observed last year. The pond was approximately 25 feet at its widest (Figure 3-3). Water was observed flowing into the previously noted sinkhole at the southern end of the pond but at a much lower rate than observed in 2012 (Photograph 3-

8). Although, it could not be visually confirmed, it is presumed the water was flowing underground and exiting further down the ravine. The sinkhole, which was repaired in 2010, and again observed in 2012 contains wood and metal debris and has increased in size from the previous inspection. The sinkhole was observed to be approximately 15 feet in diameter with an unknown depth. Metal debris was also observed in the pond and protruding along the water's edge on the west side of the pond. It is recommended that the sinkhole be repaired.

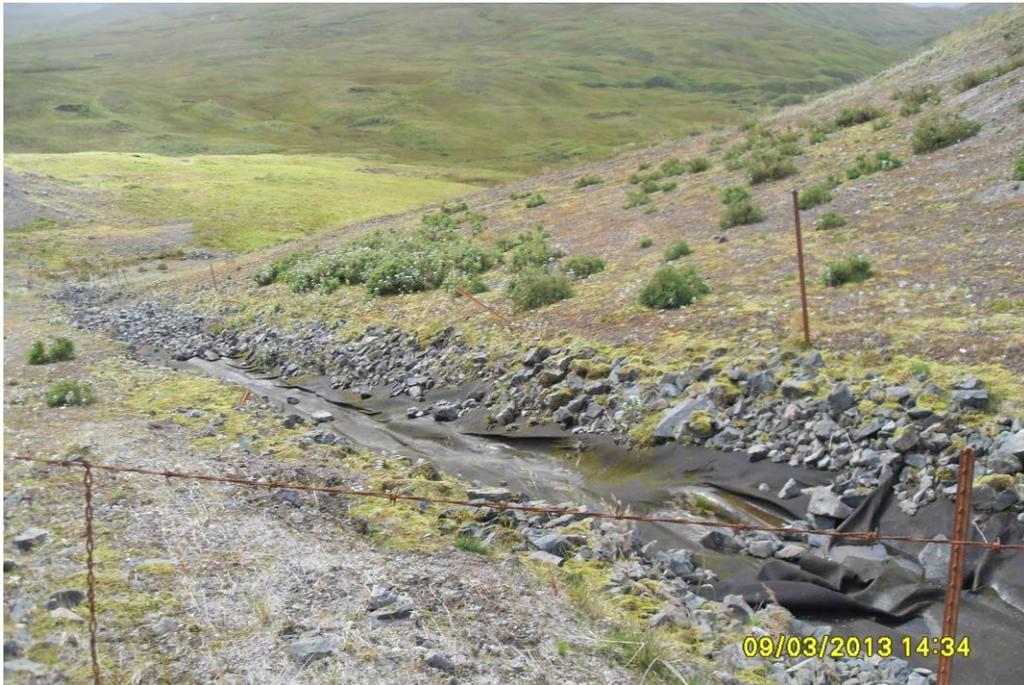
Photograph 3-9. SWMUs 18 and 19, White Alice Landfill – looking south at southern swale with exposed liner

- The repaired and re-seeded eroded area on the southern boundary at the top of the swale appears to be stable but re-vegetation efforts have not been successful. The seeded area at the top of the swale outside of the fence is approximately 150 feet by 75 feet is still not vegetated and could be susceptible to future erosion (Photograph 3-9).

- The swale coming from the southern boundary has three areas of exposed liner where the gravel has slid off (Photograph 3-9). A newly observed area of exposed liner was observed inside the landfill perimeter north of the southern boundary at the confluence of two swales (Photograph 3-10, Figure 3-4).

- Continue to monitor the ponding outside the northern landfill boundary for potential erosion along the fence line.
- Seed and fertilize the eroded area north of the entrance gate.
- The non-vegetated areas will be re-seeded. Use of other tundra mixes than what has been used previously will be investigated to yield better re-seeding results.
- Re-rock the swale so the liner is not exposed. Install some type of flow dissipater within the channel at several locations to prevent rock from sliding down the incline.
- Move the sign near the gate so the vegetation does not obscure it.
- Repair broken fencing.

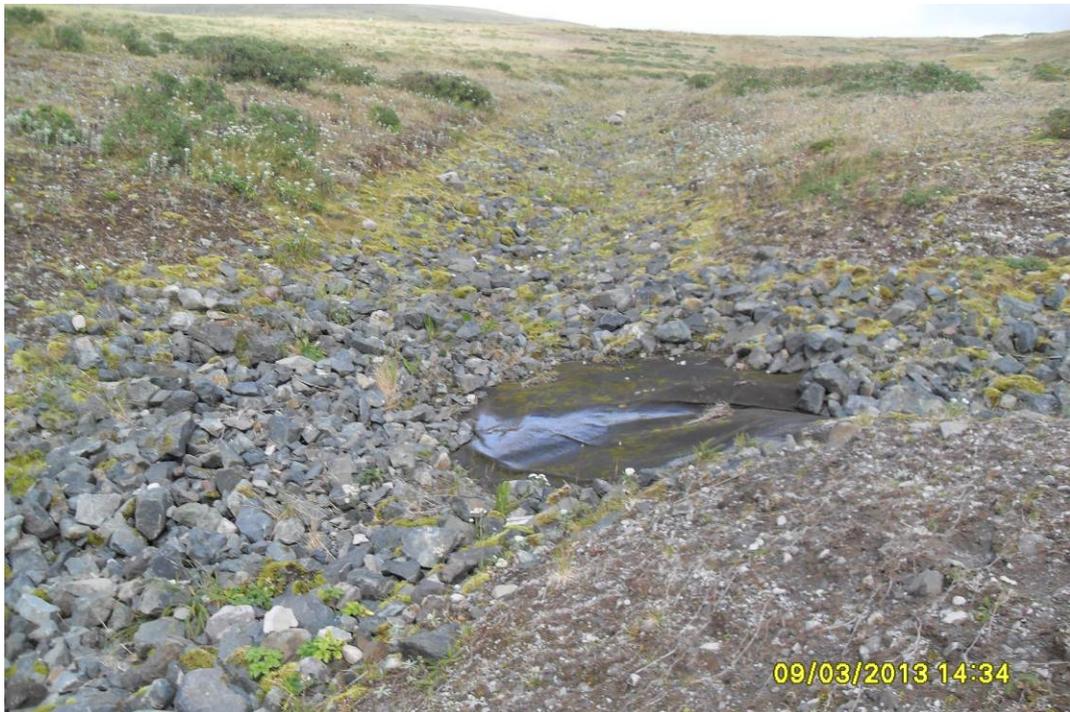
Photograph 3-10. SWMUs 18 and 19 White Alice Landfill – looking north at the newly observed swale liner area.

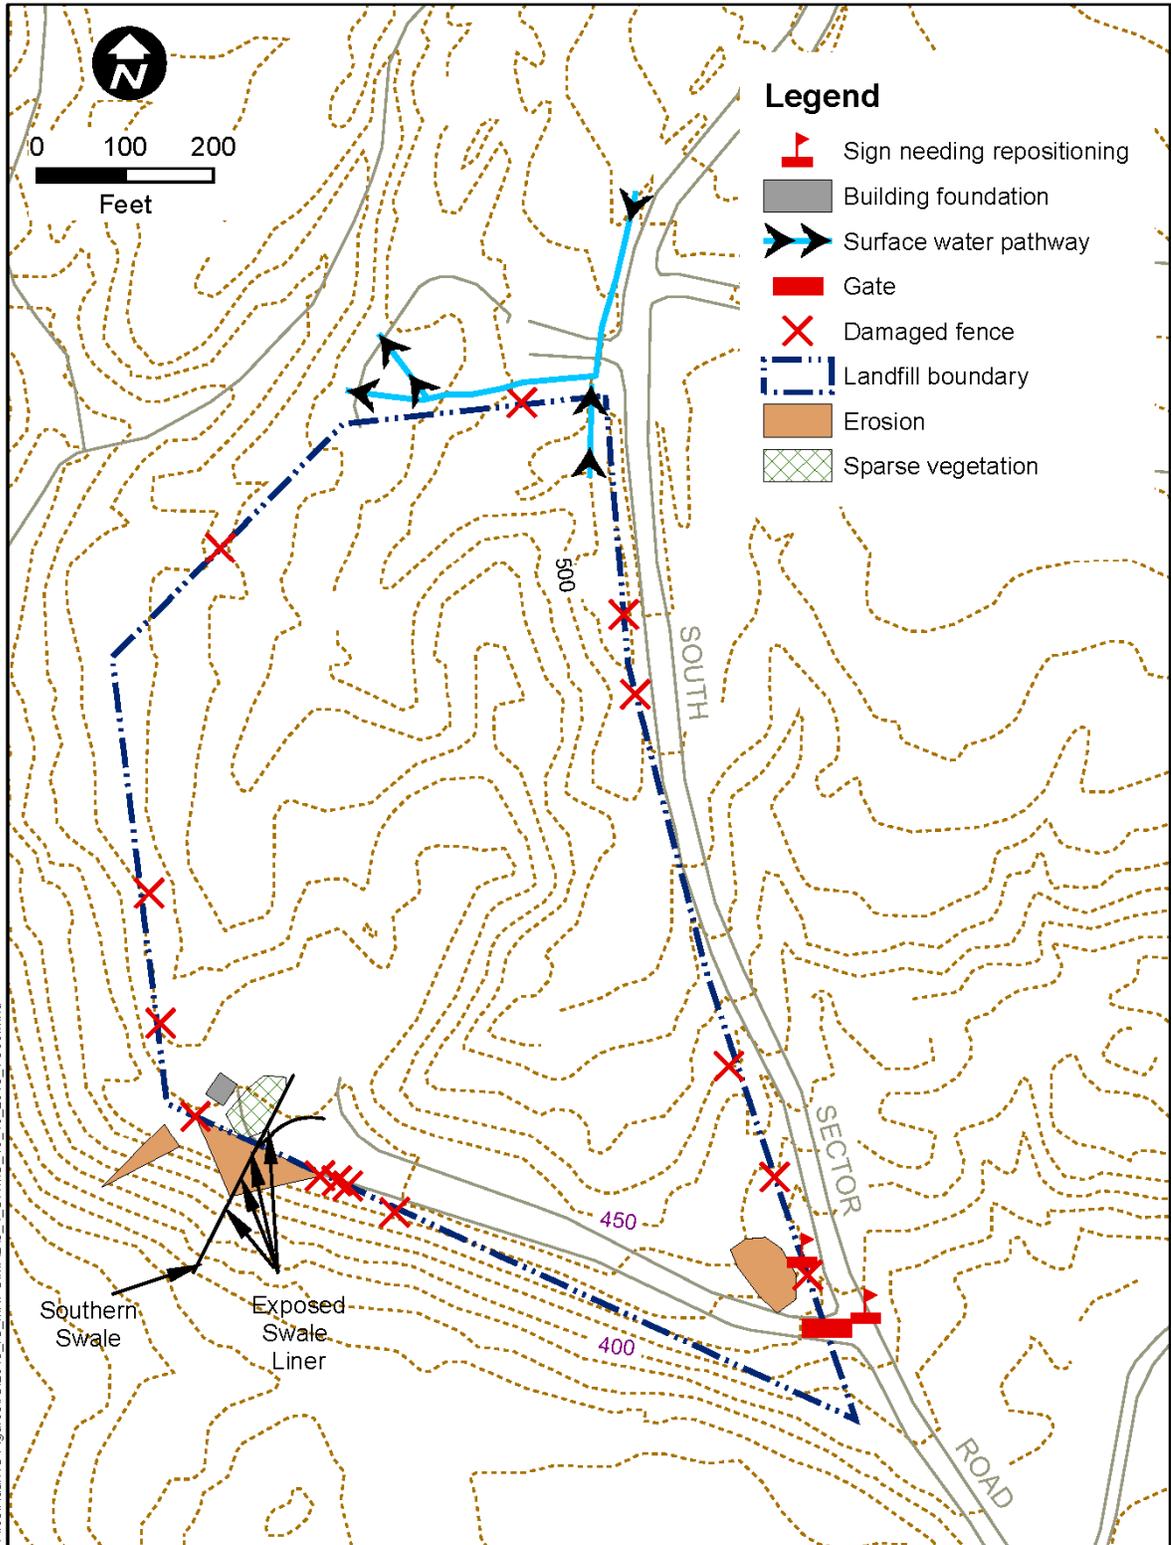
U.S. NAVY	SEALASKA	Figure 3-4 SWMU 18/19, White Alice Landfill	Task Order 66 Adak Island, AK 2013 IC Inspection Report
-----------	----------	--	--

The following items were noted during the 2013 inspection which are described below and illustrated on Figure 3-4:

- Ponding observed during previous inspections outside and adjacent to the northern landfill perimeter fence is still present. This pond receives surface water from the northeast swale and roadside ditch. This ponding did not appear to be affecting the cap integrity in 2013.
- A sparsely vegetated 50 feet by 100 feet area near the old building foundation on the south inside the fence that was previously observed was still present in 2013 and unchanged.
- The eroded area approximately 100 feet by 30 feet by 100 feet triangle outside the landfill on the southwest on the cliff is still present but appears to be stable and in the same condition as observed in 2012. It is currently not affecting landfill cap integrity but will continue to be monitored for stability and possible encroachment into the landfill.

- The sign next to the gate at the entrance is partially obscured by vegetation and should be moved or raised.
- An eroded area was observed on the southeast side of the site behind the sign by the south entrance gate. The eroded area is 42 feet by 96 feet but is not on the cap.

- A total of 22 sections of fencing are in need of repair on the north, south, east and west perimeters.

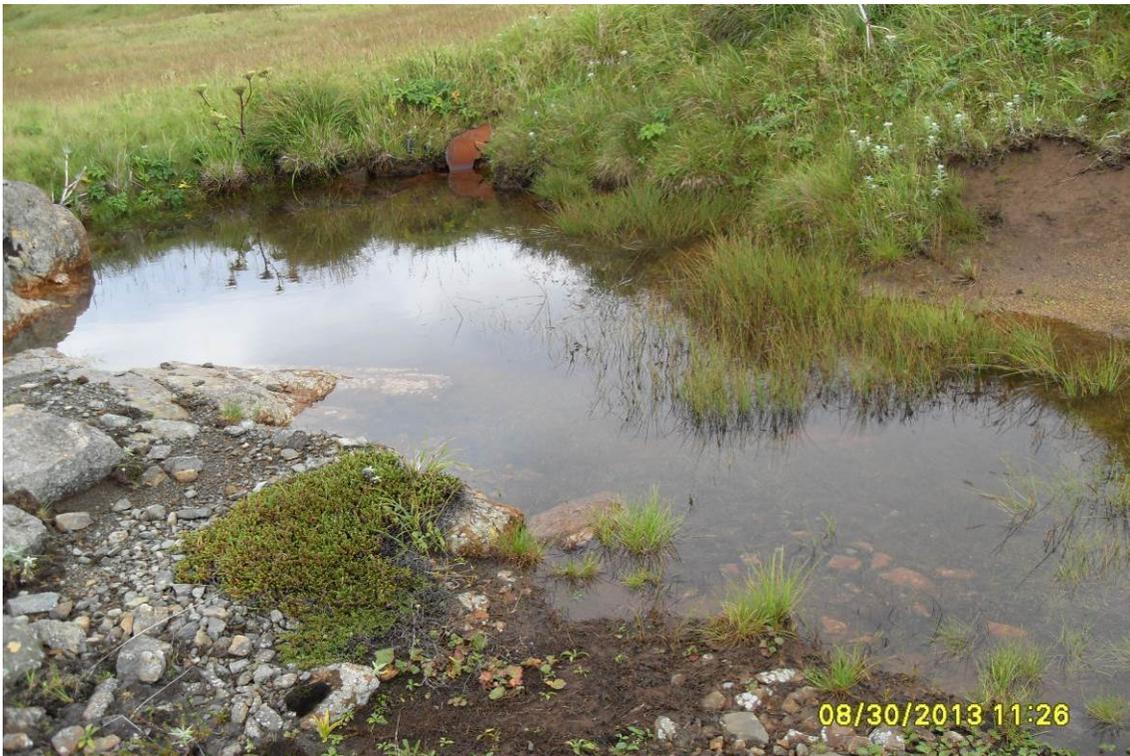
Photograph 3-11. SWMU 29, Finger Bay Landfill – ponded water with debris on central portion of landfill

Much of the area is marshy with thick tundra. Due to recent rains, saturated ground and ponding were observed across the site. The water levels in the ponds noted in 2013 were lower compared to the 2012 inspection. The pond observed on east side of the site high point in 2012 was observed to be approximately 4 feet by 20 feet in size during the 2013 inspection. The pond observed during previous inspections containing wood and metal debris which is located in the central section of the landfill was estimated to be approximately 30 feet by 15 feet in 2013 (Photograph 3-11). Small quantities of debris were noted on the surface of the landfill east of the high point (Figure 3-5). A hole was observed at the south end of the landfill approximately 4 feet by 2 feet.

- Debris should be removed from the surface of the cap and pond.
- The two onsite ponds and the hole at the south end of the landfill should be evaluated to determine if action is needed.

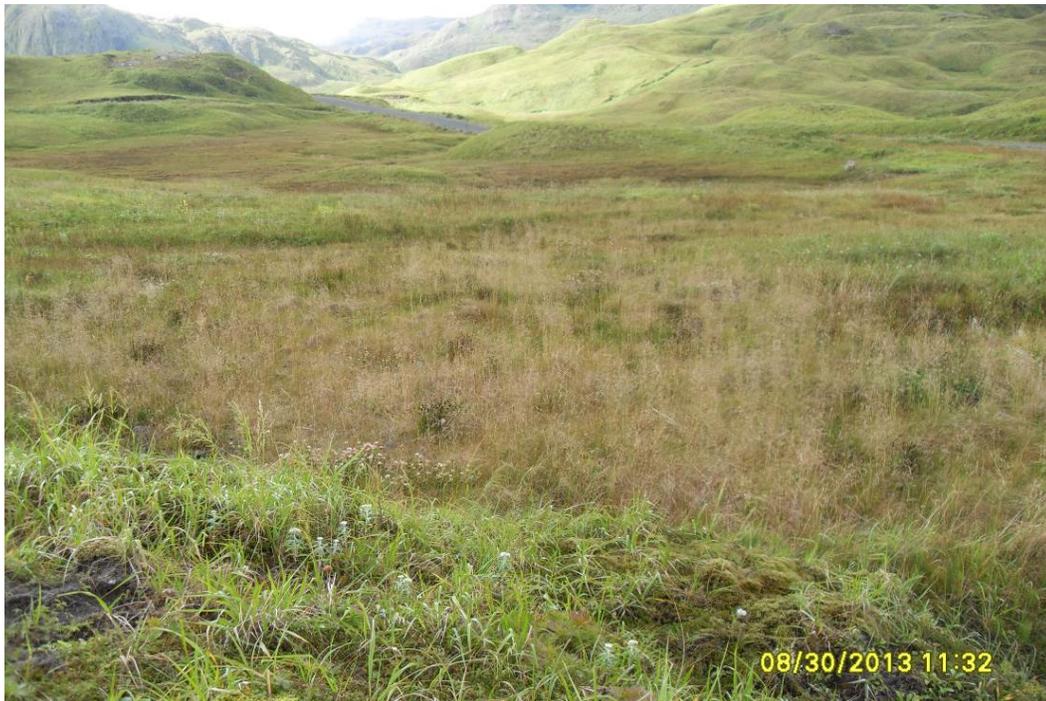
Photograph 3-12. SWMU 29, Finger Bay Landfill – looking southwest at the former seep location

The location of the previously observed seep was saturated with small amounts of standing water caused by recent heavy rains. This area was re-graded, filled with gravel, seeded and fertilized in 2010. Repairs are in good condition and thick vegetation has been established here. No evidence of a flowing seep or iron staining as noted in 2011 was observed in 2013. (Photograph 3-12).

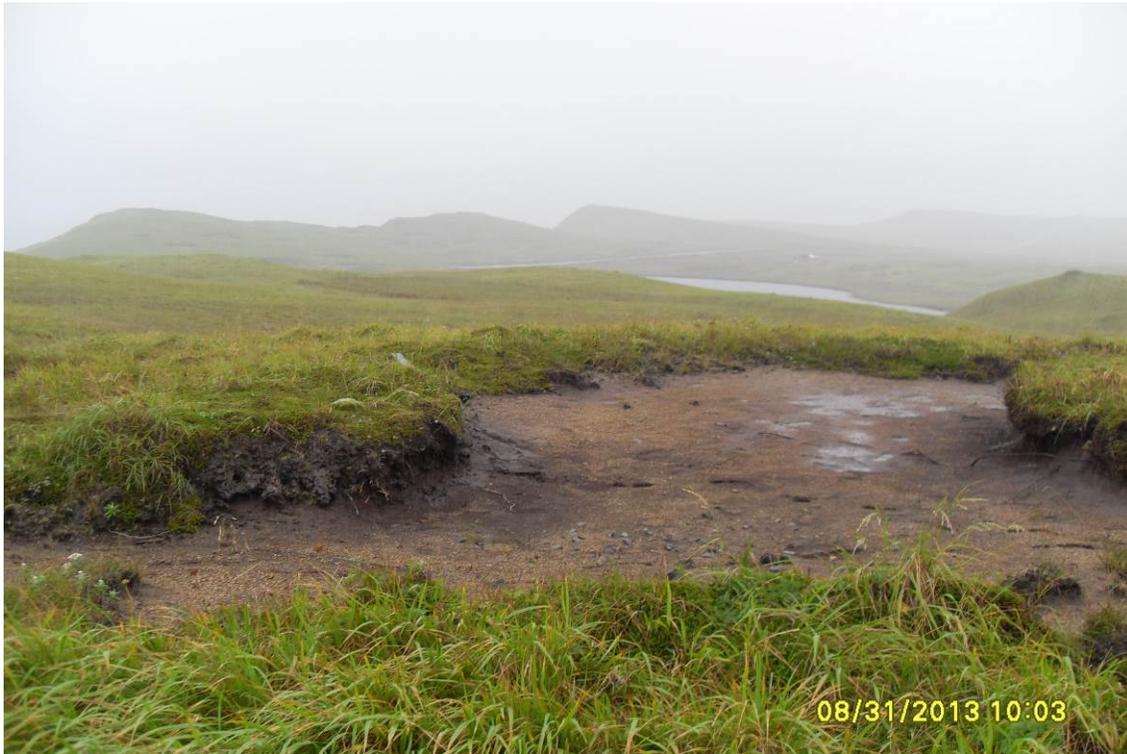
Photograph 3-13. Antenna Field – Site overview looking southeast

During the inspection on August 31, 2013, evidence of ground disturbance was observed due to the well decommissioning activities conducted by the Navy in spring of 2013. No permit was required since activities did not exceed 2 feet below ground surface. No other changes to the site were observed compared to the 2012 inspection results. No indications of a change in land use in this area were found and no residential construction had occurred at the site. No indications of groundwater use or excavation activities were found, and excavation restriction signs were clearly visible. Therefore, ICs appear to be functioning as intended to protect human receptors from exposure to contaminated soil or groundwater.

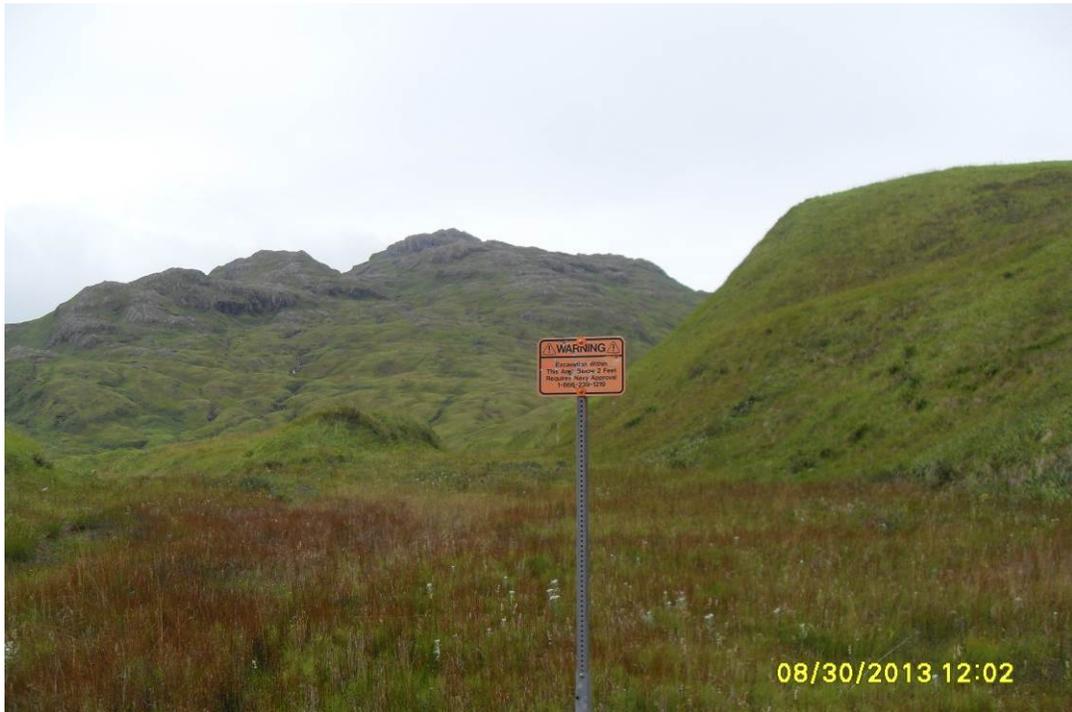
Photograph 3-15. Finger Bay Quonset Hut – looking west at the site sign

During the inspection on August 30, 2013, no changes to the site were observed compared to the 2012 inspection results. No indications of a change in land use in this area were found and no residential construction had occurred at the site. No indications of groundwater use or excavation activities were found, and the excavation restriction sign was clearly visible (Photograph 3-15). The sign was observed to have bullet holes in it, but it was still legible.

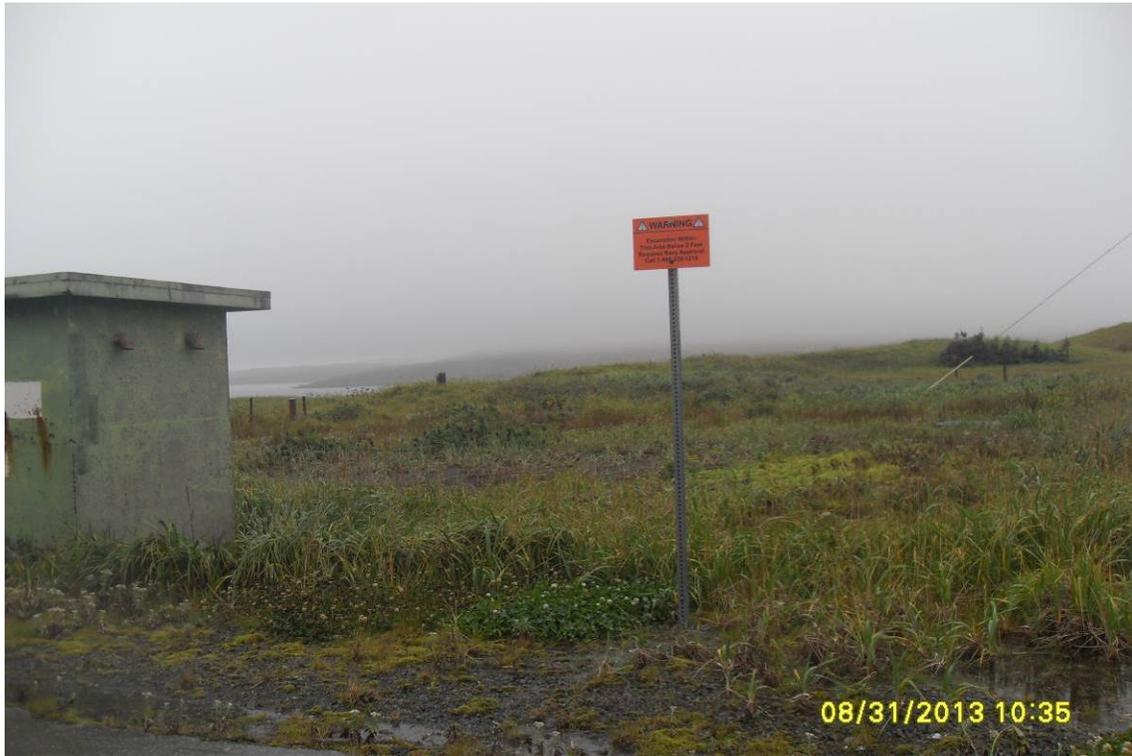
Photograph 3-18. SWMU 58 and SA 73, Heating Plant 6 – looking southeast at the sign and monitoring wells

During the inspection on August 31, 2013, evidence of ground disturbance was observed due to the well decommissioning activities conducted by the Navy in spring 2013. No permit was required since activities did not exceed 2 feet below ground surface. No indications of a change in land use in this area were found. No indications of groundwater use or excavation activities were found, and excavation restriction signs were clearly visible (Photograph 3-18). Based on these findings, ICs appear to be functioning properly to protect humans and the environment.

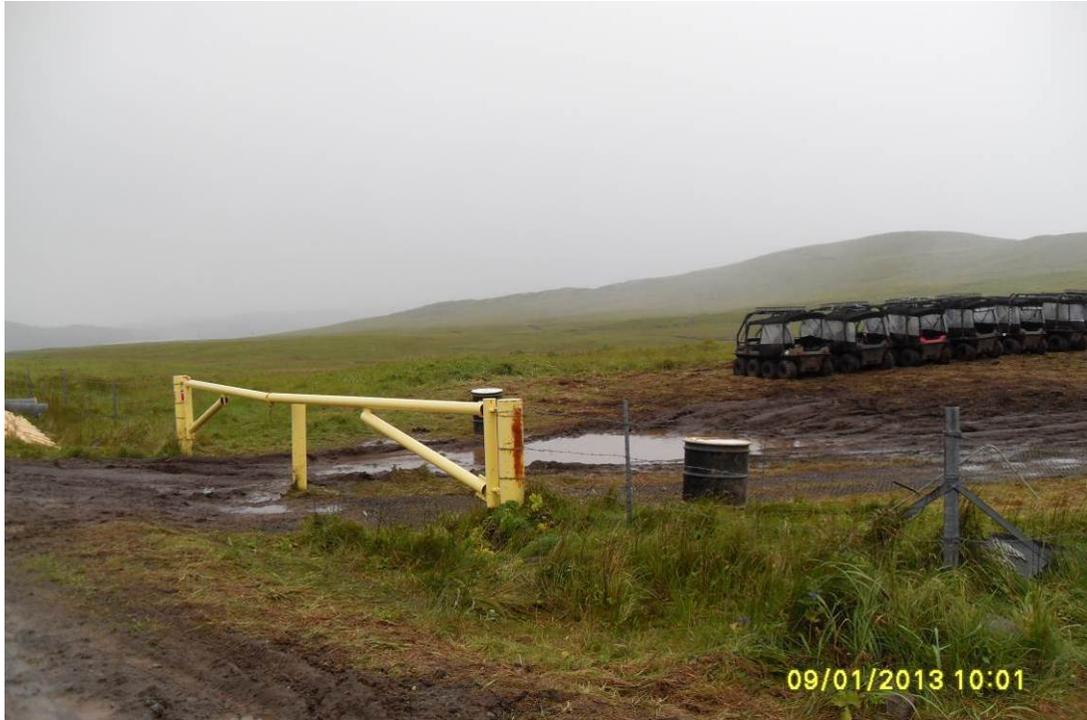
Photograph 3-22. SA 93, WWII Mortar Impact Area (Parcel 4) – looking southwest at east perimeter fence and new gate next to road with Navy UXO contractor equipment.

- The sign by the northeast corner gate is missing and needs to be re-installed (Photograph 3-22).
- Two sections of fencing along the north perimeter fence, sixteen sections along the east perimeter fence and five sections along the south perimeter fence need to be repaired.
- One UXO warning sign on the east perimeter fence is in poor condition and need replacing (Photograph 3-23).
- The gate along the southwestern entrance to SA 93 at the Andrew Lake Recreational Center was inspected and found to be locked and in good condition. There is no sign present at the gate and it is recommended that one be installed at the gate location.

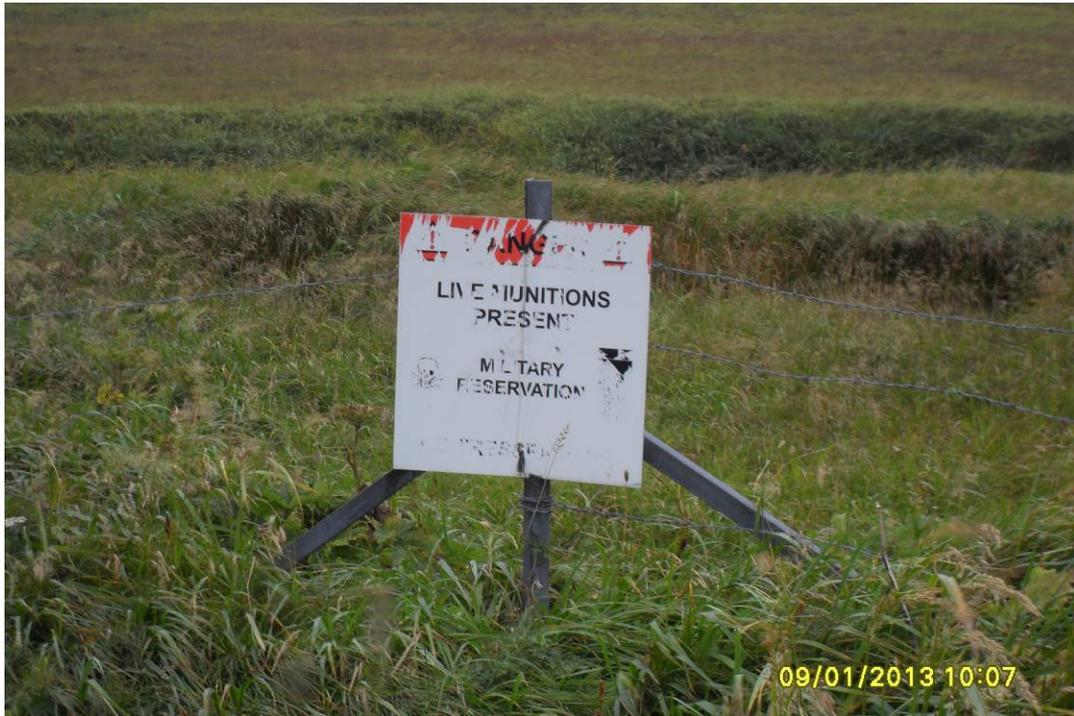
Photograph 3-23. SA 93, WWII Mortar Impact Area (Parcel 4) – looking west at east perimeter fence sign

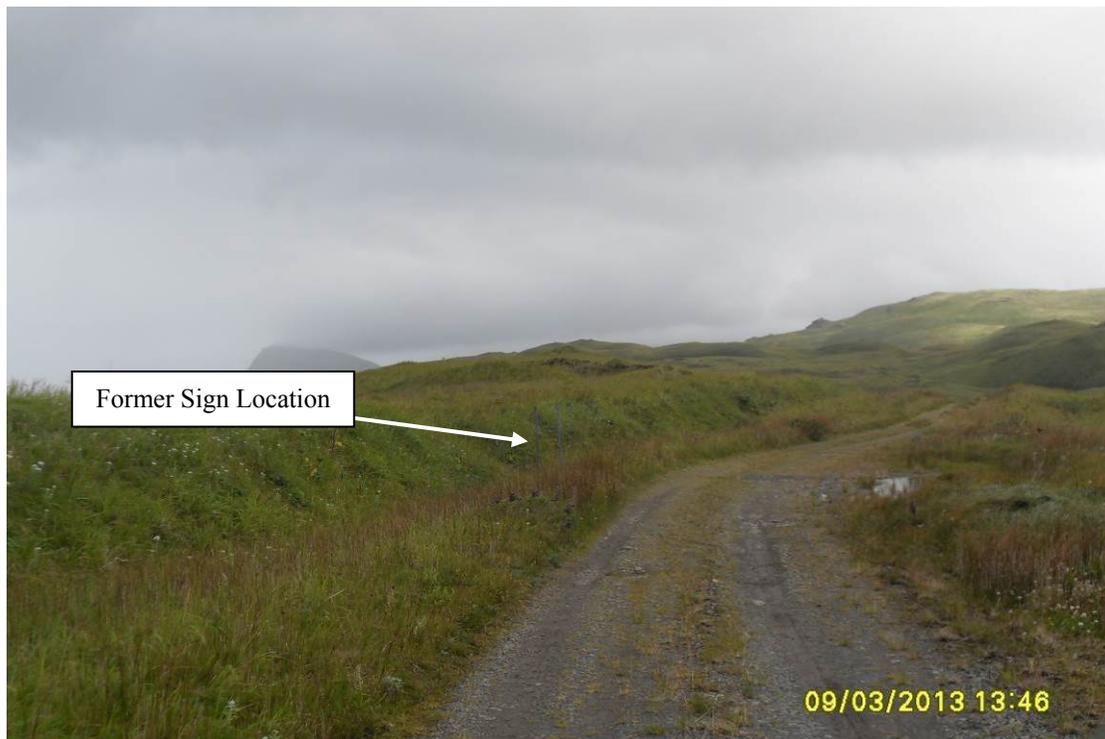
- The gate along the southeast entrance to SWMU 1 was inspected and found to be closed, locked, and in good condition.
- South perimeter fencing near the gate has three sections that need to be repaired.
- The two UXO warning signs on Lake Jean road, the south entrance road, and one on the south gate were missing during the 2013 inspection and need to be replaced.

Photograph 3-24. SWMU 1, Andrew Lake Waste Ordnance Demolition Range (Parcel 4) – south entrance road looking north towards missing UXO warning sign

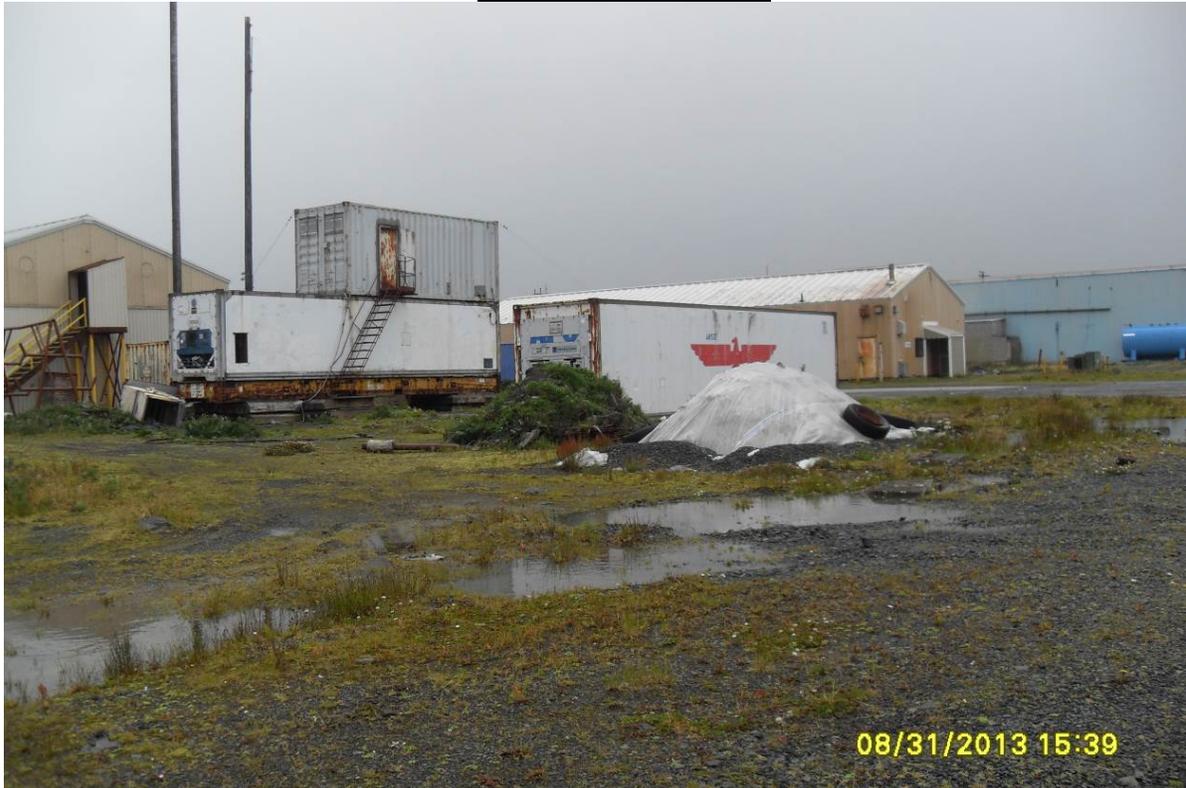
Photograph 1539 – Former AST location and stockpile near well MW15-424 along the southern site boundary.

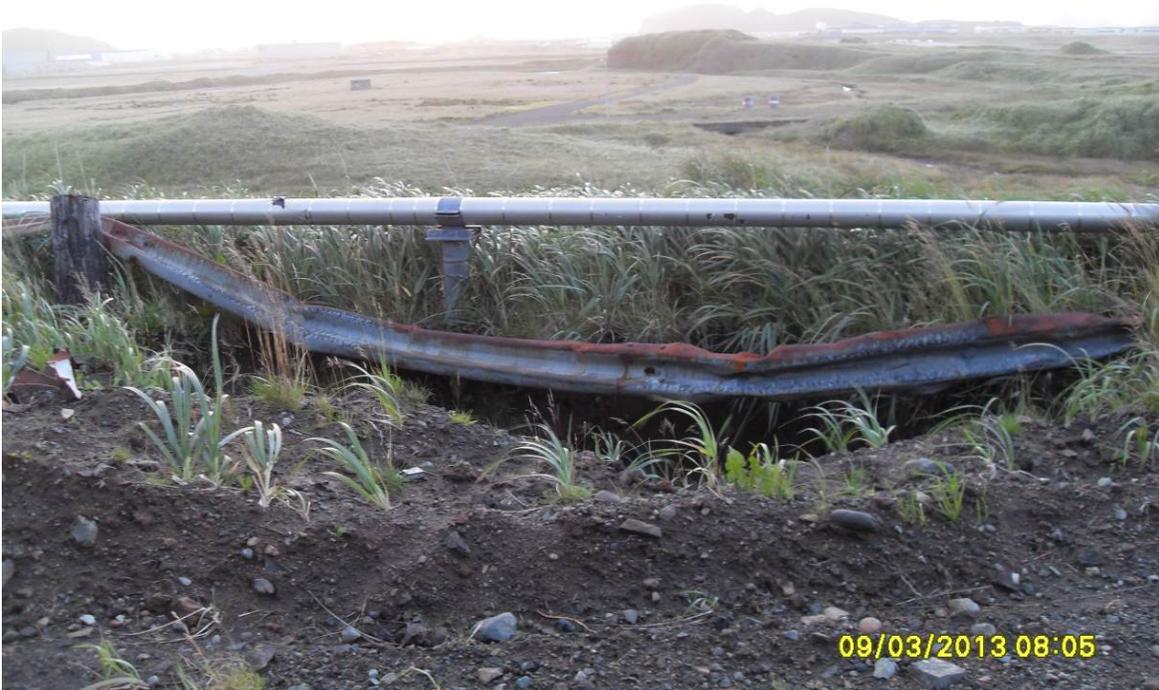
Photograph 0805 – Excavated area along access road on the east side of the power plant looking east

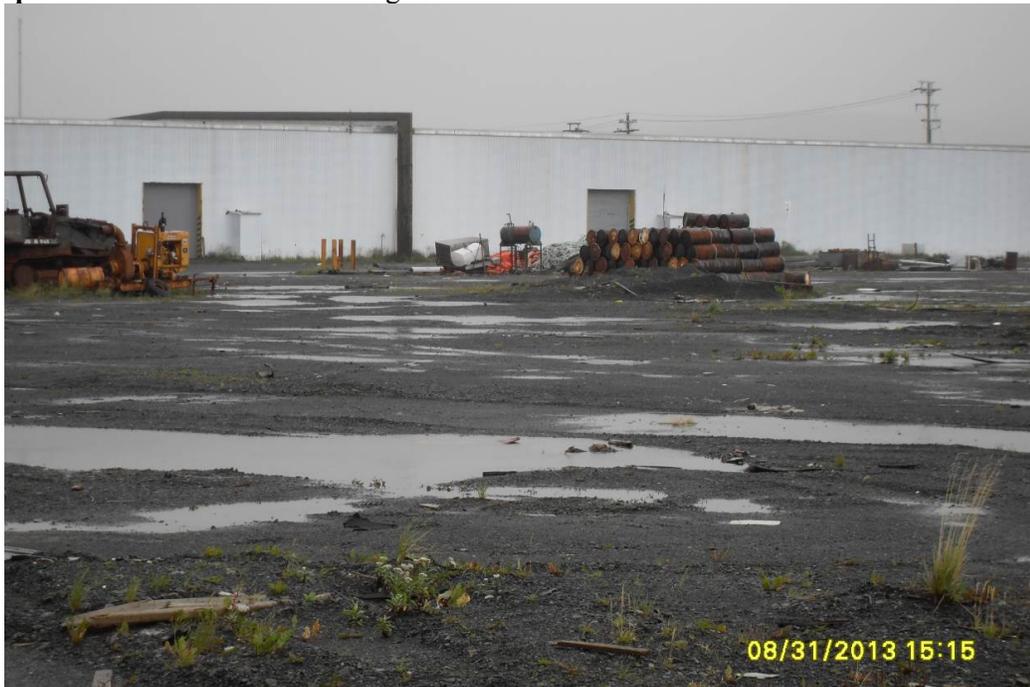
Photograph 1515 – Drums and small AST stored onsite

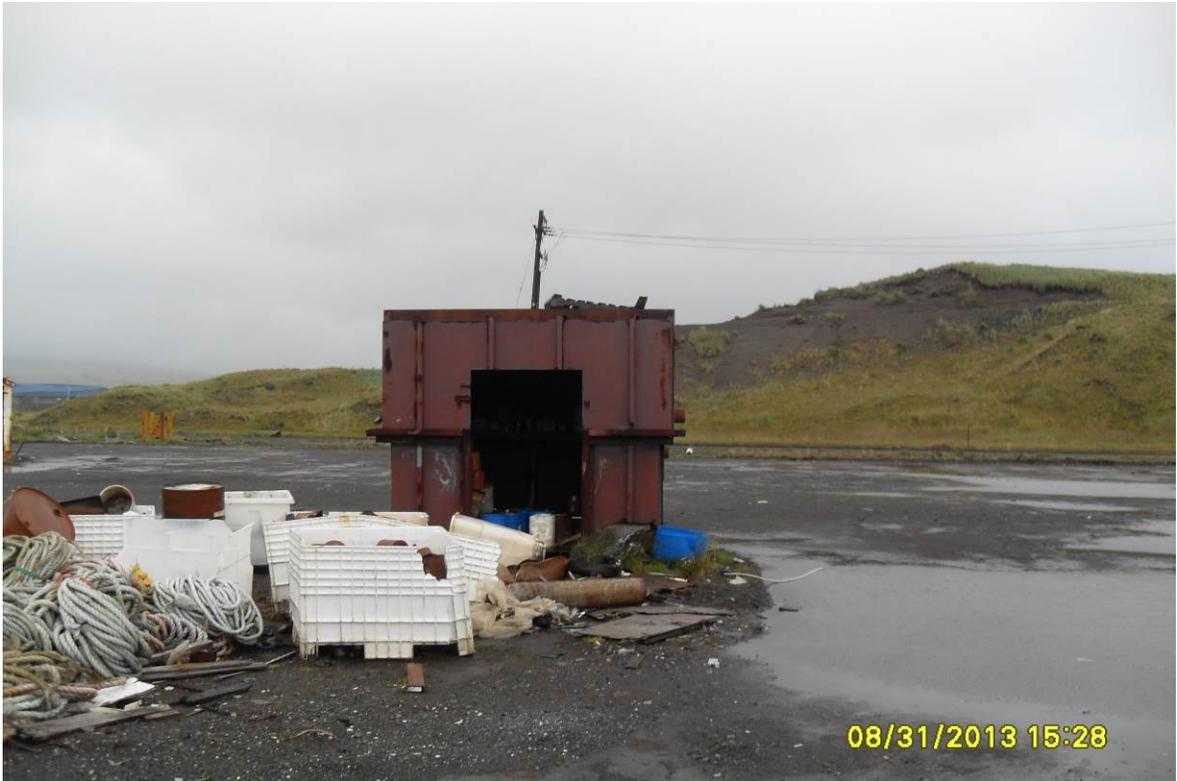
Photograph 1528 – Conex box with hazardous materials and paint stored inside looking north

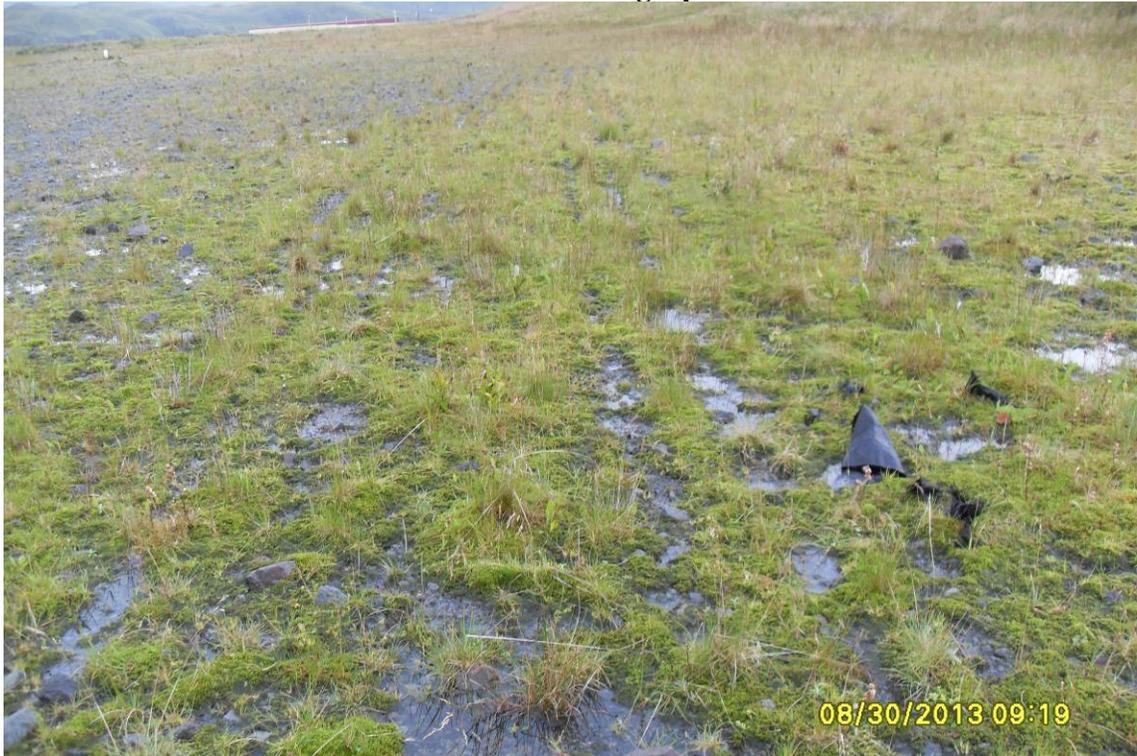
Photograph 0919 – ATV tracks on lower bench at the south end of the site, looking south
