2013 Institutional Controls Site Inspection Report

Operable Units A and B-1

Former Naval Complex

Adak, Alaska

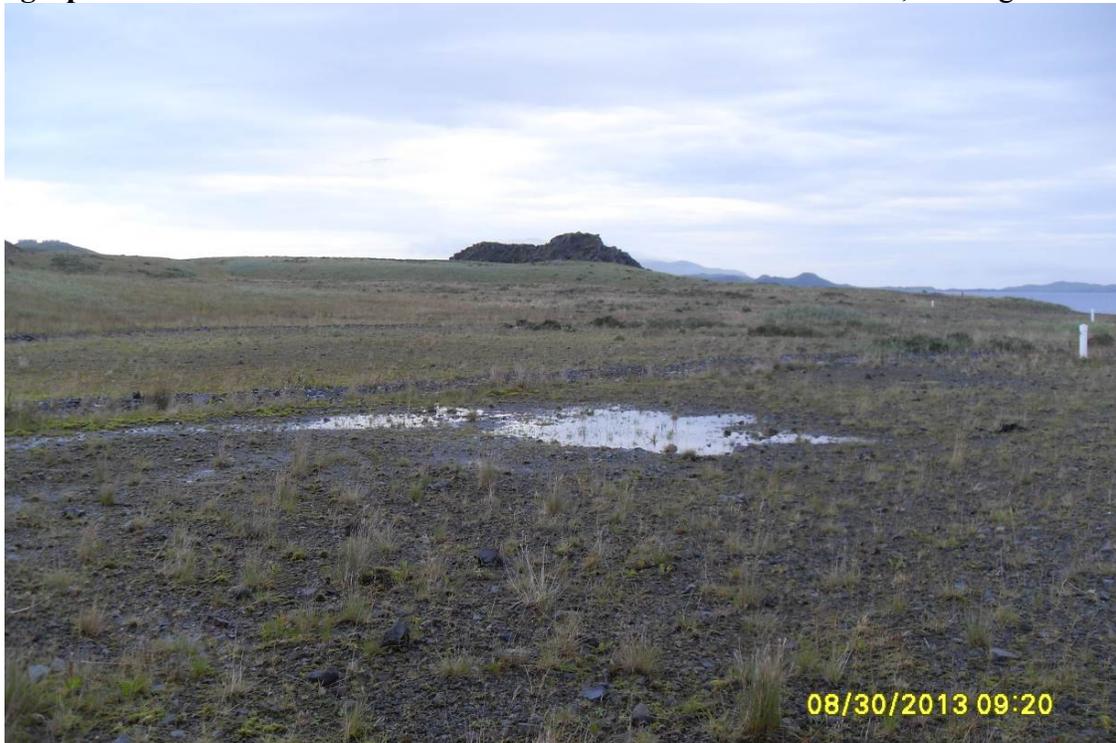
Photograph 0920 – Example of ponding on lower bench on the east side of the site, looking north

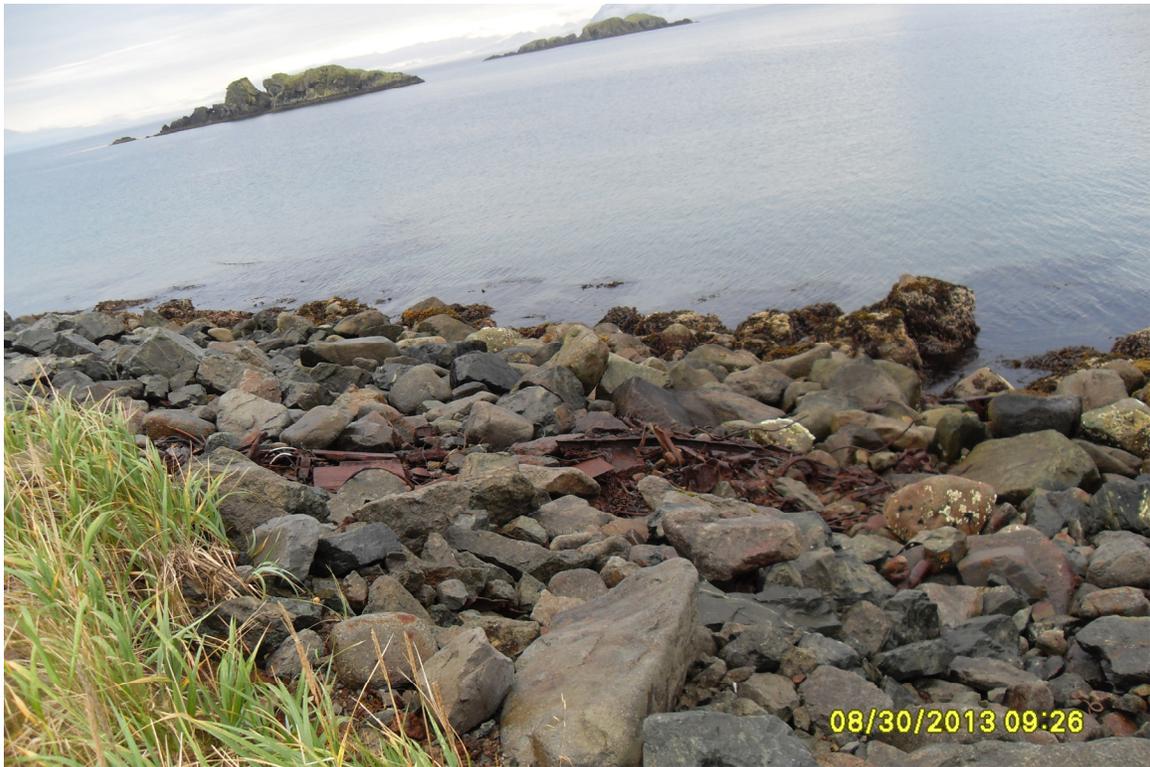
Photograph 0926 – Eroded area fifty feet by forty feet in size located just north of the end of Swale 3, with metal exposed (view northeast).

It is recommended that the eroded areas near the end of Swales 6 and along the armor wall be repaired. All other ICs appear to be functioning as intended. Site inspections have been reduced to every odd year with the next inspection occurring in 2015.

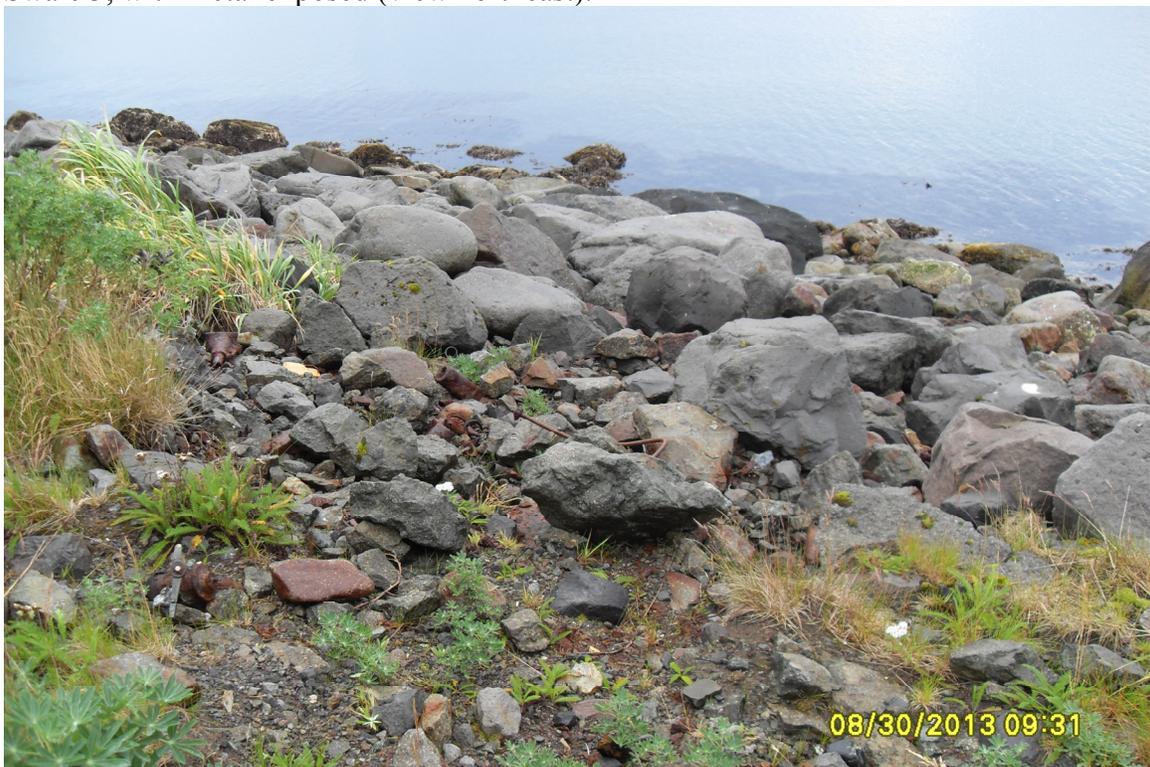
Photograph 0931 – Smaller eroded area north of well MW13-2, at top of armor rock slope approximately eight feet by ten feet in area.

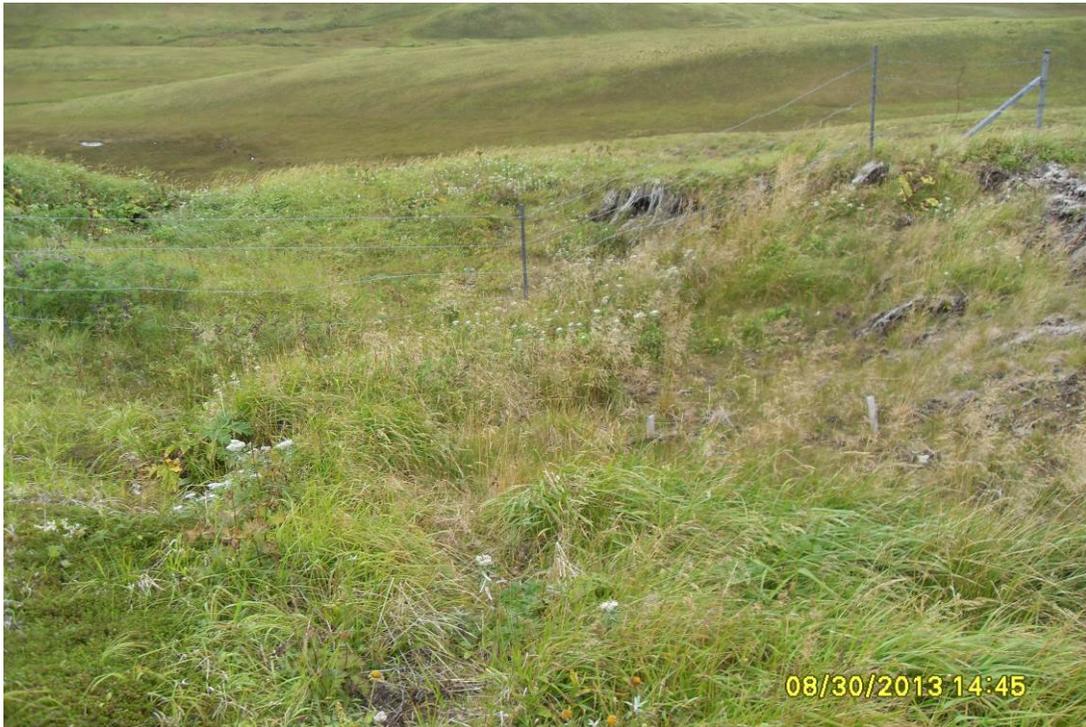
Photograph 1445 – Previously eroded area with sufficient vegetation growth. Continue to monitor repair.

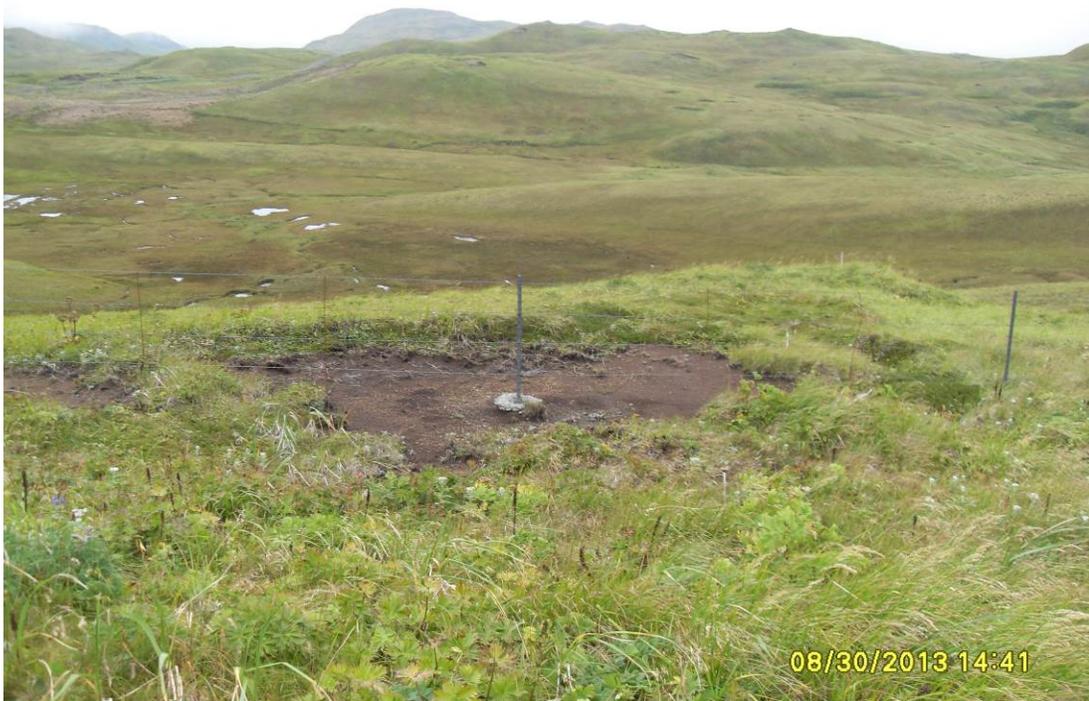
Photograph 1441 – Previously repaired eroded area along western site fence looking west; continue to monitor.

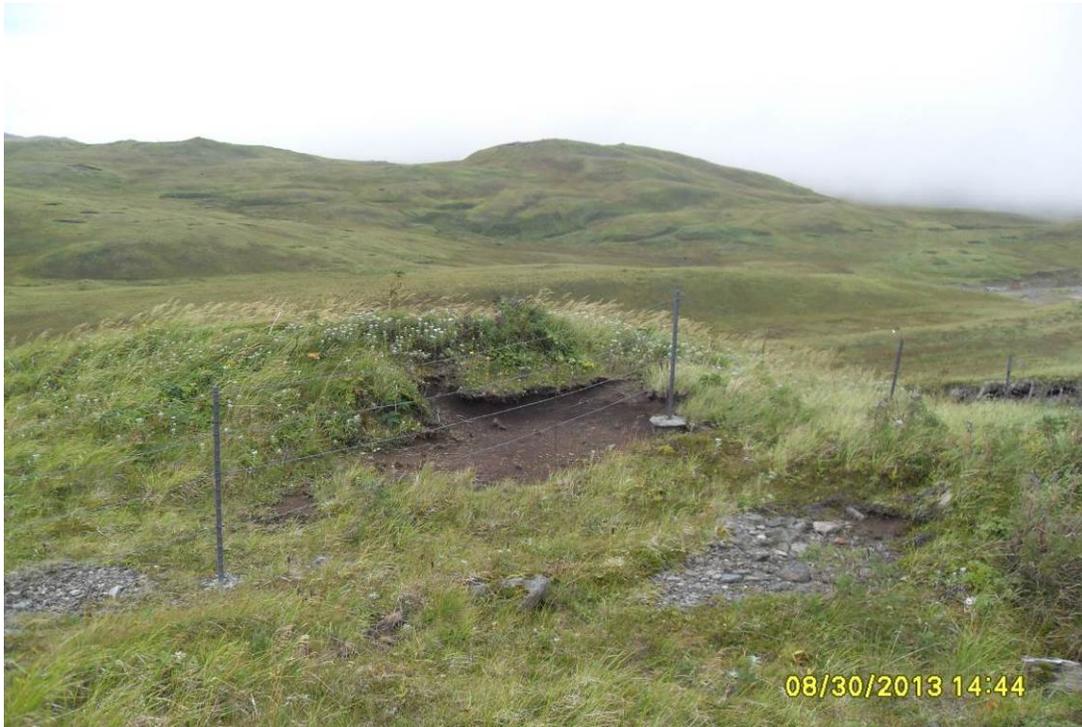
Photograph 1444 – Previously repaired eroded area along western site fence; continue to monitor.

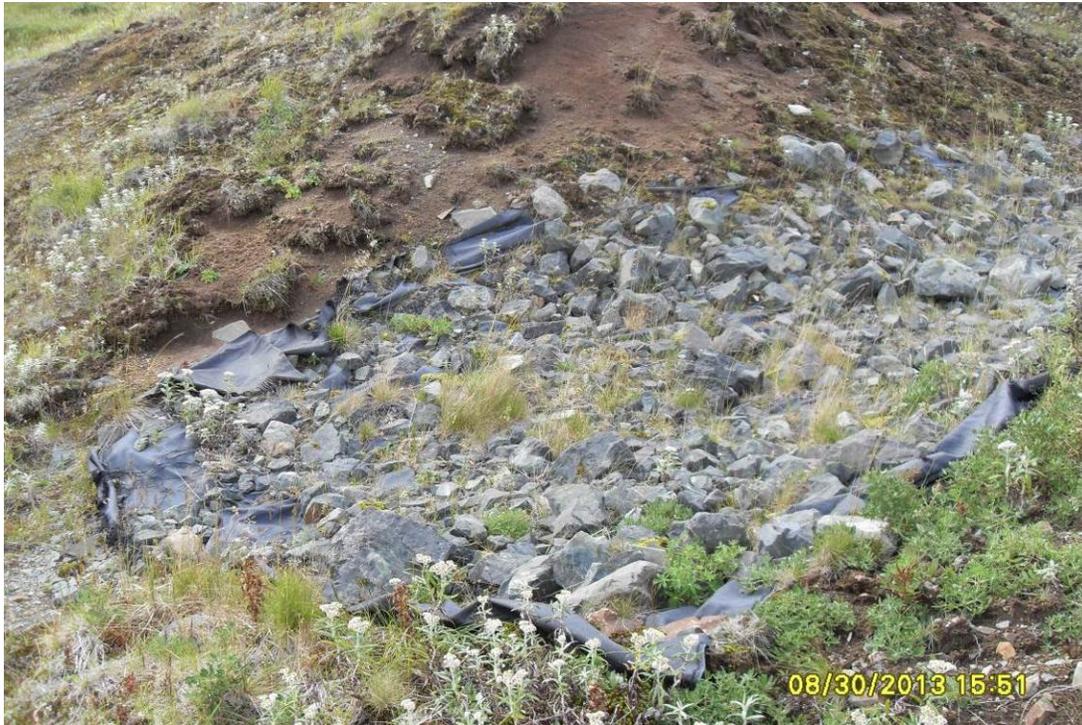
Photograph 1551 – Swale with exposed liner and eroded area on the southwest side of the site looking west

- Continue to monitor the four small eroded and repaired areas along the western fence line for future threat to the landfill cap.
- Repair the newly observed eroded area and swale liner on the southern portion of the landfill.
- Sample surface water at the blue seep on the northwest side of the landfill (NL-14) in 2014 and determine if it is associated with the landfill. Take appropriate actions as determined by EPA, ADEC and the Navy if needed.
- Repair the perimeter fence and re-attach and/or replace the three perimeter signs.
- Replace the three asbestos warning signs across the road from the landfill.
- Repair or replace the northern gate adjacent to the Adak Fuels Facility.
- Notify Adak Fuels Facility to keep the northern gate locked to prevent vehicle access to the site.

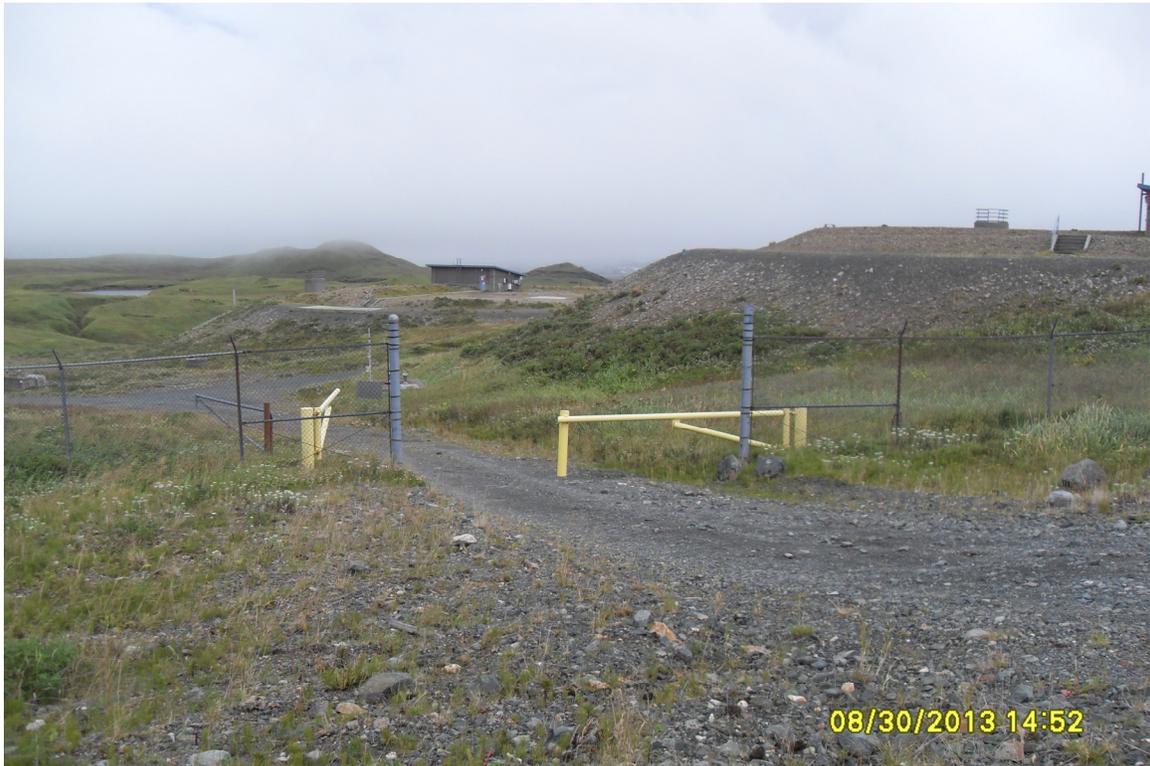
Photograph 1452- Gate to Adak Fuels Facility area – as of 2012 gate arms will not line up to lock.

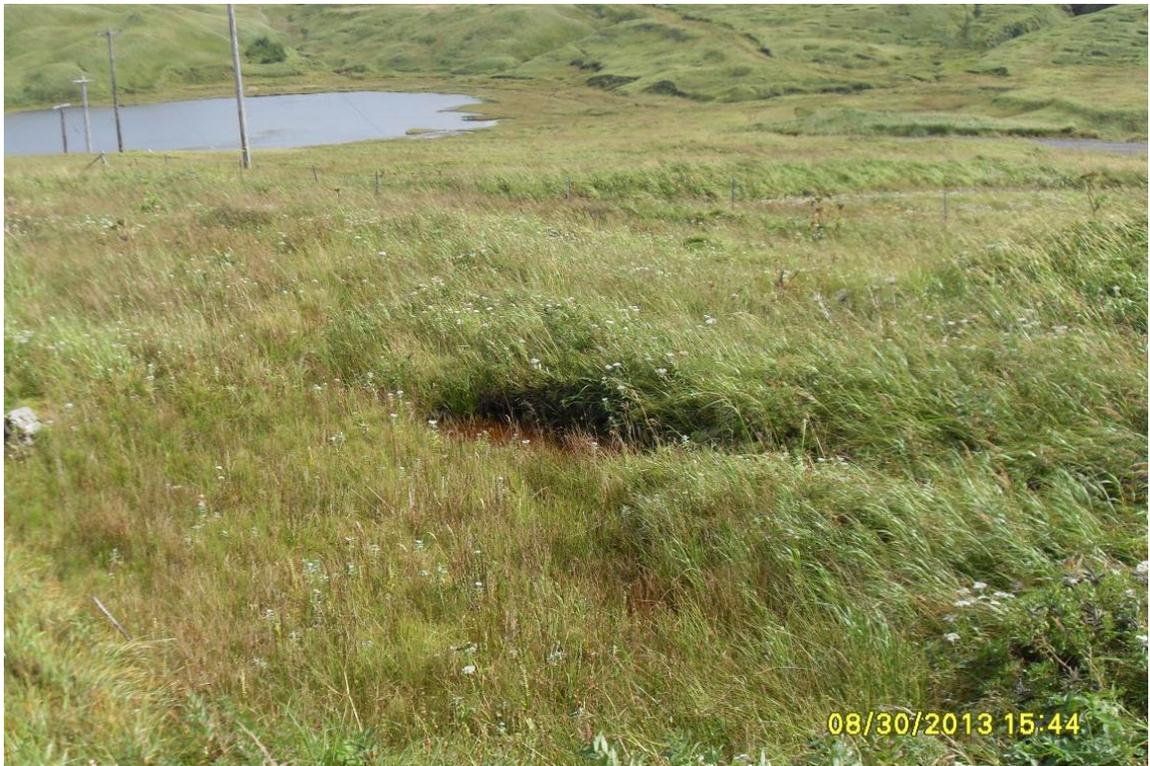
Photograph 1544 – Small, five foot by five foot hole near well B-1.

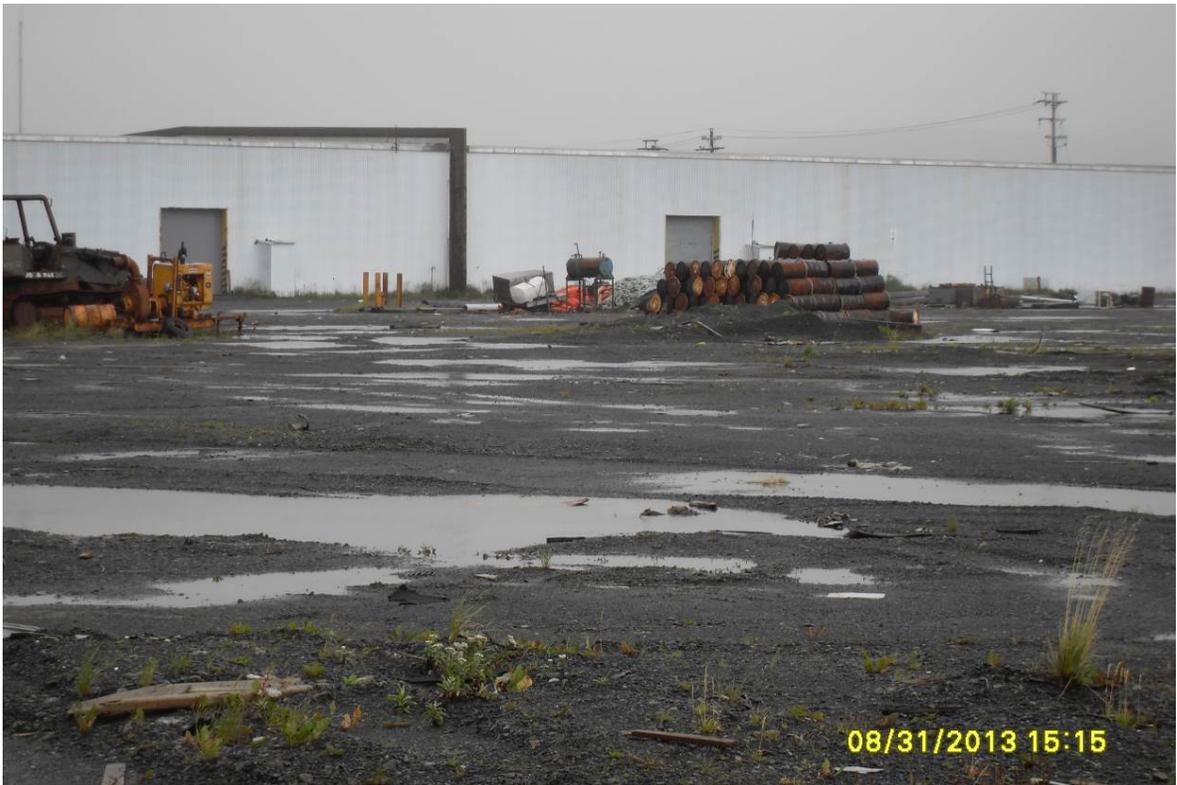
Photograph 1515 – Drums and small AST stored onsite

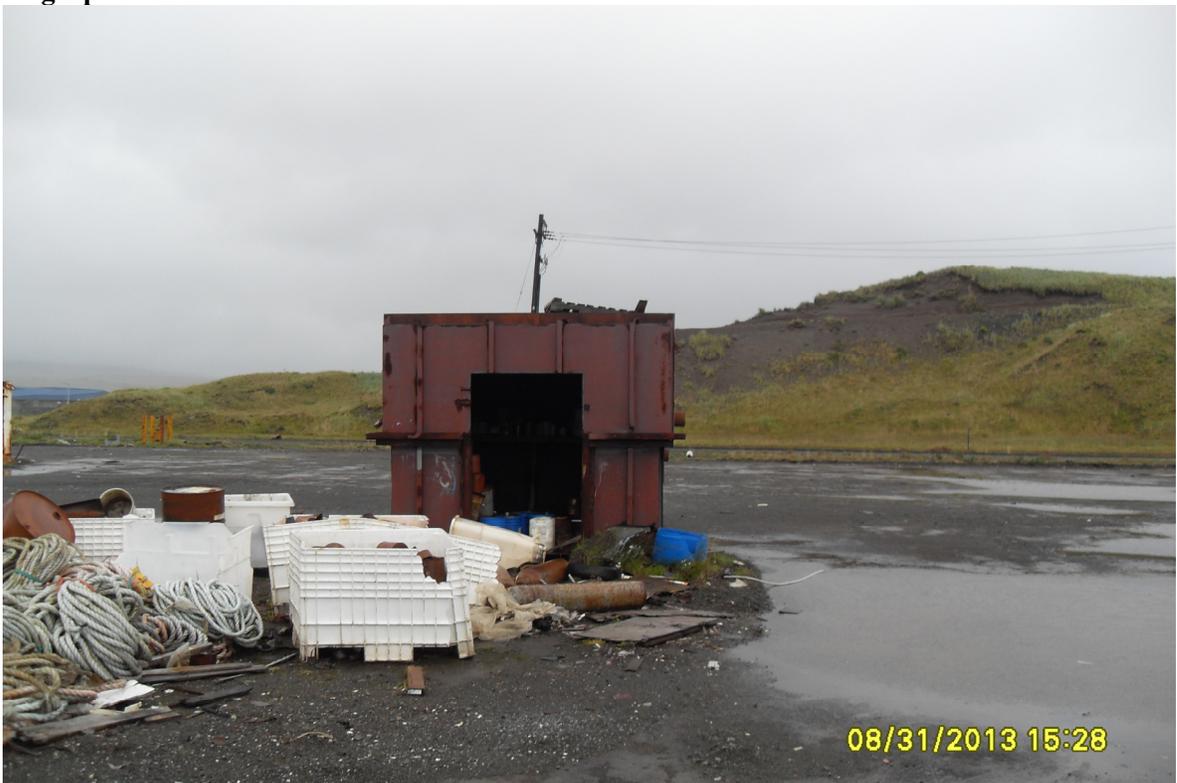
Photograph 1528 – Conex box with hazardous materials and paint stored inside looking north

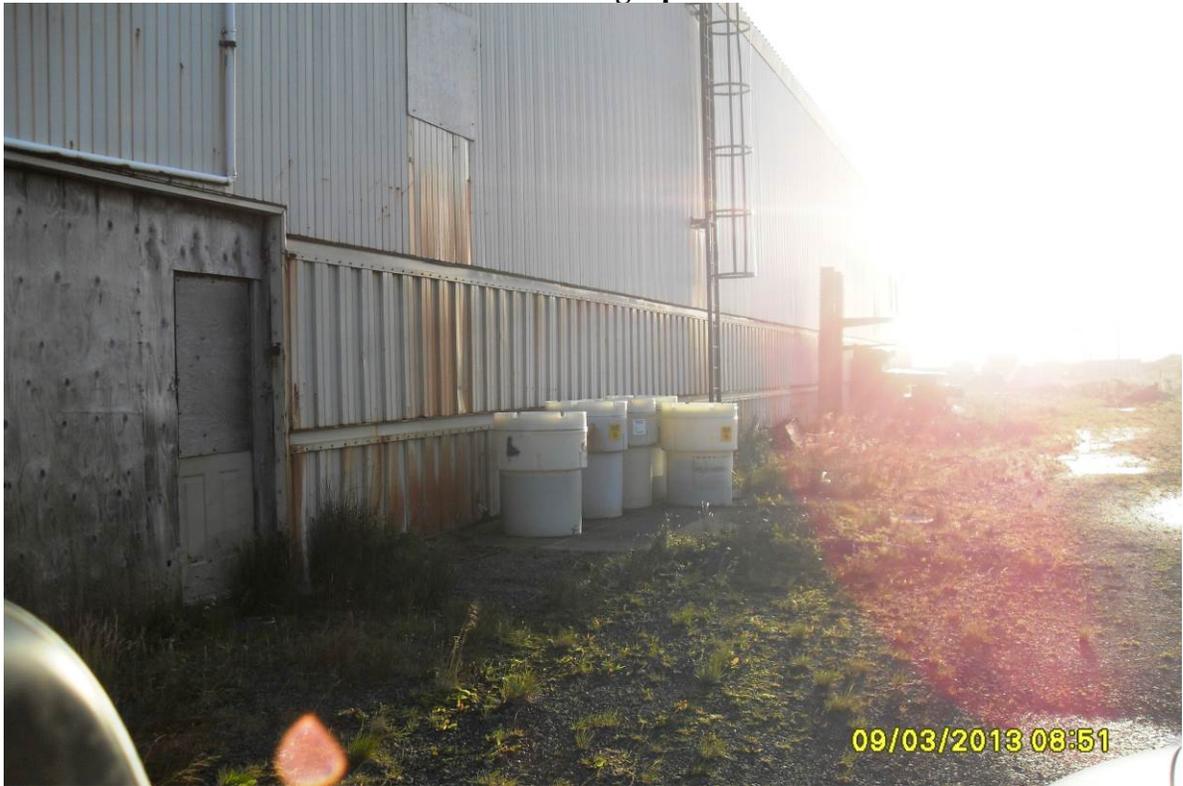
Additional notes: On the south side of the west building the poly-containers of waste oil noted during previous inspections still remain. On the south-west side of the west building, empty 55-gallon drums and debris were observed near monitoring well 02-453. One car battery remains on the ground on the northeast corner of the east building. These wastes could be impacting site soils and underlying groundwater.

Photograph 0851 – Poly drums on the south side of building looking east

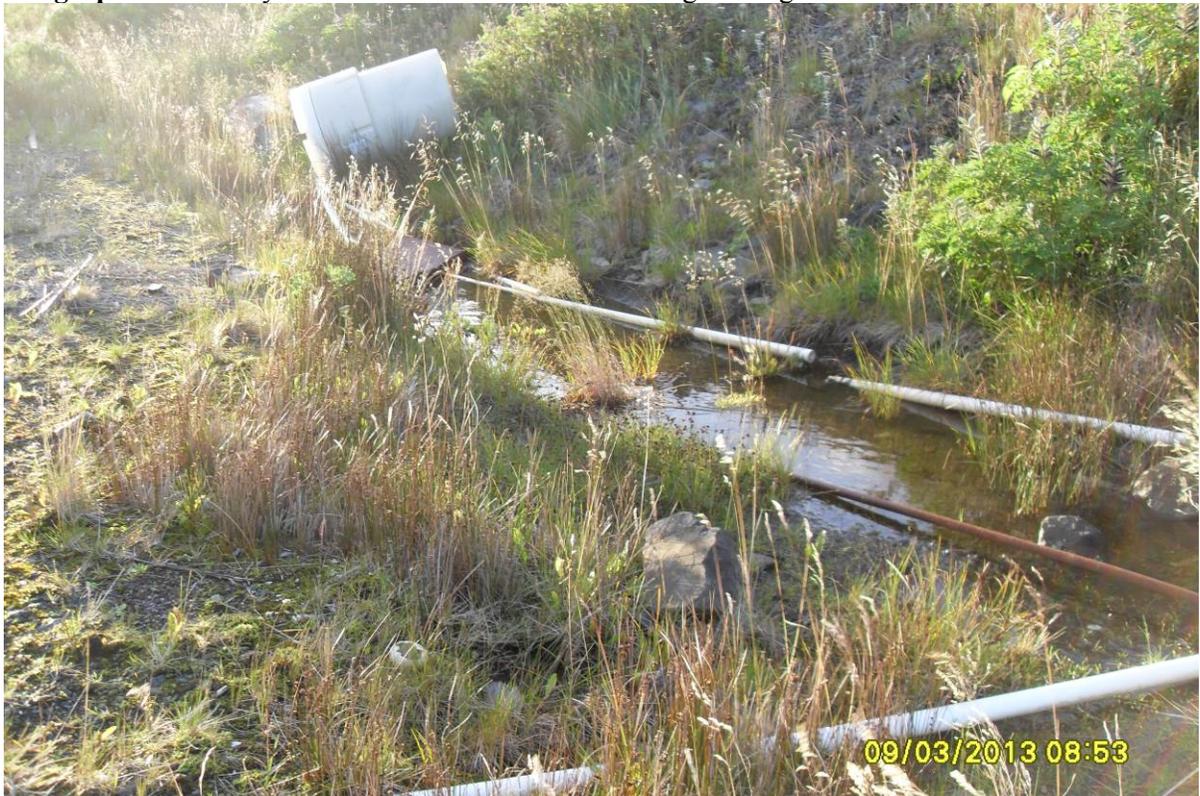
Photograph 0853 – Poly drum and PVC pipe in ditch on the west side of buildings looking east
PRODUCTION – INSERT FIGURE 2-8

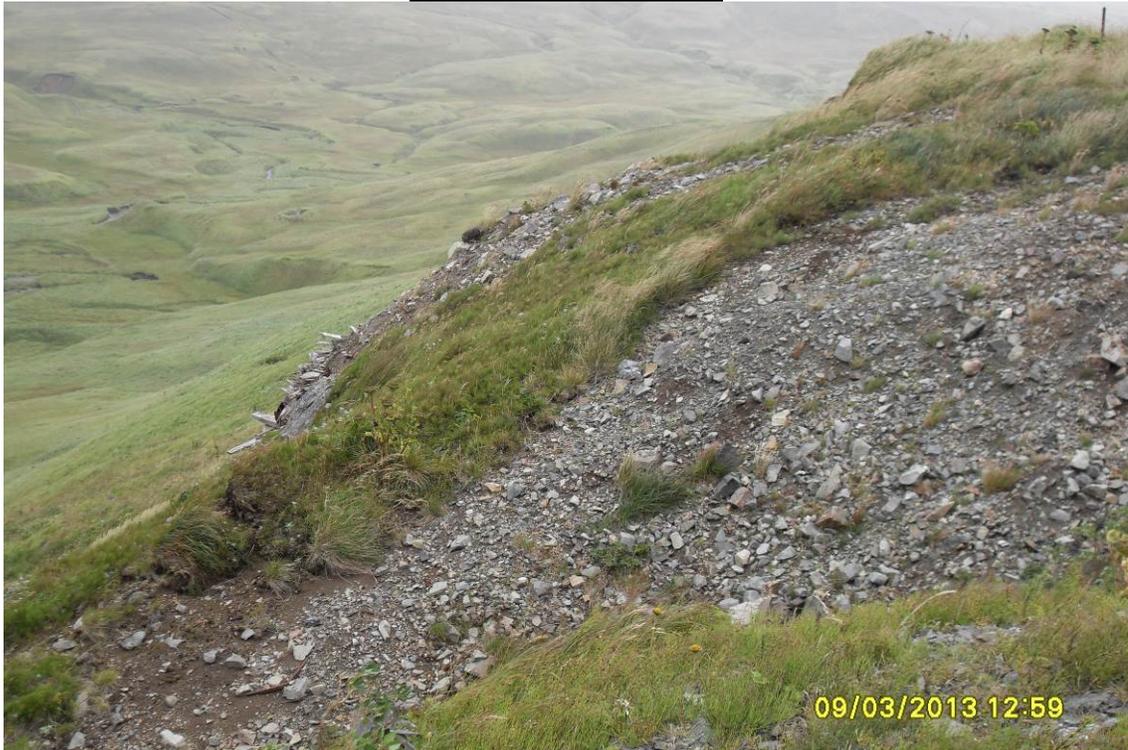
Photograph 1259 – Cliff edge with exposed debris in hillside on the north boundary of the site looking east

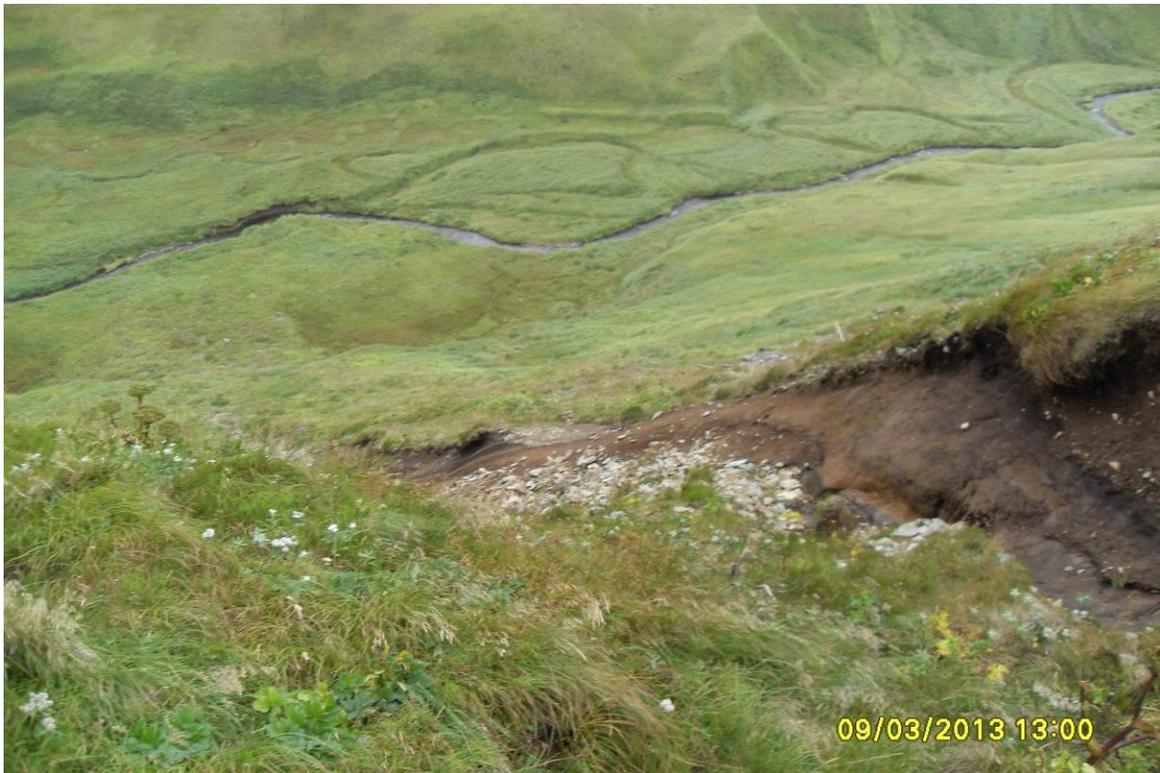
Photograph 1300 – Cliff edge looking at the eroded hillside close up on the north boundary looking east

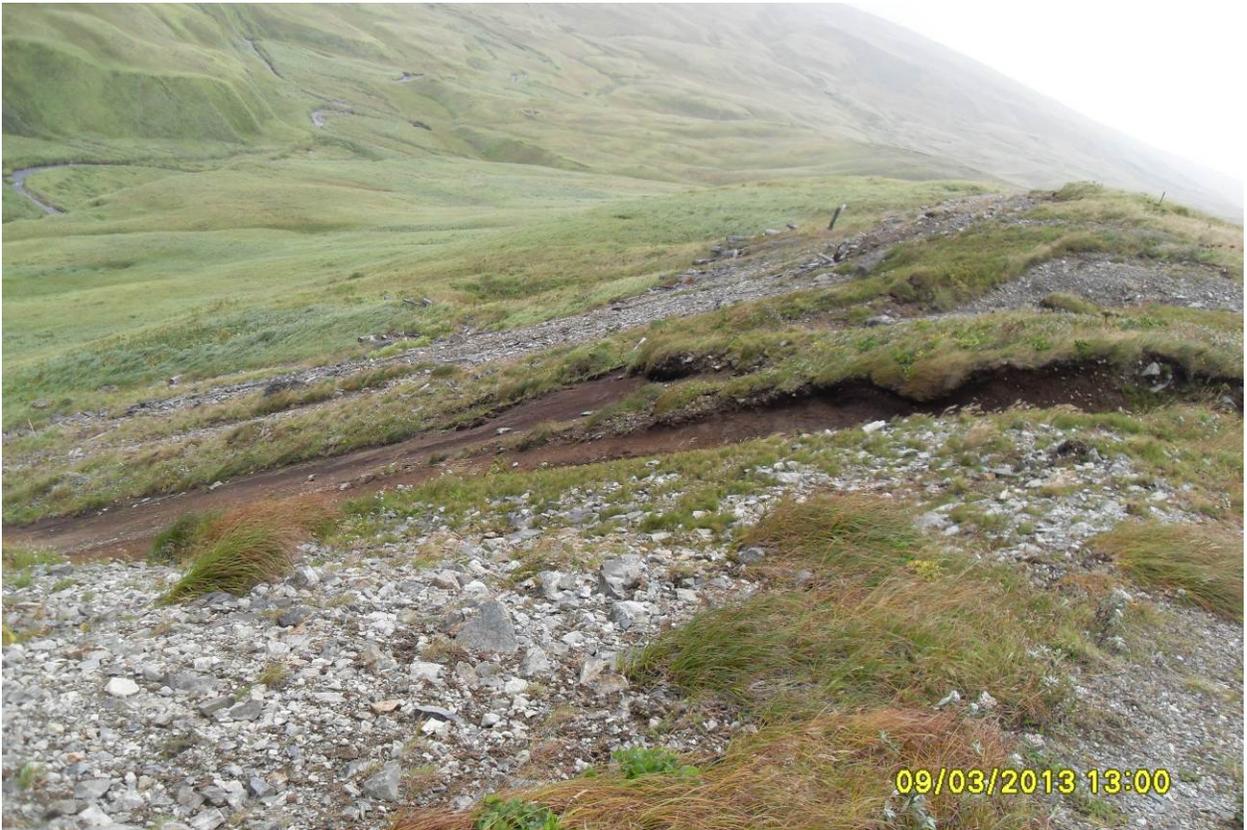
Photograph 1300 – Cliff edge looking at the eroded hillside on the north boundary looking east

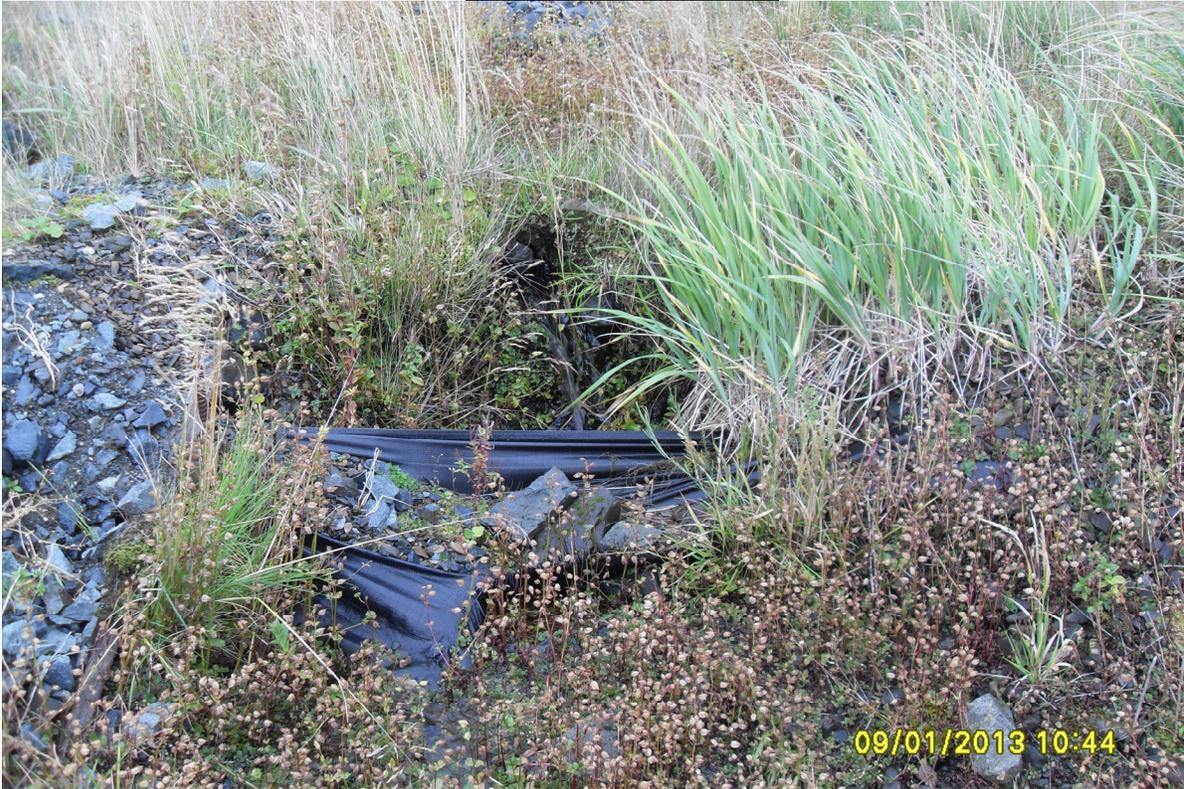
Photograph 1044 – Eroded swale along the shoreline looking east

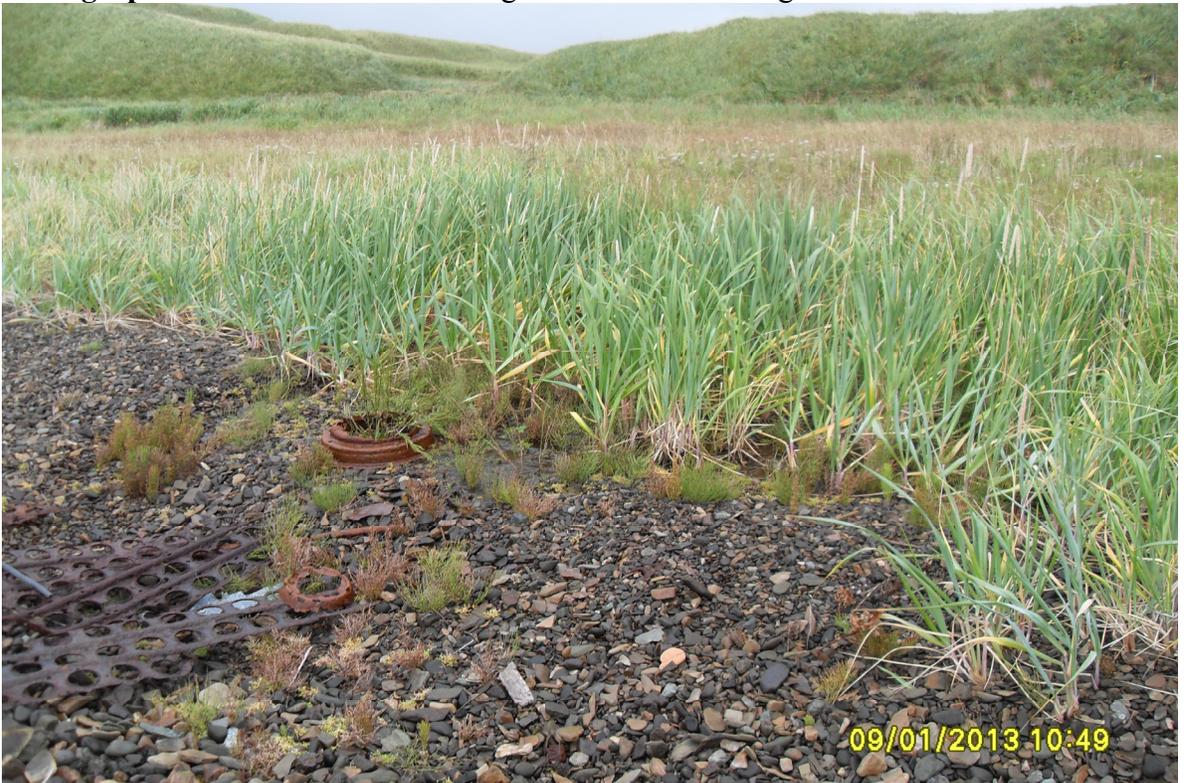
Photograph 1049 – Seep overview at the south end of the site looking northeast

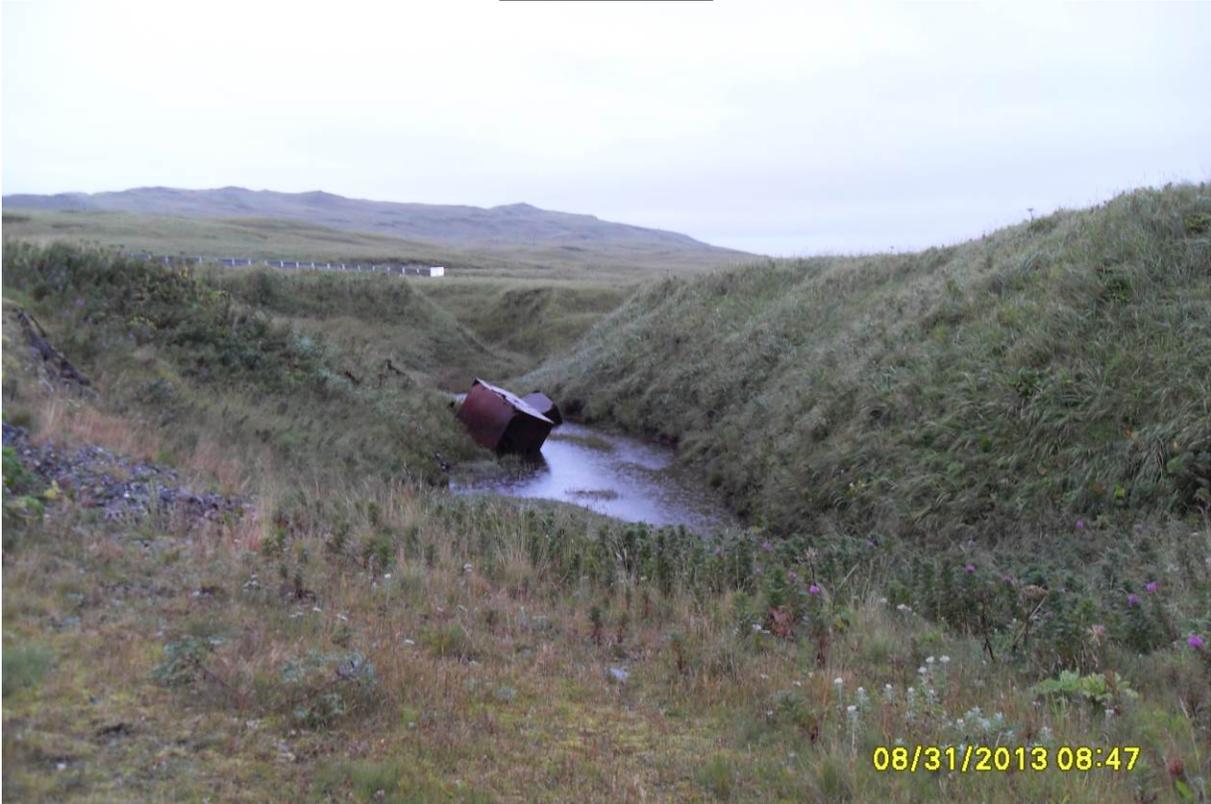
Photograph 0847 – View of ponded area from the south end of the pond looking north

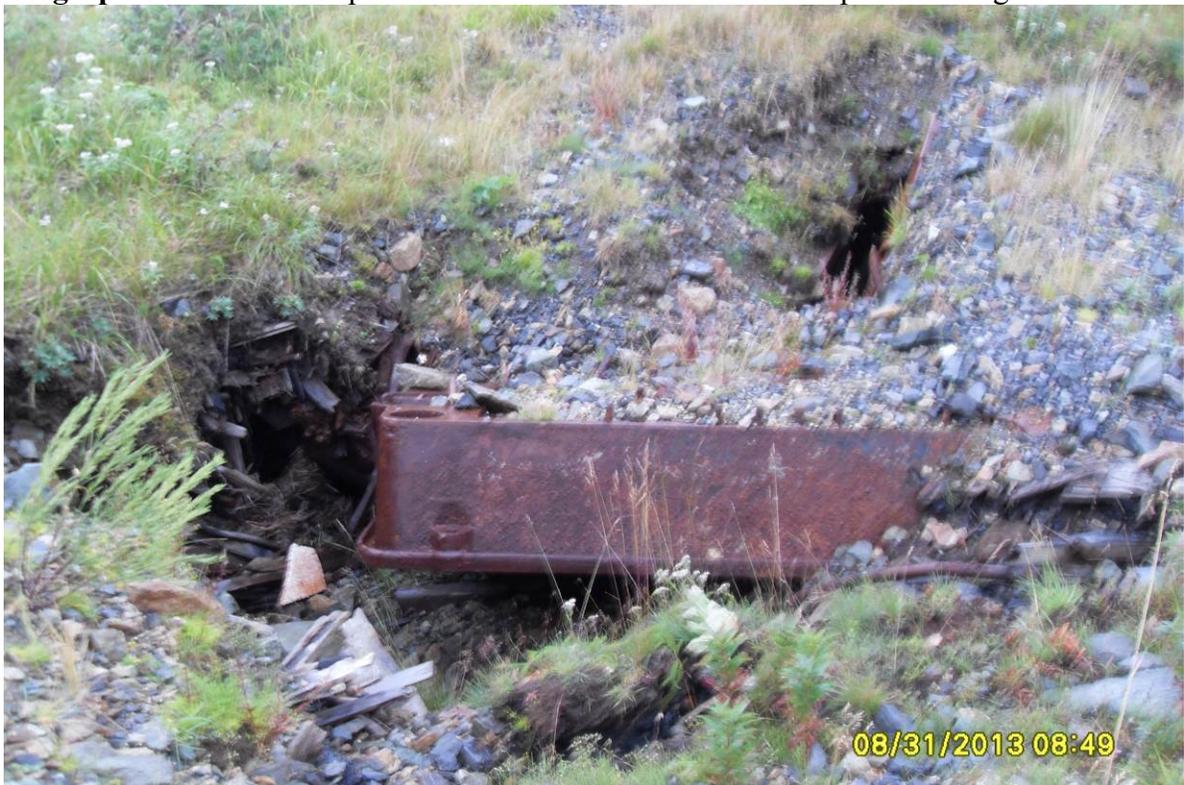
Photograph 0849 – Sinkhole in the stream looking south

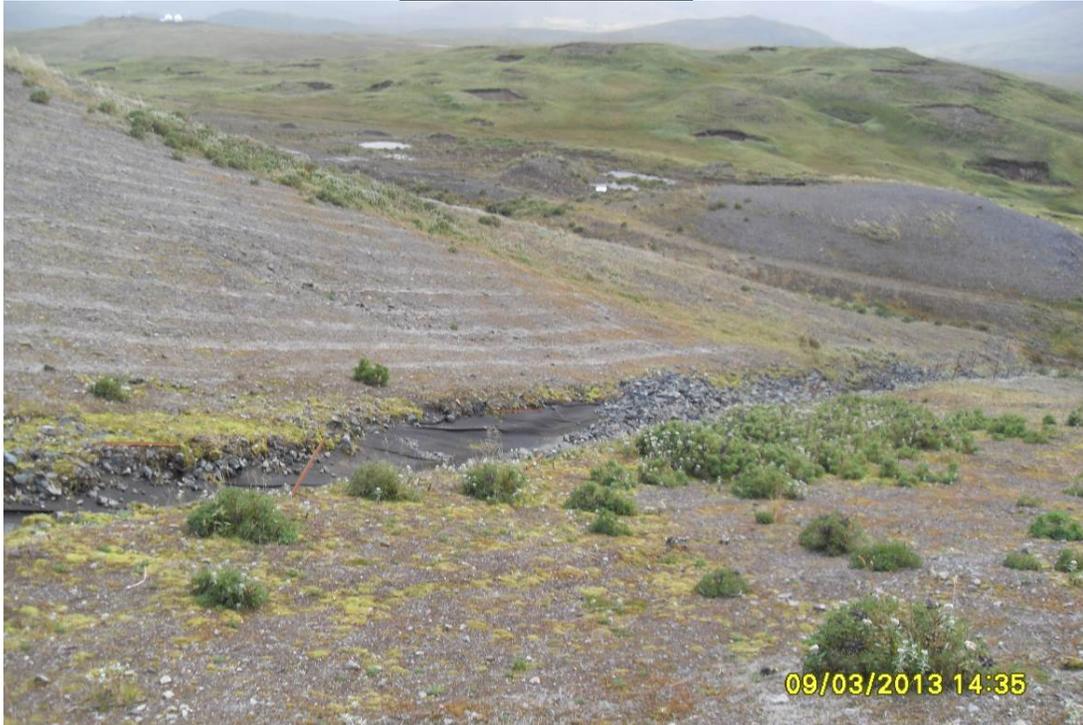
Additional notes: The swale on the southern boundary has several areas of exposed liner where the gravel has slid off. It is recommended that these areas be re-rocked and some type of flow dissipater be installed within the channel at several locations.

Photograph 1435- Additional view of the southern swale with exposed liner and sparse vegetation looking southeast

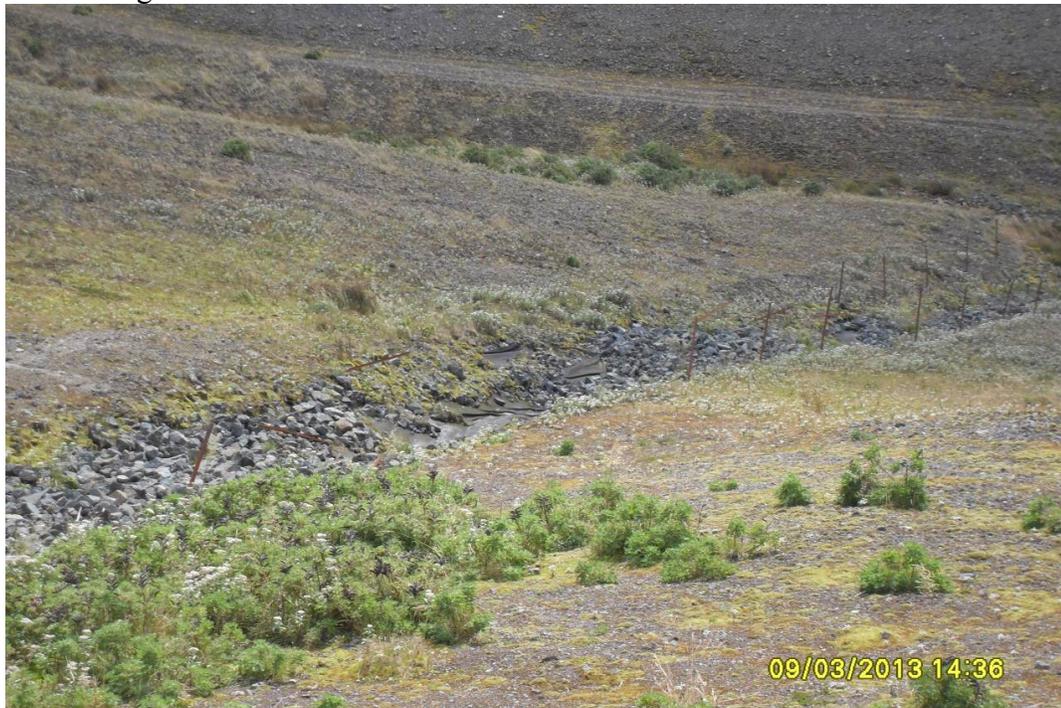
Photograph 1436 – Bottom of southern swale with exposed liner and sparse vegetation looking southeast

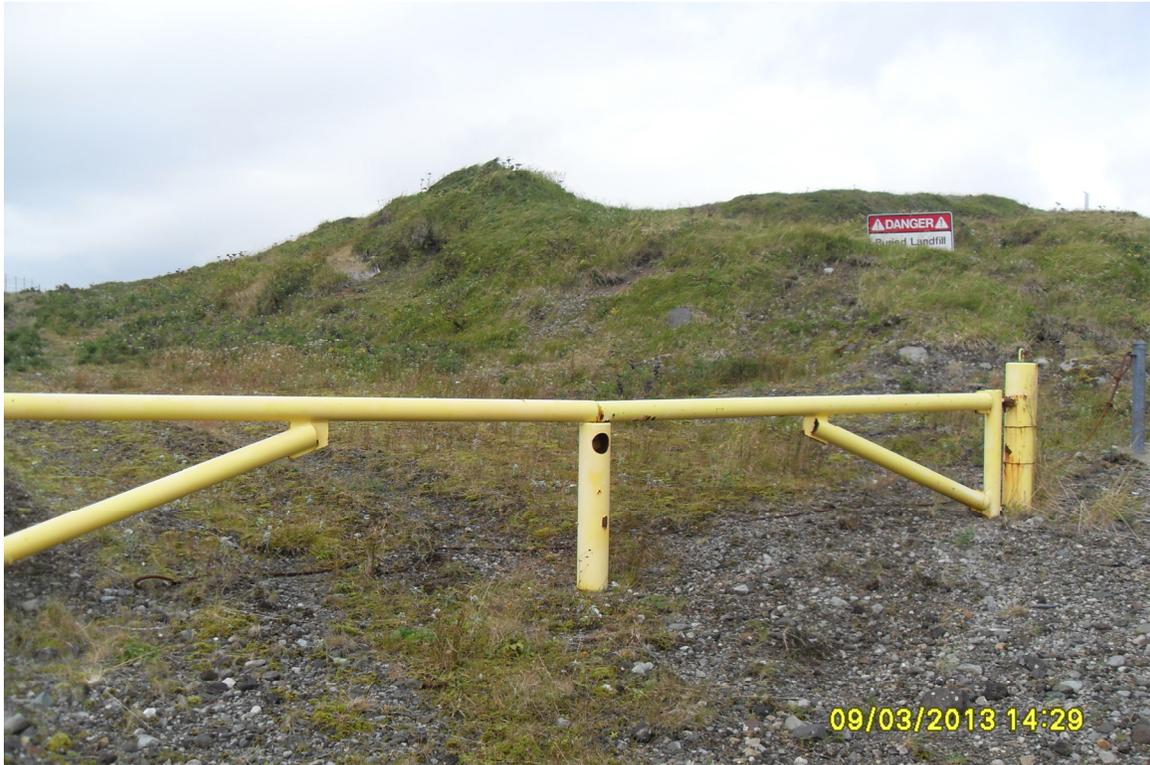
Photograph 1429 – Partially obscured sign at gate entrance to landfill, view north

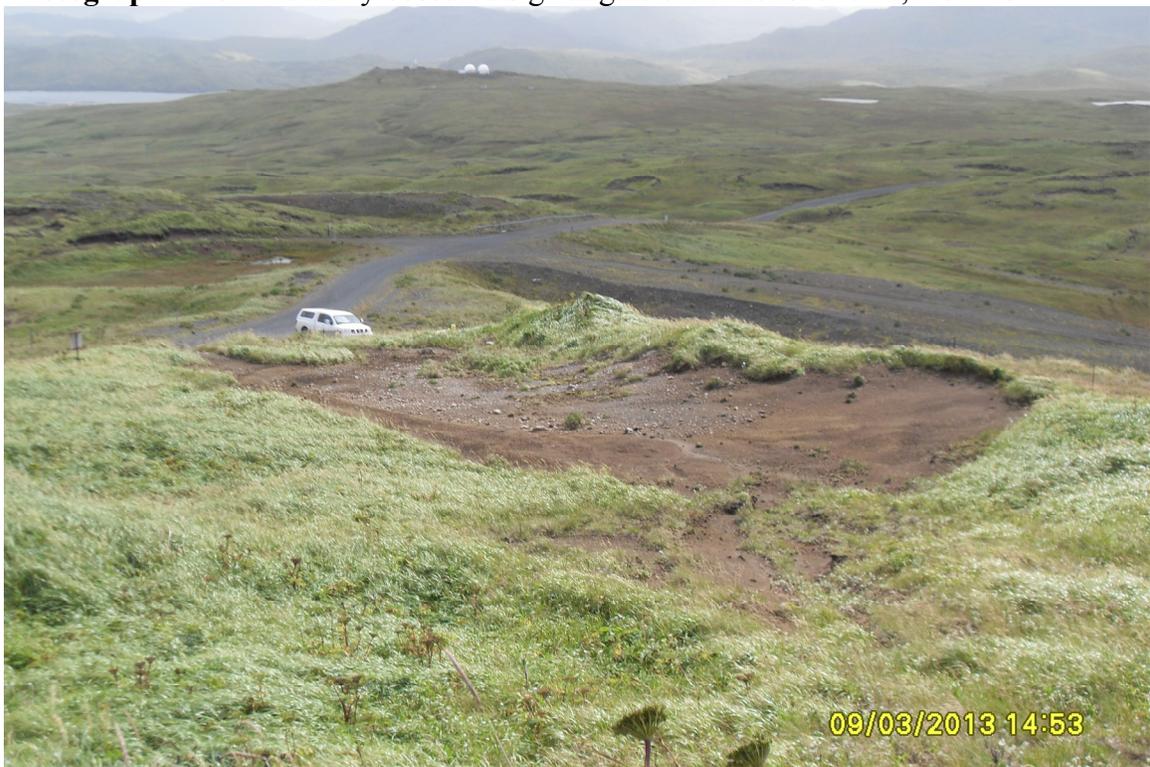
The eroded area (approximately 100 x 30 foot triangle outside the landfill on the southwest on the cliff) is still present and is in the same condition as observed during previous inspections. The repaired and re-seeded eroded area on southern boundary at the top of the swale appears to be stable, but revegetation efforts have not been successful. The rock in the swales has slid downhill in places exposing the liner beneath. One additional small 4 foot by 5 foot area of exposed swale liner was observed at the confluence on the landfill just above the previously eroded area. An area of erosion 40 feet x 90 feet is located near the entrance gate on the southeast perimeter of the landfill. This area is not thought to be on the landfill cap.

Photograph 1453 – Eroded area that is off the landfill cap view south.
