2013 Institutional Controls Site Inspection Report

Operable Units A and B-1

Former Naval Complex

Adak, Alaska

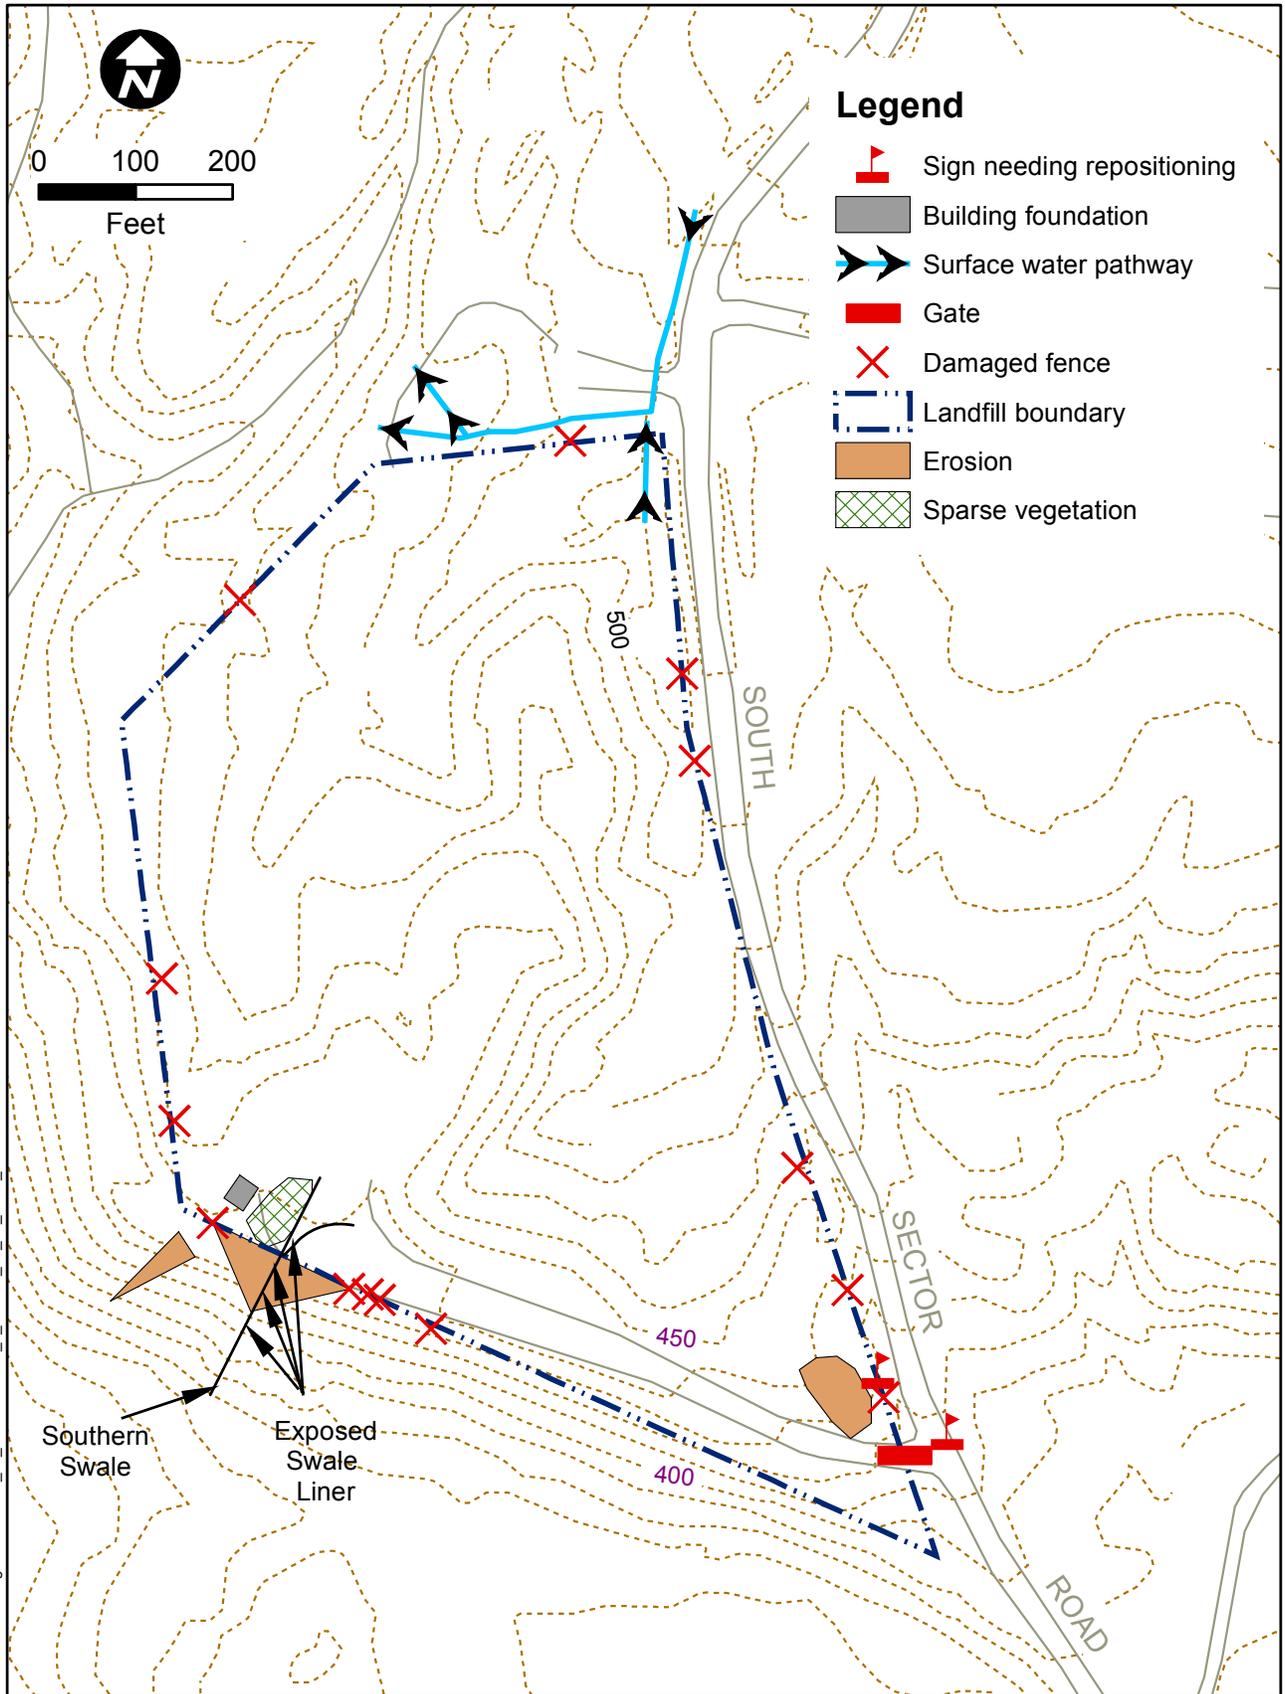
U.S. NAVY	SEALASKA	Figure 3-4 SWMU 18/19, White Alice Landfill
------------------	-----------------	--

Gate is in good condition. A total of 22 sections of fencing are in need of repair around the perimeter.

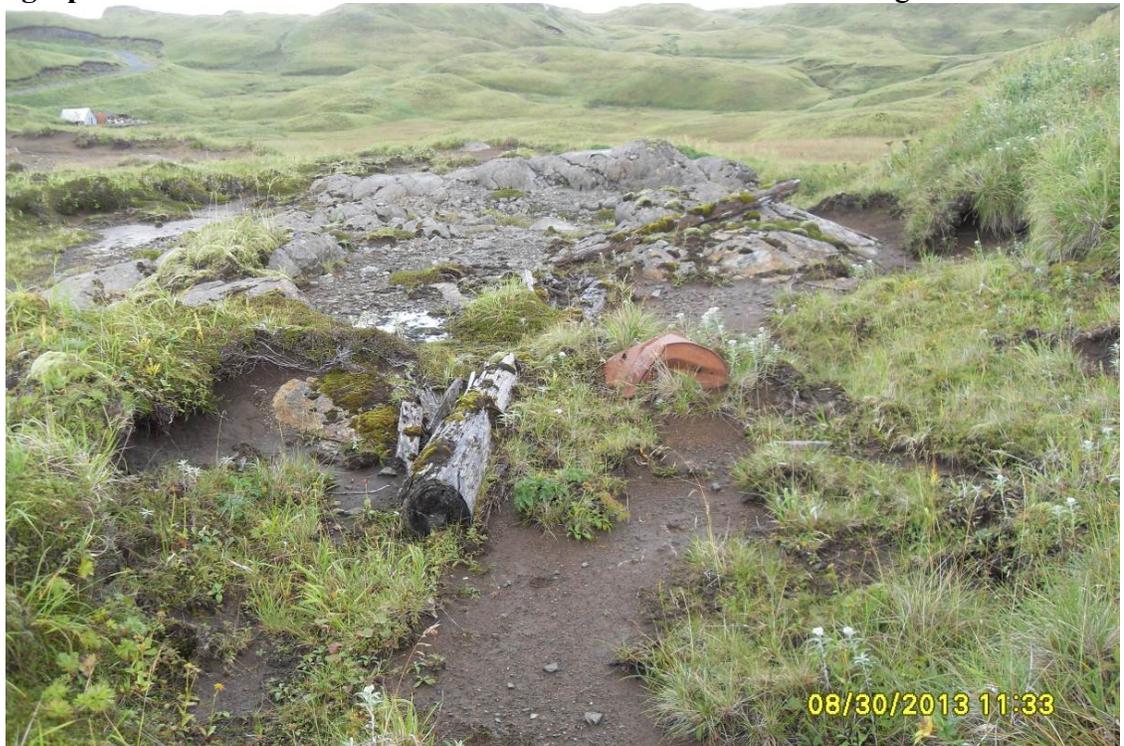
Photograph 1133 – Drum and power pole observed onsite on the south side of the landfill looking north

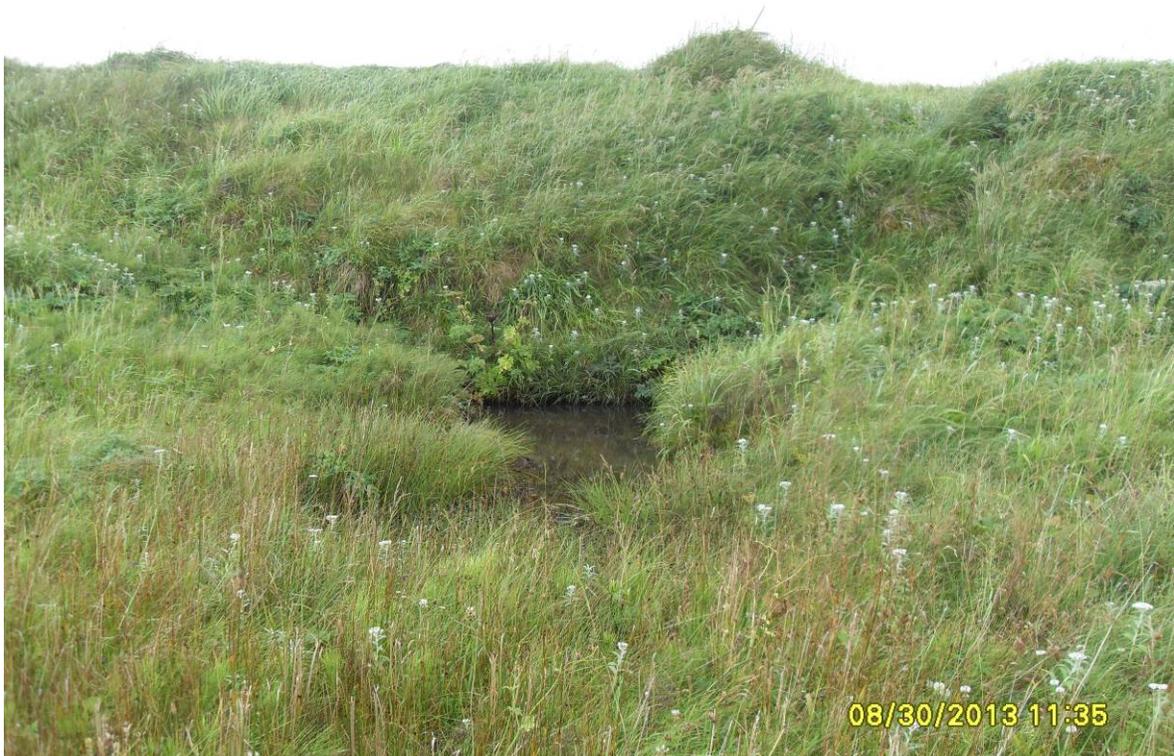
Photograph 1135 – Ponded area east of high point looking west

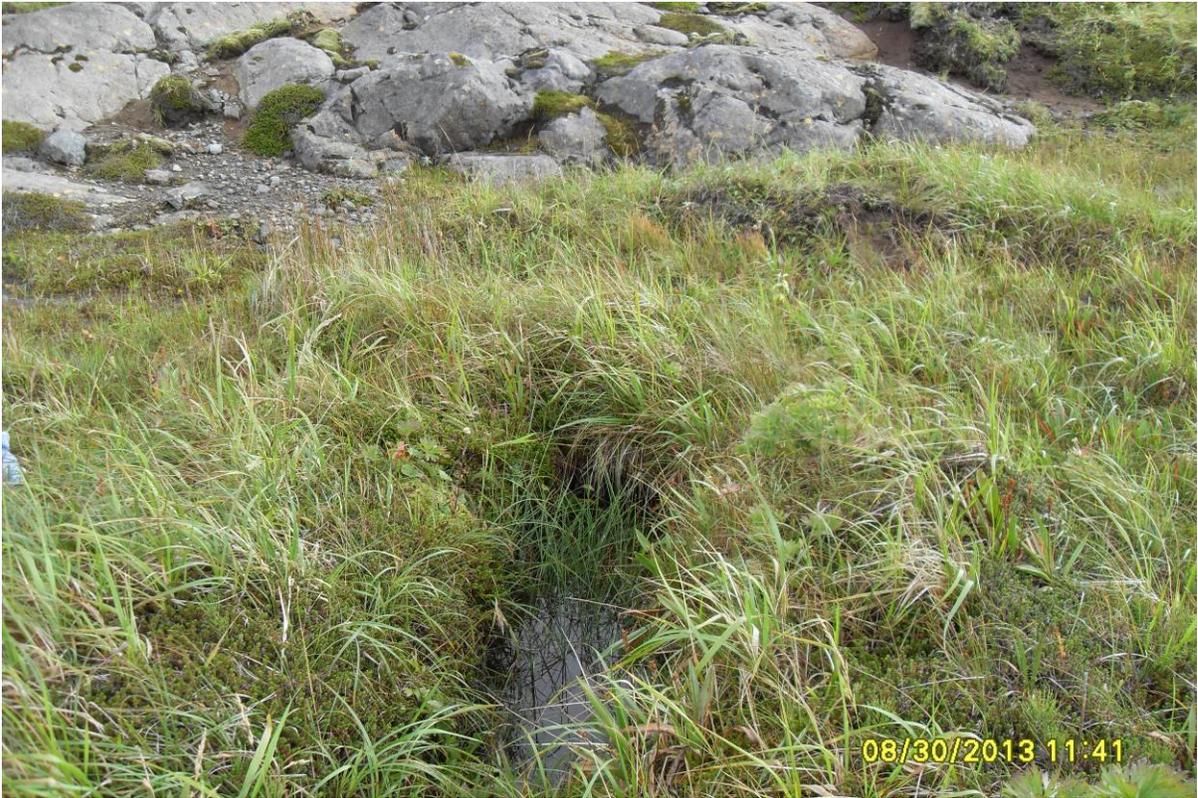
Photograph 1141 – Hole on southwest side of landfill looking east

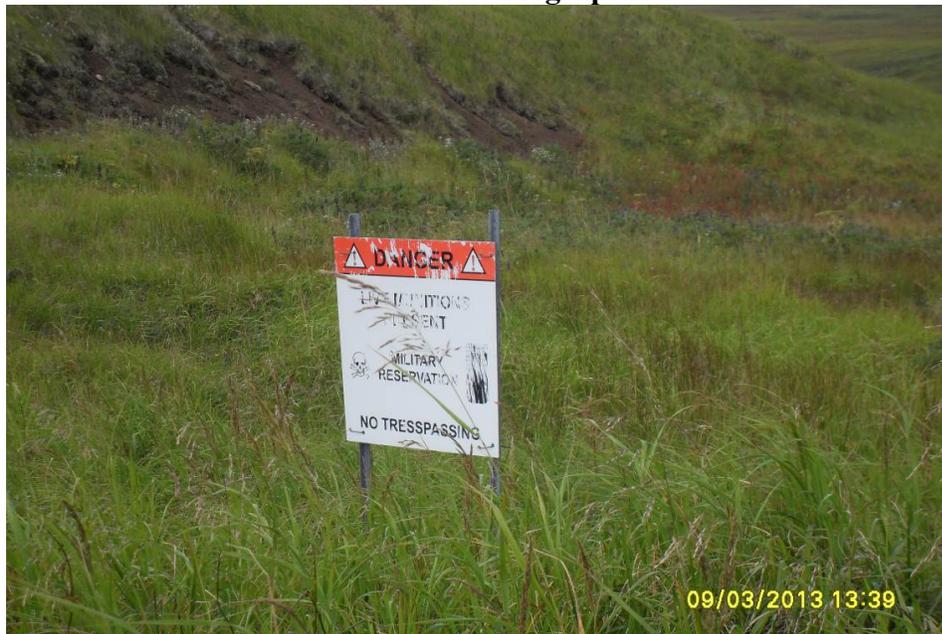
Photograph 1339 – Faded sign example along access road looking west

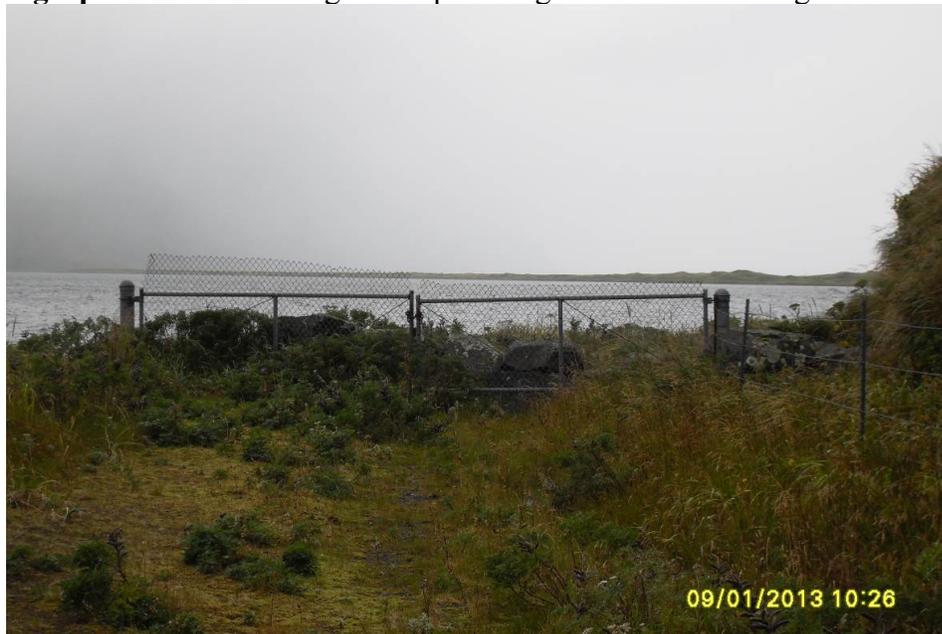
Photograph 1026 – Gate at Lake Andrew Recreation Center with missing sign looking north
