Adak Island UPDATE

SWMU 62, New Housing Fuel Leak Site: Proposed Cleanup

Naval Facilities Engineering Command Northwest

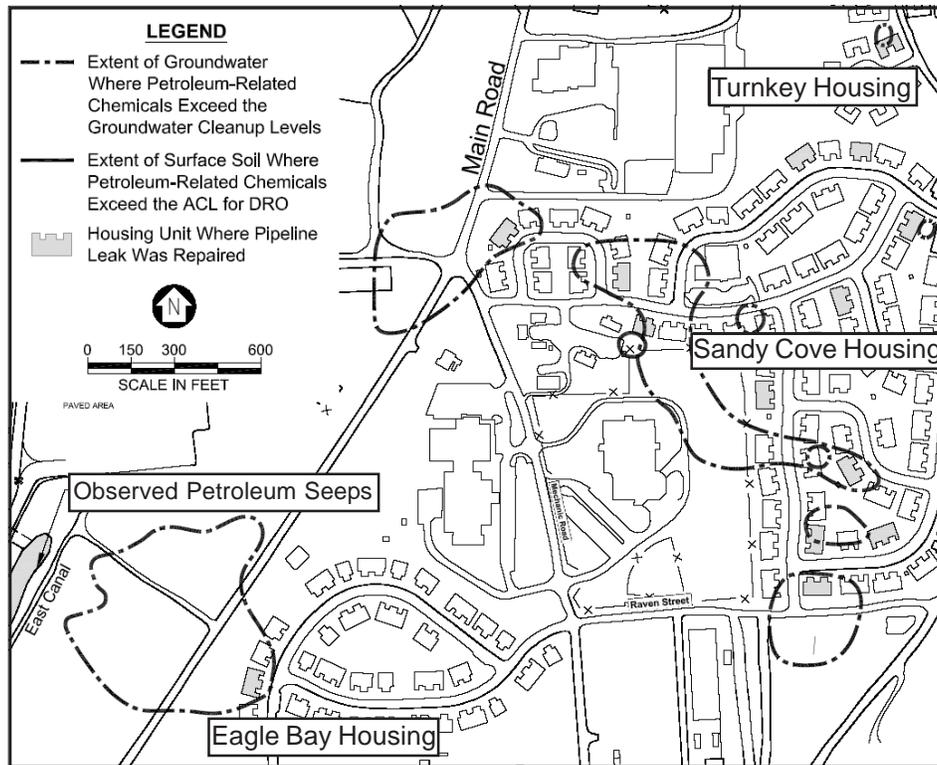
Figure 2. Extent of Surface Soil and Groundwater Contamination, SWMU 62, New Housing Fuel Leak site

During 1988 and 1989, five piping fuel leaks were discovered and repaired after occupants reported hydrocarbon-like odors in the housing units. Because of the leaks that had been detected, the heating fuel distribution system was pressure tested to assess the extent of potential releases. Sixteen additional piping leaks were detected and repaired as a result of pressure testing. Figure 2 shows the 14 housing units where the 21 piping leaks were identified. The

goals: a cumulative carcinogenic risk of 1 in 100,000 and a cumulative noncarcinogenic hazard index of 1.0. Figure 2 shows the extent of surface soil at the SWMU 62, New Housing Fuel Leak site containing petroleum-related chemicals at concentrations greater than the ACLs.

The Alaska regulations establish three methods for determining cleanup levels for groundwater. Cleanup levels specified for remediation of groundwater at the SWMU 62, New Housing Fuel Leak site, are based on the tabulated groundwater cleanup levels (18 AAC 75.345[b][1], Table C) because groundwater is considered to be a reasonably expected potential future source of drinking water. The extent of groundwater at the site containing petroleum-related chemicals at concentrations greater than the applicable groundwater cleanup levels is also shown on Figure 2.

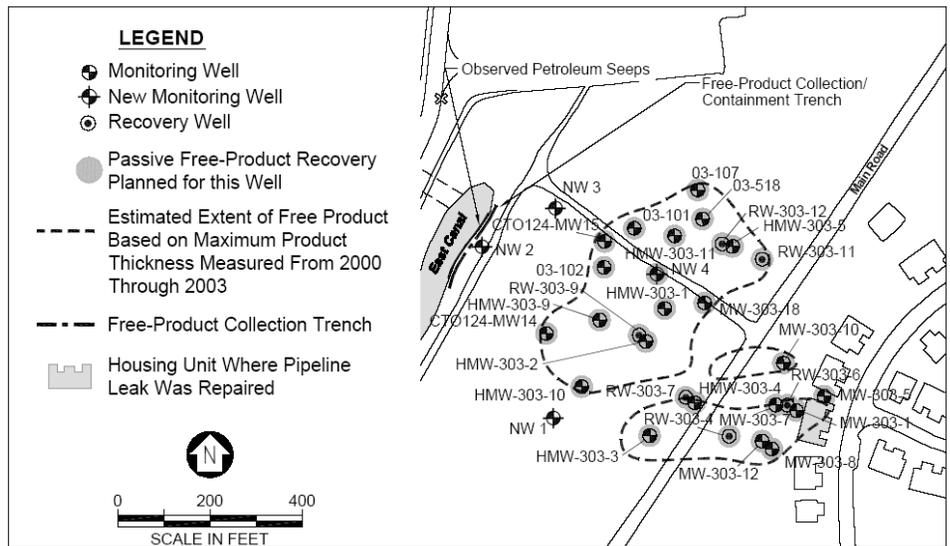
Figure 3. Preferred Cleanup Alternative Activities at Eagle Bay Housing, SWMU 62, New Housing Fuel Leak Site

Alternative 2 is the preferred cleanup alternative for the SWMU 62, New Housing Fuel Leak site (see Figures 3 and 4). As mentioned above, this remedy will involve continued use of institutional controls, recovery and containment of free product, excavation of surface soil, and MNA for groundwater. This alternative will provide an appropriate, cost-effective remedy that protects human health and the environment and can be implemented at the earliest possible time. The Alaska DEC concurs with the selection of this alternative as the preferred cleanup alternative. However, the Navy, in consultation with the Alaska DEC, may modify the preferred cleanup alternative, based on public comments.

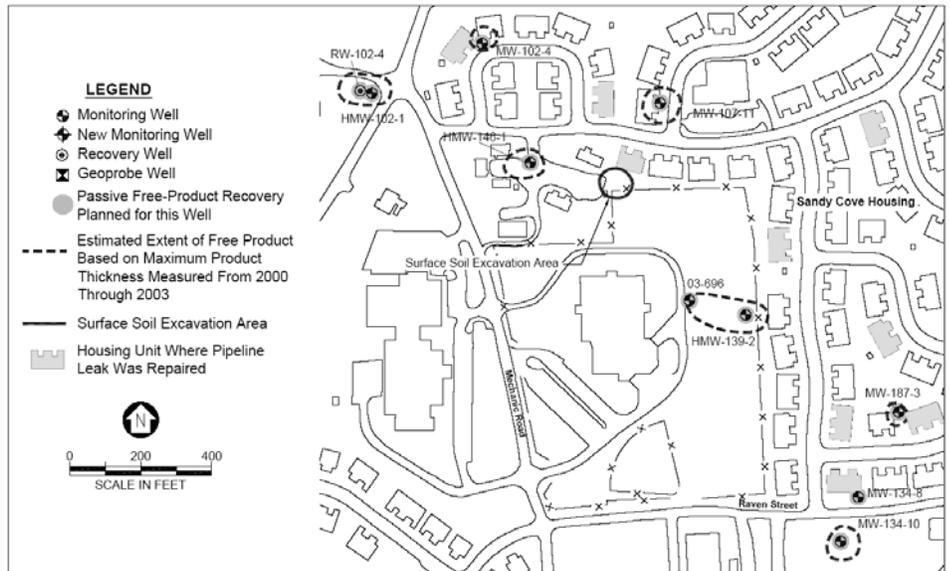
Figure 4. Preferred Cleanup Alternative Activities at Sandy Cove Housing, SWMU 62, New Housing Fuel Leak Site
