FINAL
NAVAL AIR STATION ALAMEDA RESTORATION ADVISORY BOARD
MEETING SUMMARY

March 1, 2007

ATTACHMENT B-2
DATA GAP SAMPLING RESULTS AT IR SITE 26
(12 Pages)

Data Gap Sampling Results IR26, Alameda Point, Alameda

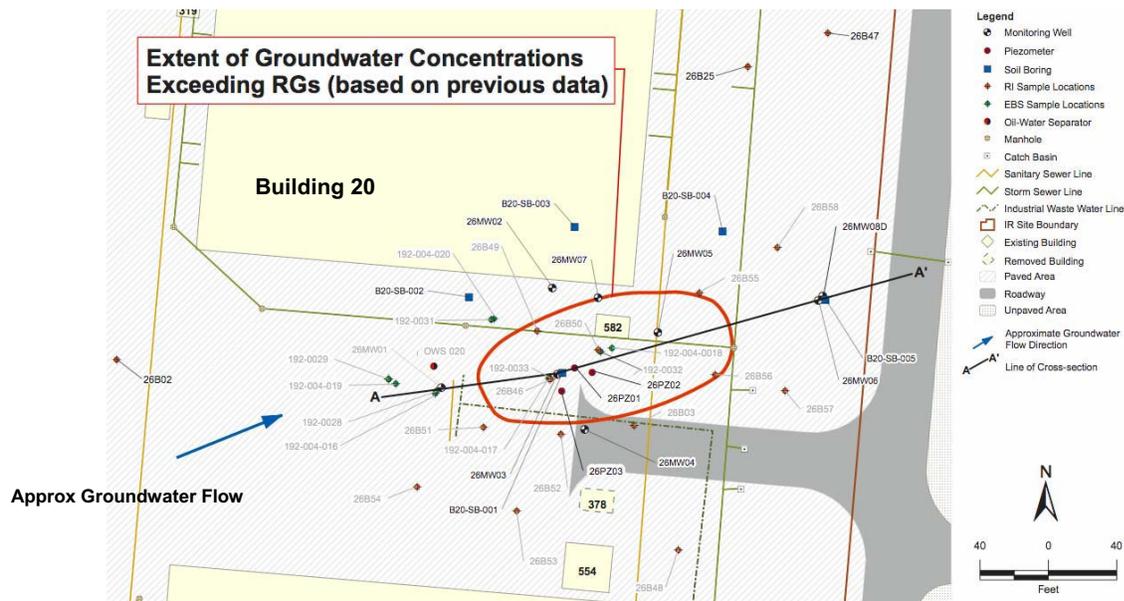
IR26 - Building 20 Study Area

Slide 8 showed the study area at IR Site 26 Building 20. Ms. Hess noted that the map showed the extent of contaminant concentrations in groundwater that exceeded RGs based on previous data that were presented in the ROD. The primary objective of the data gap investigation was to evaluate whether the plume extended beneath Building 20. The other objective was to further evaluate the lithology and depth of contamination within the boundaries of the plume that had been established in the ROD.

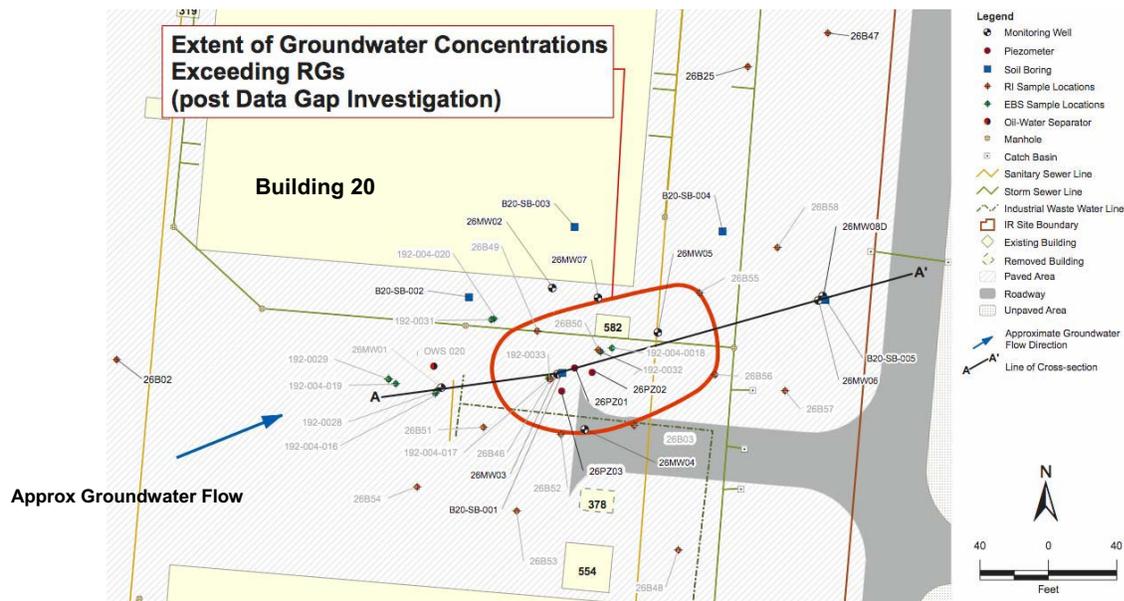
Data Gap Results (continued)

The results of the data gap investigation confirmed that the boundaries of the groundwater plume in the final ROD represent current site conditions. The groundwater sample results indicated that high concentrations of VOCs are restricted to fill materials that overlie the native soil. Slide 16 showed a map of the study area with the data gap results. The extent of the contaminant concentrations in groundwater that exceed RGs based on the data gap investigation was shown on the map. Slide 17 compared the pre- and post-data gap extent of concentrations in groundwater that exceed RGs.

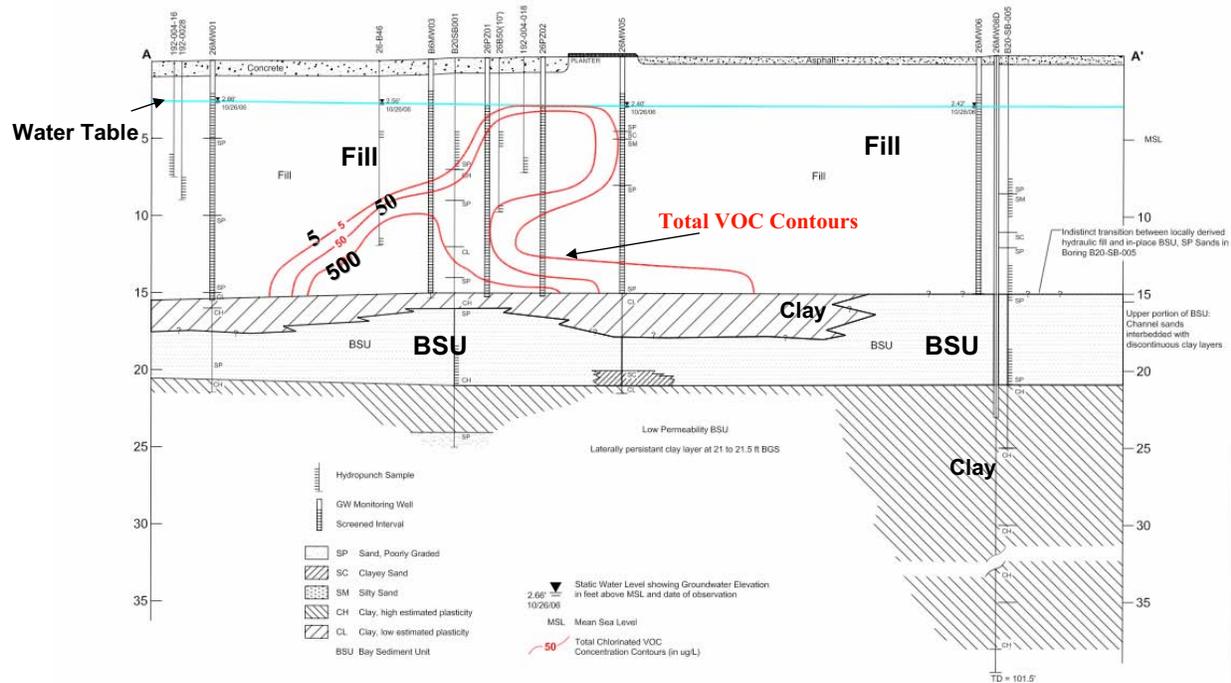
IR26 Cross-section A - A'

Evaluation of both previous and current geologic logs provided more detailed understanding of the site lithology. Fill materials overlay the native Bay sediment unit (BSU). The BSU extends from 15 to 15.5 feet bgs. A laterally persistent clay layer was encountered at 21 feet bgs and persisted from 21 to 101.5 feet bgs in one location. Slide 19 showed a cross-section of the groundwater plume. Contours for total VOCs were identified on the figure. The contamination did not extend into the clay layer.

Ms. Konrad asked about the shape of the contour lines on the cross-section figure of the groundwater plume on Slide 19. Ms. Hess commented that the contours were based on the RI/FS data and the data gap sampling results. The profile will help to establish the locations of injection points for ISCO. Mr. Humphreys commented that it appears the contamination is adsorbing into the clay. Ms. Hess responded that the grab groundwater samples indicated no VOC contamination in the clay layer. Mr. Humphreys asked if the BSU was the Merritt Sand. Ms. Hess replied that the BSU is the Bay Mud.

Merritt Sand was not found in the boring that extended from 21 to 101.5 feet bgs. The BSU shown in the figure is a poorly graded sand layer.

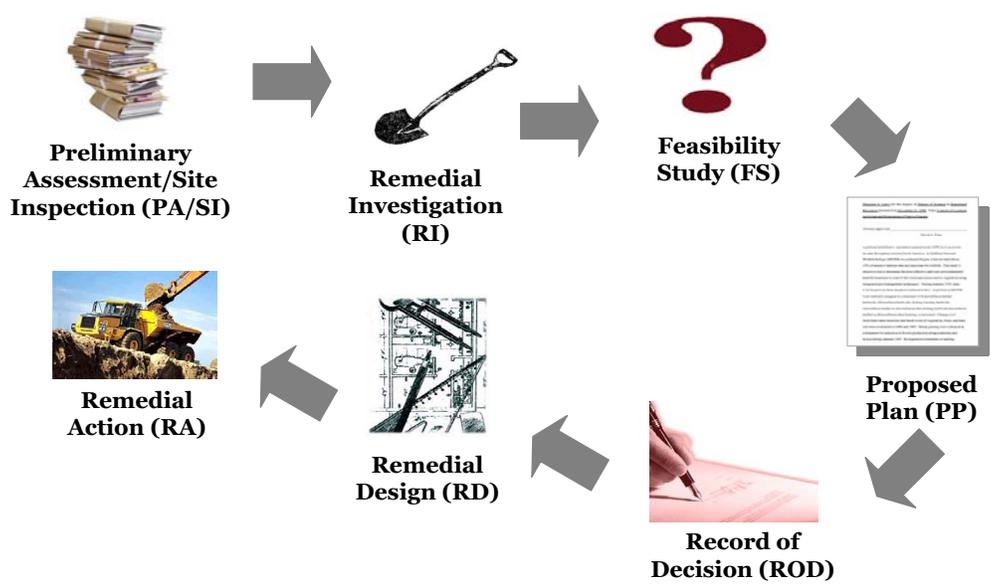
CERCLA PROCESS

Slide 5 showed a flow diagram of the CERCLA process. The draft final RI with response to comments (RTCs) is being prepared for IR Site 32. IR Site 2 is in the draft final FS stage and will be issued April 4, 2007. The draft ROD for IR Site 1 will be issued to the agencies on April 11, 2007.

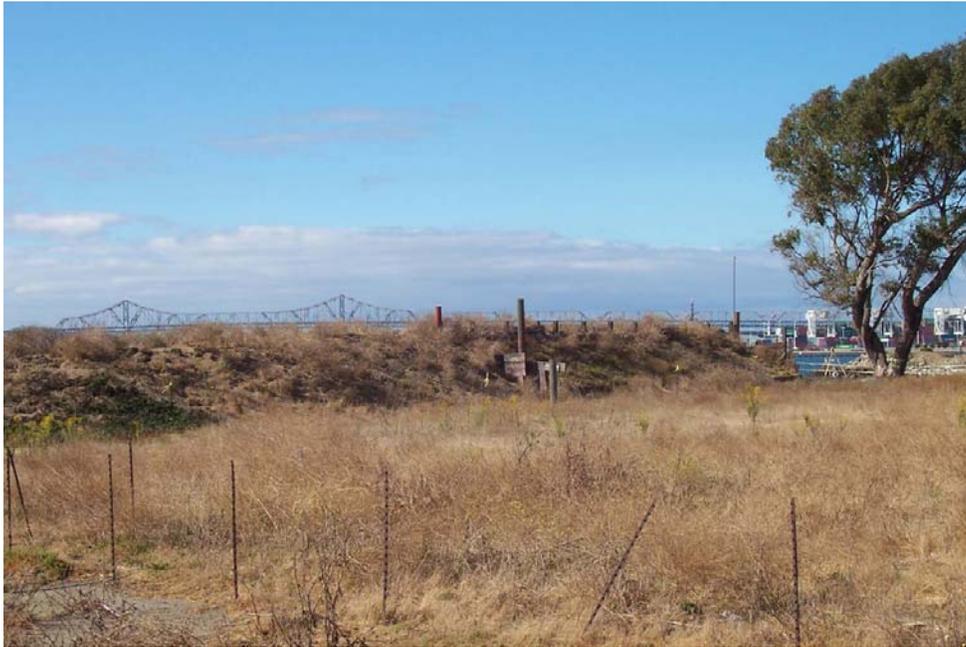
Firing Range

Slide 8 showed a photograph of the firing range. There is a two-step process for the former firing-range berm removal. The first step is to transfer excavated material to screening pads, where it is spread in a 6-inch layer for a MPPEH and radiological survey, visual and instrument screening. The material then is transferred to an on-site Trommel-type screening plant to separate the soil and shell casings into stockpiles of various sizes. Each stockpile will be then be chemically and radiologically screened again and disposed of off site. Approximately 5,100 cubic yards of material is anticipated. Mr. Humphreys asked why the Navy needs to screen the material a second time and divide it into different sizes if it will all be disposed of off site. Mr. Baughman replied that the various stockpiles may be disposed of at different locations and that sifting the material makes it easier to characterize and demonstrate no materials of concern are overlooked. Mr. Humphreys asked if material that is not contaminated will be disposed of off site. Mr. Baughman replied that it would be disposed of off site.

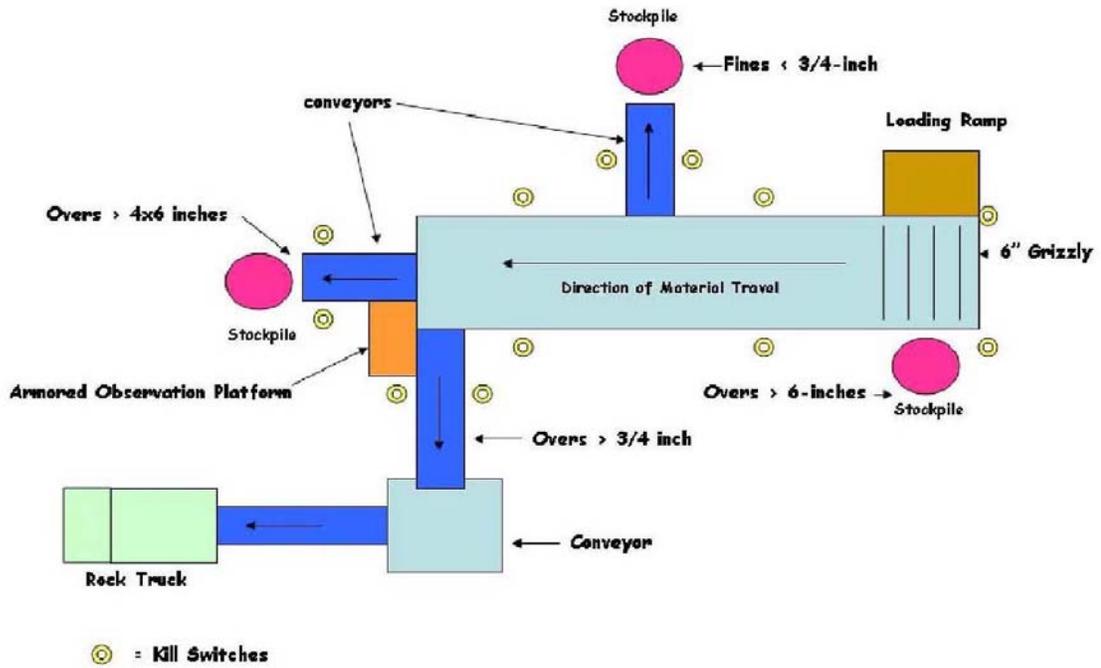
Screening Plant Configuration

Slide 10 showed a schematic diagram of the configuration for the Trommel-type screening plant. The 6-inch grizzly catches large items. After it passes through a rotating drum, material is sifted into stockpiles of various sizes. Slide 11 showed photographs of a typical screen plant. The grizzly is shown in the left photograph, and the rotating drum is shown in the right photograph.

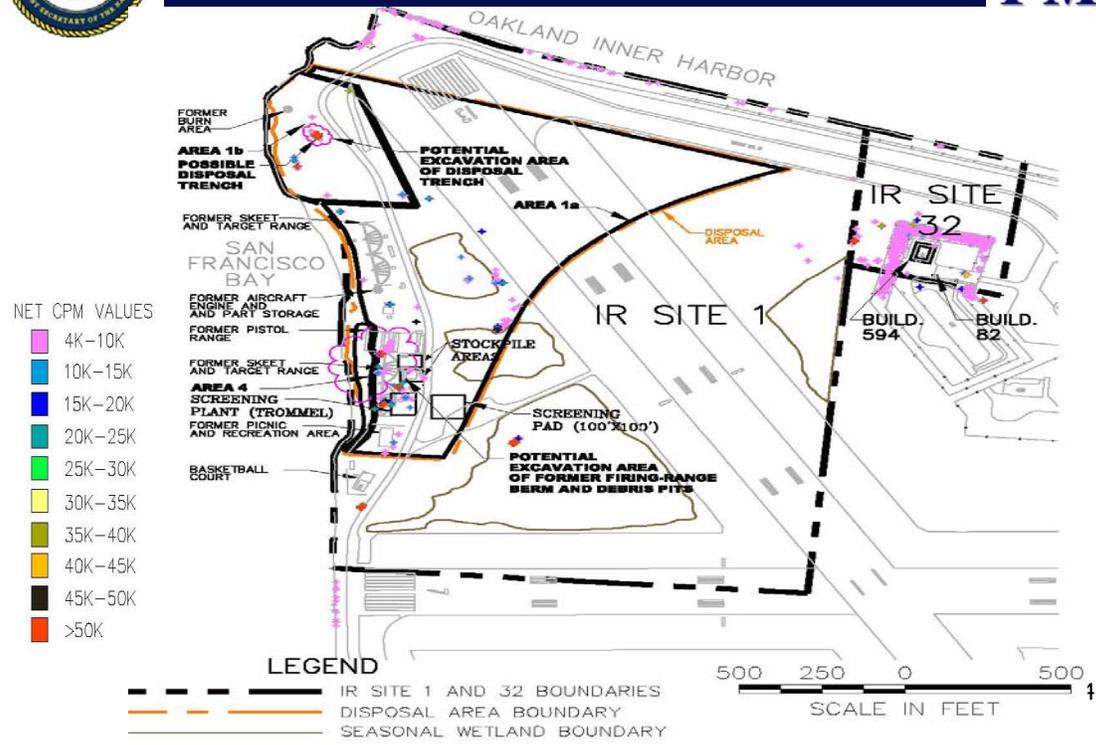
IR Site 1 and 32 Radiological Survey

Slide 14 showed the results of radiological surveys for IR Sites 1 and 32. The pink areas show results that are at about background. The pink areas that exceed the criteria of about 9,000 net counts per minute (cpm) will be excavated, and all other areas shown in color on the map will be removed. The pink cloud shape in IR Site 1 represents the disposal trench and berm excavation. The pink area in IR Site 32 is attributed to the naturally occurring readings in gravel. Mr. Humphreys asked the spots in the firing range are the result of depleted uranium rather than radium. Mr. Baughman replied that there is no history of depleted uranium at the site. Mr. Humphreys asked if the spots beneath the berm indicate that the berm was constructed on top of areas where radium had been previously disposed of. Mr. Baughman responded that the spots are surface locations identified during the survey. When the berm is removed, soil will be scanned in 6-inch increments to make sure that all materials of concern are removed.

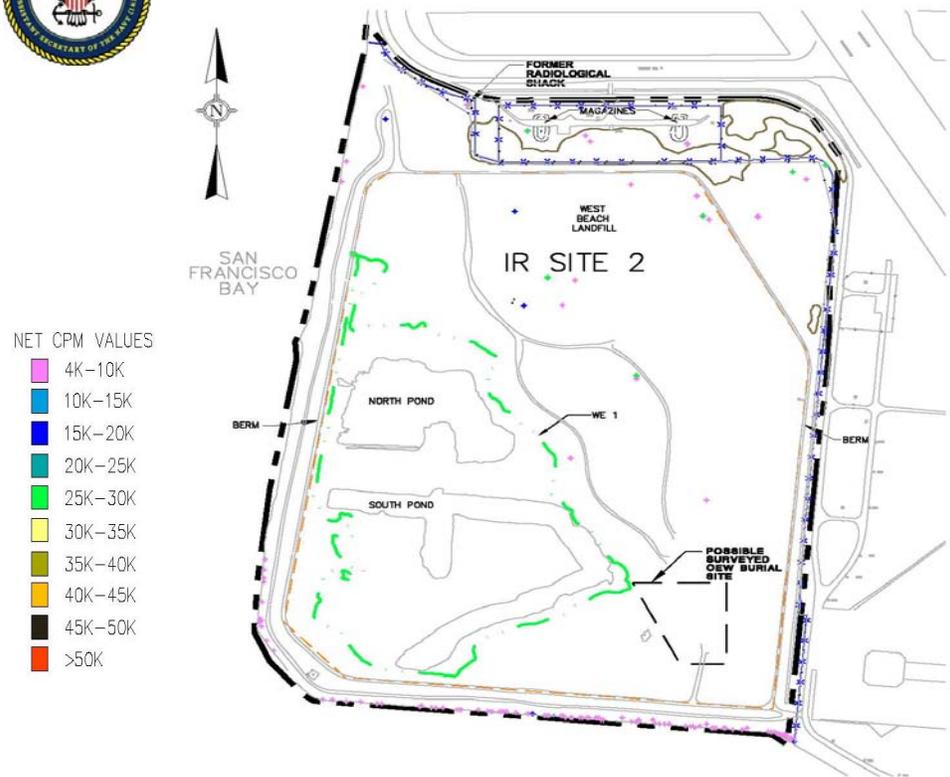
IR Site 2 Radiological Survey

Slide 15 showed the results of the radiological survey for IR Site 2. Mr. Baughman noted that the green dotted line is the boundary of the wetlands and the blue around the edge is a fence. There are removals at the former radiological "shack." The blue and green spots are locations where all materials will be removed. The pink spots along the south boundary are a result of the naturally occurring readings from the riprap. This area was hand surveyed between the riprap, and one spot shown in blue is planned for removal.

Ms. D. Smith commented that the radiological survey mentioned a bunker near the radiological shack that was used to store radiological materials. She asked if that bunker was sampled for radiological material and noted that the original intended use was not storage of these materials, although it was later used in that capacity. Mr. Baughman commented he was aware only of Bunker 357, but he would investigate and discuss it further after he reviews the reference to the bunker in the radiological survey.
